RE: RESPONSE TO APRIL 1, 2021 LETTER REGARDING FURTHER ACTION AT THE LAKE TAPPS MINI-MARKET 18215 9th STREET EAST, LAKE TAPPS, WASHINGTON FARALLON PN: 571-001 VCP IDENTIFICATION NO: SW0741

RESPONSE TO APRIL 1, 2021 ECOLOGY LETTER LAKE TAPPS MINI-MARKET 18215 9th Street East Lake Tapps, Washington

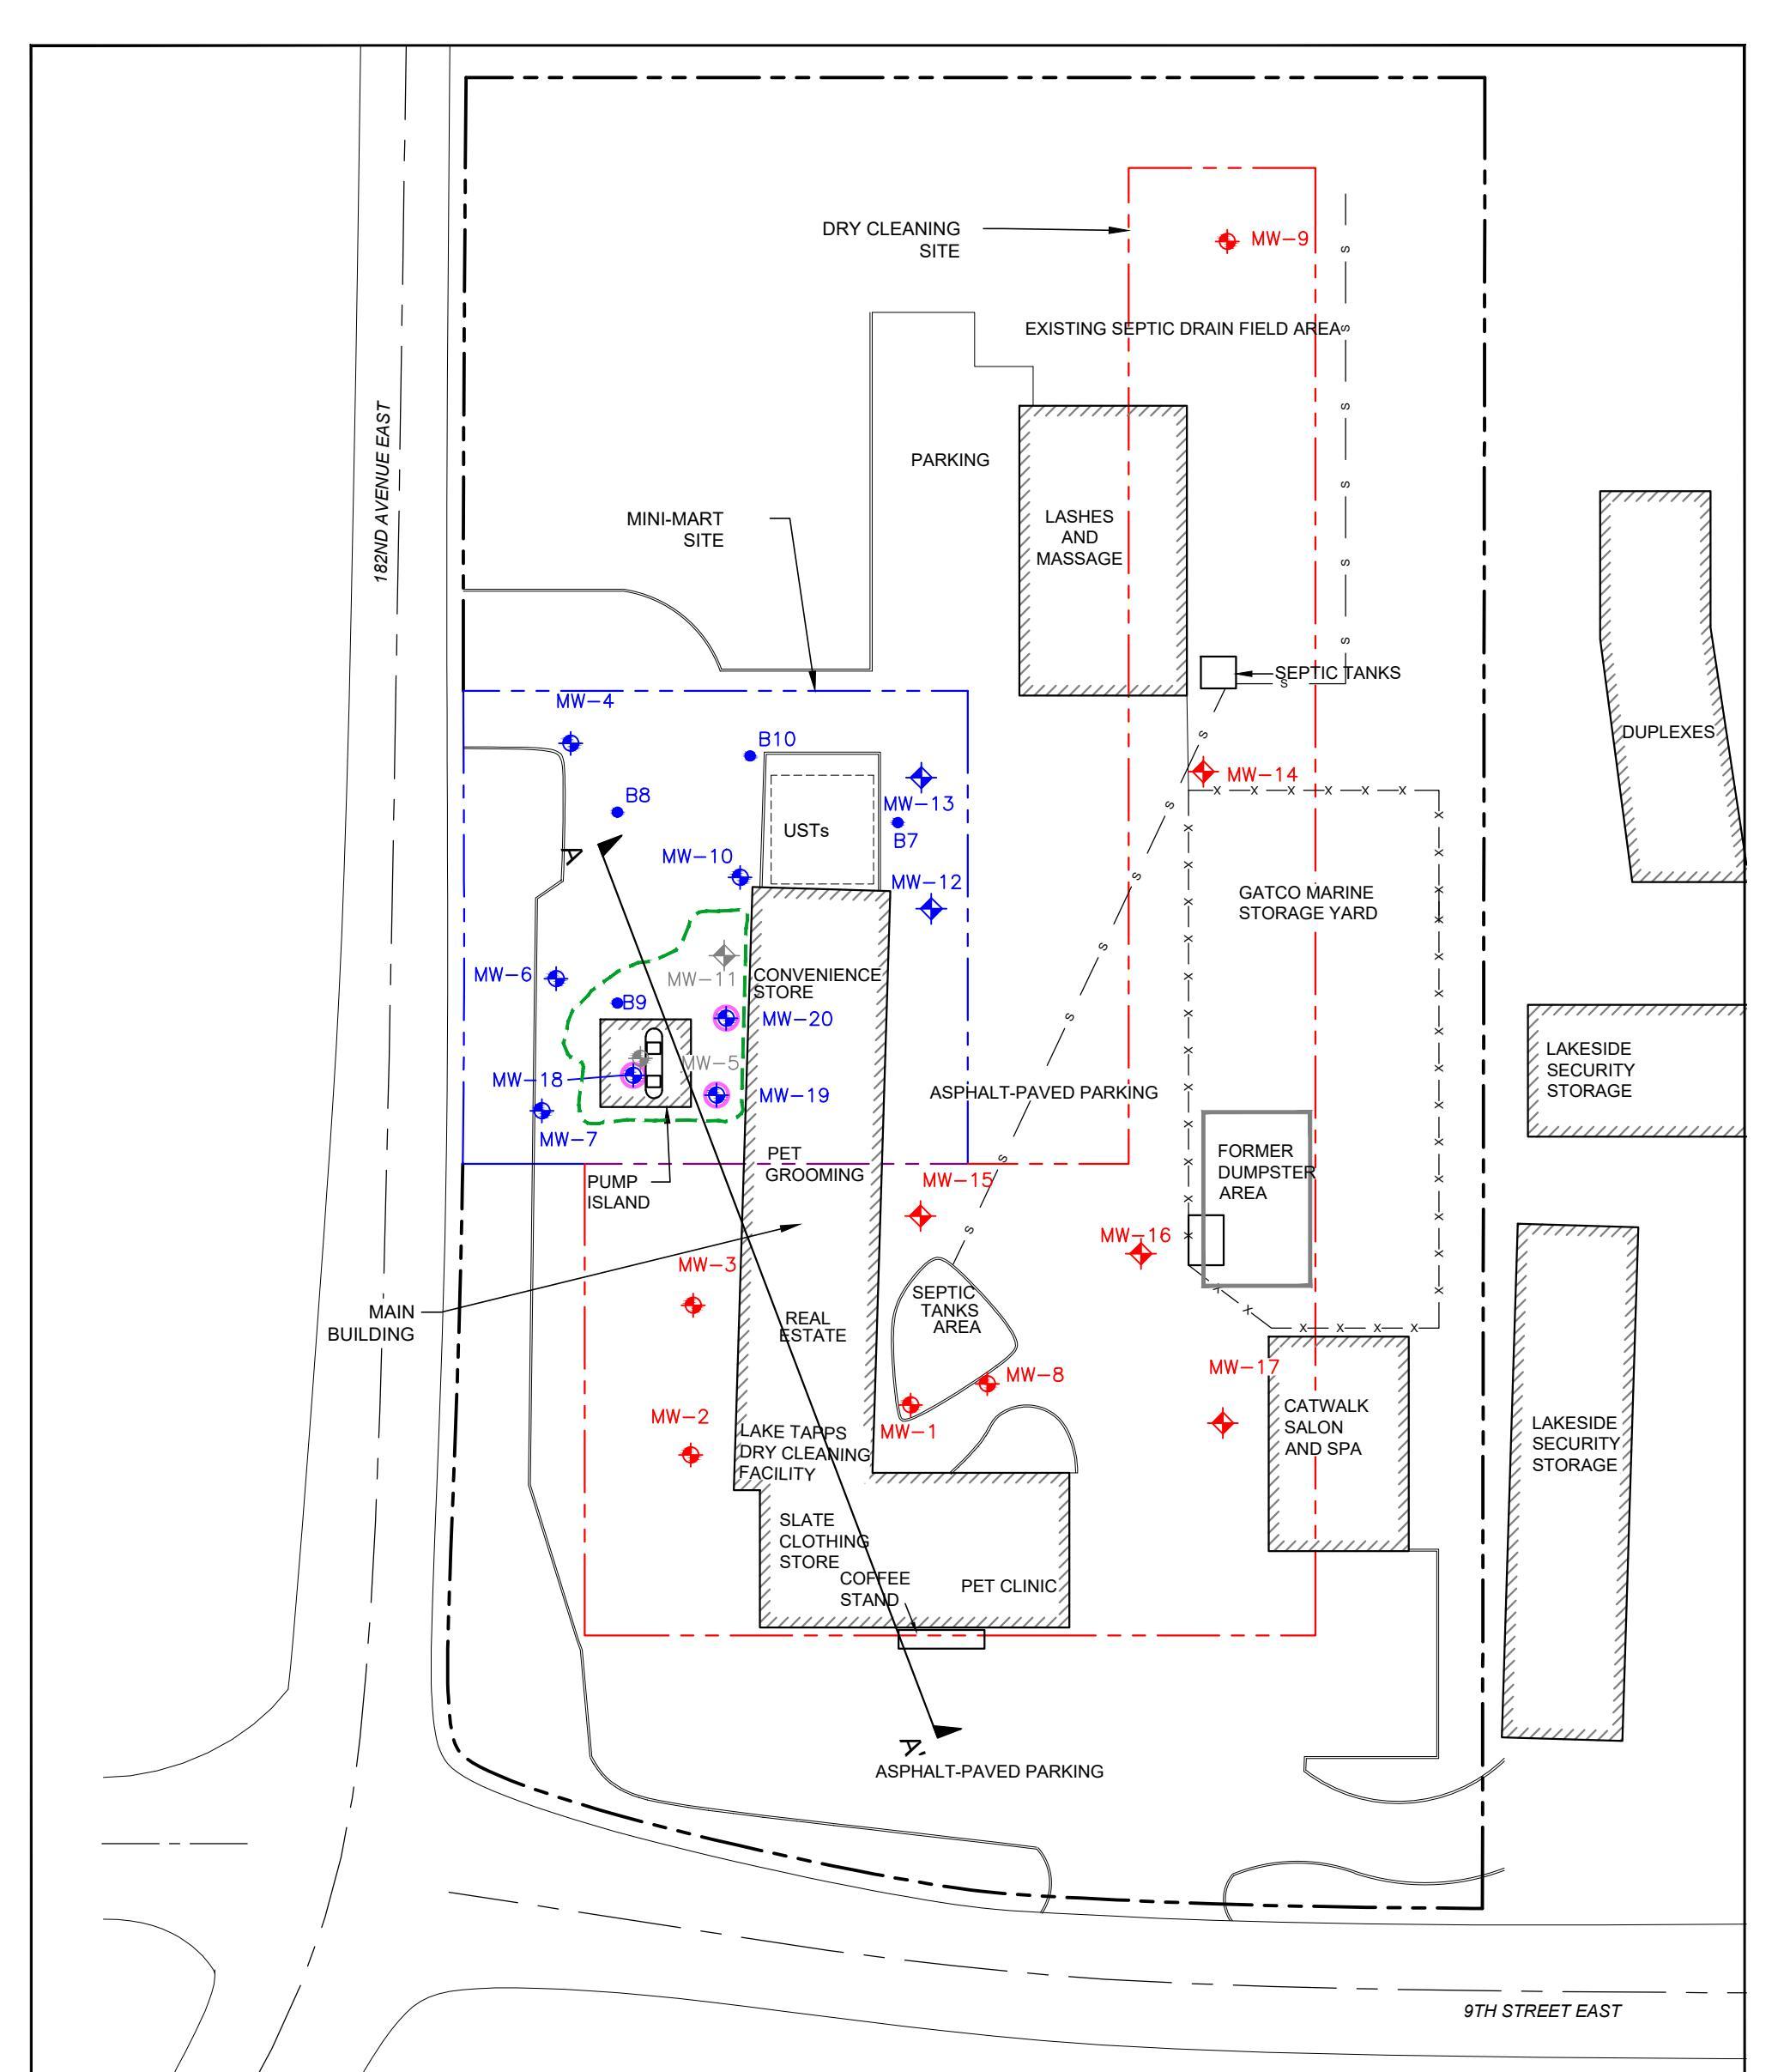
- Figure 1 shows a Site Plan that identifies the Site and the Lake Tapps Dry Cleaning Facility (herein referred to as the Dry Cleaning Facility) boundaries, sample locations associated with the Site, including point-of-compliance groundwater monitoring wells, and sample locations associated with the Dry Cleaning Facility.

Attached Figure 1 identifies monitoring wells located on the Site versus the Dry Cleaning Facility. Boring and soil sample locations at the Site and the Dry Cleaning Facility were identified in historical reports previously provided to Ecology . Collective historical documentation and the supplemental materials provided herein are sufficient for Ecology to define the sites and evaluate the cleanup status of the limited release of gasoline at the former dispenser location at the Site.

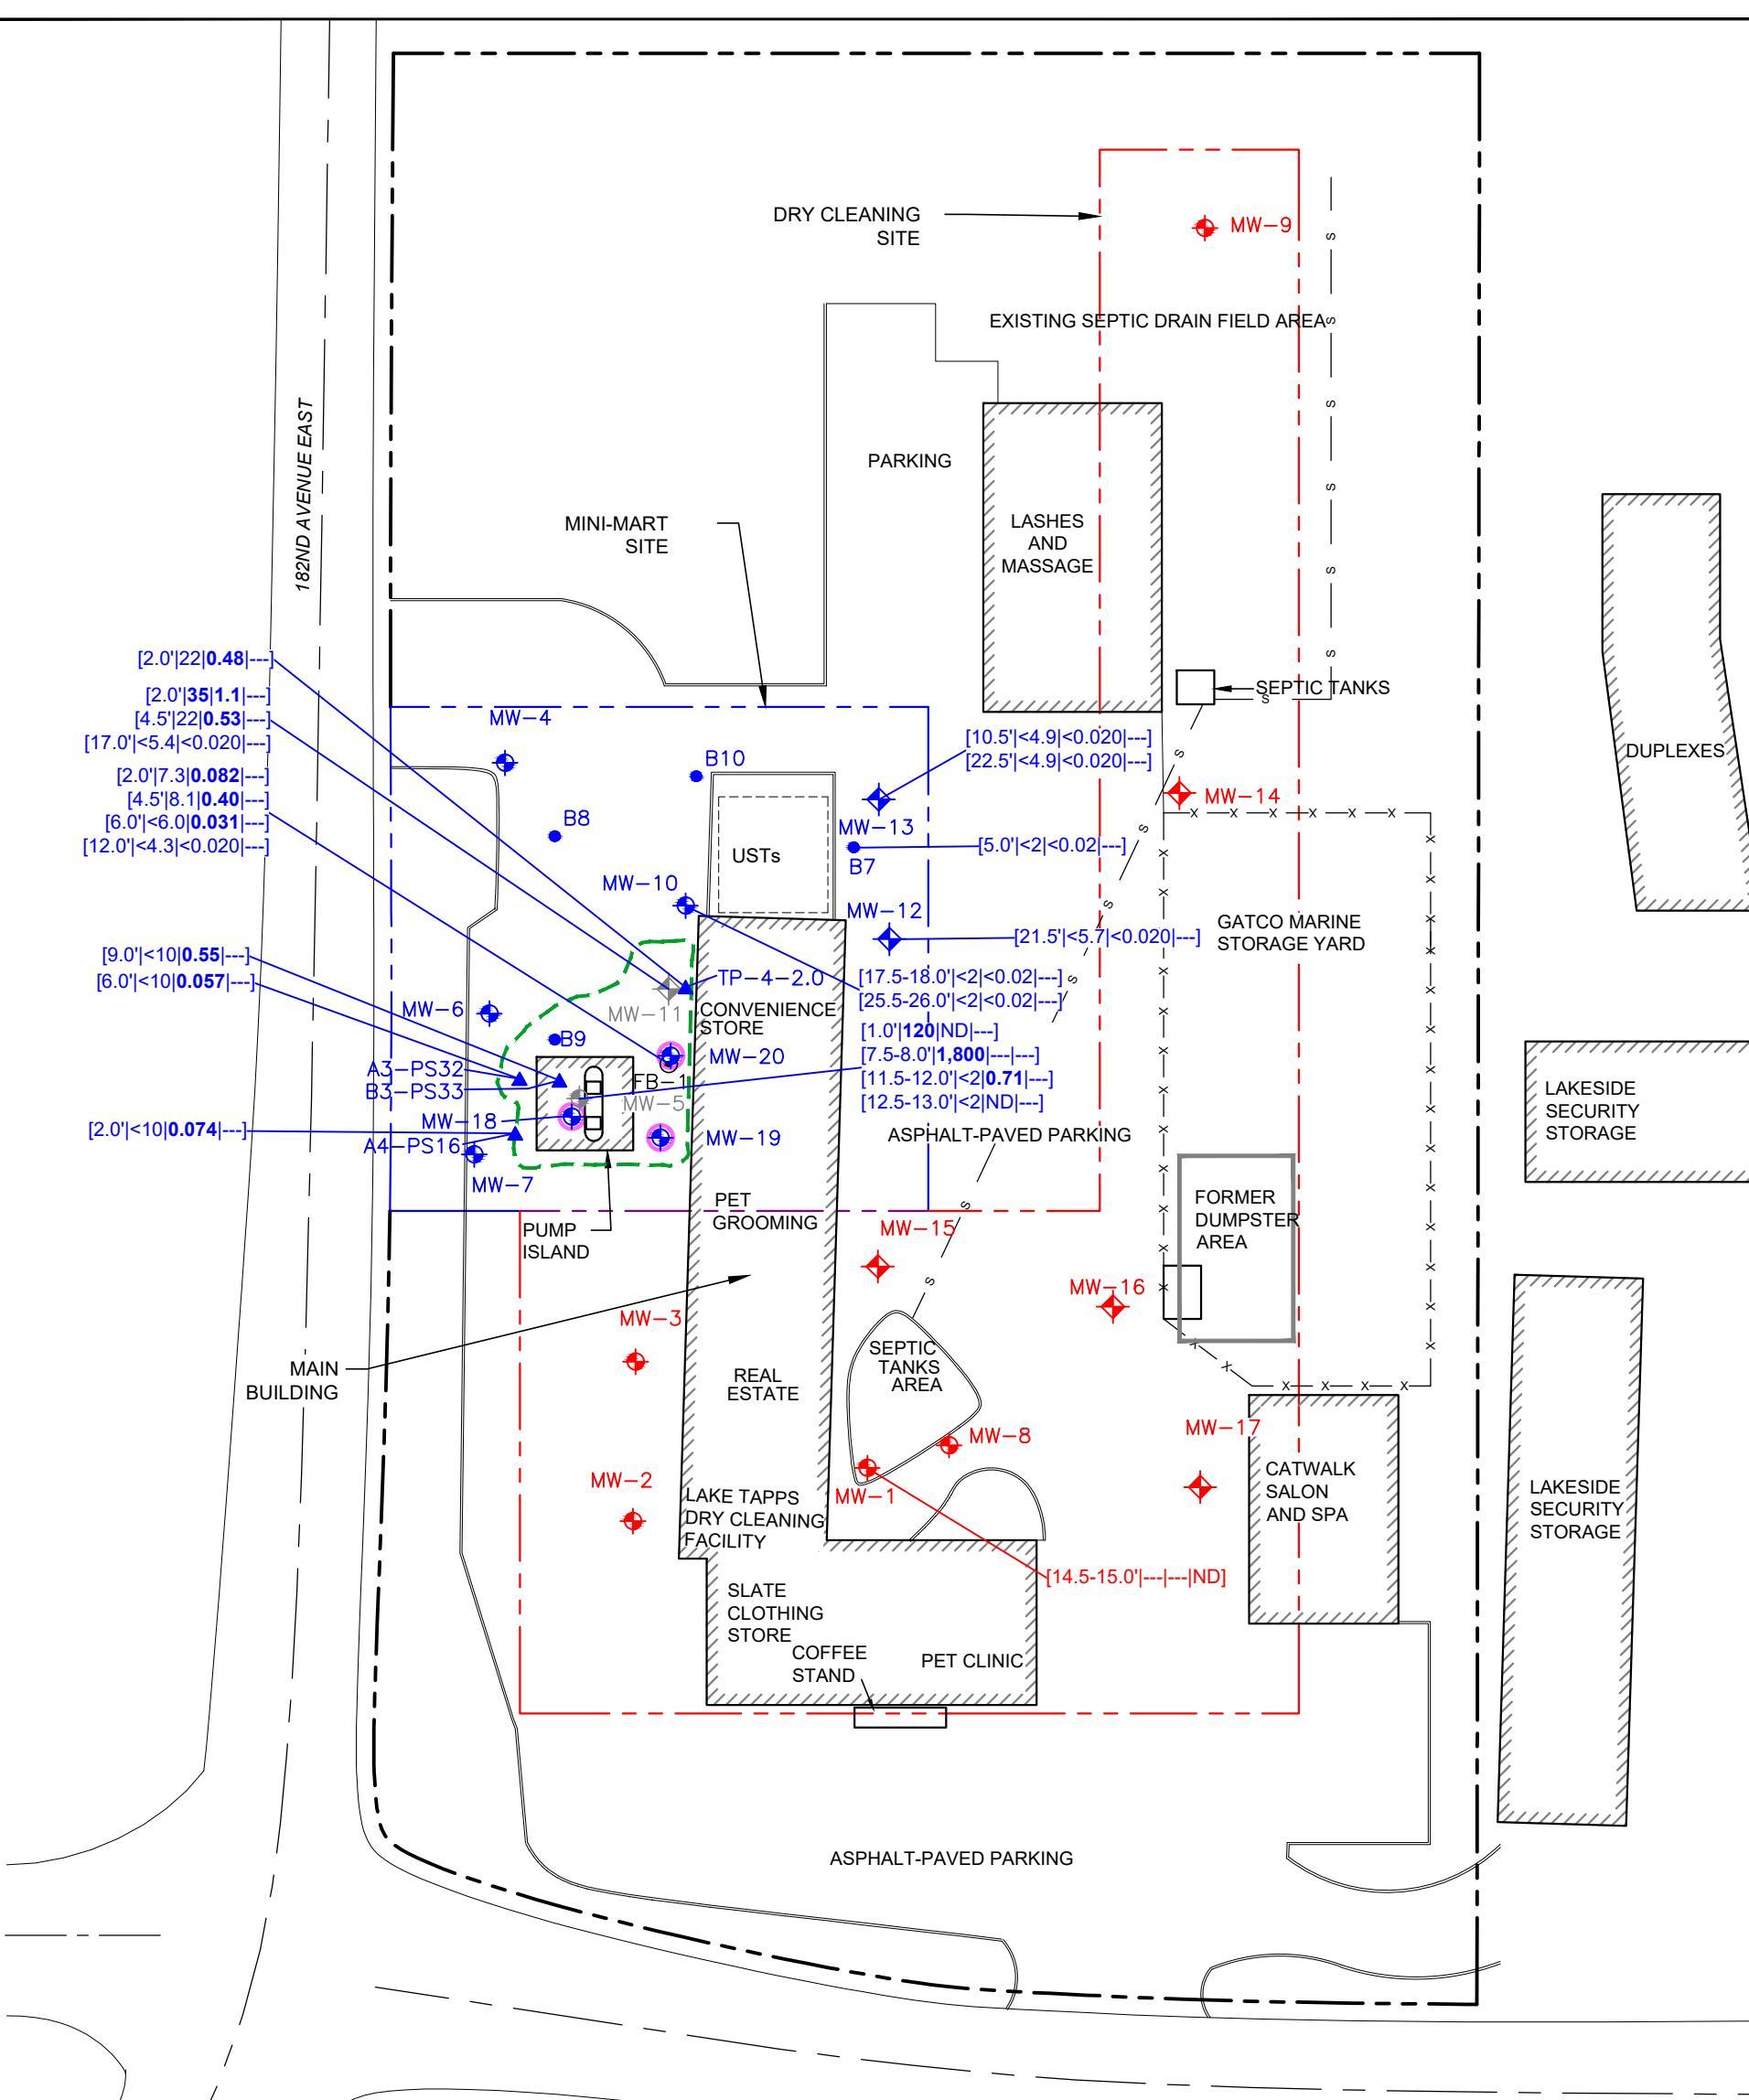
- Figure 2 shows TPH soil analytical results for subsurface investigation activities conducted following excavation and removal of the TPH-impacted source area that occurred at the Site in 2011, and HVOC soil analytical results for the Dry Cleaning Facility.

Oregon Portland Baker City	SITE PLAN SHOWING SOIL ANALYTICAL DATA
UST = UNDERGROUND STORAGE TANK	EDALLO	California	LAKE TAPPS, WASHINGTON
RED = DRY CLEANING FACILITY	FARALLO Consul	Oakland Irvine	
BLUE = MINI-MARKET SITE	Your Challenges. Our P	riority. farallonconsulting.com	
ALL LOCATIONS ARE APPROXIMATE	Drawn By: NM	Checked By: CB	FARALLON PN: 571-001

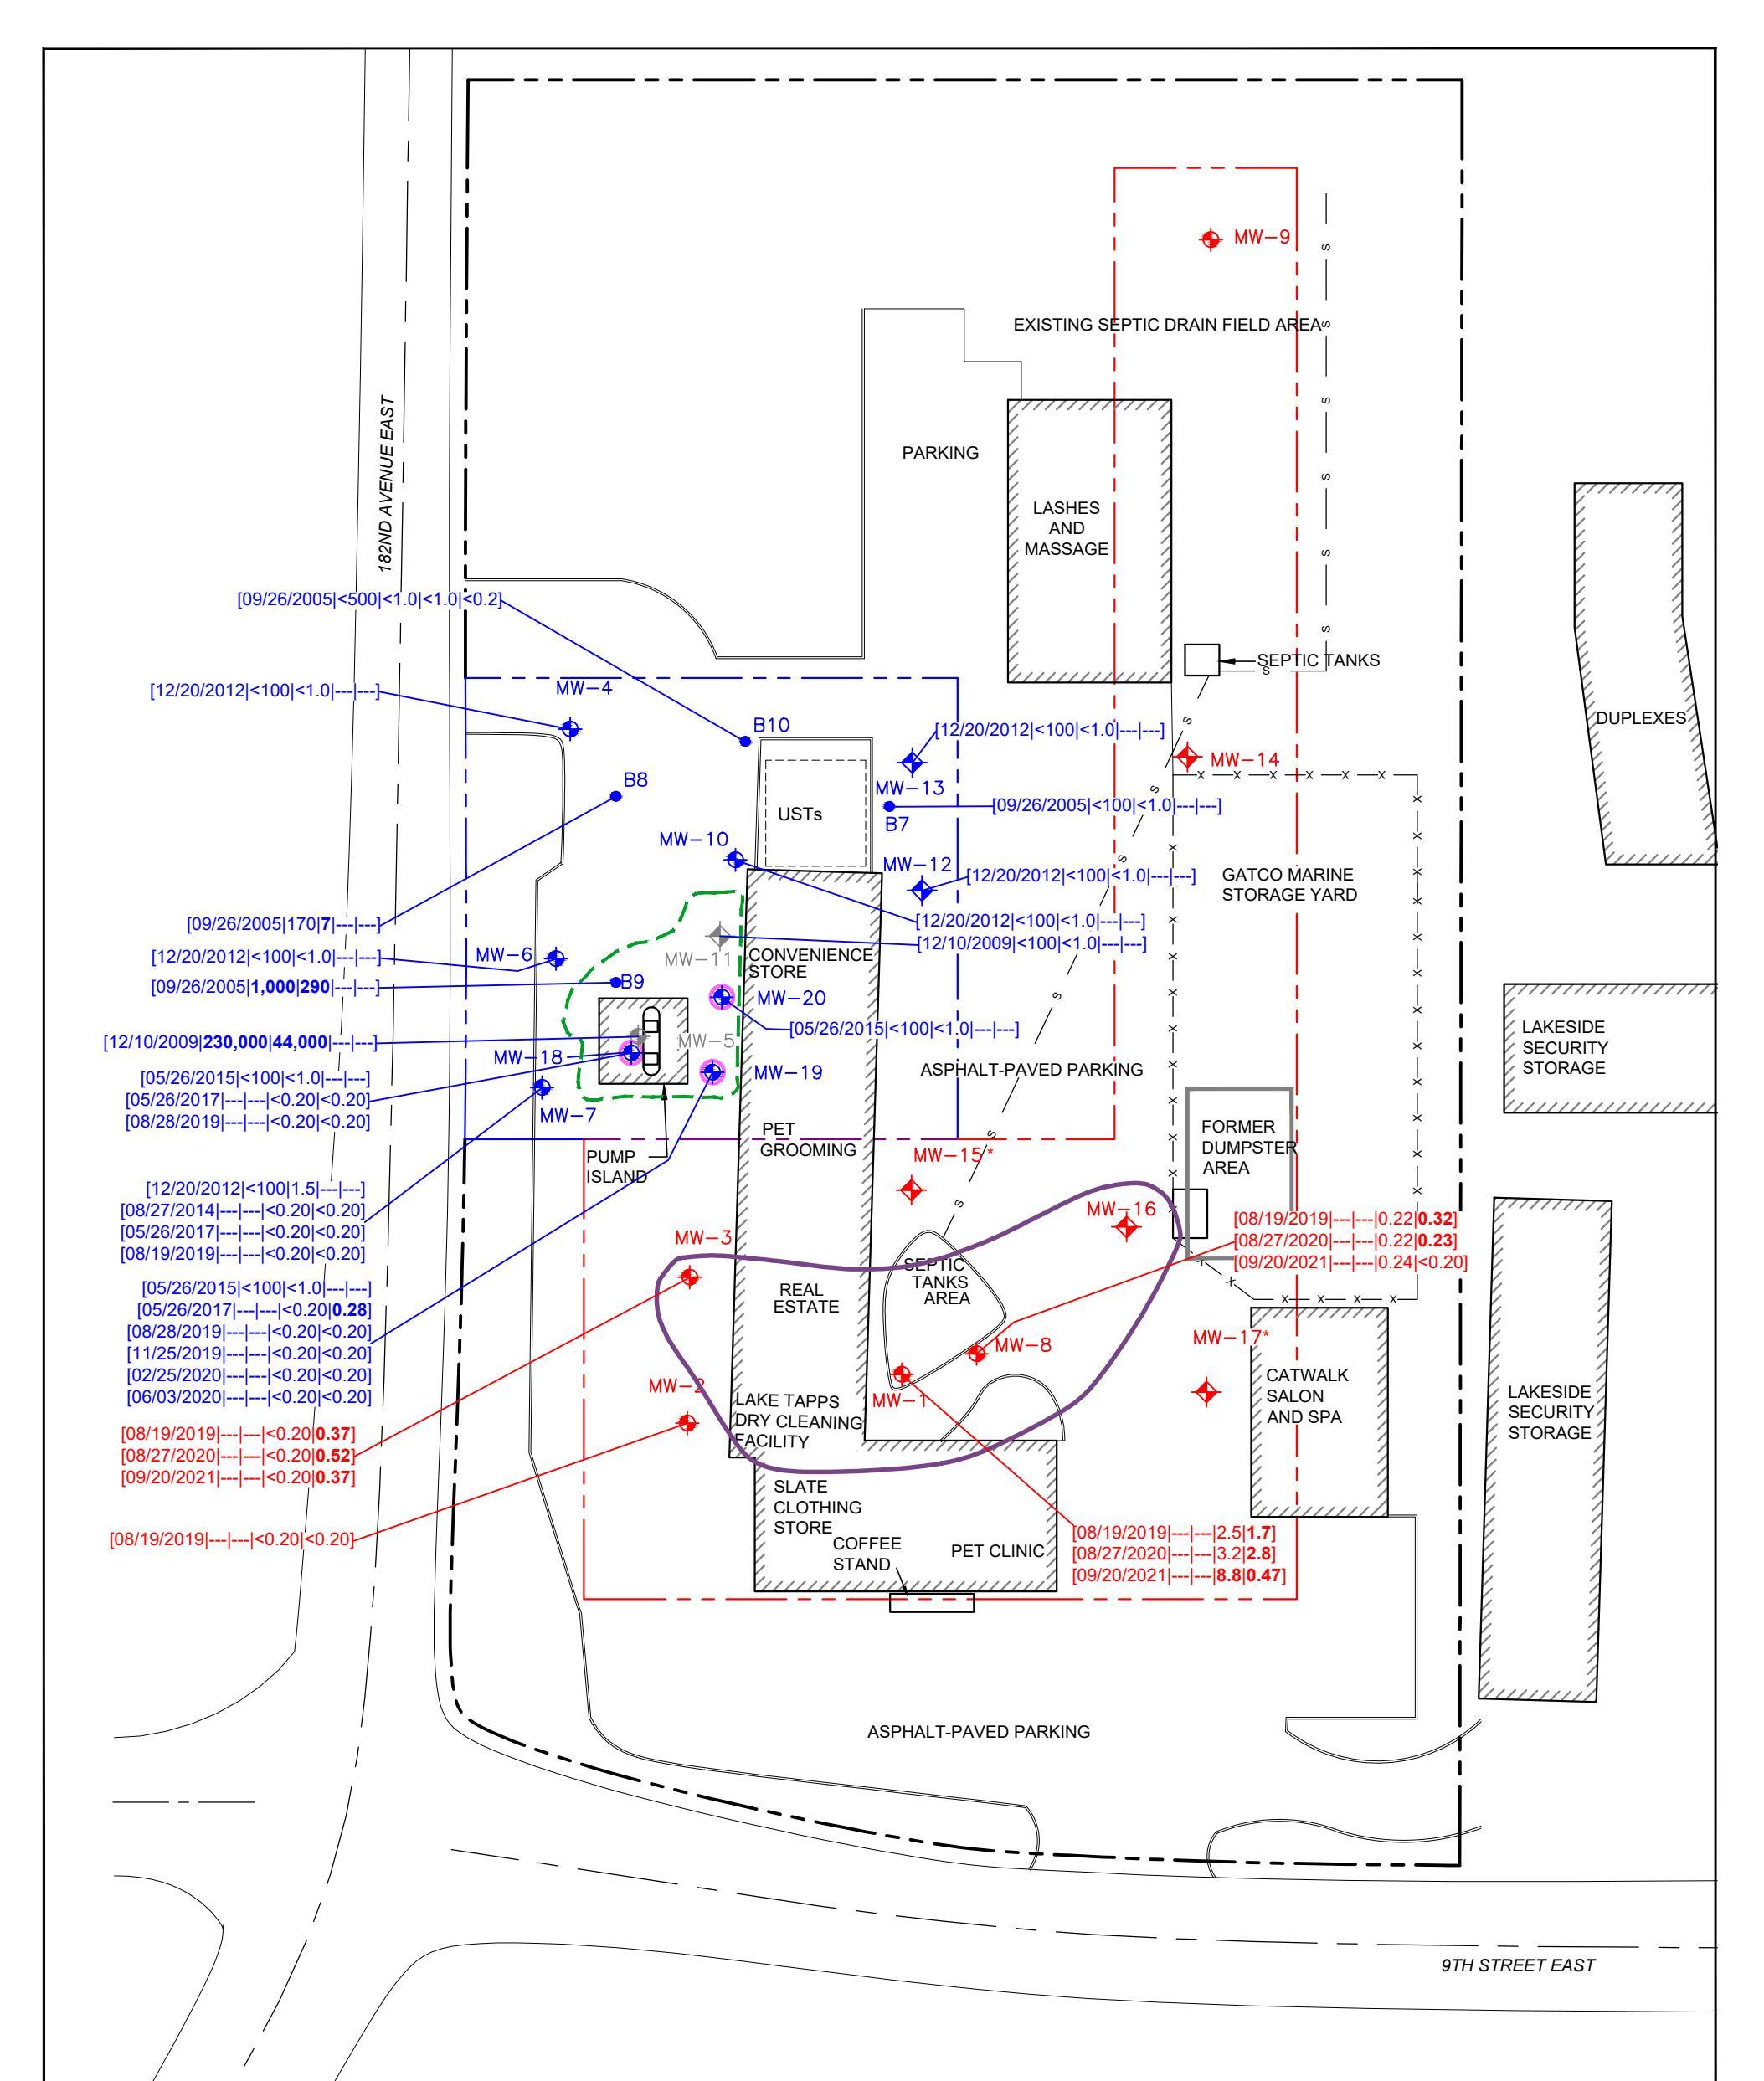
- Figure 3 shows current TPH groundwater analytical results following excavation and removal of the TPH-impacted source area at the Site, and current HVOC groundwater analytical results at the Dry Cleaning Facility.

LEGE	<u>ND</u>				
	PROPERTY BOUNDARY	[09/26/2005 170 7] =	GROUNDW	ATER ANALYTICAL RESULT [SAMPLE
	DRY CLEANING FACILITY BOUNDARY			DATE GRO	BENZENE PCE VC] IN MICROGRAMS PER LITER
	MINI-MARKET SITE BOUNDARY	<	=	DENOTES A	NALYTE NOT DETECTED AT OR EXCEEDING THE LISTED
—x —x —x — — — — — — — — — — — — — — —	FENCE LINE		=	DENOTES S	SAMPLE NOT ANALYZED OR DATA UNKNOWN
	2011 EXCAVATION LIMITS	BOLD	=	DENOTES C	CONCENTRATIONS THAT EXCEED THE WASHINGTON STATE
	CURRENT EXTENT OF HALOGENATED VOLATILE ORGANIC			MODEL TO	KICS CONTROL ACT CLEANUP REGULATION CLEANUP LEVEL
	COMPOUNDS (HVOCS) DETECTED ABOVE THE LABORATORY	Y PCE	=	TETRACHLO	DROETHENE
	PRACTICAL QUANTITATION LIMITS IN SOIL AND GROUNDWA	TER GRO	=	TOTAL PET	ROLEUM HYDROCARBONS AS GASOLINE RANGE ORGANICS
MW-13 🔶	GROUNDWATER MONITORING WELL INSTALLED BY FARALLON CONSULTING, L.L.C.	VC	=	VINYL CHLO	DRIDE
MW-8 🔶	GROUNDWATER MONITORING WELL INSTALLED BY ENVIRONMENTAL ASSOCIATES, INC.	ALL LOCATIONS AR	E APPROXIMA	ΓE

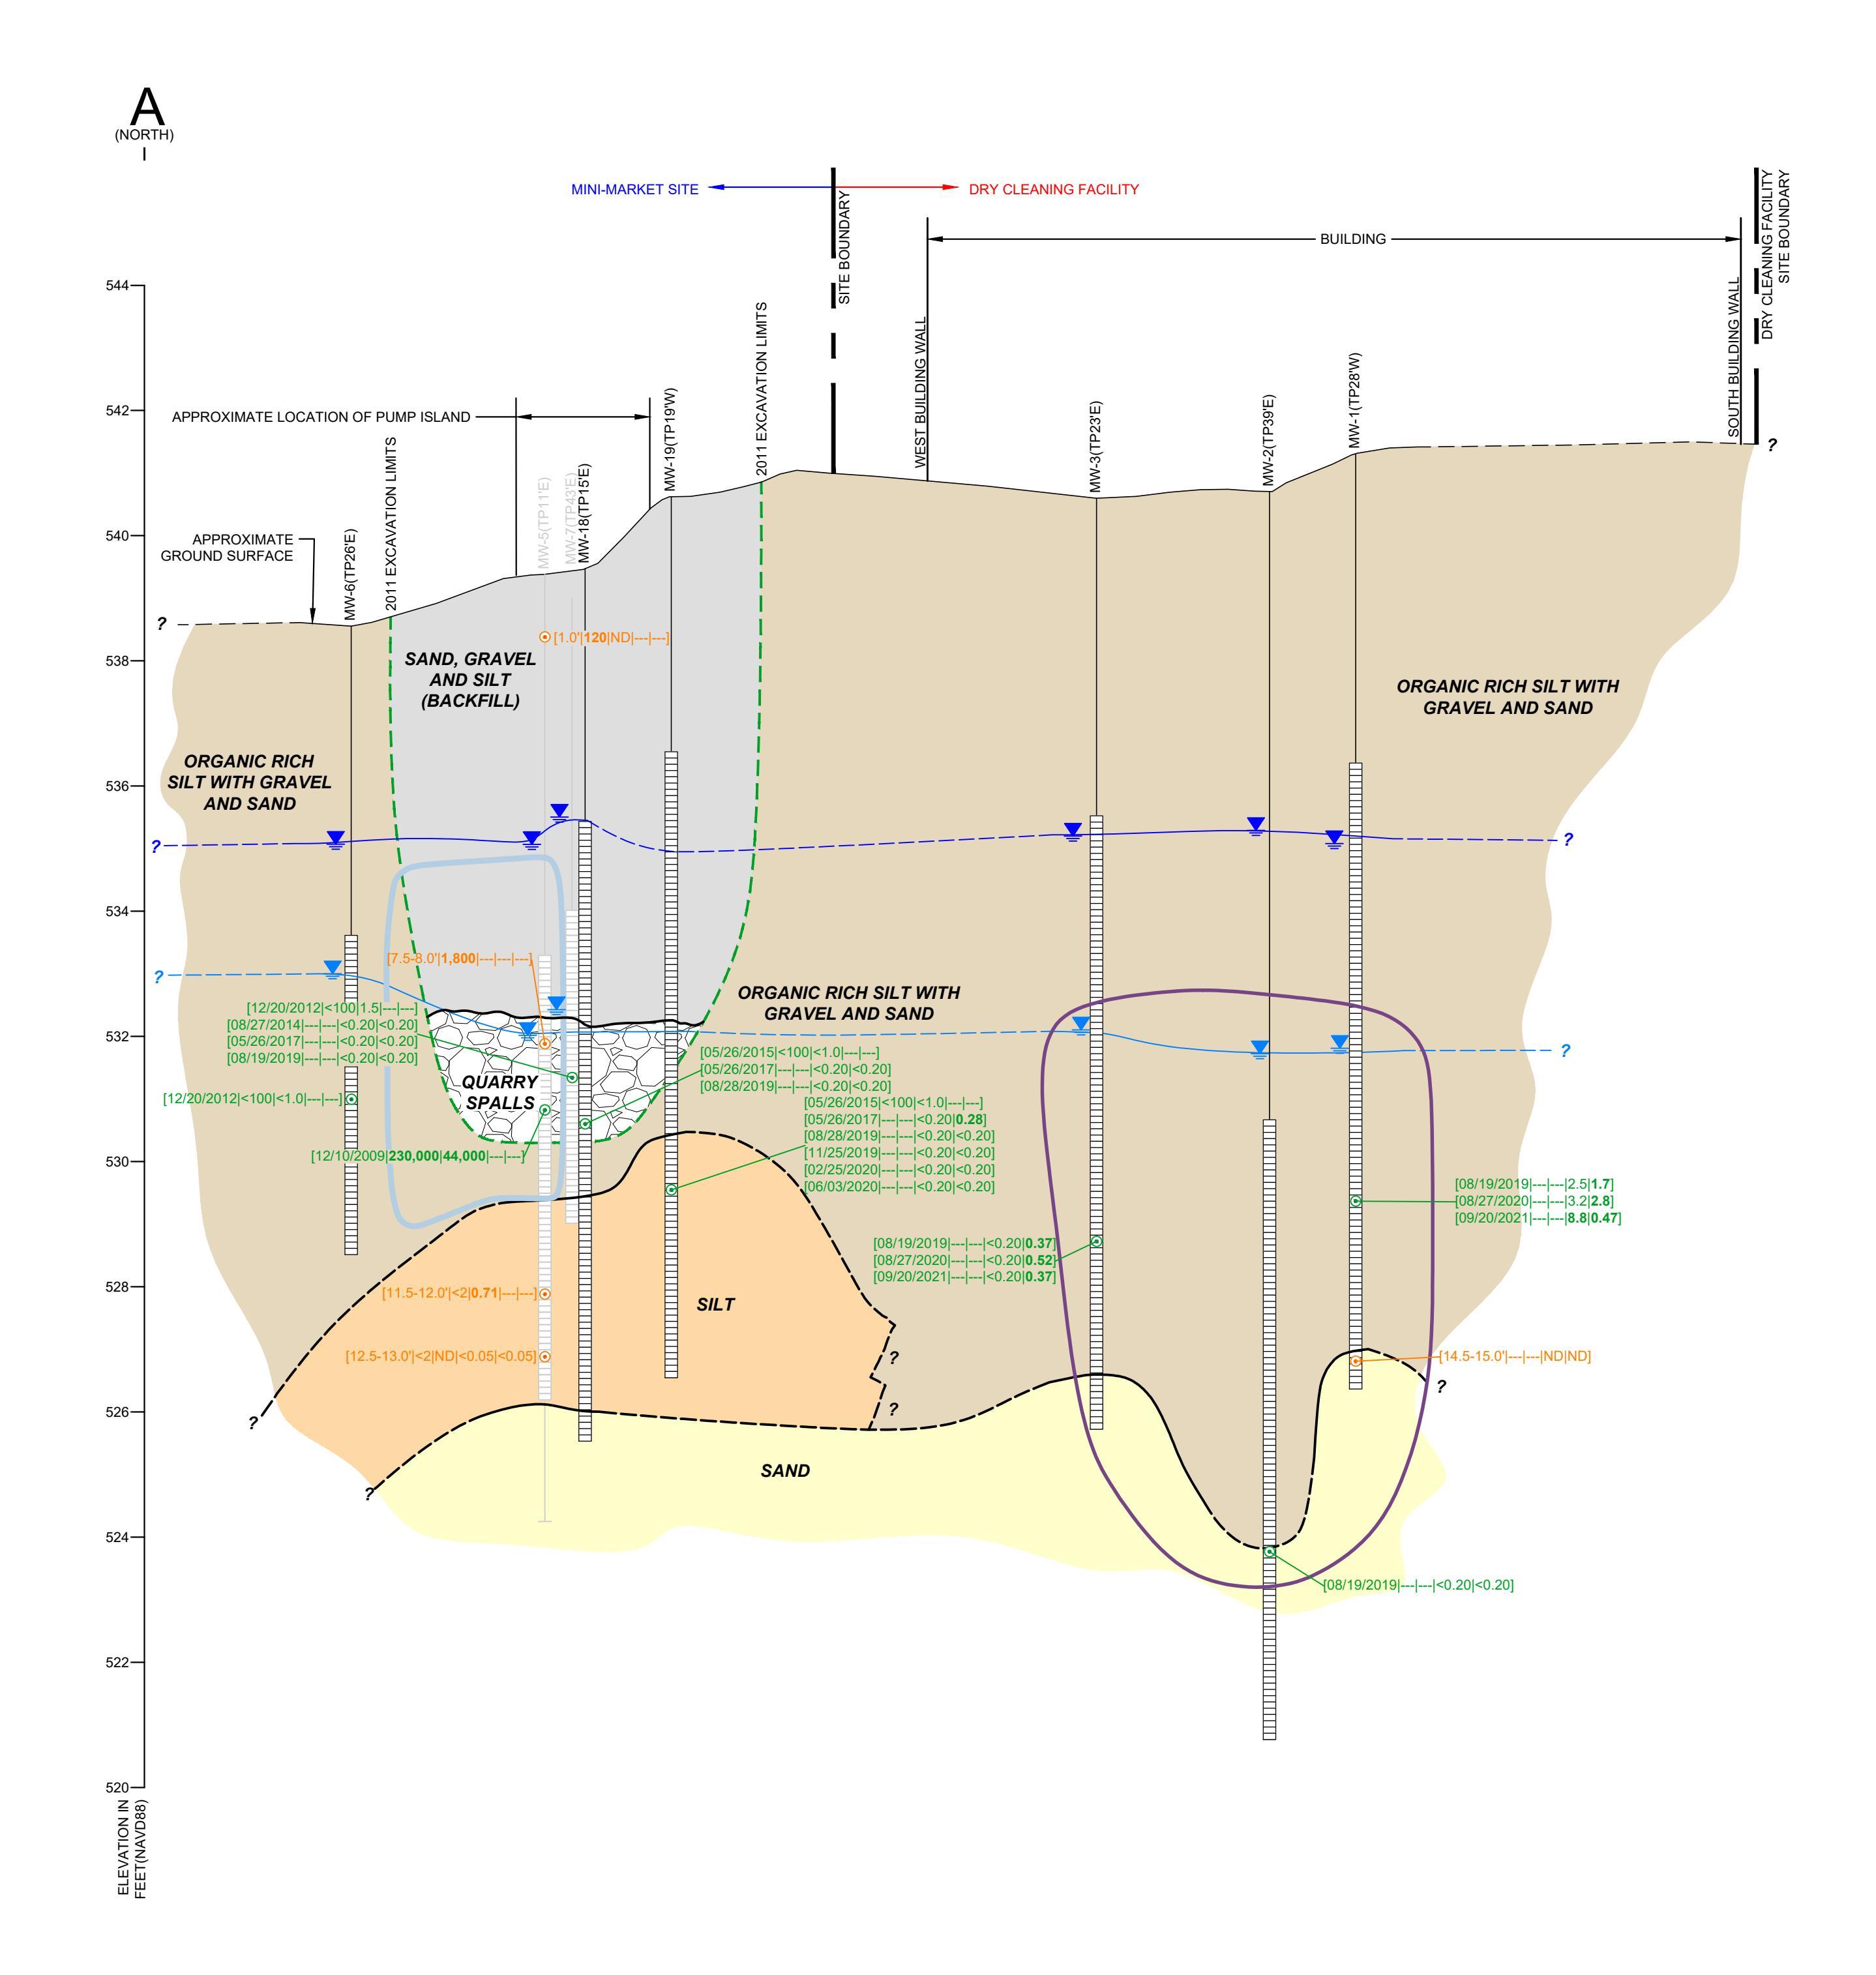
FIGURE 4
CROSS SECTION A-A'
LAKE TAPPS MINI-MARKET

- Figure 4 is a cross section showing the current extent of HVOCs detected at concentrations exceeding laboratory practical quantitation limits in soil and groundwater associated with the Dry Cleaning Facility, confirming that no commingling between the Site and the Dry Cleaning Facility boundaries is occurring.

[14.5-15.0' ND ND] [12/20/2012 <100 <1.0] < BOLD	 SOIL ANALYTICAL RESULT [DEPTH BGS GRO BENZENE PCE VC] IN MILLIGRAMS PER KILOGRAM GROUNDWATER ANALYTICAL RESULT [SAMPLE DATE GRO BENZENE PCE VC] IN MICROGRAMS PER LITER DENOTES ANALYTE NOT DETECTED AT OR EXCEEDING THE LISTED REPORTING LIMIT DENOTES SAMPLE NOT ANALYZED OR DATA UNKNOWN DENOTES CONCENTRATIONS THAT EXCEED THE WASHINGTON STATE MODEL TOXICS CONTROL ACT CLEANUP REGULATION CLEANUP LEVEL
BGS	= BELOW GROUND SURFACE
PCE	= TETRACHLOROETHENE
GRO	= TOTAL PETROLEUM HYDROCARBONS AS GASOLINE RANGE ORGANICS
VC	= VINYL CHLORIDE
ND	= NOT DETECTED AT OR EXCEEDING AN UNKNOWN REPORTING LIMIT
RED	= DRY CLEANING FACILITY
BLUE	= MINI-MARKET SITE
	 CURRENT EXTENT OF HALOGENATED VOLATILE ORGANIC COMPOUNDS (HVOCS) DETECTED ABOVE THE LABORATORY PRACTICAL QUANTITATION LIMITS IN SOIL AND GROUNDWATER FORMER EXTENT OF TOTAL PETROLEUM HYDROCARBONS DETECTED ABOVE LABORATORY PRACTICAL QUANTITATION LIMITS IN GROUNDWATER 2011 EXCAVATION LIMITS

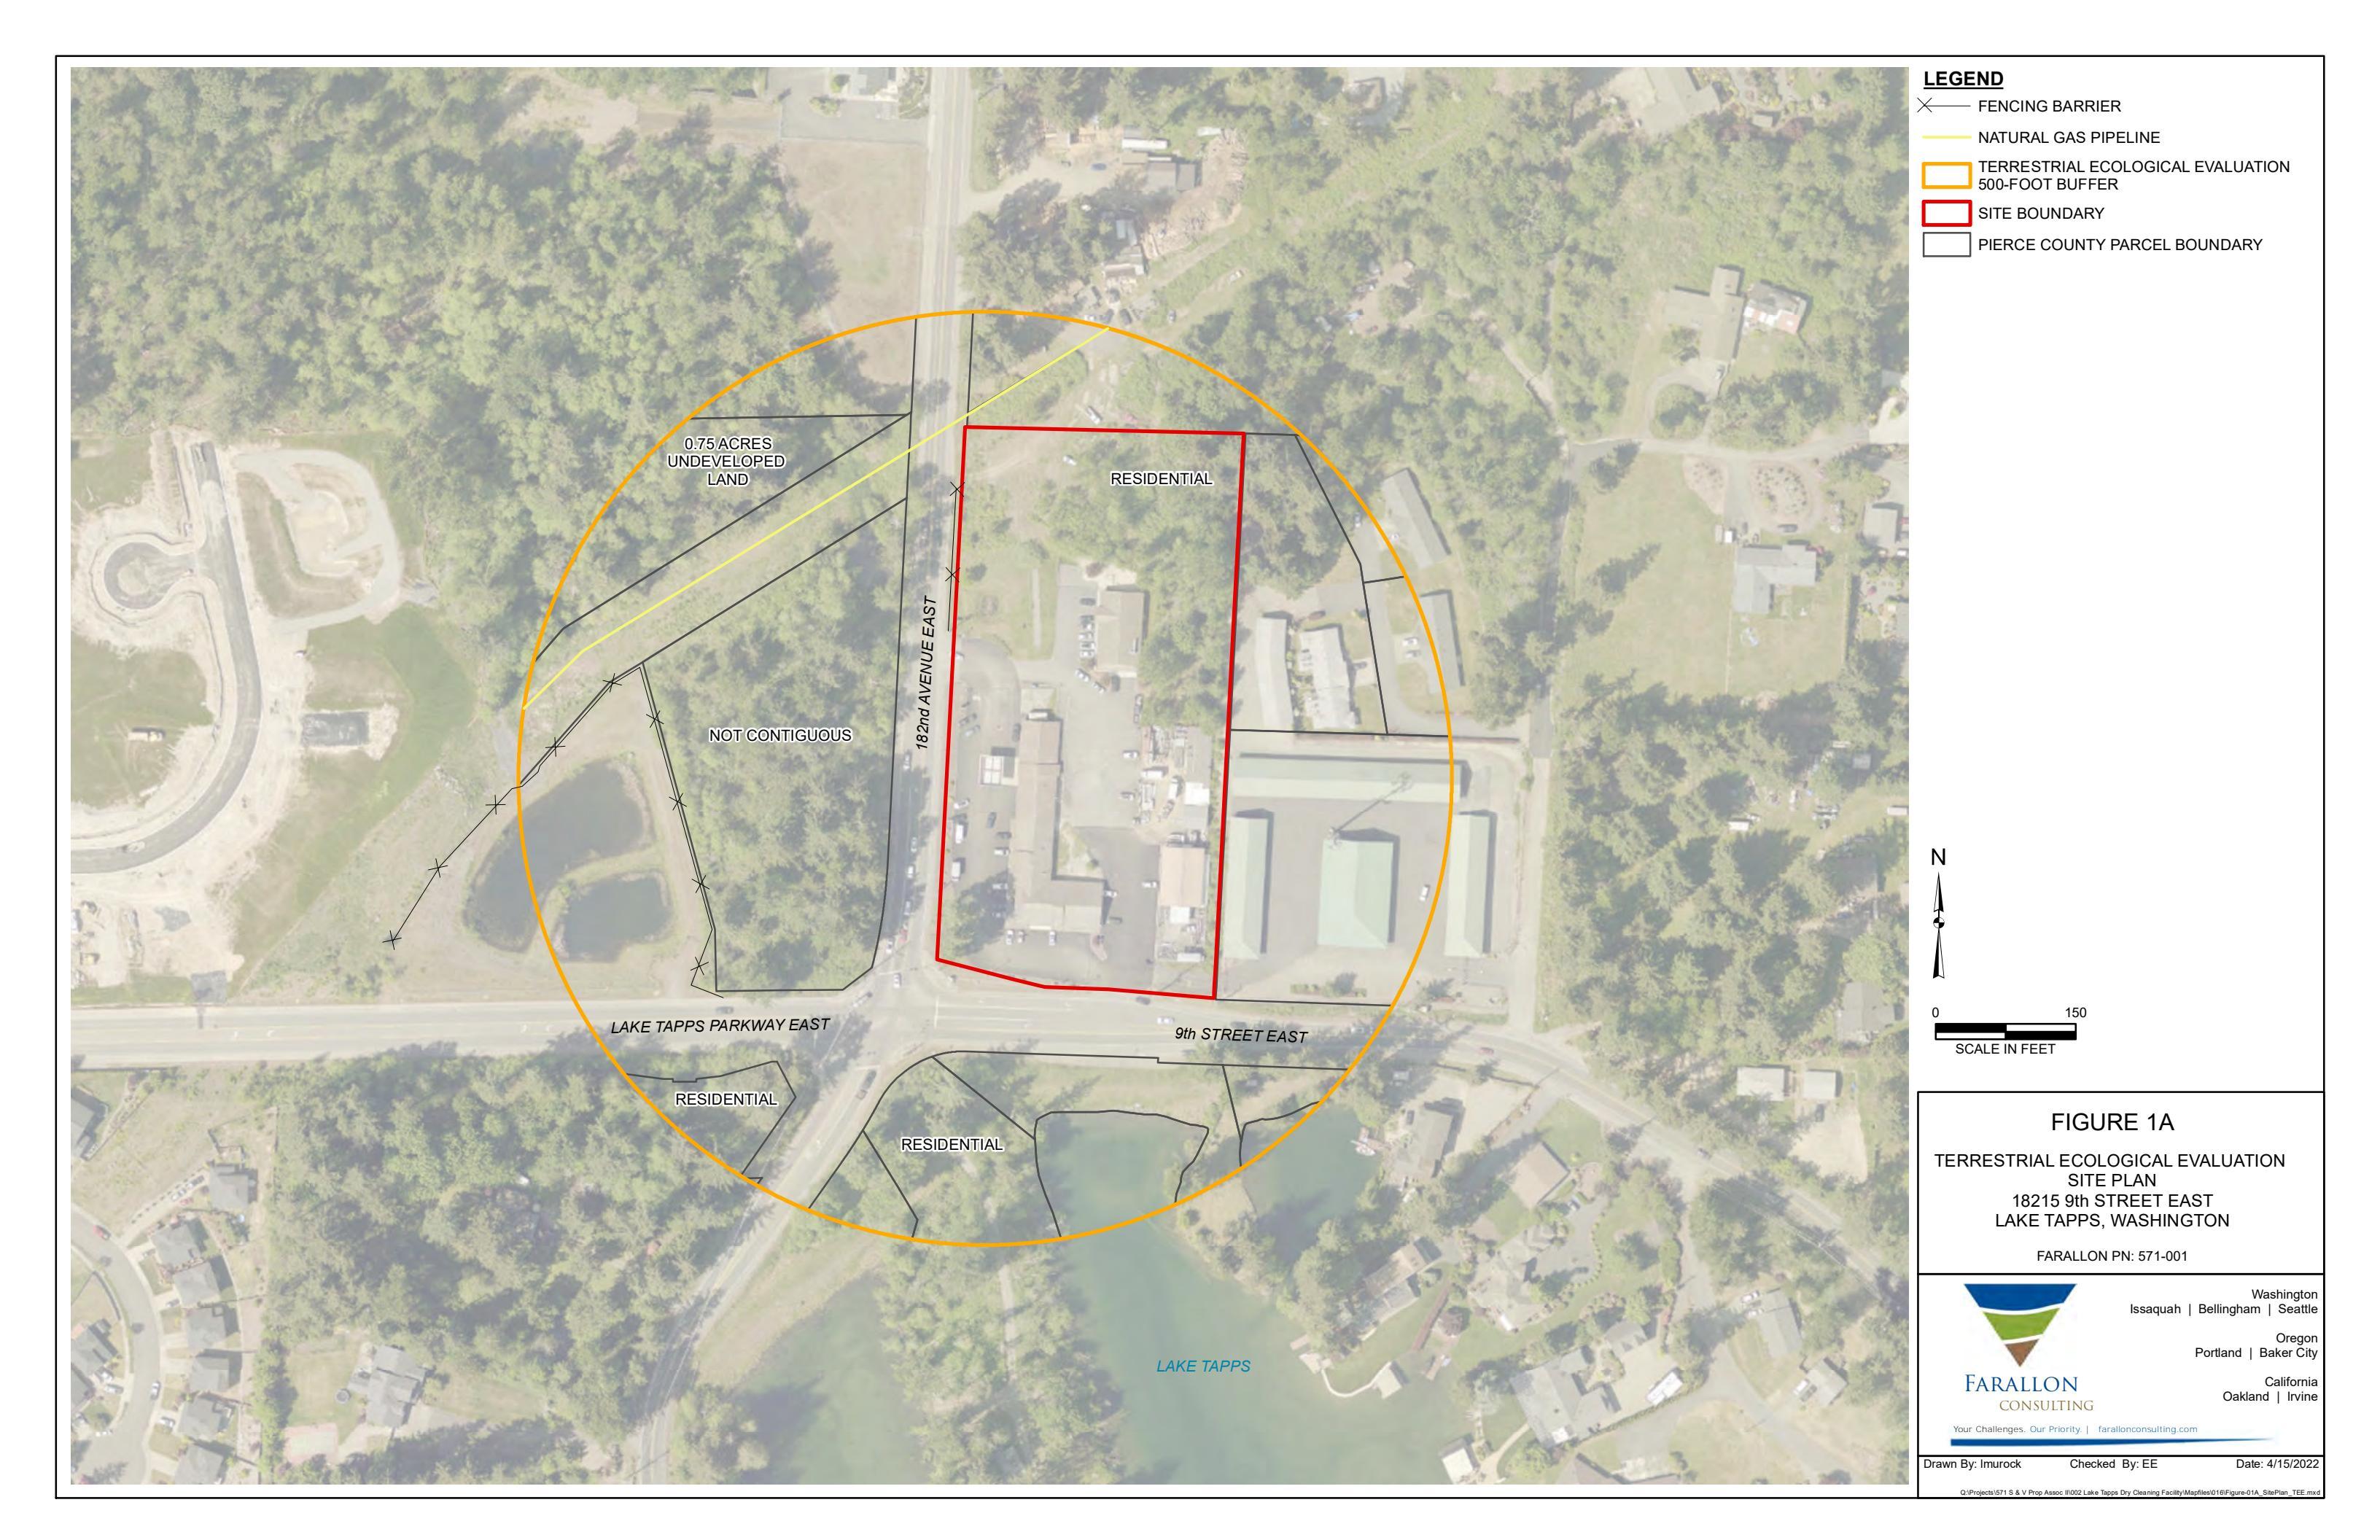
The required TEE Form, completed Table 749-1, and supporting Figure 1A for the Site are provided in Attachment A. Based on the criteria for TEE exclusion in WAC 173-340-7491(1)(c), the Site is excluded from a TEE, as there are fewer than 1.5 acres of contiguous undeveloped land on the Site or within 500 feet of any area of the Site, and the hazardous substances listed in WAC 173-340-7491(1)(c)(ii) are not present. No further consideration of terrestrial ecological impacts is required under MTCA.
