Re: 2022 Annual Groundwater Monitoring Report Modera River Trail 15801 and 15945 Northeast 85th Street Redmond, Washington

> Facility/Site ID: 75292 Cleanup Site ID: 15281 VCP Project ID: NW3292

TRC Project Number: 015353.8

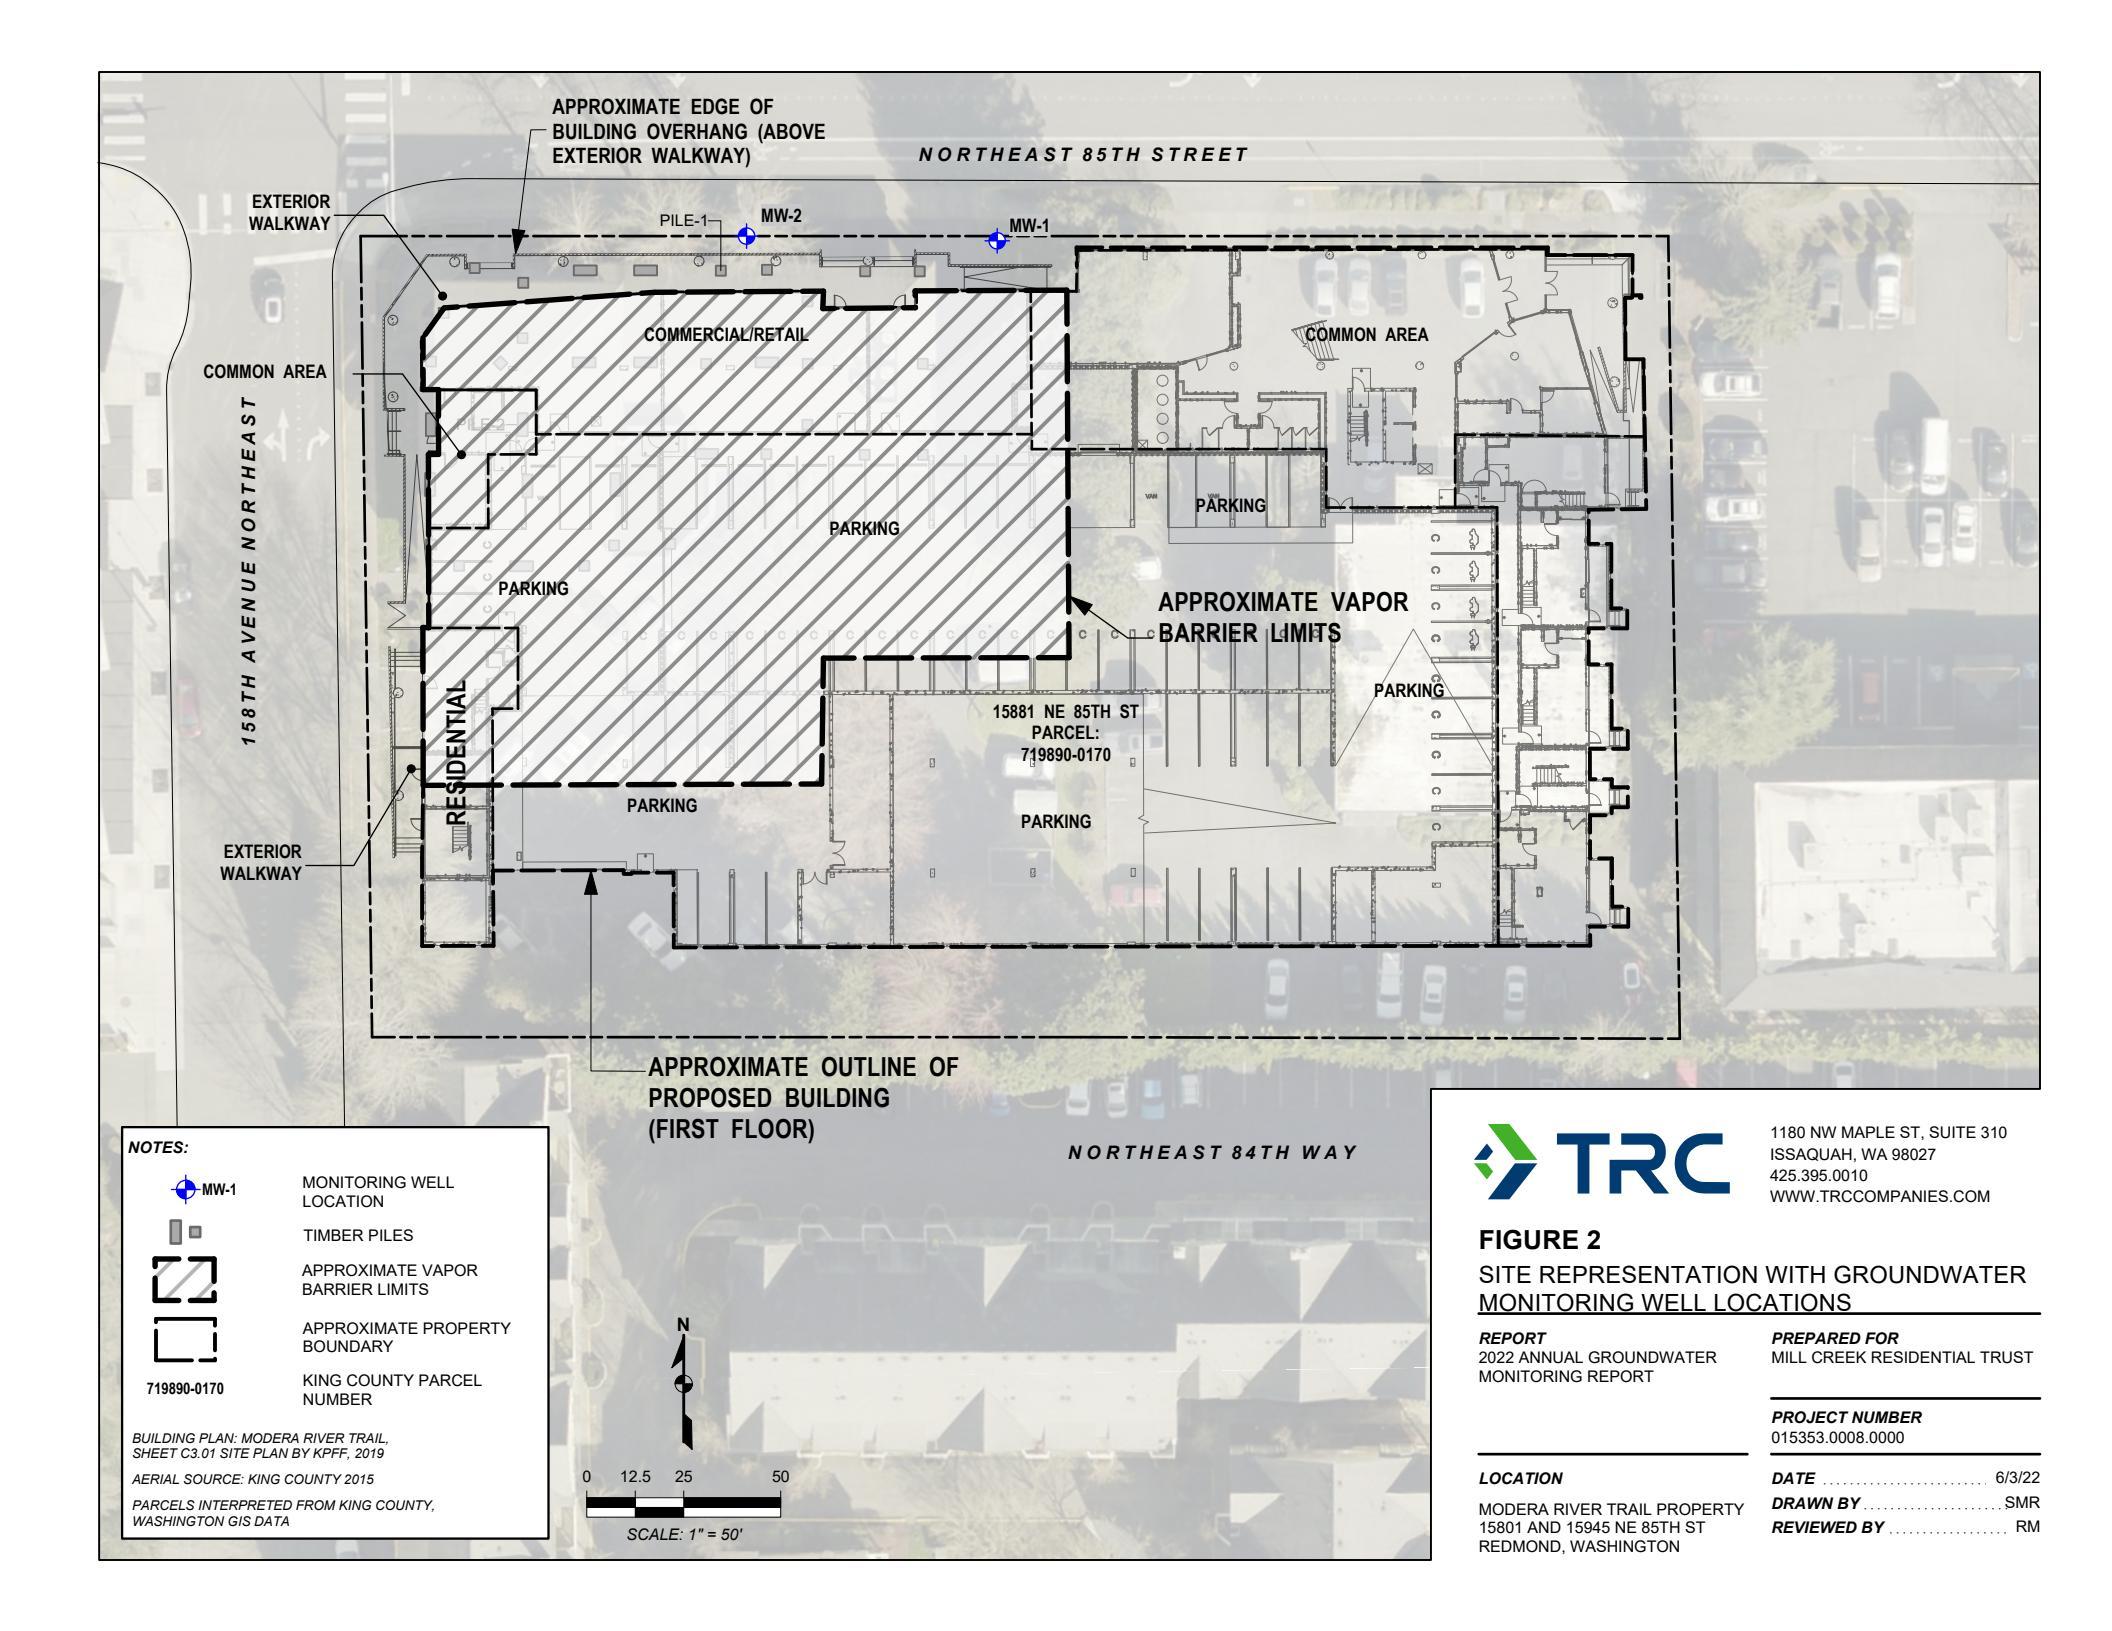
TRC conducted four consecutive groundwater monitoring events at the Site on August 24, 2021, November 18, 2021, February 17, 2022, and May 16, 2022. TRC collected samples from on-site monitoring wells MW-1 and MW-2. The locations of monitoring wells MW-1 and MW-2 are depicted on Figure 2.
