ENVIRONMENTAL CONDITIONS REPORT Cassidy Road Shooting Site CLALLAM COUNTY, WASHINGTON

December 9, 2022 Shannon & Wilson No: 107843-005

## Subject: ENVIRONMENTAL CONDITIONS REPORT, CASSIDY ROAD SHOOTING SITE, CLALLAM COUNTY, WASHINGTON

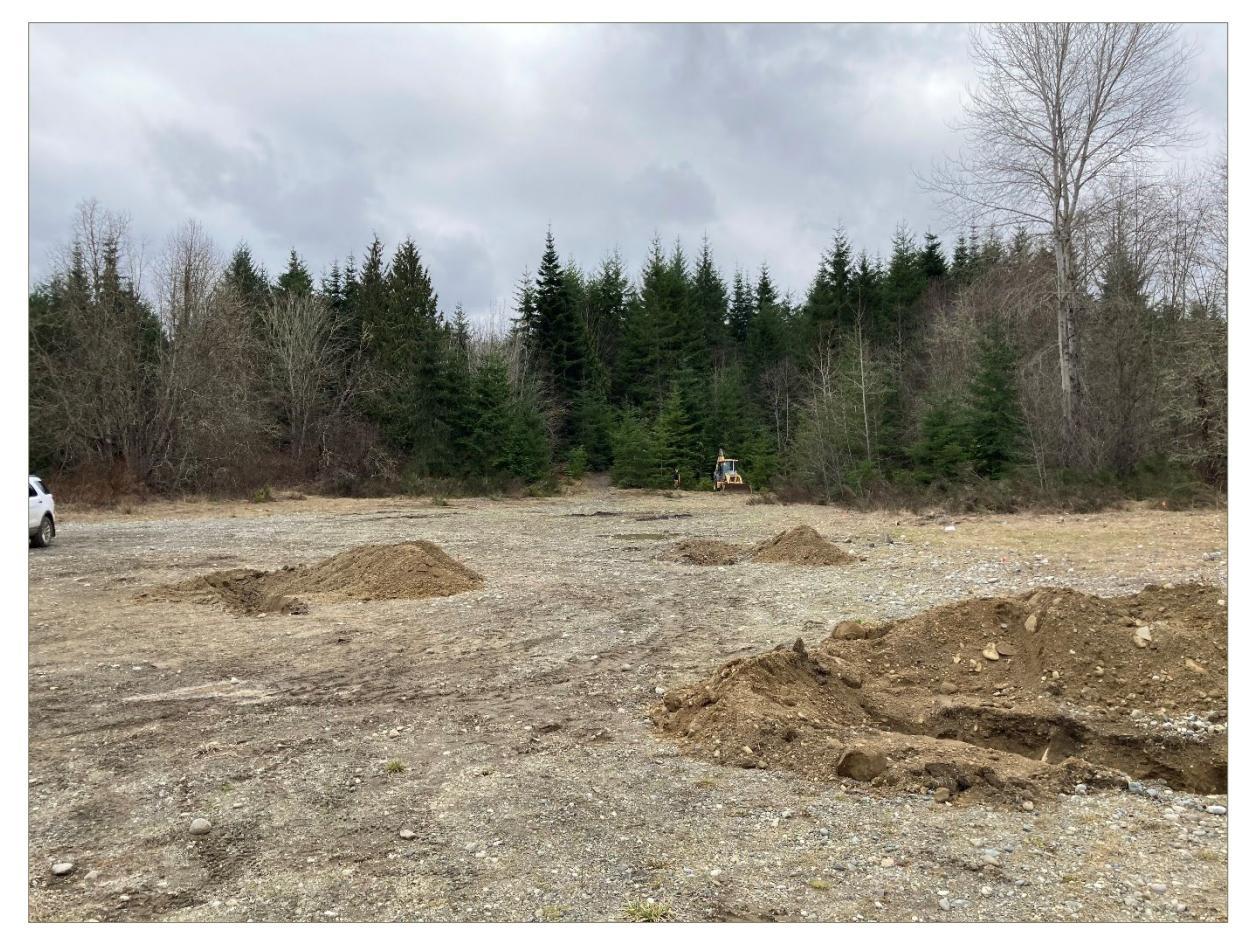
Exhibit 2-1: Cassidy Road Shooting Site, August 2001, Facing South

On August 27, 2003, it was reported to staff from the Clallam County Environmental Health that the area where the soil samples had been collected in June 2000 had been since graded over and trees had been planted. No further characterization related to the extent of contamination has reportedly been conducted until 2021. Although a gate restricts access to the site, the public can still access the premises on foot. There is a residential area approximately 0.5 mile from the site to the west (see Exhibits 2-1 and 2-2 as follows).

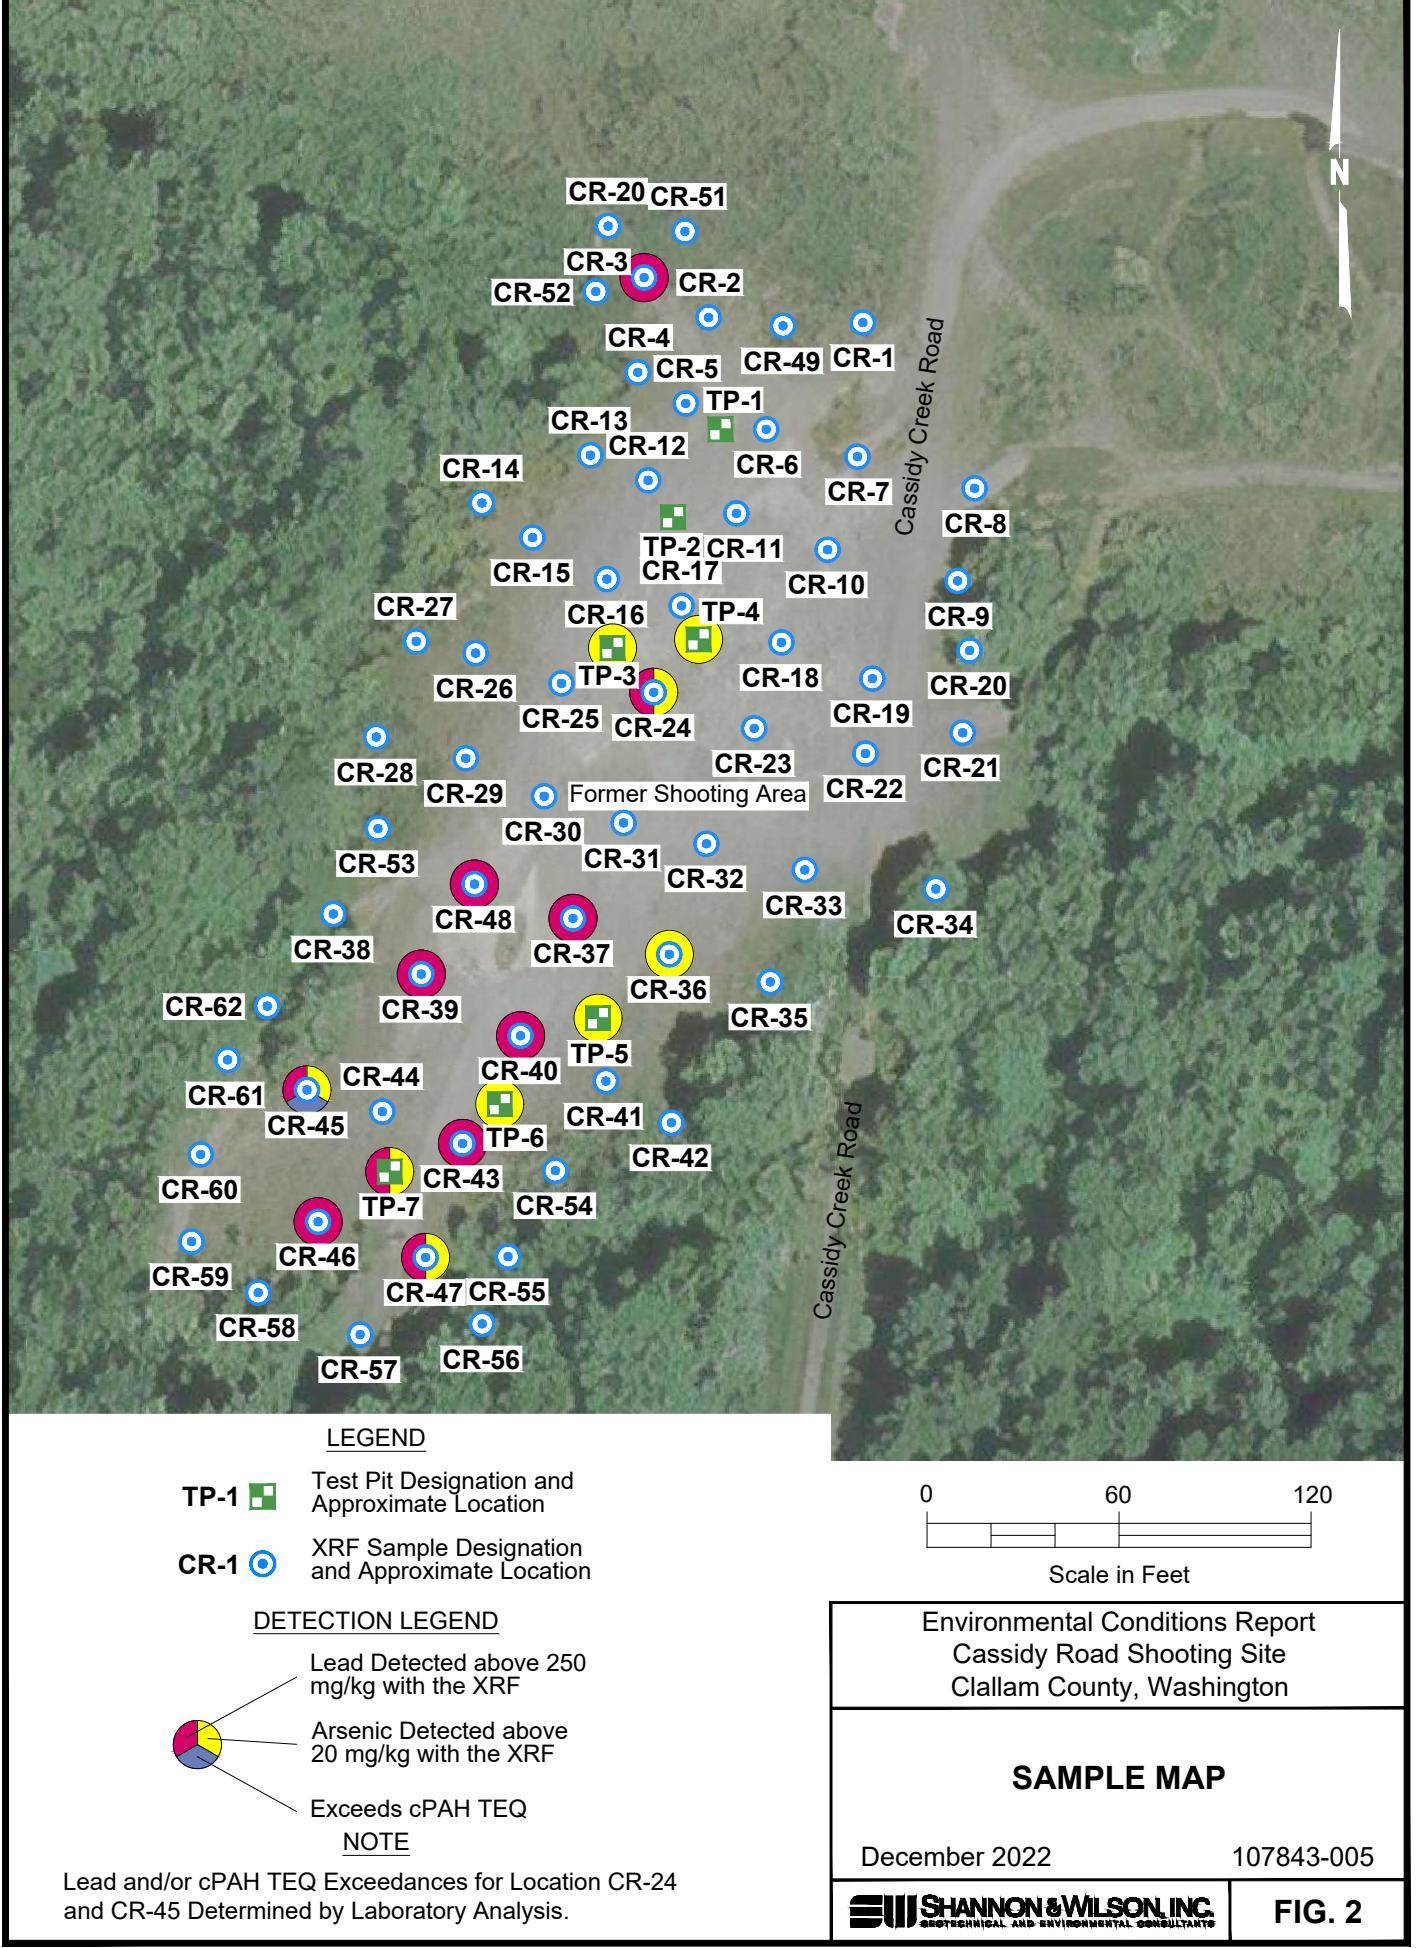
Laboratory detection limits were reported below the MTCA-A CULs. Each soil sample was analyzed with the XRF during field activities and those results used to select the sample submitted for qualitative laboratory analysis. Sampling equipment that was re-used was decontaminated prior to initial use, between sampling locations, and at the completion of the site-specific sampling. The sampling locations were established using agrid-like approach and located in the field with an Arrow Series® global positioning device (GPS). Approximate soil and XRF sample locations can be seen in Figure 2.

Arsenic, copper, and zinc were not detected above their respective screening criteria in the select samples that were analyzed. Other PAHs were not detected in the select samples that were analyzed. Approximate sample locations and results can be seen in Figures 2 and 3.

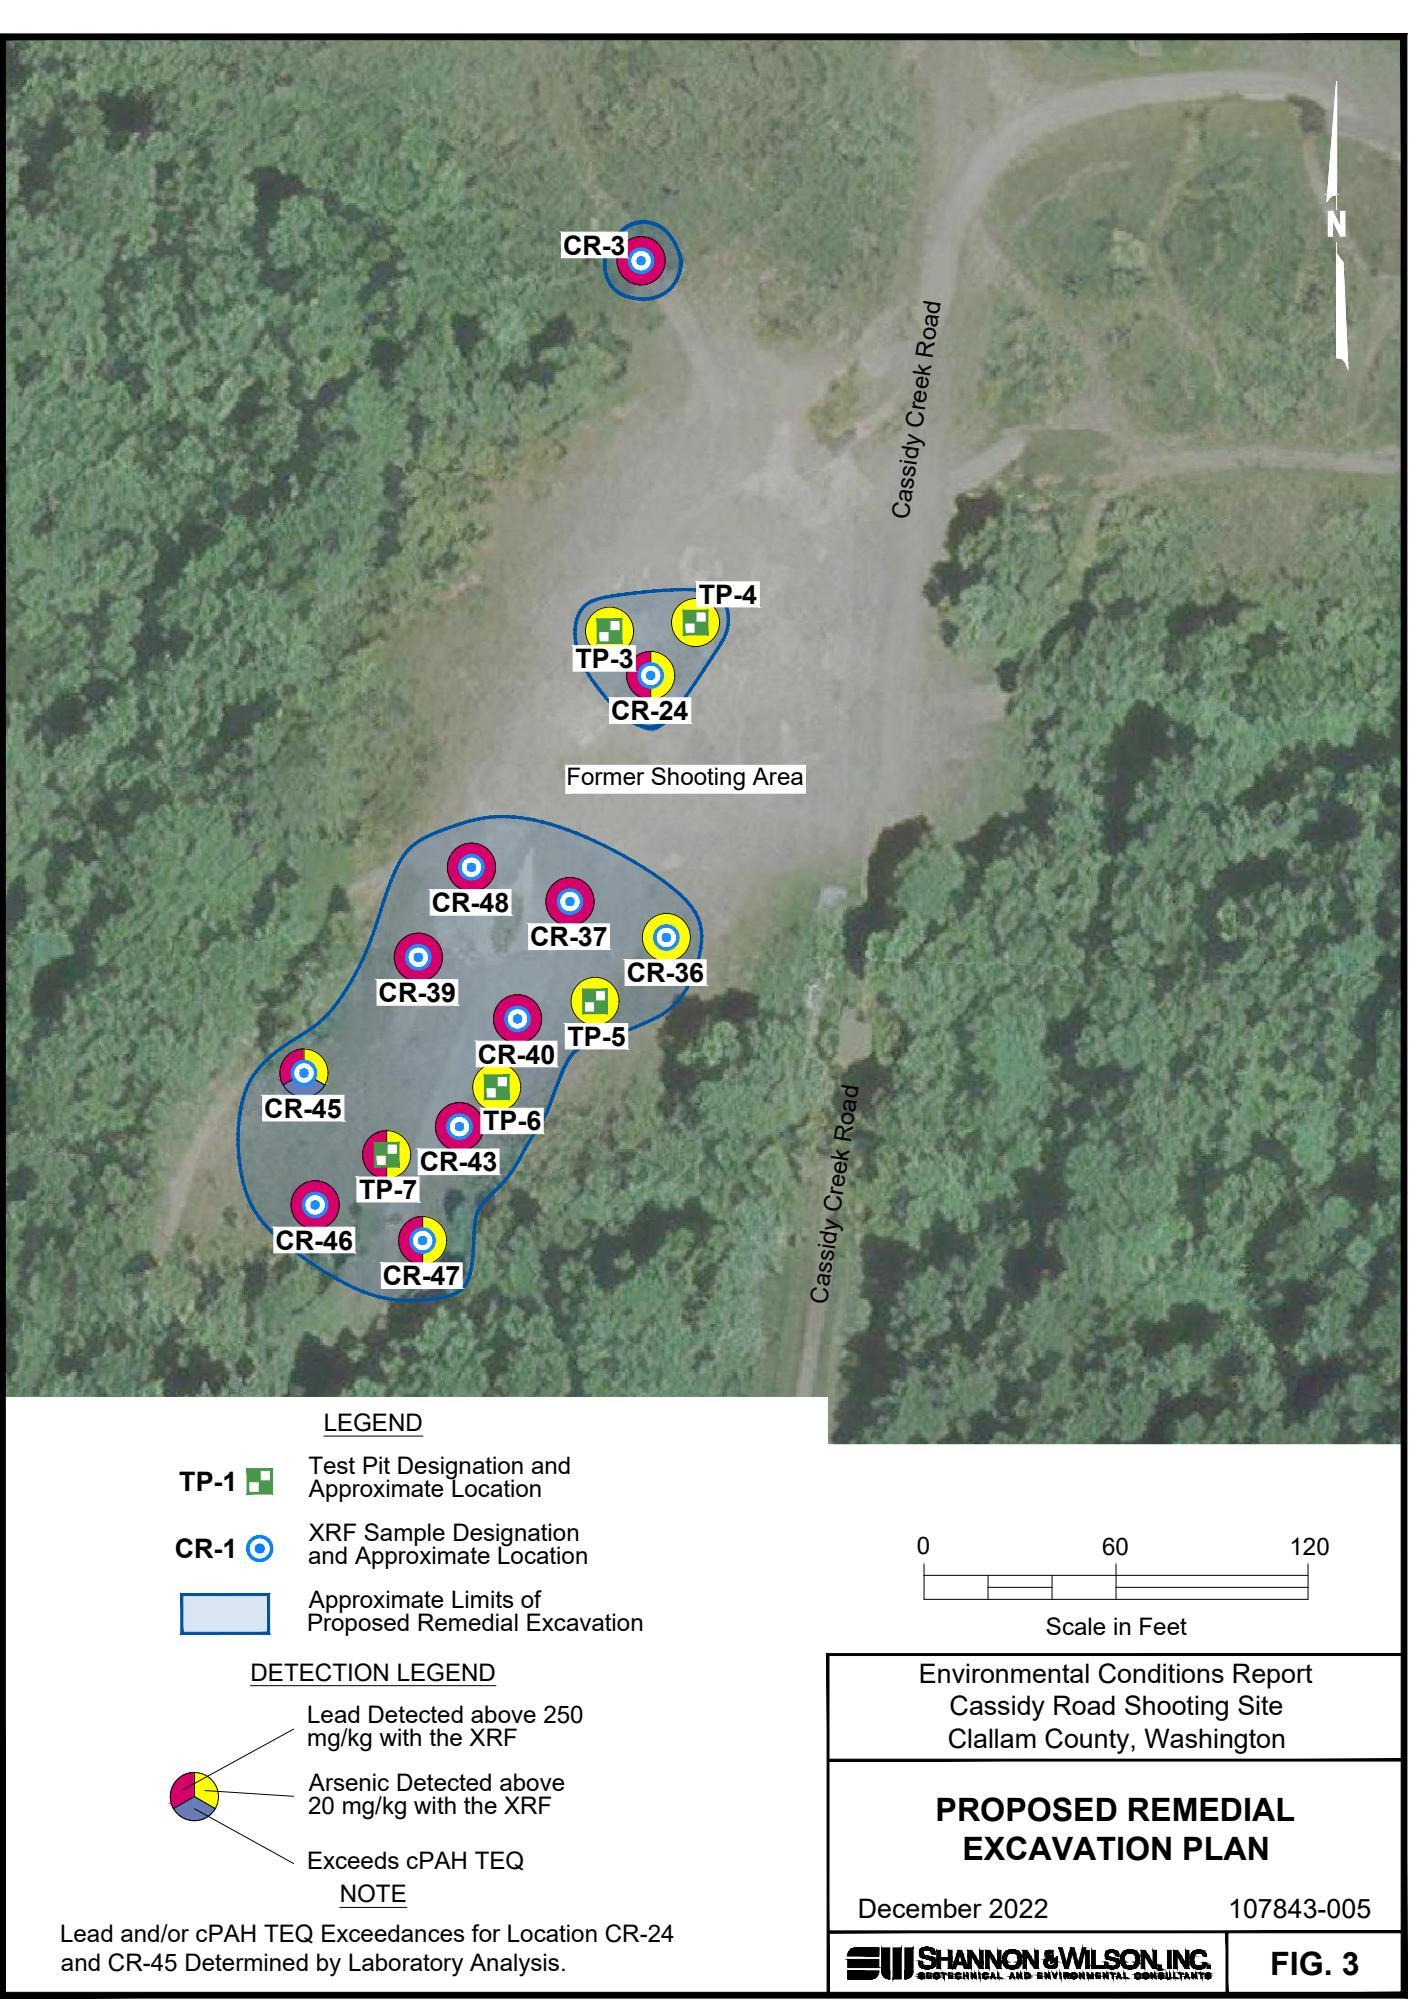
- Arsenic, lead and cPAHs in soil samples were detected in some samples at values that exceeded the MTCA CULs.
- Three areas of concern shown highlighted in Figure 3 should be removed as contaminated soil. We recommend a minimum of a 5-foot lateral distance from the known contaminated soil sample locations and a minimum 1-foot vertical limit of excavation. This soil should be taken offsite and disposed of at a Subtitle D licensed waste facility.

- Confirmation soil samples should be collected from the sidewalls and bottom of excavations after contaminated soil removal. Analytical testing of confirmation samples should include the analyte(s) with concentration exceedance(s), with respect to their location, to confirm if the extent of contamination has been removed. These contaminates include lead, arsenic, and cPAHs.

- Once confirmation chemical analysis results have demonstrated contaminant concentrations to be below their respective cleanup criterion, the Site can be re-graded to eliminate the excavation pits.
