# SUBJECTRemedial Investigation Report Revision 2<br/>Gearjammer Truck Plaza – Diesel & Gasoline Fueling Area<br/>Gearjammer Truck Plaza<br/>2310 Rudkin Road<br/>Union Gap, Washington 98903

#### **REMEDIAL INVESTIGATION REPORT**

# **Remedial Investigation Report**

Report Version: Revision 2

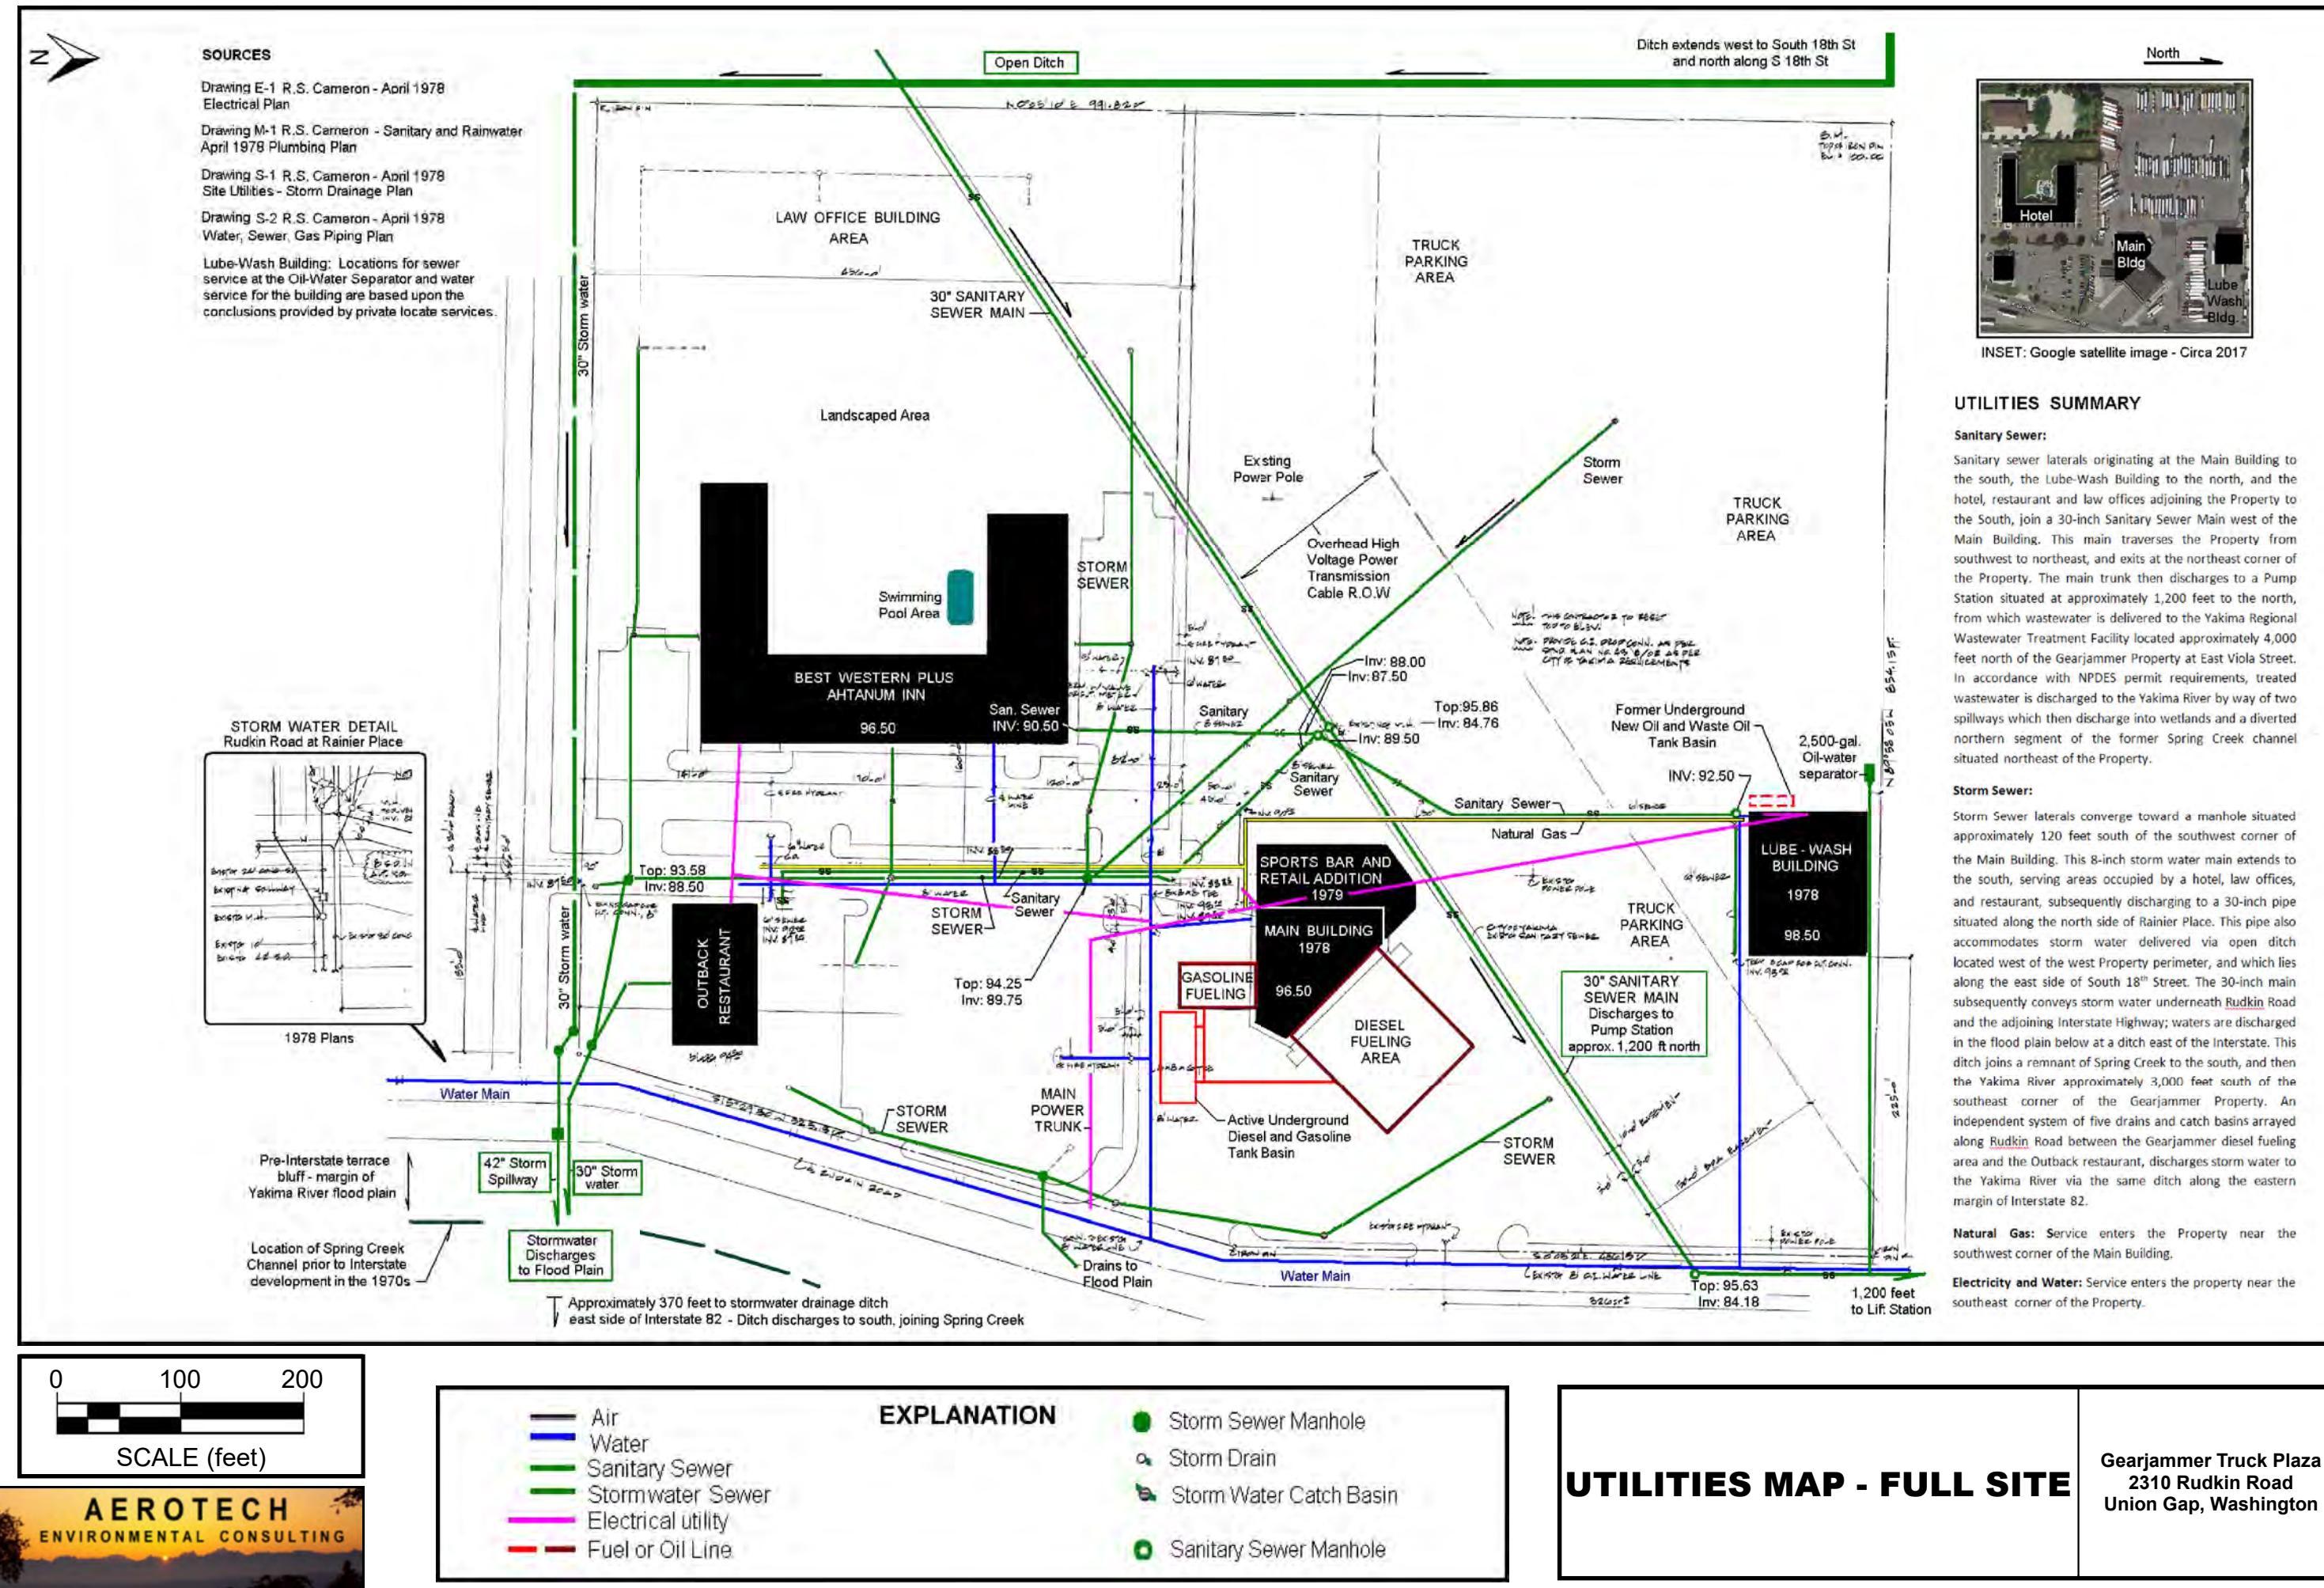
8

the south, the Lube-Wash Building to the north, and the hotel, restaurant and law offices adjoining the Property to the South, join a 30-inch Sanitary Sewer Main west of the Main Building. This main traverses the Property from southwest to northeast, and exits at the northeast corner of the Property. The main trunk then discharges to a Pump Station situated at approximately 1,200 feet to the north, from which wastewater is delivered to the Yakima Regional Wastewater Treatment Facility located approximately 4,000 feet north of the Gearjammer Property at East Viola Street. In accordance with NPDES permit requirements, treated wastewater is discharged to the Yakima River by way of two spillways which then discharge into wetlands and a diverted northern segment of the former Spring Creek channel

approximately 120 feet south of the southwest corner of the Main Building. This 8-inch storm water main extends to the south, serving areas occupied by a hotel, law offices, and restaurant, subsequently discharging to a 30-inch pipe situated along the north side of Rainier Place. This pipe also accommodates storm water delivered via open ditch located west of the west Property perimeter, and which lies along the east side of South 18th Street. The 30-inch main subsequently conveys storm water underneath Rudkin Road and the adjoining Interstate Highway; waters are discharged in the flood plain below at a ditch east of the Interstate. This ditch joins a remnant of Spring Creek to the south, and then the Yakima River approximately 3,000 feet south of the southeast corner of the Gearjammer Property. An independent system of five drains and catch basins arrayed along Rudkin Road between the Gearjammer diesel fueling area and the Outback restaurant, discharges storm water to the Yakima River via the same ditch along the eastern

Sanitary Sewer Main west of the Main Building. This main utility line traverses the Property from southwest to northeast and exits at the northeast corner of the Property. The main line then discharges to a Pump Station situated at Rudkin Road at approximately 1,200 feet to the north, and from which wastewater is delivered to the Yakima Regional Wastewater Treatment Facility located approximately 4,000 feet north of the Gearjammer Property, at East Viola Street. In accordance with NPDES permit requirements, treated wastewater is discharged to the Yakima River by way of two spillways which then discharge via two spillways into wetlands and a diverted northern segment of the former Spring Creek channel situated approximately 1,600 feet northeast of the Property (Figures 7 and 8).

Storm Sewer laterals converge toward a manhole situated approximately 120 feet south of the southwest corner of the Main Building. This 8-inch storm water main extends to the south, serving areas occupied by a hotel, law offices, and restaurant, subsequently discharging to a 30-inch pipe situated along the north side of Rainier Place. This pipe also accommodates storm water delivered via an open ditch located west of the west Property perimeter, and which also lies along the east side of South 18<sup>th</sup> Street. The 30-inch main subsequently conveys storm water to the south underneath Rudkin Road and the adjoining Interstate Highway; waters are discharged into the flood plain below at a ditch along the east side of the Interstate (Figure 9). This ditch joins a remnant of Spring Creek to the south, and then the Yakima River approximately 2,800 feet south of the southeast corner of the Gearjammer Property. An independent system of five drains and catch basins arrayed along Rudkin Road between the Gearjammer diesel fueling area and the Outback restaurant, discharges storm water to the Yakima River via the same ditch along the eastern margin of Interstate 82 (Figures 7 and 8).

Service enters the Property near the southwest corner of the Main Building via a gas main extending to the south (Figures 7 and 8).

Service for both water and electricity enter near the southeast corner of the Property in the vicinity of well MW-3 (Figure 8). Water is supplied by the City of Union Gap and is generally withdrawn from relatively deep unconsolidated valley fill aquifers in the Yakima Basin (Figure 10). City of Union Gap well design and well testing records attached as Appendix D.
