#### STATE OF WASHINGTON DEPARTMENT OF ECOLOGY

#### RE: Dangerous Waste Compliance Inspection on September 10, 2019 at Lovric's Sea-Craft Inc., EPA/State ID Number: WAR000003616

### **INSPECTION NARRATIVE**

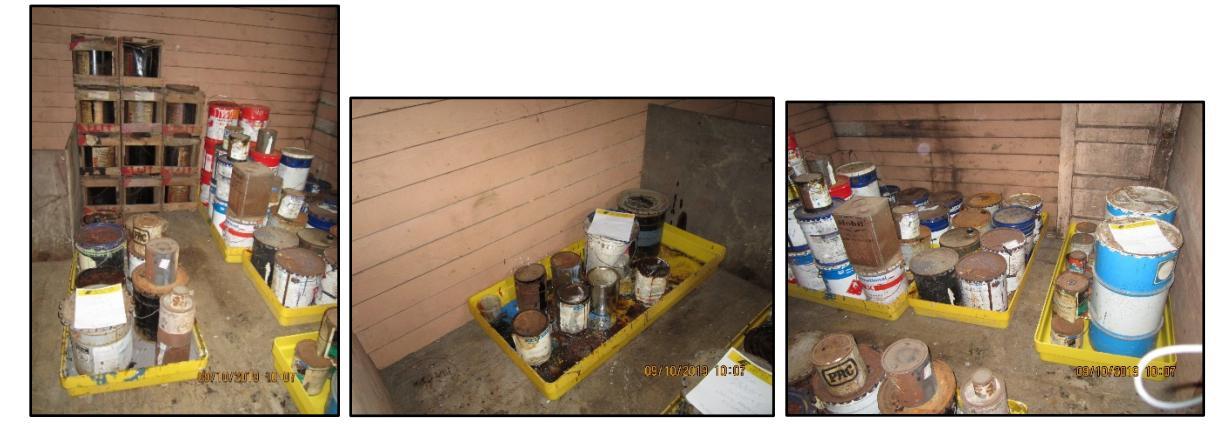
Photo 1: IMG\_0977.JPG

- Paints in this shed have been organized and placed mostly in yellow trays. Mr. Ehler stated that he is having a hard time finding a contractor who will pick up the wastes. He said Skagit County Transfer Station had agreed to take 25 gallons at a time. I told him this was not permitted, as Lovric's has large quantity generator volumes of dangerous waste at this time. I offered to call Emerald Services to see why they were not able to assist Lovric's.
- Paints in the northeast room (photos 1-3) were divided into the following categories (no bottom paints)
  - Two-part epoxies
  - Two-part polyurethanes

- Rust-Oleum
- Chlorinated rubber "Woolsey"
- Latex (still useable, along back wall)

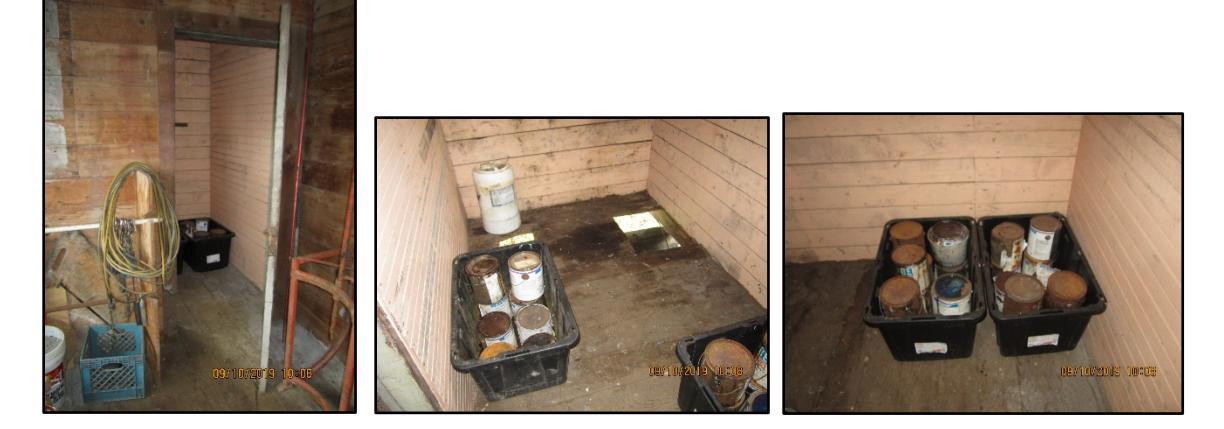
Photo 4: IMG\_0981.JPG Photo 5: IMG\_0982.JPG

• Paints in the southeast closet space (photo 4-6) have not been sorted yet but Mr. Ehler said they are wastes. All containers are sitting in secondary containment trays.

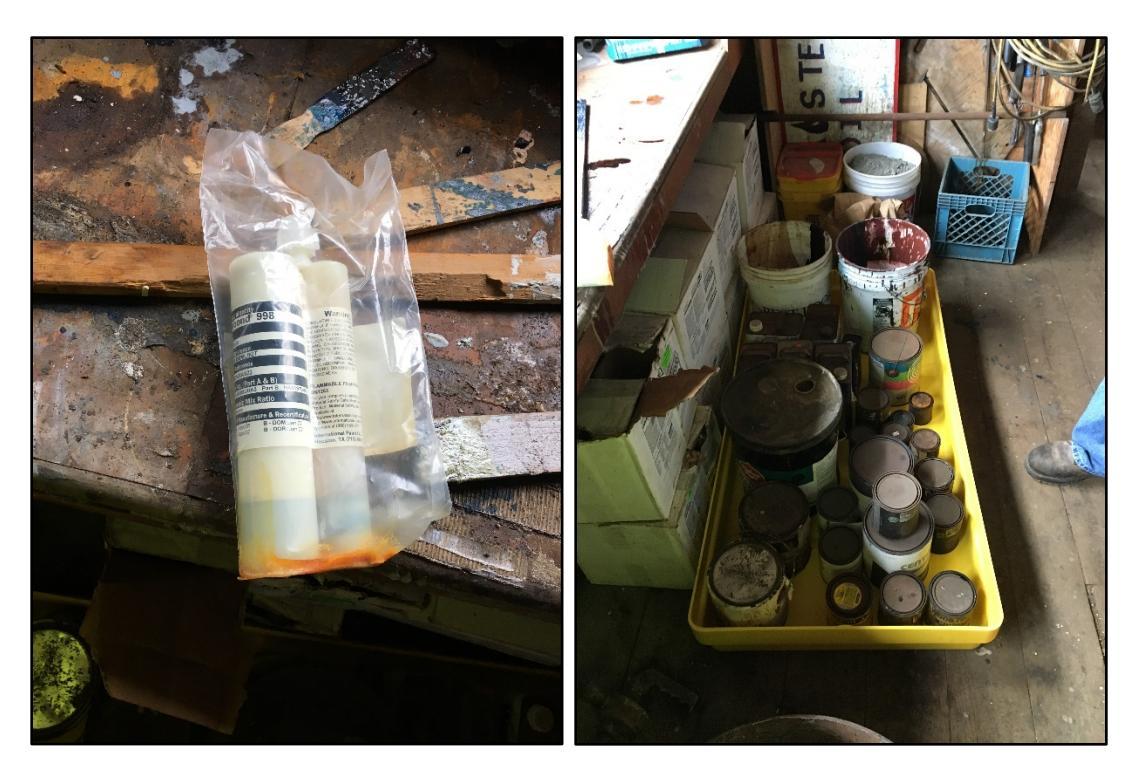
Photo 7: IMG\_1244.JPG

- Materials in the southeast room include:
  - Two-part International brand "Interbond 988" in boxes along the east wall (photos 7-8).

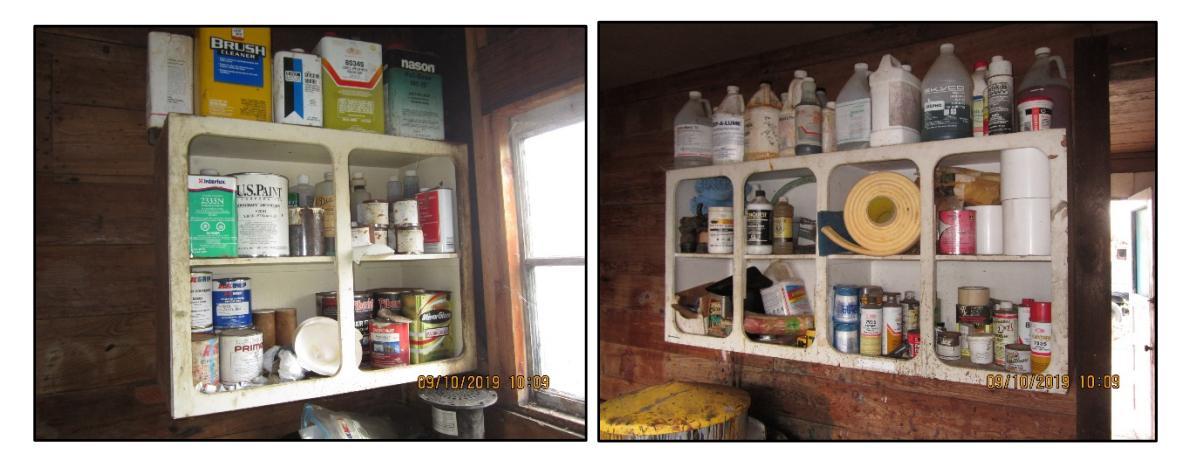
Photo 9: IMG\_0985.JPG

• Waste paints in the center of the room and on shelves along the wall (photos 9-10).

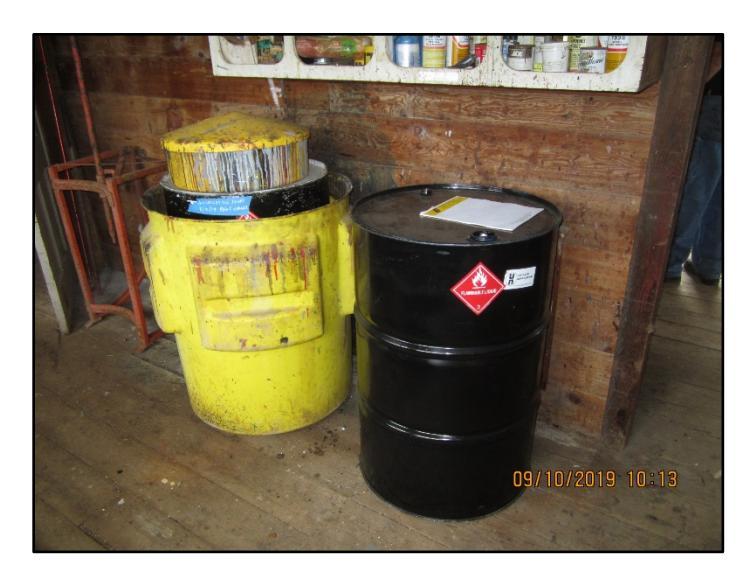
#### Photo 11: IMG\_0986.JPG

• Mr. Ehler identified one drum as acetone product, and one 55-gallon drum as spent acetone and paint wastes, labeled "paint thinner," and dated "8/12/19" (photo 11).

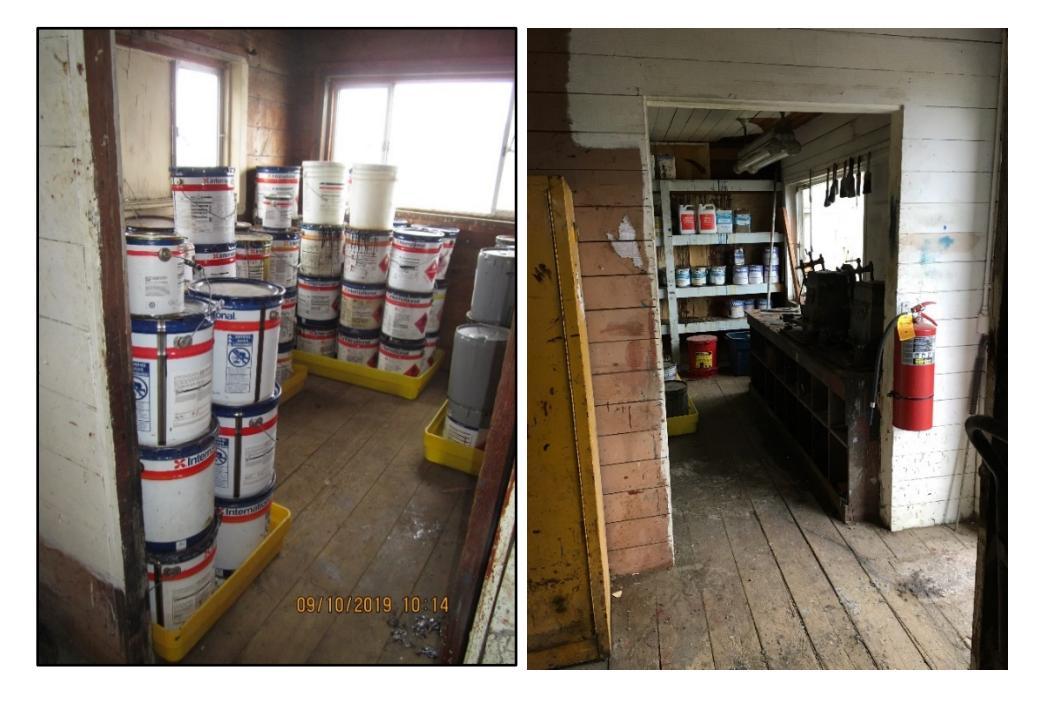
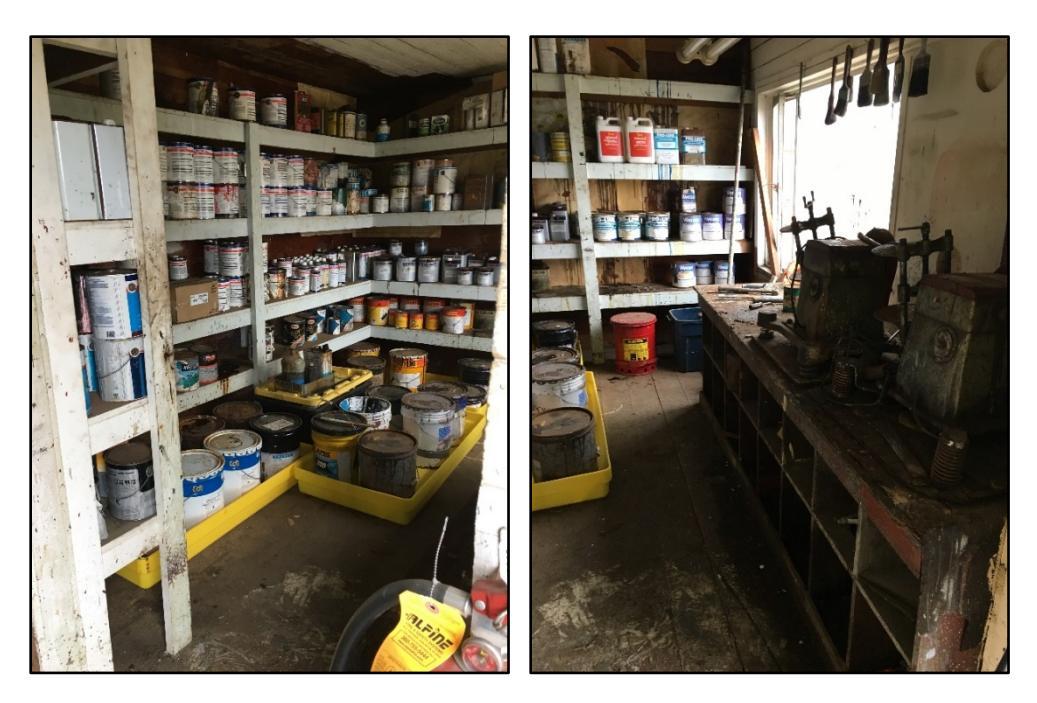
Photo 12: IMG\_0987.JPG

• The Northwest and Southwest rooms contain useable products (photos 12 -15).

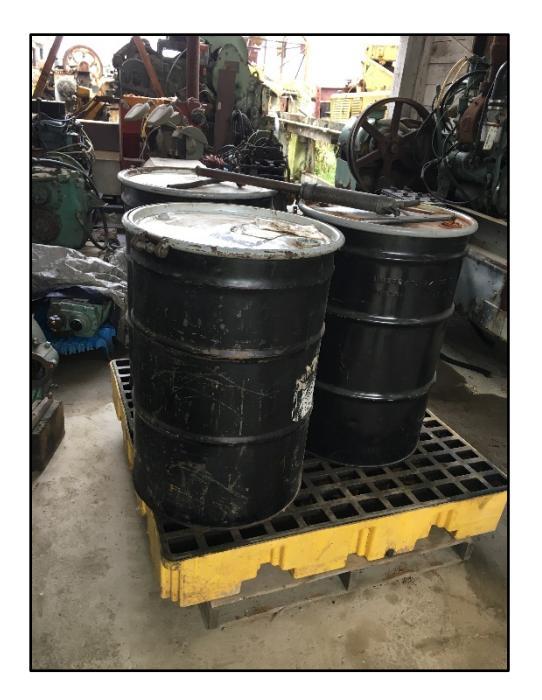
Photo 16: IMG\_1247.JPG

- The lead-acid batteries that were here during the May inspection are now gone from this area.
- Remaining are three black steel 55-gallon drums sitting on a secondary containment pallet. Mr. Ehler stated that one of these drums contained oily rags (photo 16).

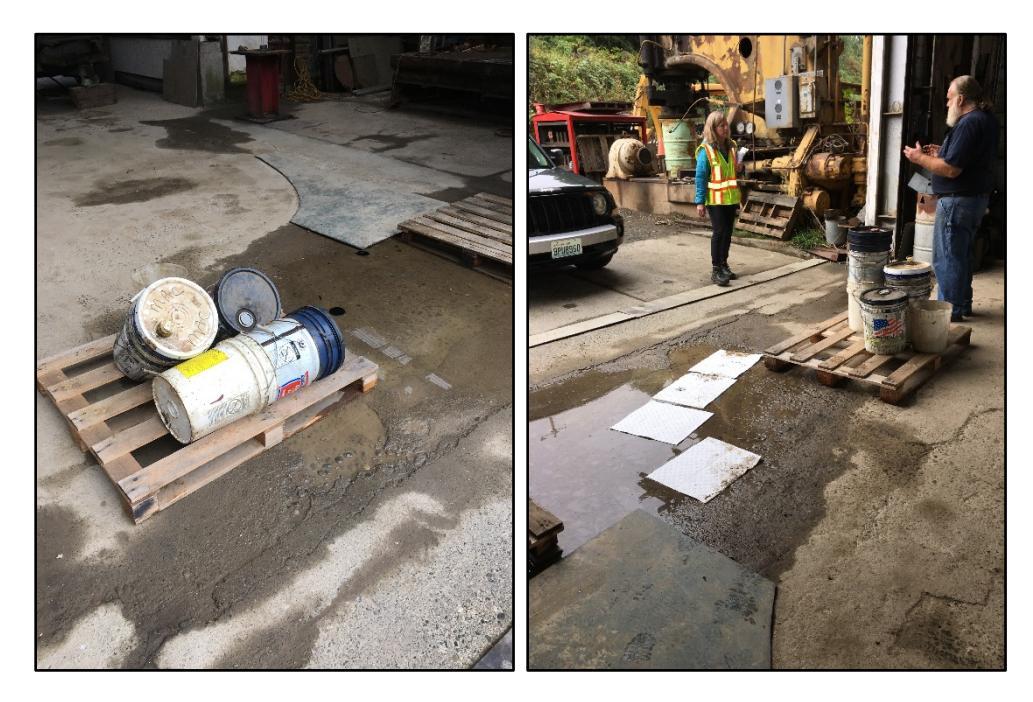
Photo 17: IMG\_1246.JPG

• Five five-gallon buckets, two with lids, were lying on a wooden pallet over a puddle of water. Oil was evident floating on the water. Mr. Ehler placed absorbent pads on the oily water and turned the buckets so they were sitting upright (photos 17-18).

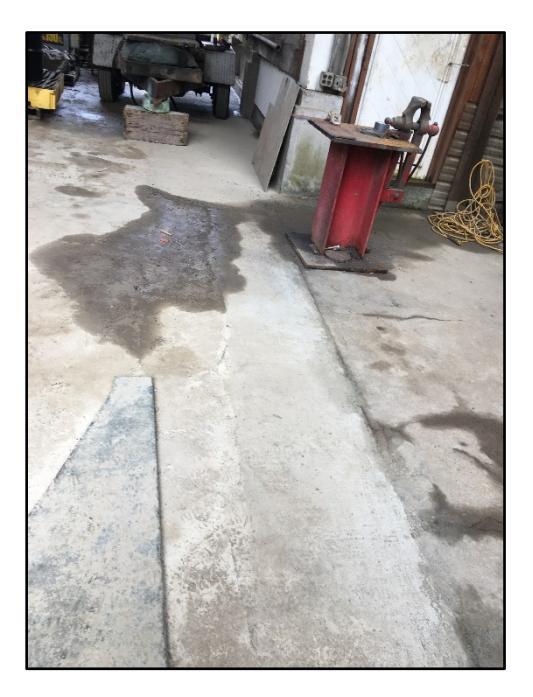
Photo 19: IMG\_1248.JPG

• Mr. Ehler showed us how Lovric's had recently cemented over drains that used to run along the east side of this area, in the north-south direction (photo 19).

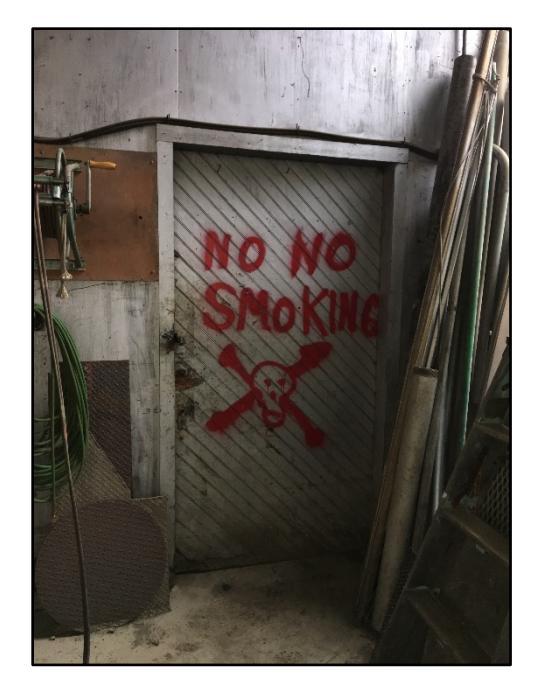
Photo 20: IMG\_1265.JPG

• We entered this building through a door with a red skull and crossbones painted on it and the words "No No Smoking" (Photo 20). Mr. Ehler told us this was "Motor Room Storage." This room is kept locked.

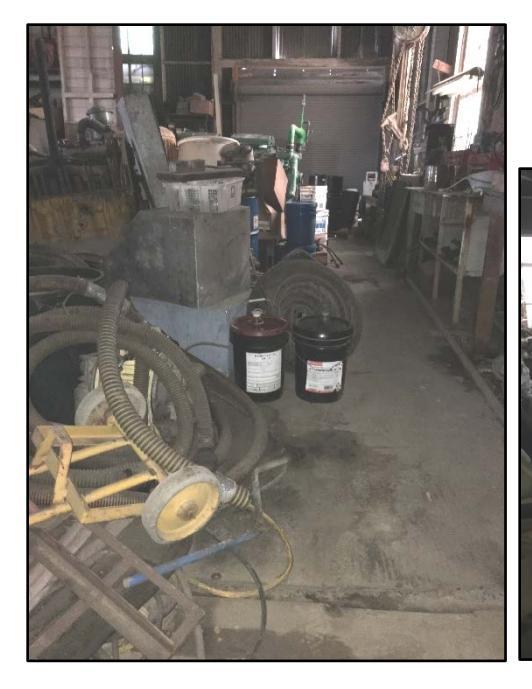
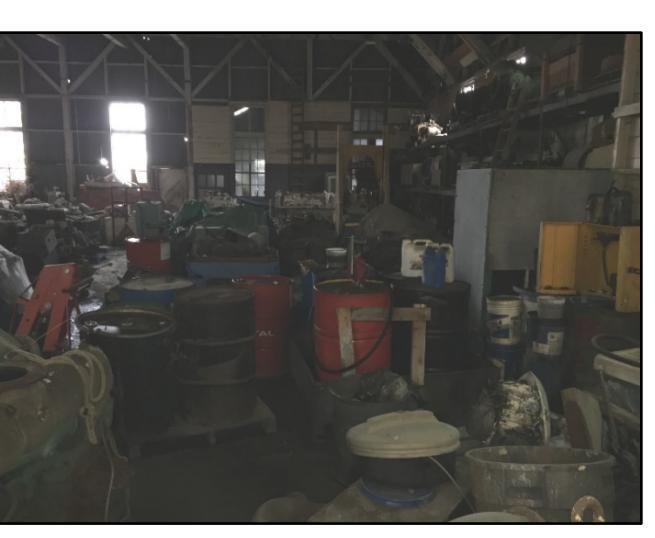
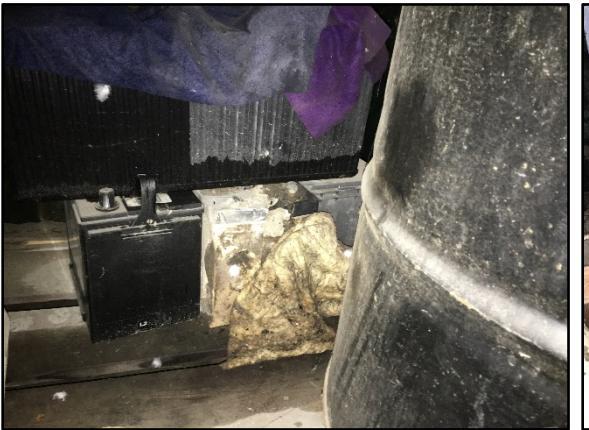
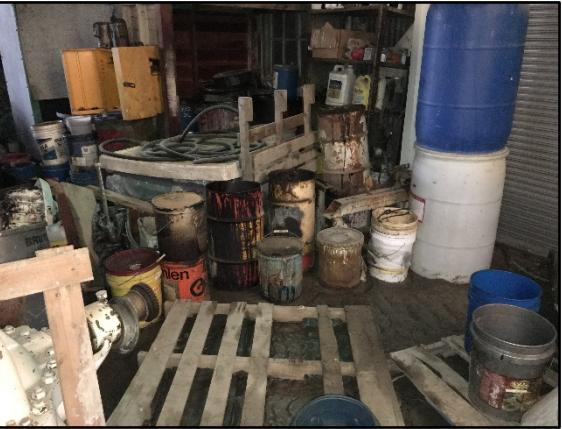
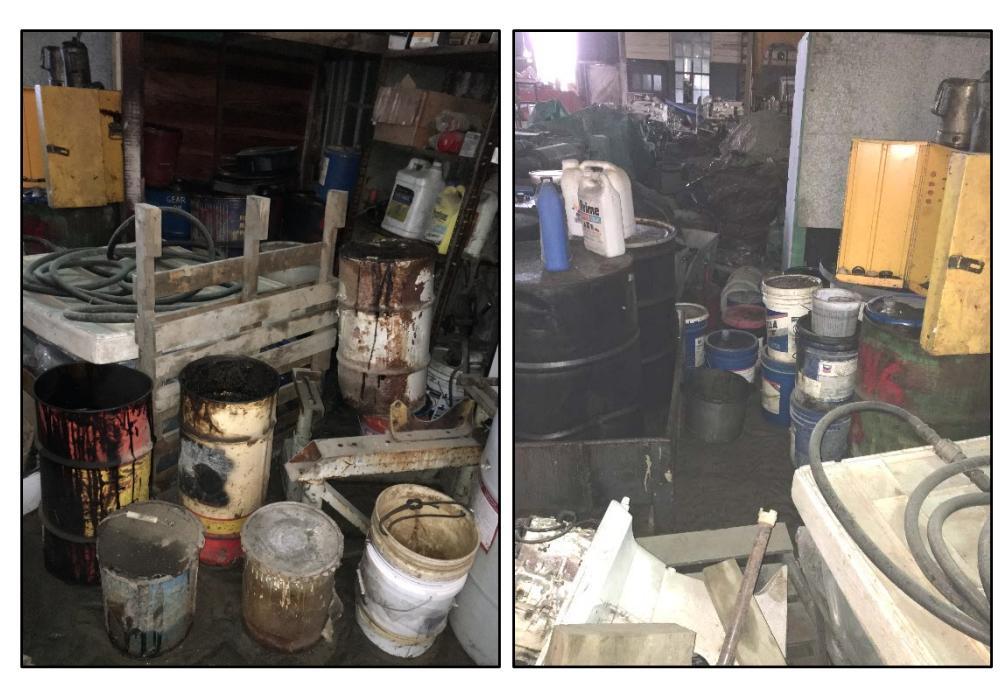
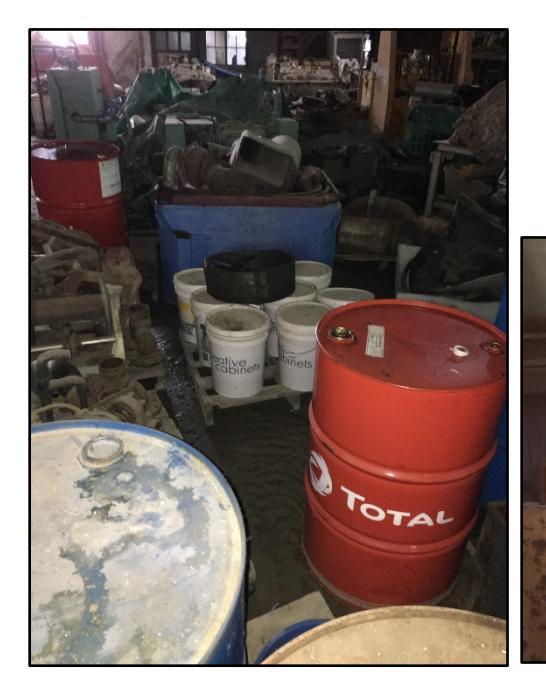
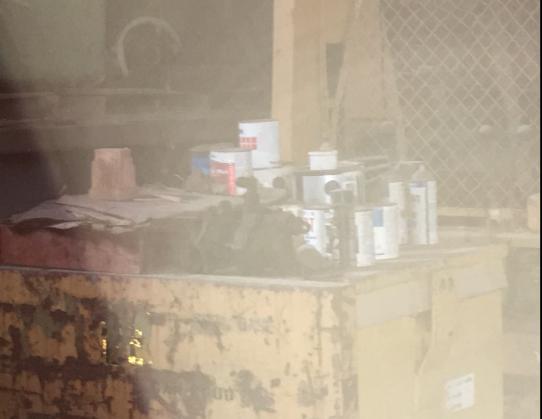
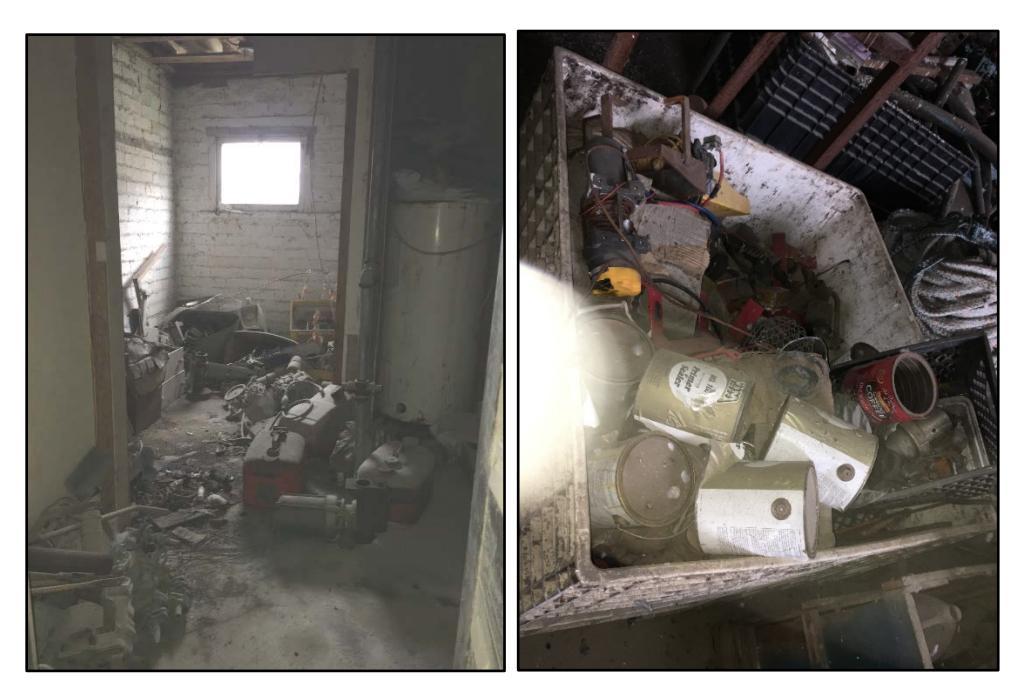
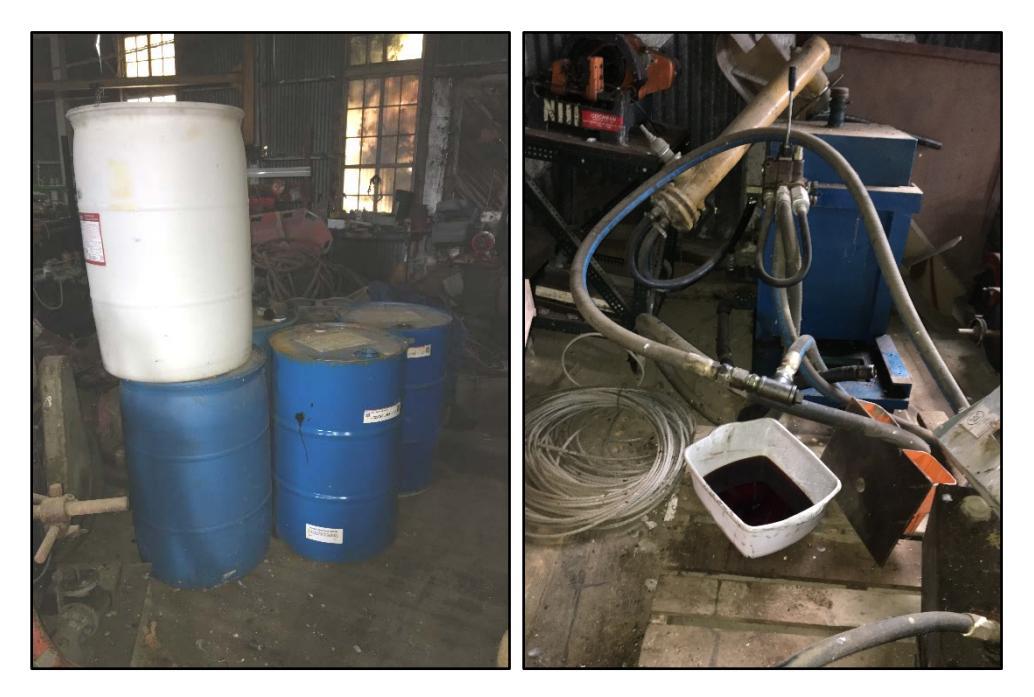
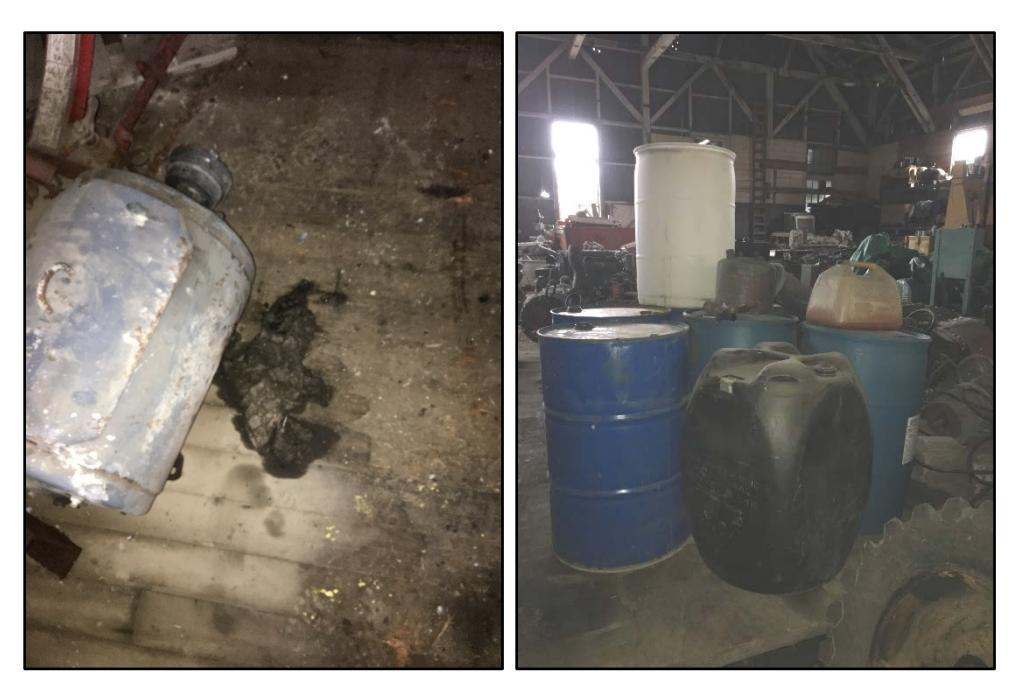
- Areas of the floor in this building were covered with wet mud and sand. Mr. Ehler told us the City of Anacortes had a water main break, and water flowed down the hill and through this building at the south end. He said it flowed into a drain then into underground pipes.
- The room is very dark and crowded. Numerous engines are stored on one side, and other non-hazardous materials throughout.

Materials of concern in this room (photos 21-34) include things such as:

- Numerous (10 or more) 55-gallon metal and plastic drums with unknown contents, some with original labels, others unlabeled. A few of these appeared empty.
- Numerous one-gallon paint cans that appeared to be primer.
- Numerous five-gallon pails with lids and unknown contents.
- Open containers stained with black material with the appearance of oily or asphaltic waste.
- Lead acid batteries on a wooden pallet, with a tote stacked on top. This is cited as a violation above.
- Numerous small paint-like cans.
- An open tub containing what looked like used or waste oil.
- Numerous gas cans that may or may not be empty.

Summary of Violations & Observations	Actions Required
<ul> <li>WAC 173-303-520(1) and 016(1)(b)(ii):</li> <li>Spent lead-acid batteries that are recyclable materials must be handled in a manner that does not pose a threat to public health or the environment.</li> <li>Easternmost Building :</li> <li>At least three lead acid batteries are being stored underneath a container and on a wooden pallet. This could lead to potential leakage of battery acid and lead contamination (photo 23).</li> </ul>	Move all lead-acid batteries to a location where they are covered and contained. When you return the Compliance Certificate, include a photo of the properly contained batteries or describe the actions you will take to ensure the spent lead-acid batteries will not pose a threat to human health or the environment

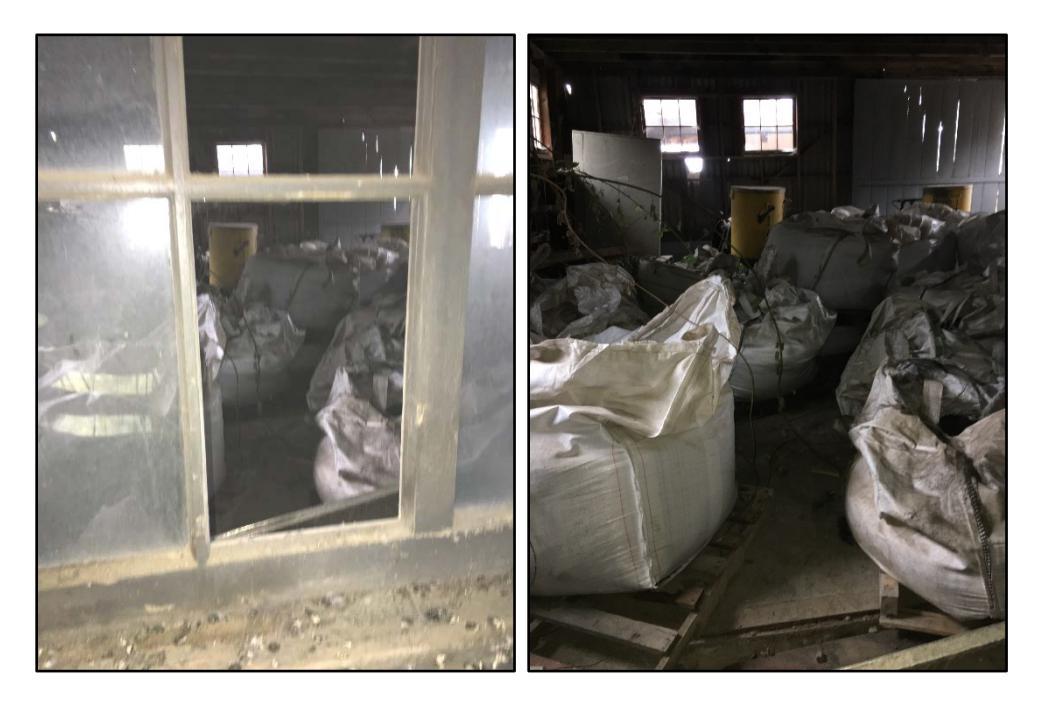
Photo 35: IMG\_1258.JPG\*

Looking through a window to the north we could see into the sandblast shed. All of the fabric totes of spent materials noted during the inspection in May are still in this area (photos 35 and 36.)

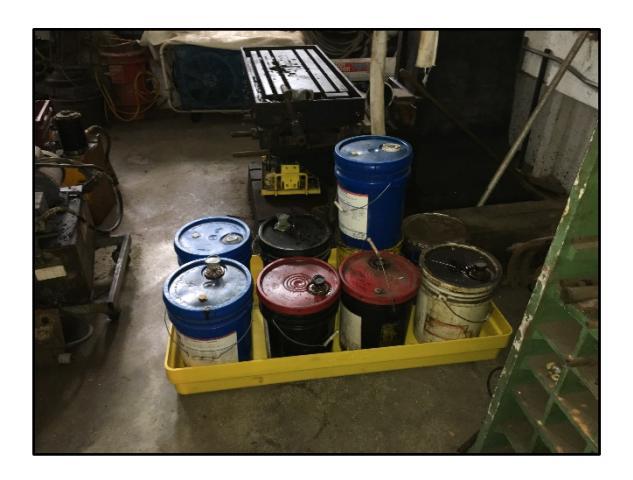
Photo 37: IMG\_1267.JPG

• Five-gallon buckets holding oils identified during the last inspection have been deemed useable product and placed in secondary containment trays (photo 37).
