Annual 2020 Groundwater and Cap Compliance Monitoring Report BNSF Hillyard Dross Cap Spokane, Washington

KJ Project No. 2096114.02

ANNUAL 2020 GROUNDWATER AND CAP COMPLIANCE MONITORING REPORT BNSF Hillyard Dross Cap Spokane, Washington

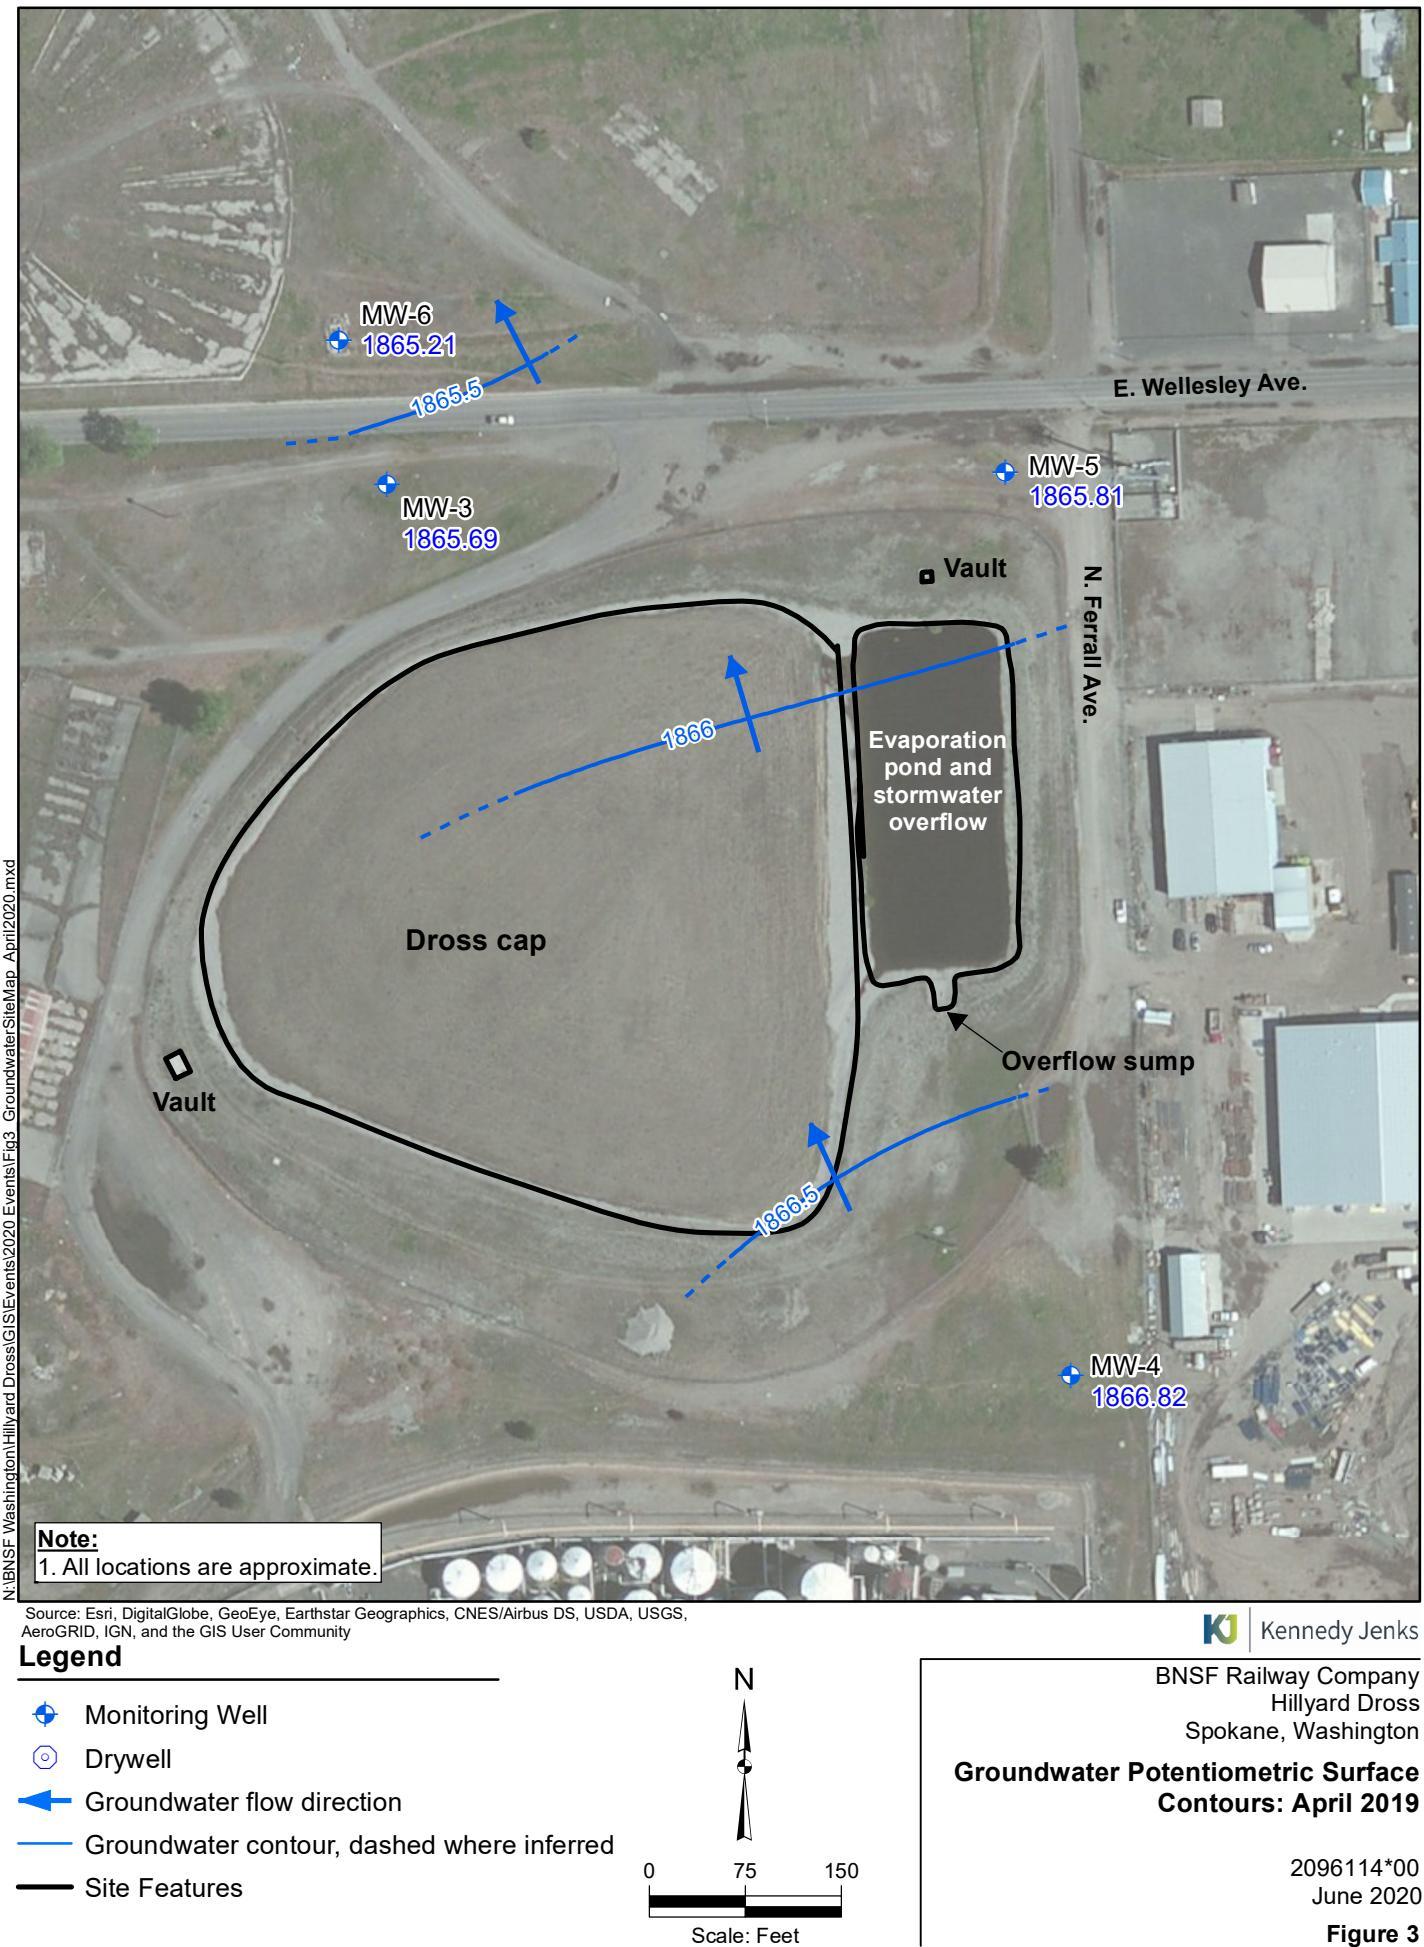
Figure 3

Groundwater elevations, calculated from depth-to-water measurements collected on 29 April 2020, ranged from 1,865.21 feet (monitoring well MW-6) to 1,866.82 feet (monitoring well MW-4) (Table 1). The interpreted groundwater flow direction beneath the Site at the time of the monitoring event was north-northwest under a hydraulic gradient of approximately 0.002 feet per foot, which is consistent with historical data. Interpreted groundwater elevation contours and groundwater hydraulic gradient direction for the 29 April 2020 monitoring event are presented on Figure 3.

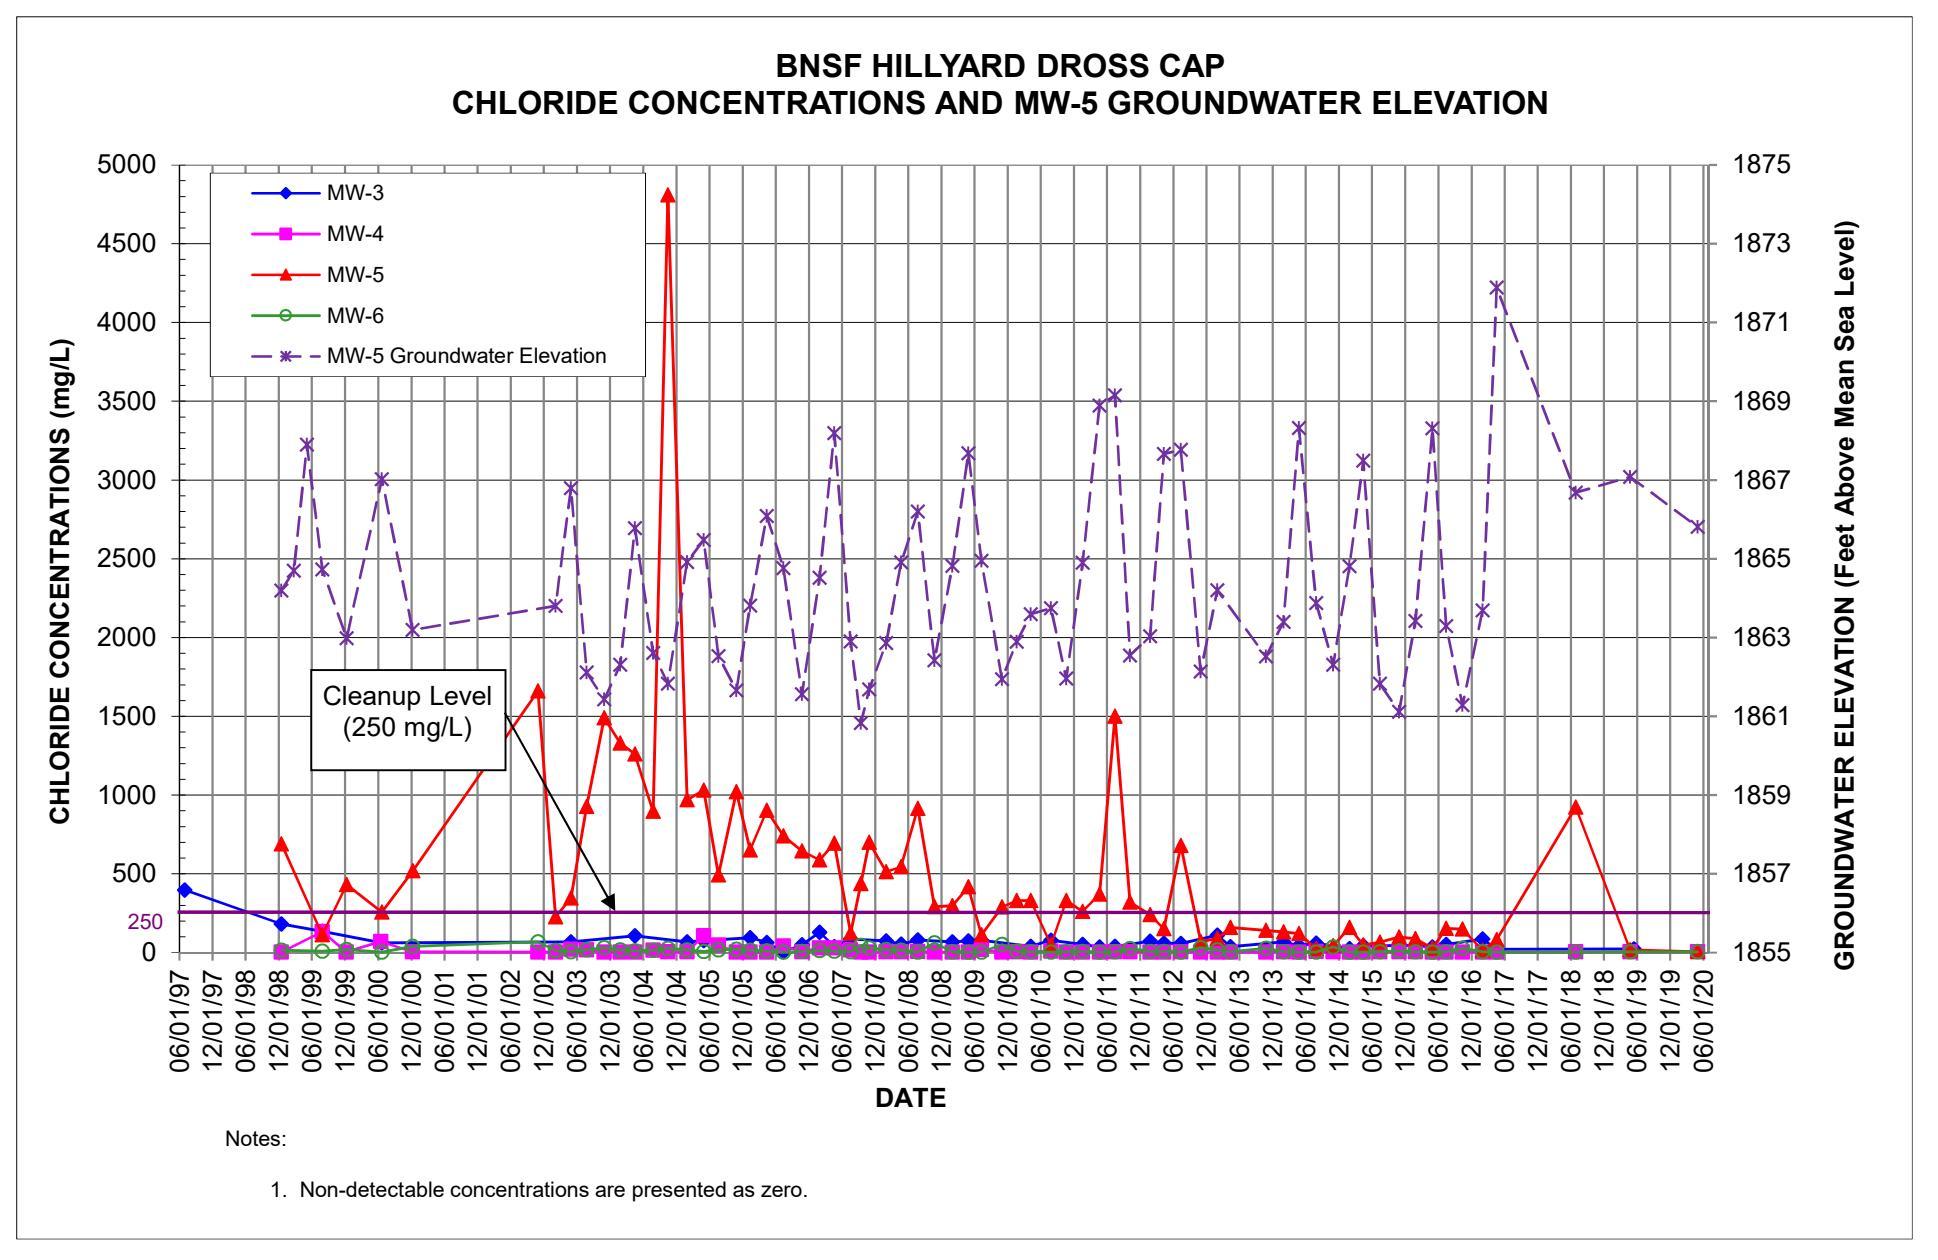
FIGURE 4

Figures 4, 5, and 6 present graphical representations of historical and current chloride, nitrate, and nitrite concentrations, respectively.
