FOCUSED PHASE II ENVIRONMENTAL SITE ASSESSMENTS

Light Industrial, Former Agricultural, and Residential Properties 7619 and 7723 48th Street East and 4708-4710 and 4716-4720 77th Avenue Court East Fife, Washington 98424 Pierce County Tax Lots 016, 026, 032, 033, 035, and 036 of Map No. 0420173

April 12, 2024

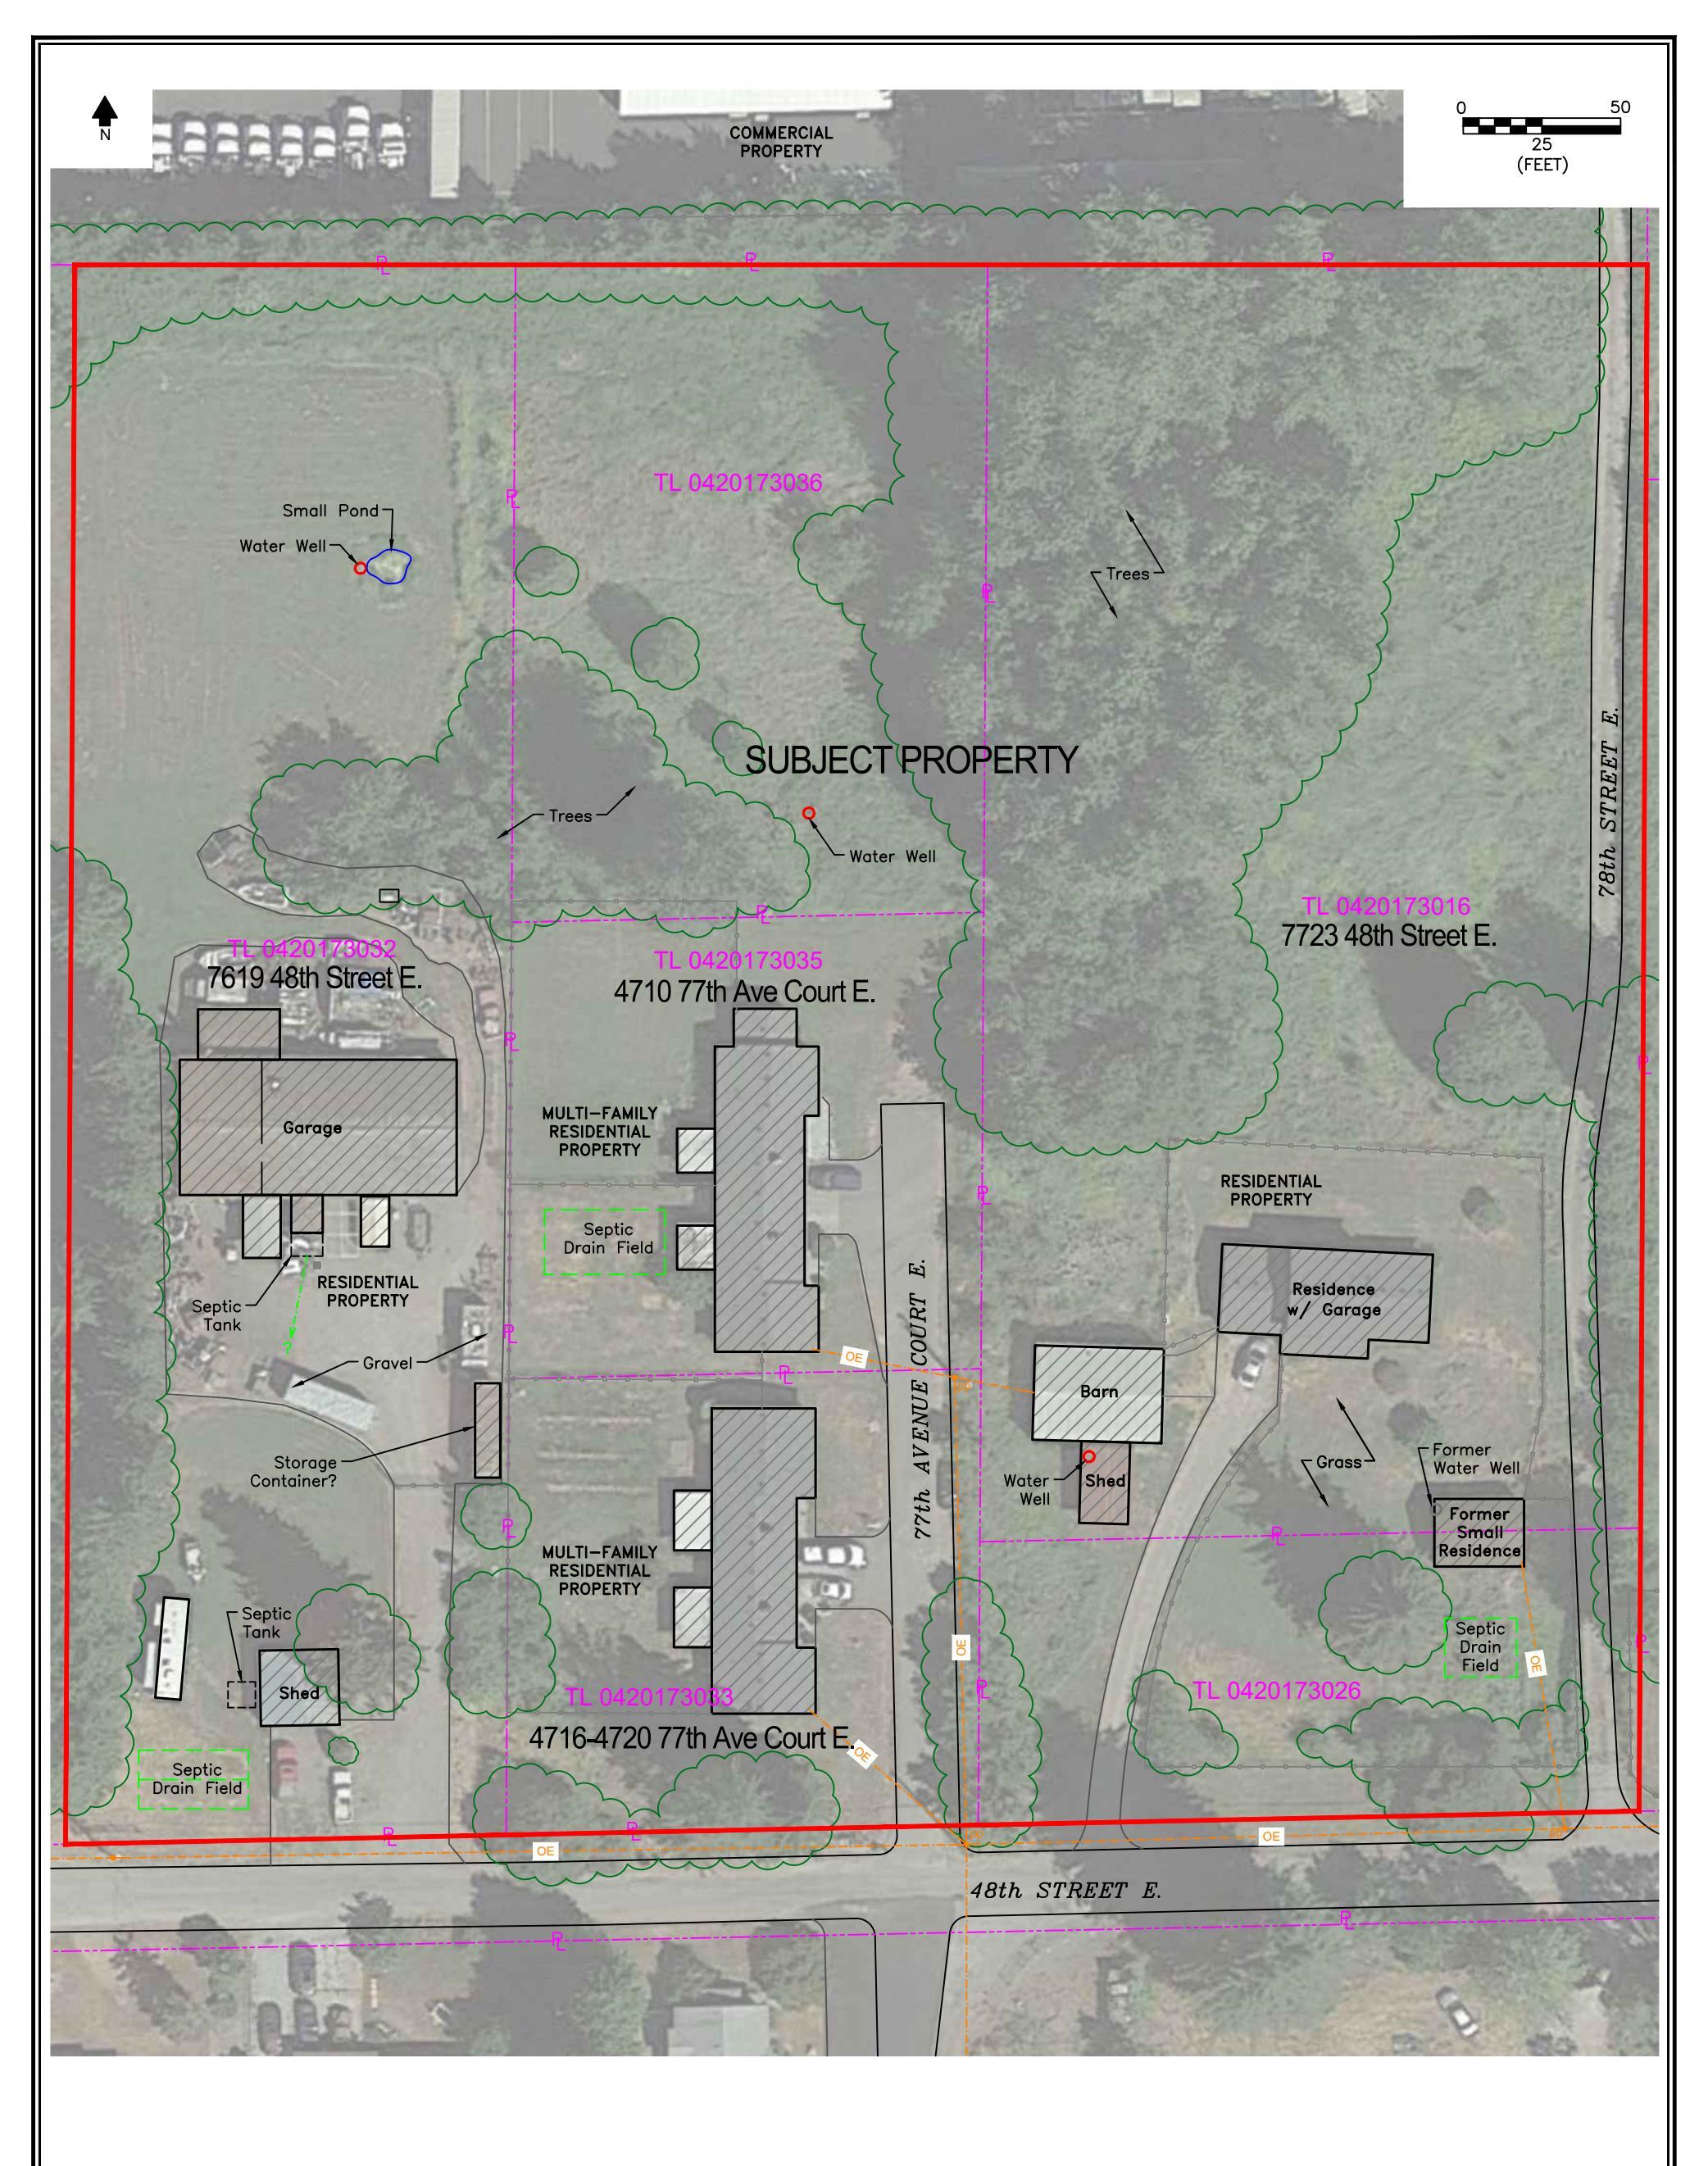
The *subject property* is located on the north side of the 7600 / 7700 block of 48th Street East, in southeast Fife, Washington. The subject property is composed of six (6) parcels. Each of the *subject* parcels are described below:

- Parcel 0420173032: This western parcel, 1.65 acres in size, is developed with a 3,700 square-foot Service Garage on the central portion of the parcel. The Service Garage is constructed with wood framing, wood siding, a concrete slab, five (5) roll-up garage doors, and a composite shingle roof. Inside the Garage is a Paint Booth, and an in-ground vehicle hoist. Stored inside the Garage are three (3) vintage cars in various stages of restoration, numerous car engines, and an abundance of car parts and tools. Inside the north-central Service Garage is a paint storage room, with may small cans of paint. According to the owner, the Service Garage was constructed in 1985, and is approximately 3,700 square feet in size. There are no floor drains in the Garage. According to the owner, the Service Garage car renovation. An abundance of old vehicles, trailers, boats, car parts, and equipment are stored outside around the Garage. A septic tank and drainfield are located immediately south of the Service Garage. A small storage shed is located on the south-central portion of this parcel.

- **Parcel 0420173036:** This north-central parcel (036) is undeveloped and covered with thick grass and areas of dense trees. This parcel is approximately 0.73 acres in size. A water well (supplying water to the duplexes to the south) is located on the southeast quarter of this parcel.

- **Parcel 0420173035:** This central parcel (035) is approximately 0.44 acres in size, and developed with a residential duplex, approximately 1,736 square feet in size. Each duplex unit contains an attached garage. Addresses for the duplex are 4708 and 4710 77th Avenue Court East. According to the Pierce County assessor database, the duplex was constructed in 1972. The duplex is constructed with wood framing, wood siding, vinyl windows, a perimeter concrete foundation wall with crawlspace, a composite shingle roof, and electric baseboard heating.

- **Parcel 0420173033:** This south-central parcel (033) is approximately 0.46 acres in size, and developed with a residential duplex, approximately 1,688 square feet in size. Each duplex unit contains an attached garage. Addresses for the duplex are 4716 and 4720 77th Avenue Court East. According to the Pierce County assessor database, the duplex was constructed in 1970. The duplex is constructed with wood framing, wood siding, vinyl windows, a perimeter concrete foundation wall with crawlspace, a composite shingle roof, and electric baseboard heating.

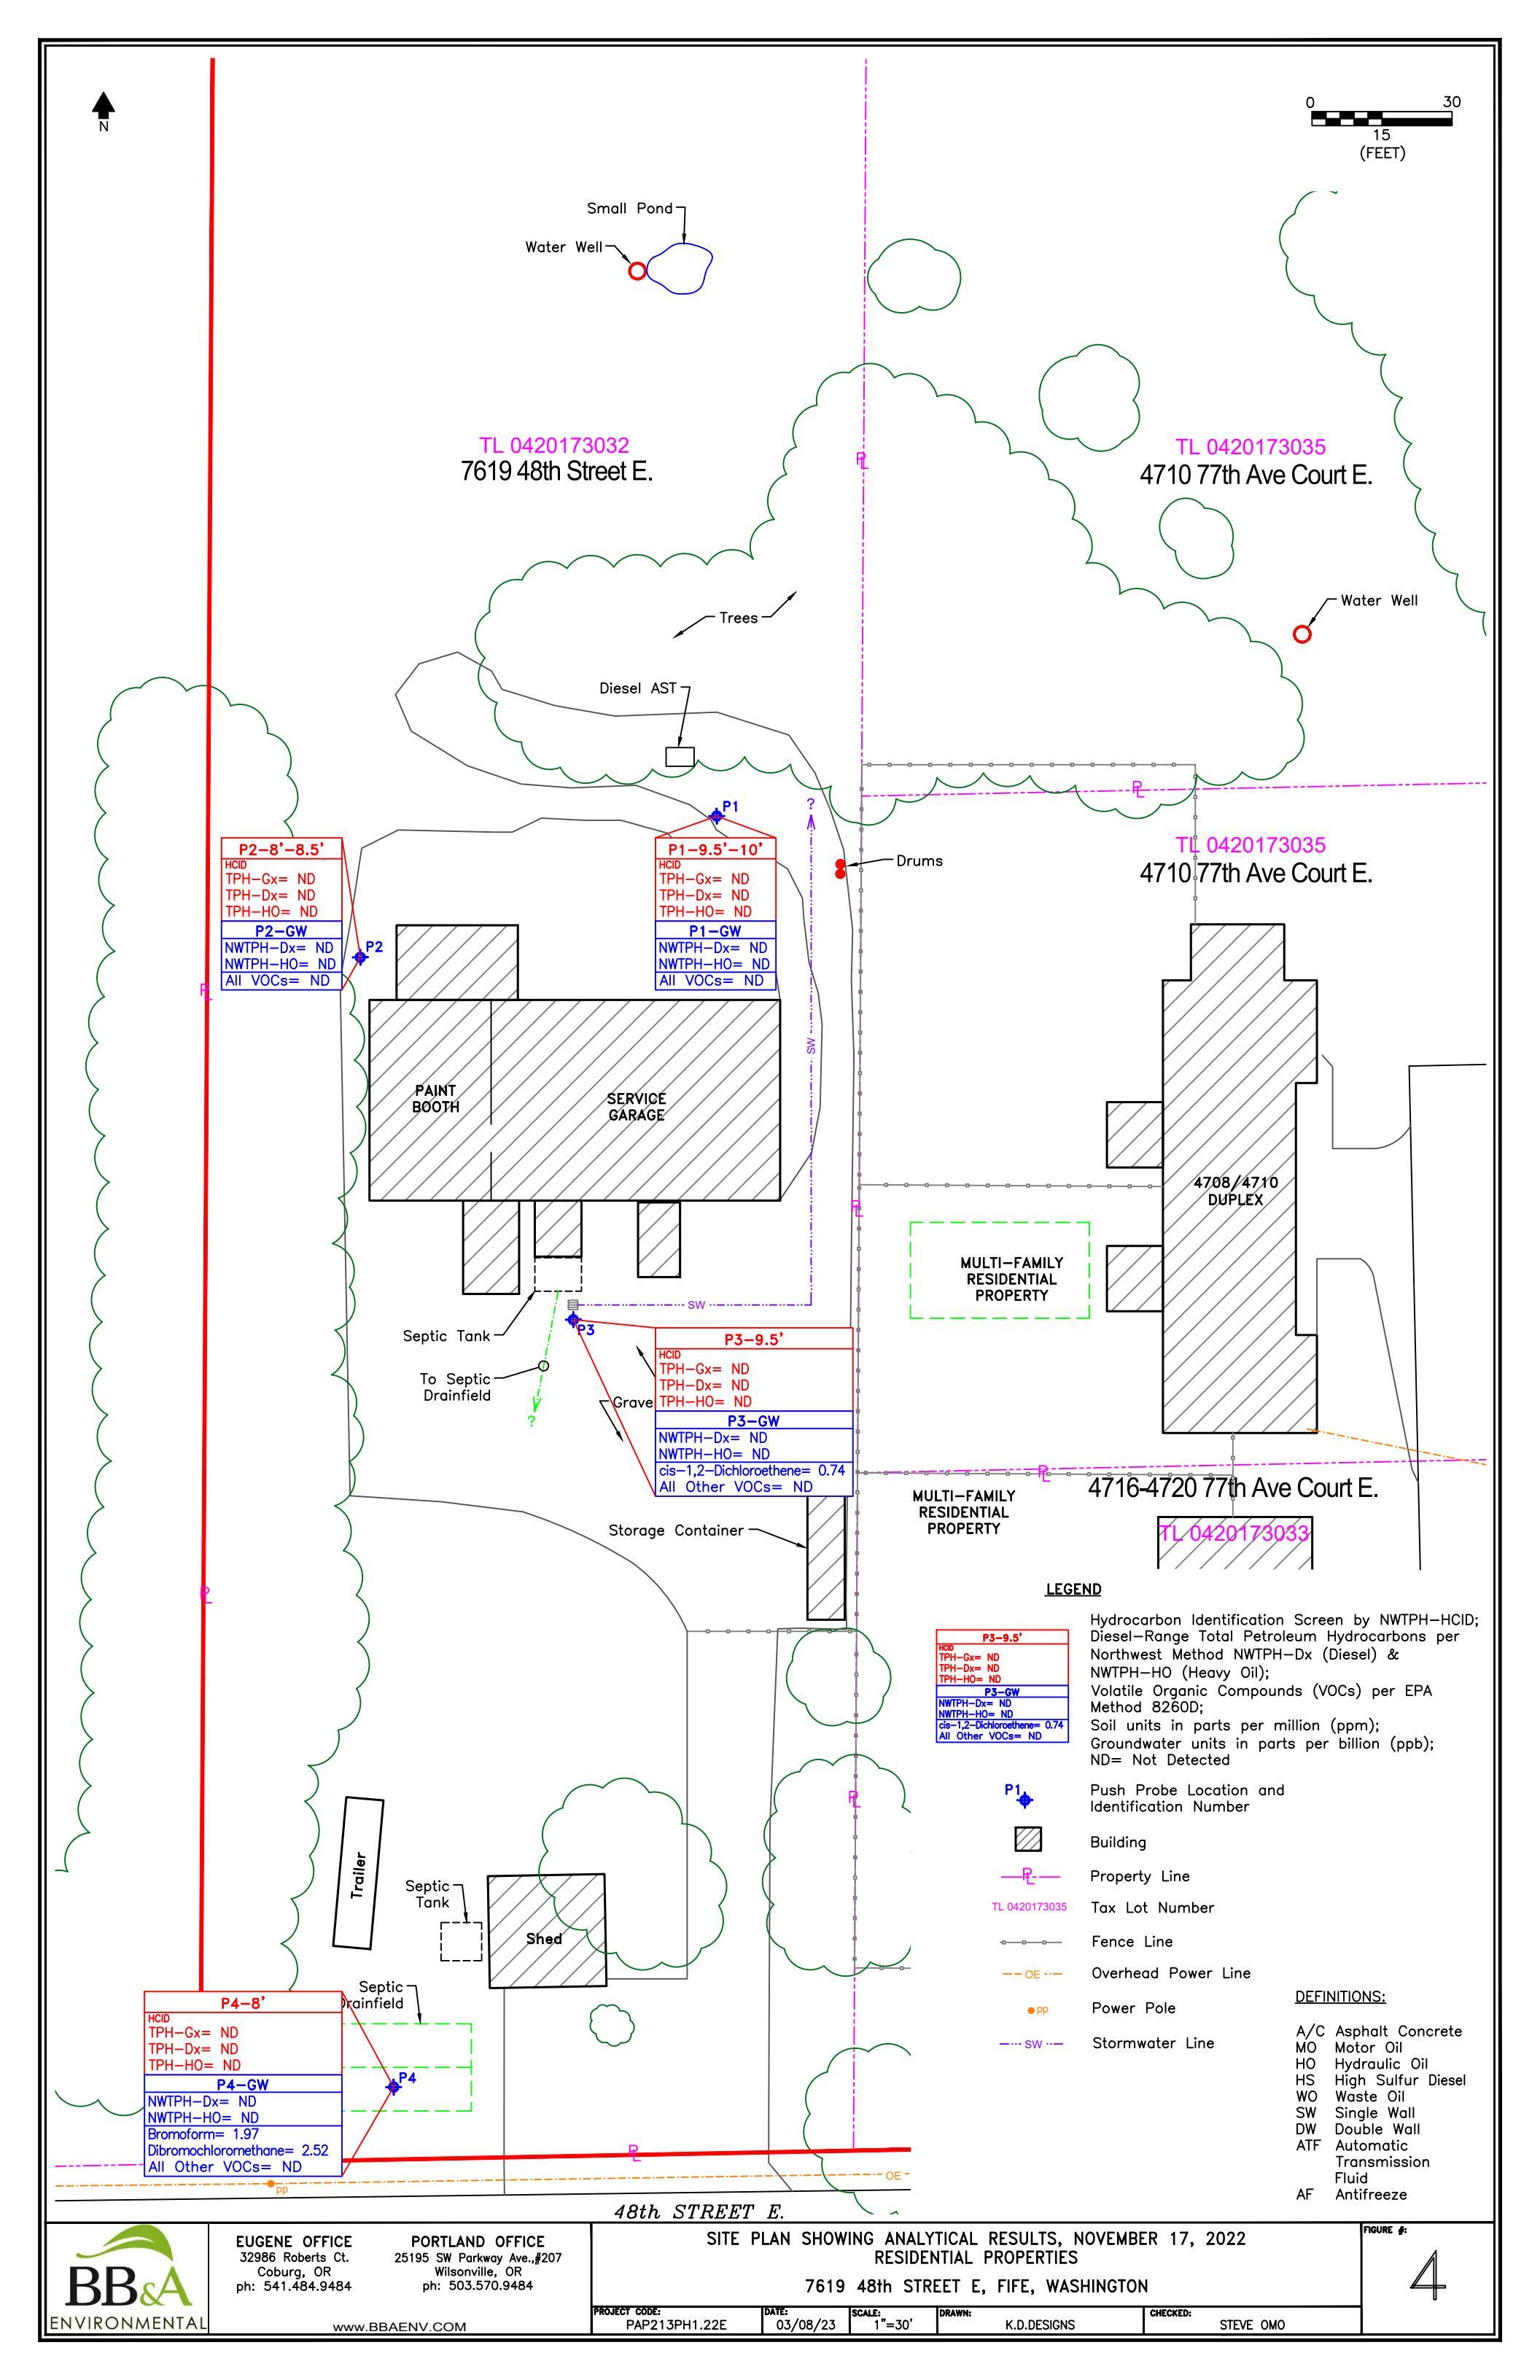
Table 1: Soil Analytical Results7619 48th Street E, Fife, Washington									
All concentrations in milligrams per kilogram (mg/kg), or parts per million (ppm). ND (>20): Indicates contaminant was not detected above method-reporting limit shown in parenthesis. *MTCA A Cleanup Level for Gasoline-range TPH is 100 ppm if benzene is not detected, and 30 ppm if benzene is detected.									
Contaminants-of-		Soil Sa	ample ID		MTCA Method A Cleanup Levels for				
Potential-Concern P1 - 9.5-10' P2 - 8-8.5' P3 - 9.5' P4 - 8' Unrestricted Lar									
Gasoline-Range TPH	ND (<25.8)	ND (<24.9)	ND (<24.1)	ND (<28.3)	<28.3) 100 / 30*				
Diesel-Range TPH ND (<64.4) ND (62.2) ND (60.3) ND (70.8) 2,000 Heavy Oil-Range TPH ND (129) ND (124) ND (121) ND (142) 2 000

Laboratory analysis of the soil samples did not detect gasoline-, diesel-, or oil-range TPH above method reporting limits (MRLs) in any of the four (4) soil samples collected from borings P1 through P4 Contaminant concentrations were compared to MTCA Method A Cleanup Levels (CULs) for unrestricted land use, protective of human-health under various potential exposure pathways and receptor scenarios, including those for excavation / utility workers, and current onsite workers or potential residents under future land use scenarios (e.g. dermal contact / inhalation exposure pathways). No contaminants were detected, nor were any MRLs above MTCA Method A CULs.

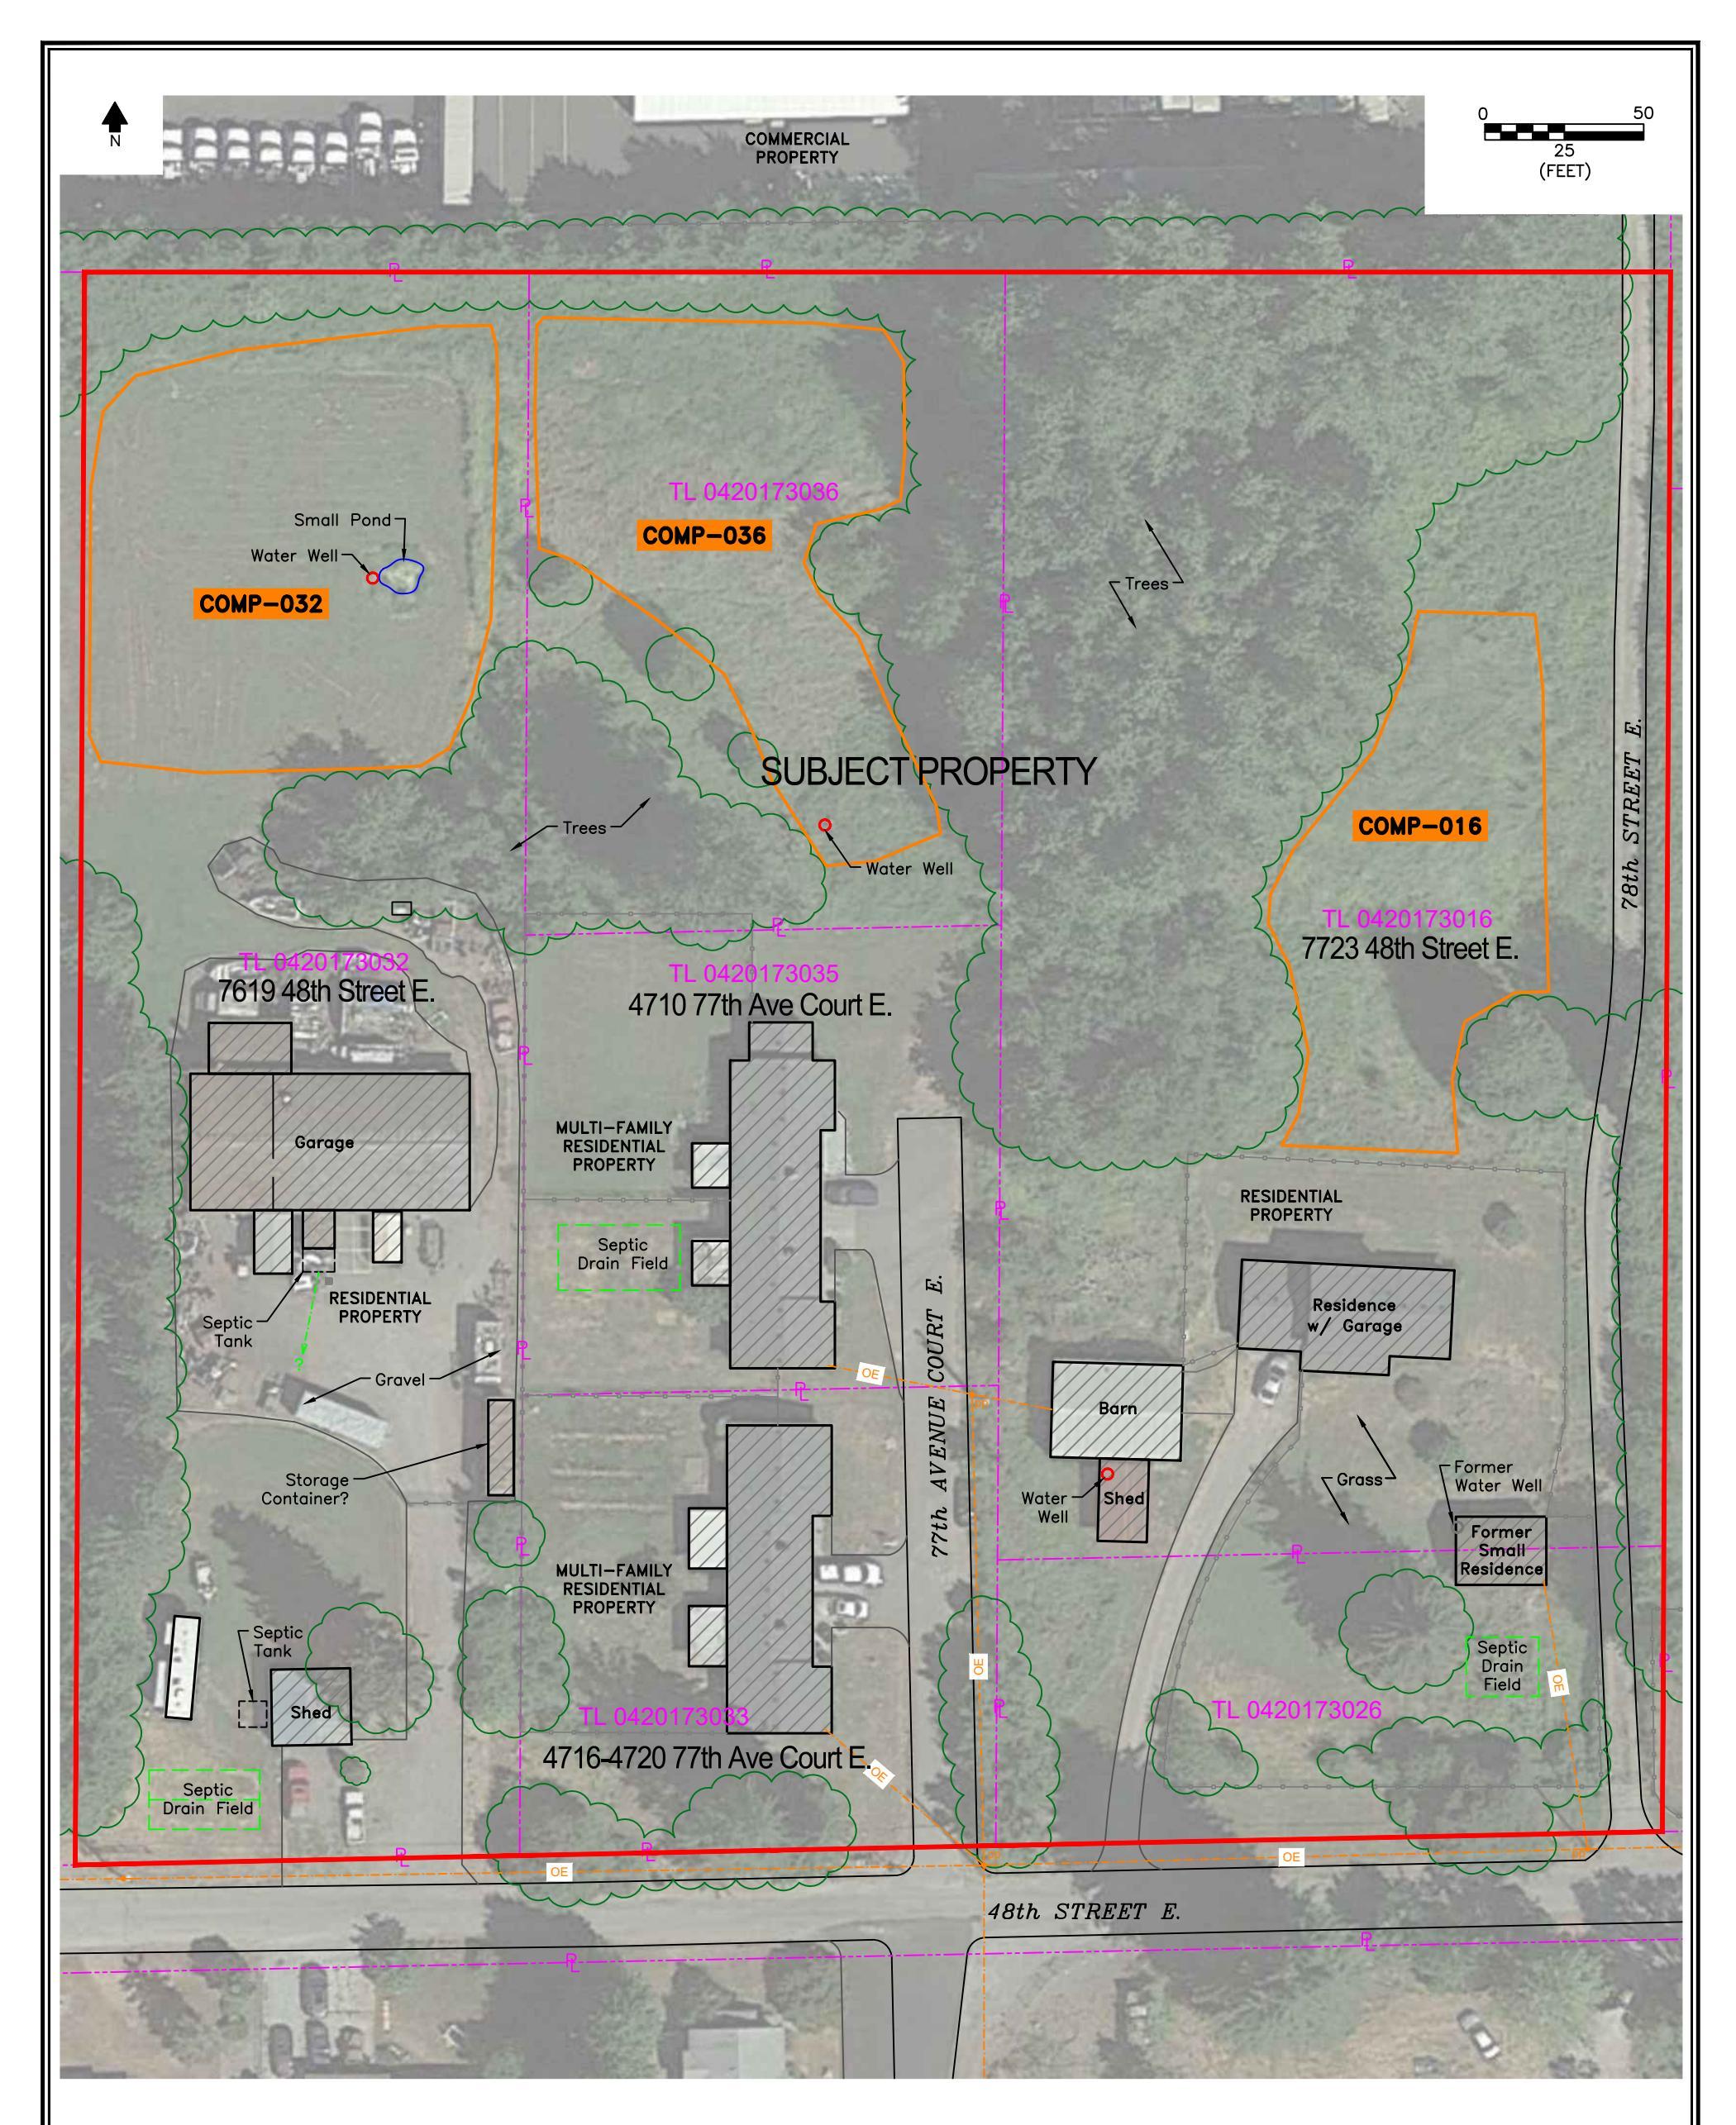
All of the composite soil samples were submitted for analysis of Organochlorine Pesticides per EPA Method 8081B, and Herbicides per EPA Method 8151A. The analytical results are summarized below in **Table 3**. Laboratory analysis only detected the pesticide Dieldrin above the method reporting limit in composite soil samples COMP-032 and COMP-036. Herbicides were not detected above method reporting limits in any of the composite soil samples.

To evaluate the analytical results, the detected Dieldrin concentrations were compared to MTCA cleanup levels. MTCA Method A cleanup levels were not available for any of the herbicides or pesticides. Instead, Dieldrin concentrations were compared to MTCA Method B cleanup levels for unrestricted land use, and MTCA. MTCA Method B includes cleanup concentrations for carcinogenic and non-carcinogenic compounds. Dieldrin did not exceed the carcinogenic MTCA Method B cleanup level, and was two (2) to three (3) orders of magnitude below the MTCA C Cancer Cleanup Level for industrial land.

No other herbicides or pesticides were detected above method reporting limits. Based on the results of the focused sampling and analytical results, and proposed future use as an industrial property, the concentrations of Dieldrin do not appear to pose a human-health concern under current or proposed future land use scenarios.
