SCOLES ASSOCIATES, INC.

This letter is a decommissioning report for the 500 gallon underground storage tank (UST) removed from 531 South 28th Street, Washougal, Washington on August 20, 1989. This report summarizes the UST removal process, existing soil conditions, analytical sampling, and laboratory results. Scoles Associates, Inc. (SAI) has compiled this report for the express use of the Port of Camas / Washougal and its designates.

Decommissioning Repc UST No. 9 Port of Camas / Washougal, Washington Page 2

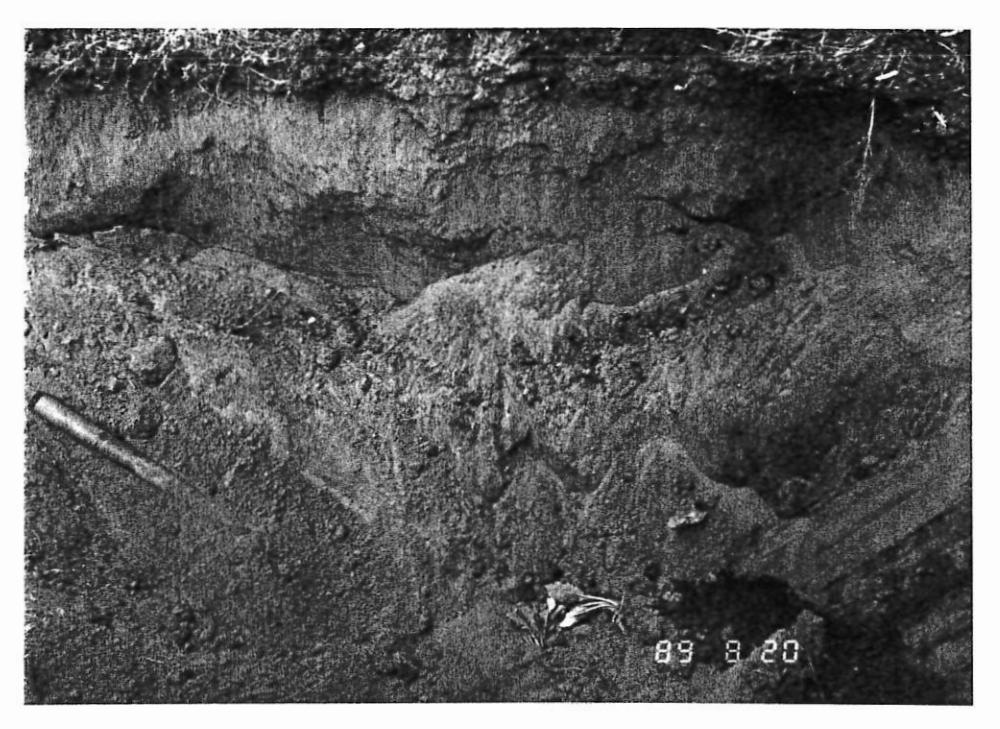
PHOTO NO. 1. View of the north side of the tank pit for UST no. 9 on the west side of Building 4, at 531 South 28th Street, Washougal, WA.

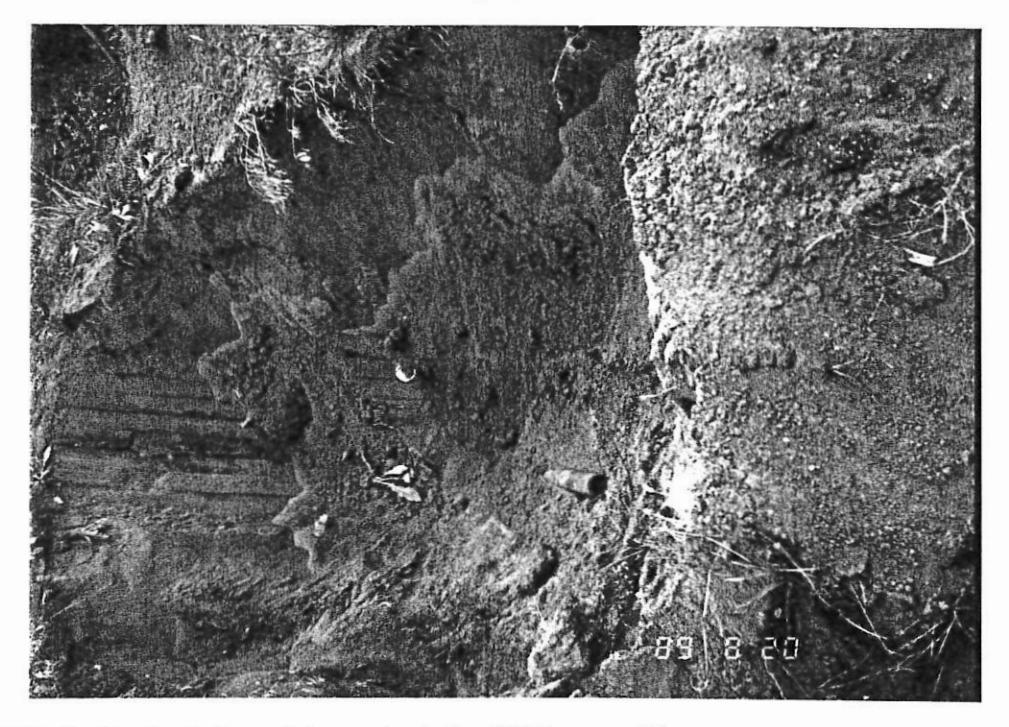
PHOTO NO. 2. Vertical view of the tank pit for UST no. 9. The back part of the tank pit was the end having the fill spout.

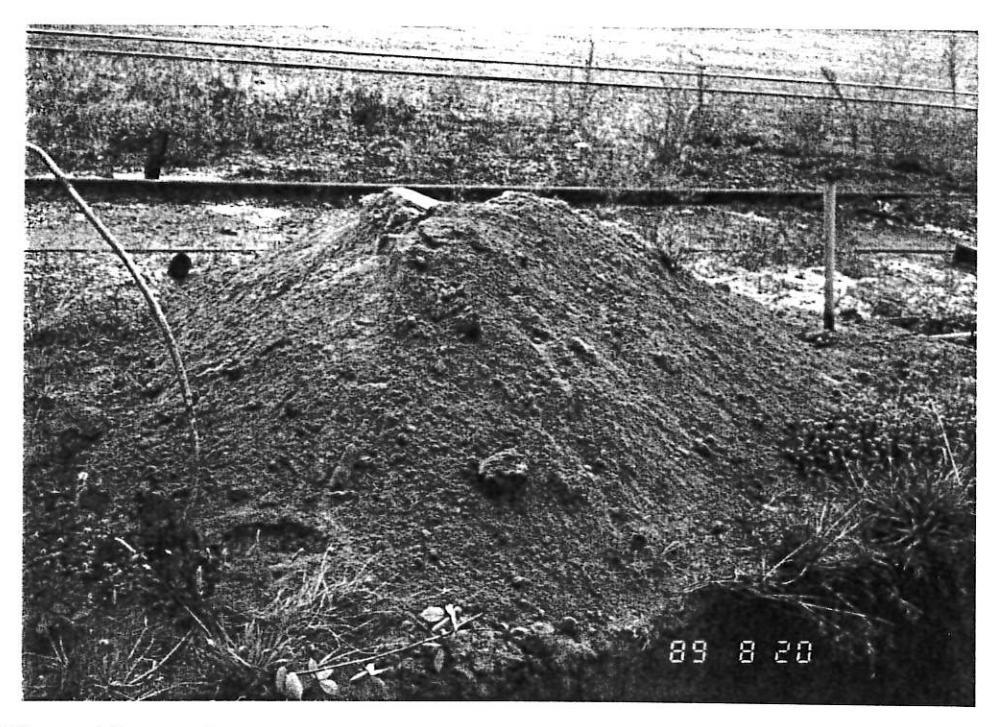
PHOTO NO. 3. View of the sandy backfill that surrounded UST no. 9. This stockpile and the soil in the bottom of the tank pit did not have any indication of leakage or spillage.

Based on soil conditions observed and the outcome of the analytical tests, SAI finds no indication of petroleum (diesel or gasoline) contamination in the tank pit or the sandy backfill soil therein. This report makes no claim or conclusions about the ground water, the rest of the property, and the report findings and their significance should not be extrapolated beyond the immediate area of observation and sampling. SAI shall not be liable beyond the fees paid for its services for errors or omissions.

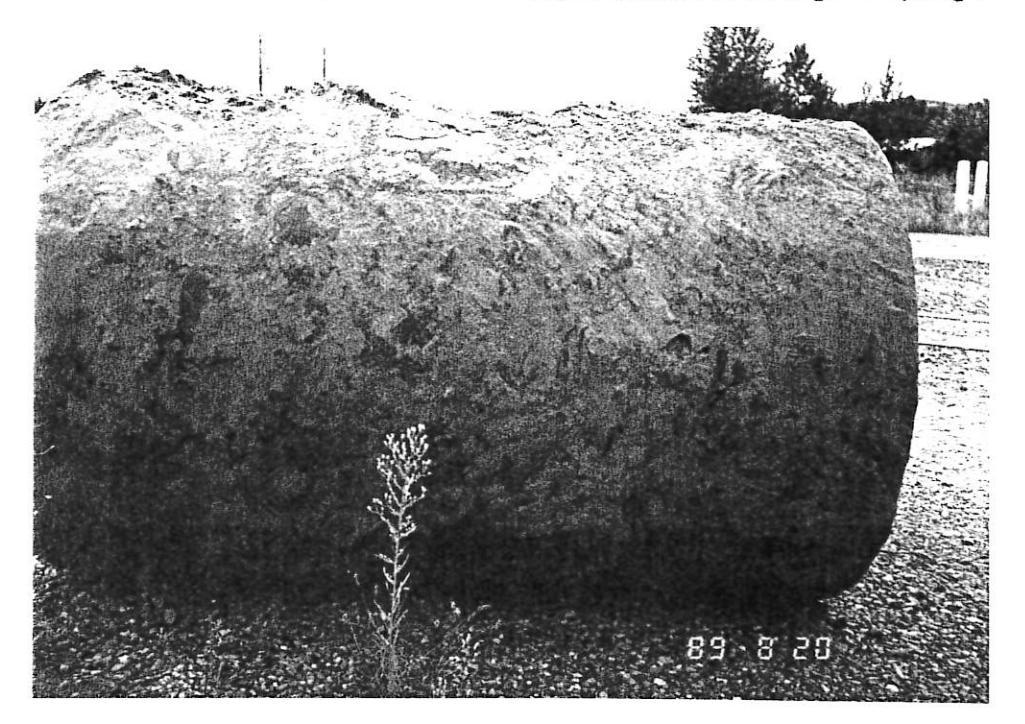
PHOTO NO. 4. Side view of UST no. 9. The exterior surface (unprotected) was in fair to good condition on all sides.

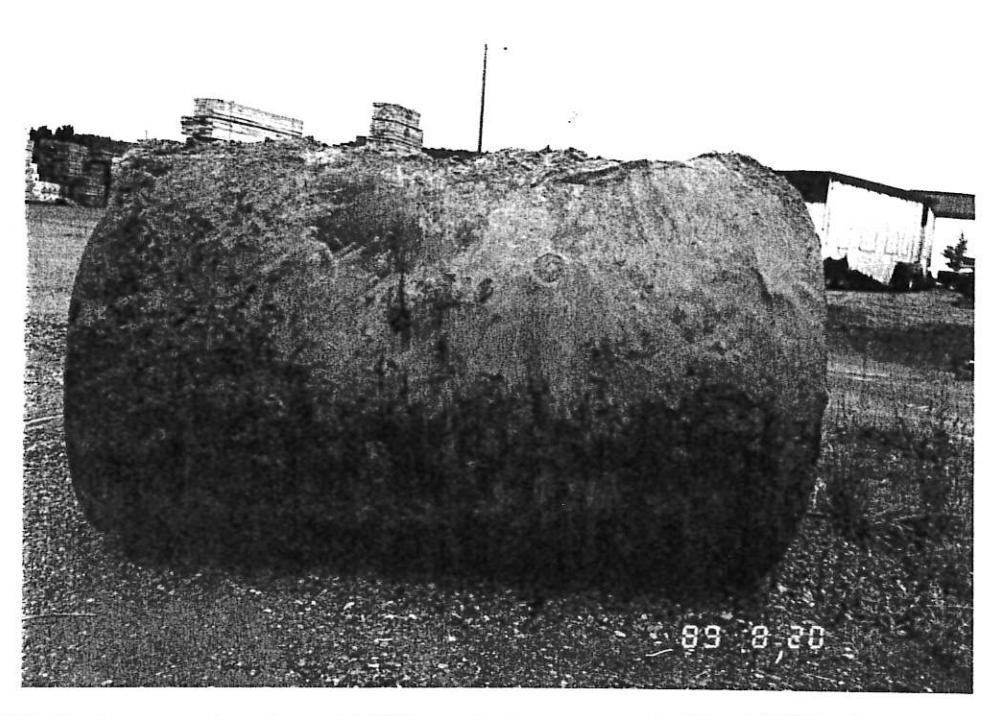
PHOTO NO. 5. An opposite view of UST no. 9 after removal. The UST had no apparent leakage or spillage stains on the exterior surface.

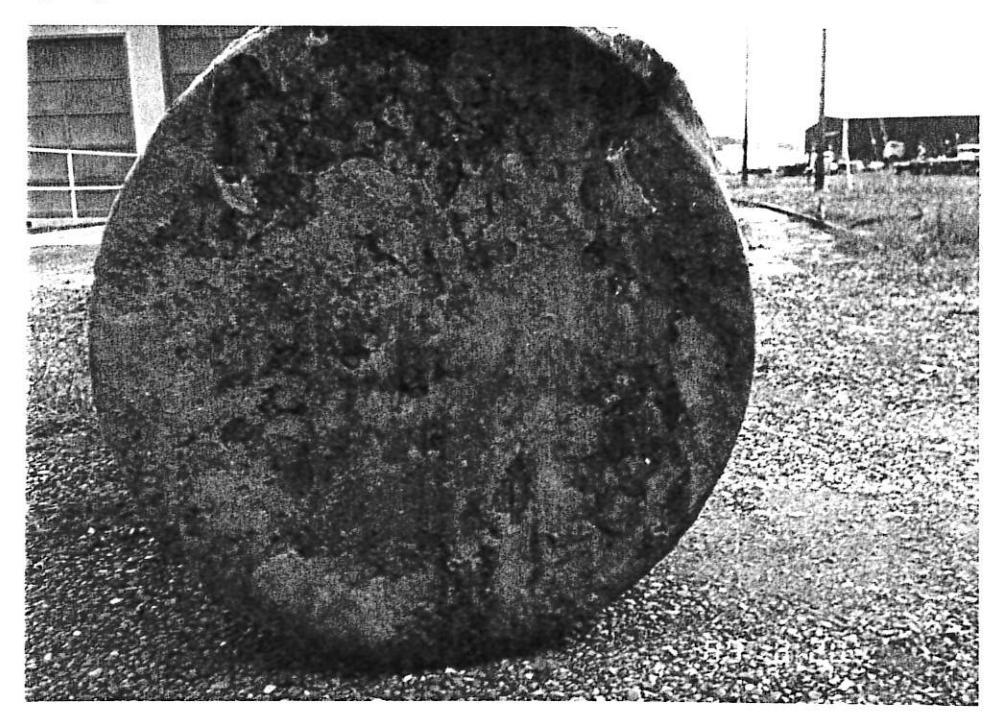
PHOTO NO. 6. End view of UST no. 9 after removal from the tank pit.
