# FINAL SITE INSPECTION REPORT Baxter Outlying Field Franklin County, Washington FUDS Property No. F10WA0616

Site Inspections at Multiple Sites, NWO Region Formerly Used Defense Sites Military Munitions Response Program

September 2011

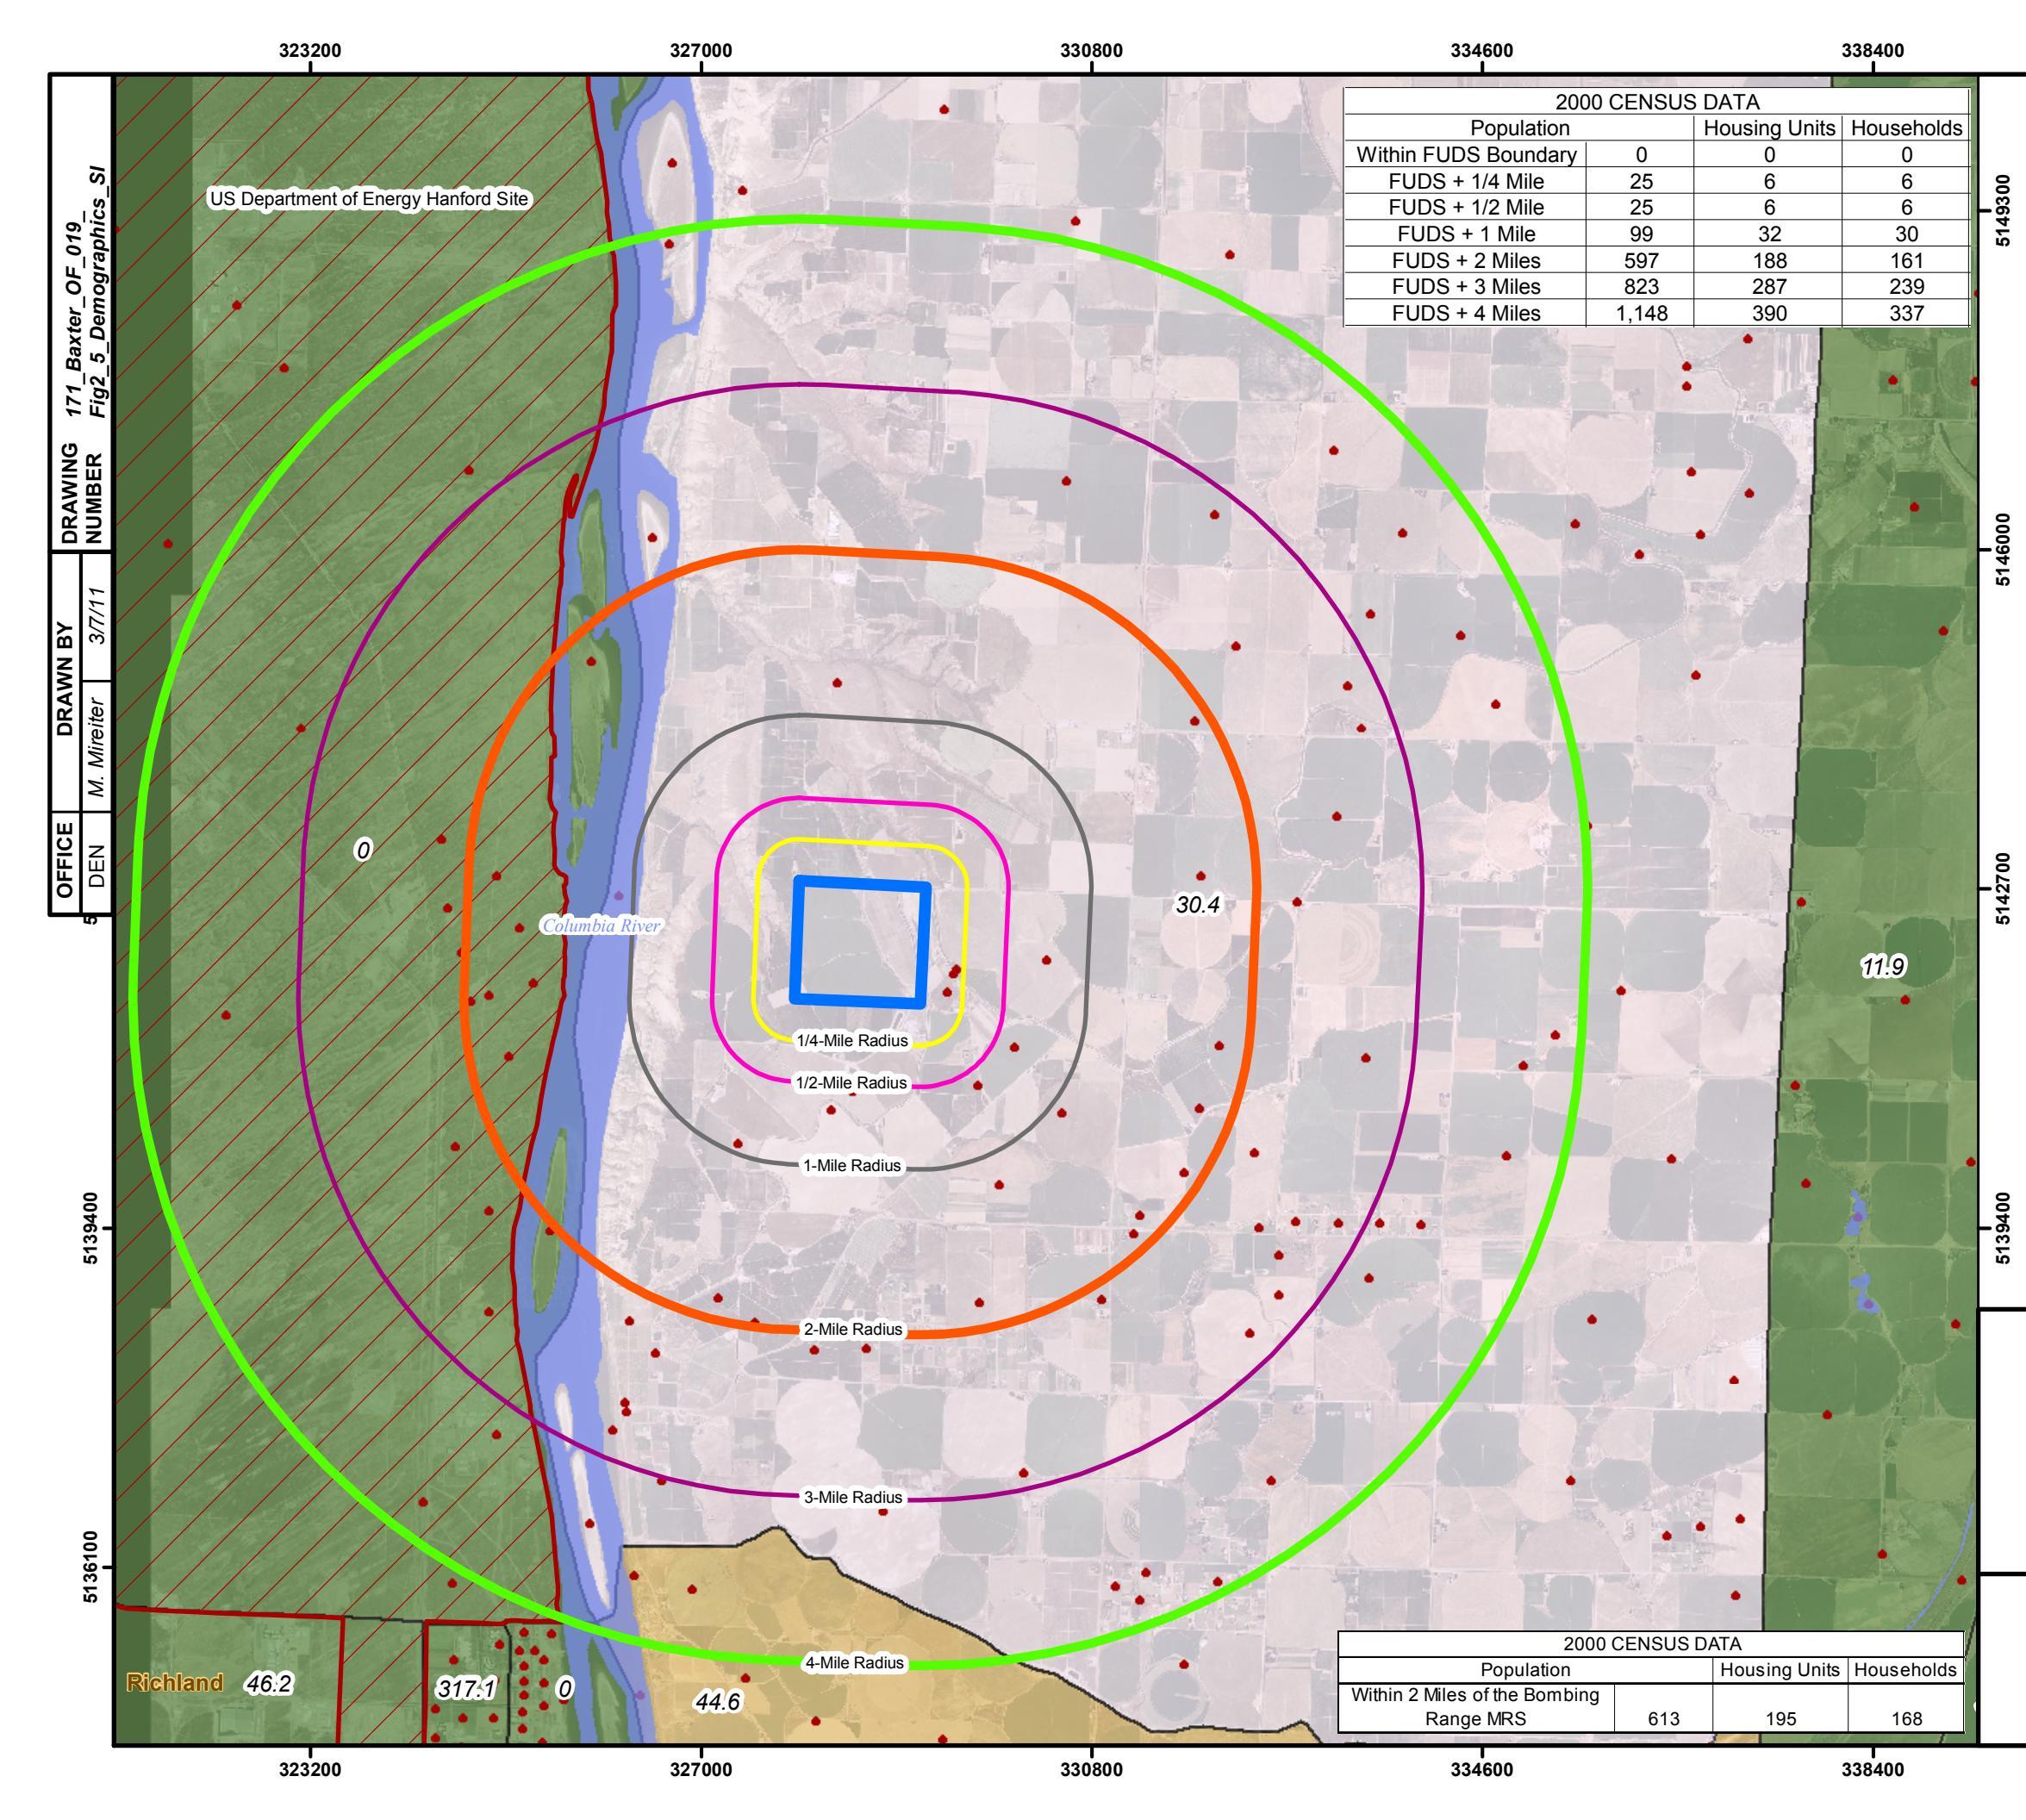
**FIGURE 2-5**

- The 2005 population of Franklin County was 47.6 people per square mile.
   The Census Block Centroid Units represent centroids of the smallest entities for which the Census Bureau tabulates census information, bounded on all sides by visible features such as streets, streams, and railroad tracks, and/or invisible boundaries such as city, town, and county limits. The population assigned to a centroid unit may be a positive integer or zero. The centroid populations were summed within defined distances from the FUDS boundary to generate population totals presented on the inset table.
   Aerial photograph (Franklin County) was obtained from the U.S. Department

## **CENSUS DATA WITHIN A 4-MILE RADIUS**

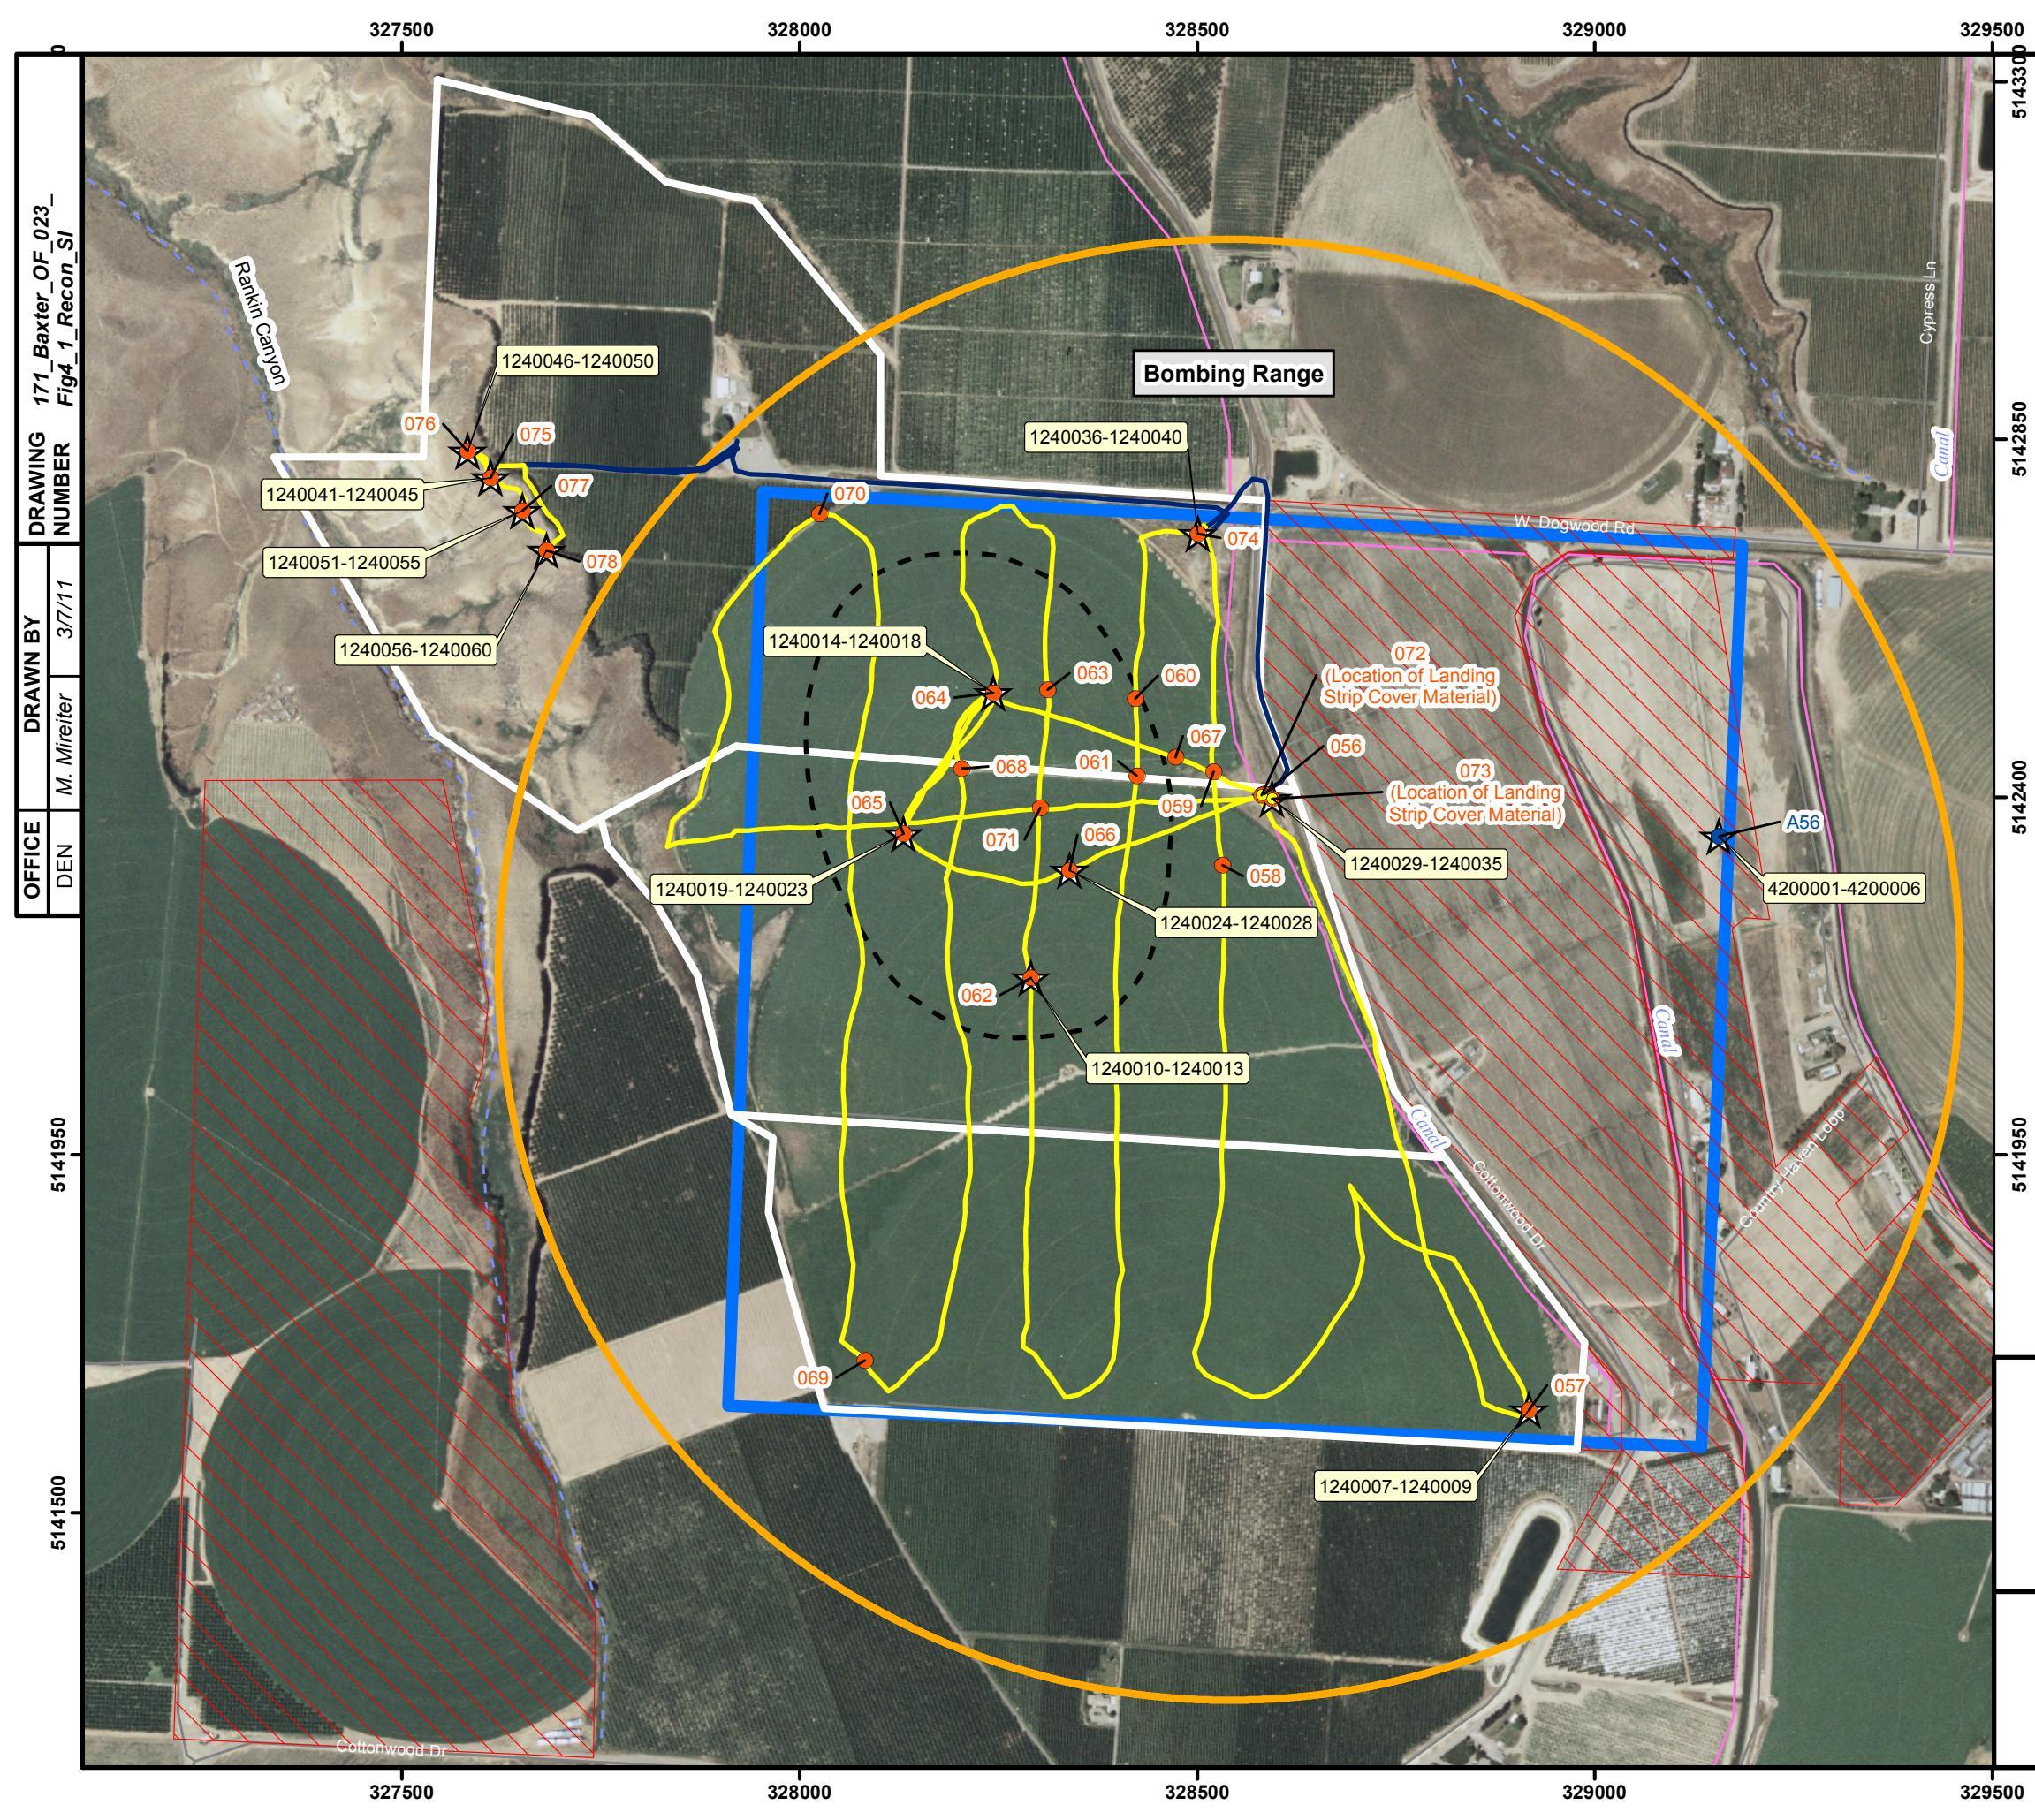
## **FIGURE 4-1**

- 1) FUDS property and range boundaries were derived from the Baxter Outlying Field ASR Supplement (USACE, 2008).
- 2) General area of reported practice bomb finds was derived from Figure 2 of the INPR (USACE, 2004).
- INPR (USACE, 2004).
  Parcel data was obtained from the Franklin County Assessor MapSifter Website: http://franklinwa.mapsifter.com/mapsifter/disclaimer.aspx
  Aerial photograph (Franklin County) was obtained from the U.S. Department of Agriculture, Service Center Agencies: photograph is from the USDA-APFO National Agriculture Imagery Program (NAIP), 2006.
  The 3,000-ft safety zone is depicted by the orange boundary line of the range.

# SITE INSPECTION RECONNAISSANCE

839 During field reconnaissance, remnants of the former landing strip cover material were observed 840 at waypoints 72 and 73 (Figure 4-1). The landing strip material appeared to have been 841 stockpiled at the edge of the field as evidenced by mounds of the material. The landing strip 842 material appeared to consist of native soils (sandy silt) that have had "soil oil" distributed atop it. 843 The material was moderately inducated by the oil. The layer of inducated soil was approximately 844 3-inches thick (Appendix E, Photographs 1240034 and 1240035). The location of the stockpiled 845 landing strip material is near the projected position of the eastern end of the east-to-west trending 846 landing strip. No evidence of the runway material within current agricultural fields was noted. 847 The 1943 aerial photograph (Figure 1-2 and Appendix L) shows the runways with small circles 848 near the end of each landing strip. The PA Report indicated that these small circles may have 849 been bombing targets. (USACE, 2006a) The circular features are not visible on the 1948 aerial 850 photograph (Figure 1-2).
