STATE OF WASHINGTON DEPARTMENT OF ECOLOGY

Re: No Further Action opinion for the following Property associated with the Asarco Tacoma Smelter Site

Site name:Olympic View Elementary Federal WayProperty address:2626 SW 327th Street, Federal Way, King County WA 98023Facility/Site ID:77894Cleanup Site ID:15410VCP Project No.:NW3305

Olympic View Elementary VCP NW3305

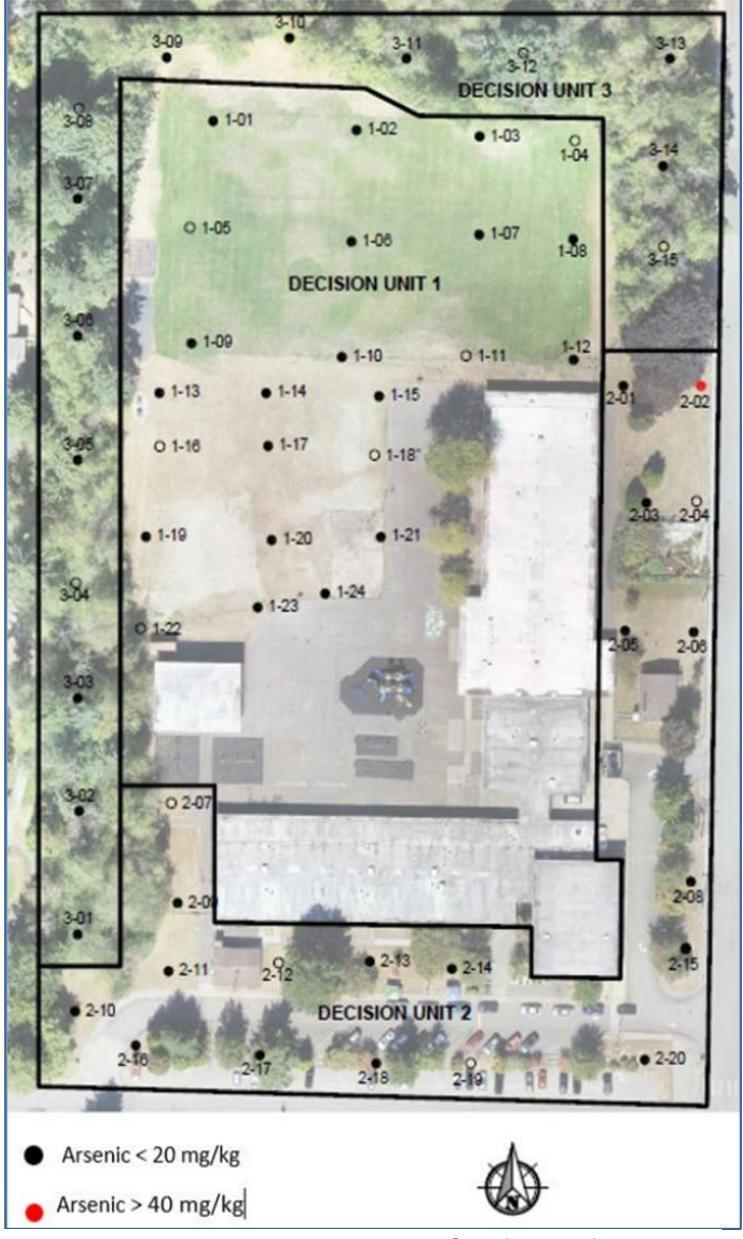
Figure 2. Approximate Locations of Soil Samples

As part of the planned redevelopment, FWPS contracted PBS to characterize the Tacoma Smelter Plume (TSP) contamination on the Property. On September 1, 2020, PBS collected 55 discrete soil samples from 44 sampling locations on the Property (Figure 2). They collected 44 soil samples from 0 to 6 inches below ground surface (bgs) and 11 soil samples from 6 to 12 inches bgs.

PBS did not sample areas outside of the proposed redevelopment areas, specifically the treed areas in the northern and western part of the Property. PBS conducted additional sampling in those areas on March 12, 2021, as requested by Ecology. An additional 19 discrete soil samples were collected. Fifteen samples were collected from 0 to 6 inches bgs and four samples were collected from 6 to 12 inches bgs (Figure 2).

Table 1 provides a summary of the characterization soil sampling on the Property (Figure 2). Enclosure E contains the comprehensive results of the soil sampling.

Samples collected at 0 to 6 inches bgs: Arsenic exceeded the MTCA Method A cleanup level of 20 (mg/kg) in three samples, with one exceeding the maximum allowable concentration for a single soil sample (40 mg/kg). Arsenic concentrations ranged from 1.81 mg/kg to 53.1 mg/kg. The average arsenic concentration was 7.56 mg/kg. None of the lead concentrations exceeded

the MTCA Method A cleanup level of 250 mg/kg for lead. Lead concentrations ranged from 3.88 mg/kg to 231 mg/kg. The average lead concentration was 20.97 mg/kg.

Samples collected at 6 to 12 inches bgs: One sample exceeded the cleanup level of 20 mg/kg for arsenic, but did not exceed the maximum allowable concentration of 40 mg/kg for a single soil sample for arsenic. The arsenic concentrations ranged from 2.34 mg/kg to 22.80 mg/kg. The average arsenic concentration was 5.3 mg/kg. None of the lead concentrations in this depth interval exceeded the cleanup level of 250 mg/kg for lead. Lead concentrations ranged from 2.52 mg/kg to 50.7 mg/kg. The average lead concentration was 11.89 mg/kg.

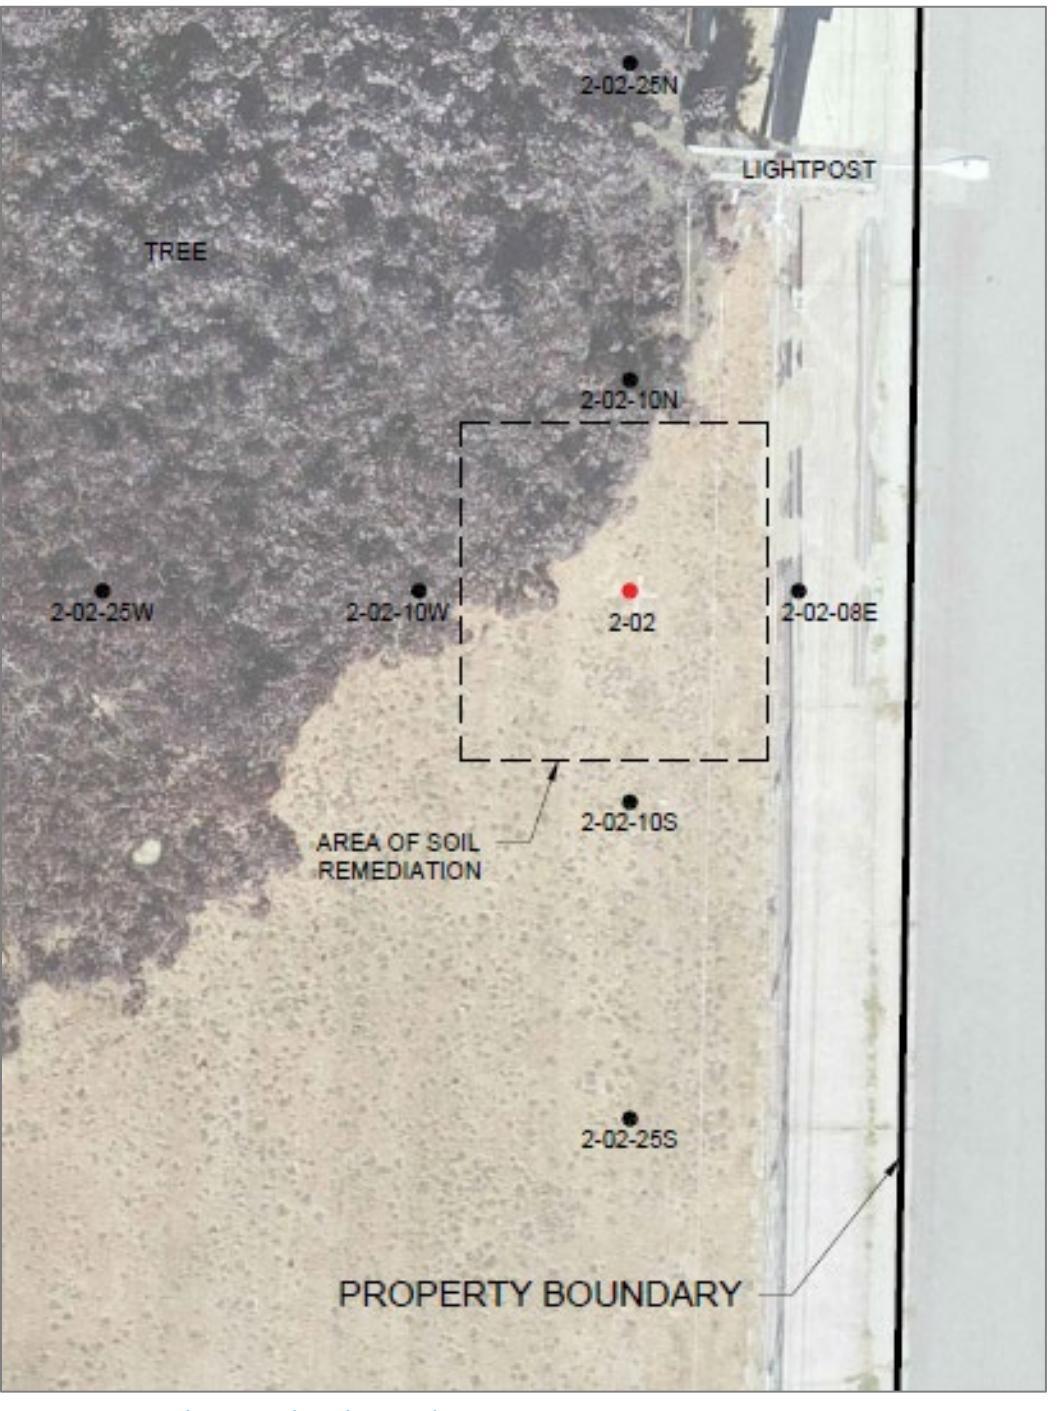
Figure 3. Supplemental Soil Sampling

In December 2020, PBS conducted supplemental soil sampling to delineate the extent of arsenic and lead concentrations in the area that exceeded twice the cleanup level of 20 mg/kg for arsenic (Sample 2-02). PBS collected additional samples from 6 to 12 inches bgs, 12 to 18 inches bgs, and 18-24 inches bgs below Sample 2-02. PBS also collected discrete samples 10 feet, 25 feet and 50 feet north, south, and west of Sample 2-02 (Figure 3). They collected samples at 0 to 6 inches bgs, 6 to 12 inches bgs, and 12 to 18 inches bgs.

Samples collected 25 feet and 50 feet from Sample 2-02 and samples collected from 12 to 18 inches bgs were submitted to the laboratory on hold, pending results of shallower and closer soil samples. PBS submitted the samples to Friedman & Bruya Inc. laboratory in Seattle, Washington for arsenic and lead analysis with EPA Method 6020B. If shallower or closer (to Sample 2-02) sample results exceeded cleanup levels, the samples collected at 25 feet and 50 feet away from Sample 2-02 would have been analyzed.

None of the supplemental samples exceeded the cleanup level of 20 mg/kg for arsenic or the cleanup level of 250 mg/kg for lead (Table 2).

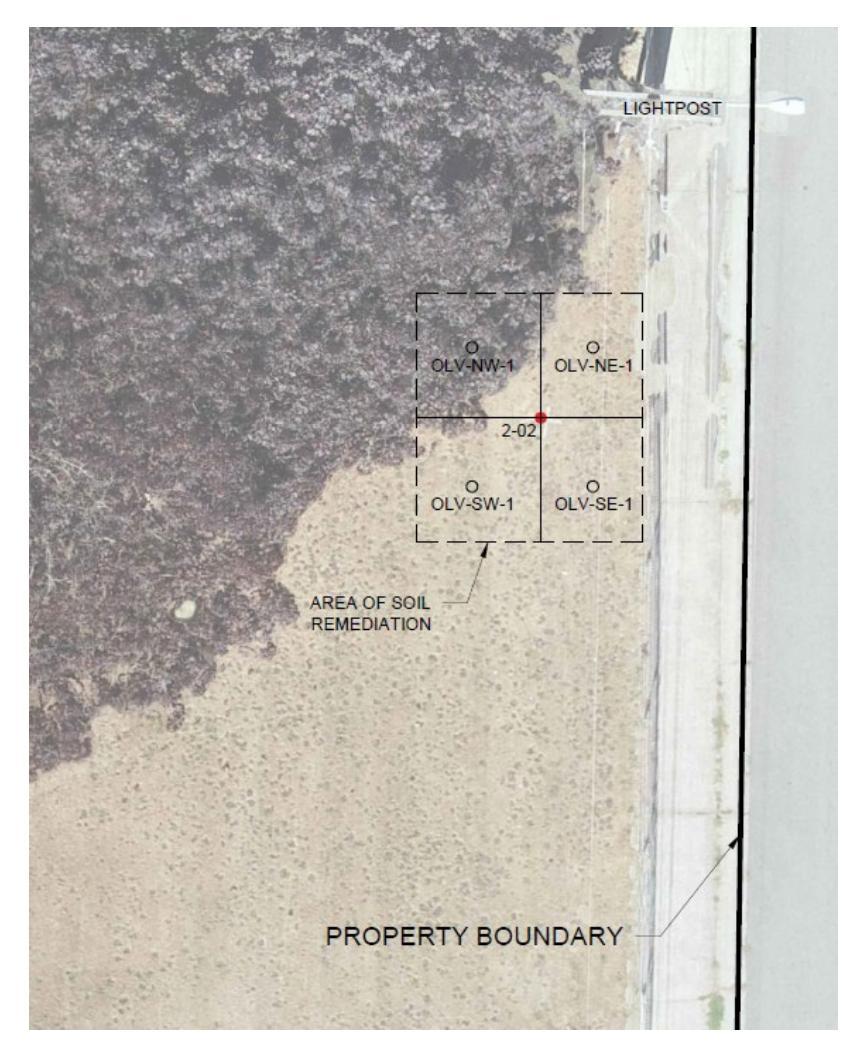
Figure 4. Confirmational Sample Locations

On January 19, 2022, SCI Infrastructure LLC, a subcontractor to Forma Construction, performed soil remediation by mixing in place to a depth of 12 inches below ground surface (bgs) in the remediation area (Figure 4). Upon completion of soil remediation, PBS collected confirmation soil samples within the remediation area and collected confirmation soil samples as specified in the RAWP.

Confirmational soil samples were collected from the remediation area at six-inch depth intervals throughout the mixing depth. The sample results indicated that arsenic concentrations had been reduced to below the cleanup level (Table 3).

On March 3, 2021, on behalf of FWPS, PBS developed a Remedial Action Work Plan for Tacoma Smelter Plume Impacts (RAWP). The RAWP described the use of soil mixing to remediate TSP contamination on the Property. PBS proposed remediating the contamination around sample location 2-02 by mixing soil in place to a depth of at least 12 inches. Following mixing, confirmational samples would be collected from the remedial area at six-inch depth intervals

throughout the mixing depth to confirm arsenic concentrations are successfully reduced to below the MTCA cleanup level. On June 10, 2021, Ecology issued a Likely No Further Action opinion letter based on the information provided in the RAWP.

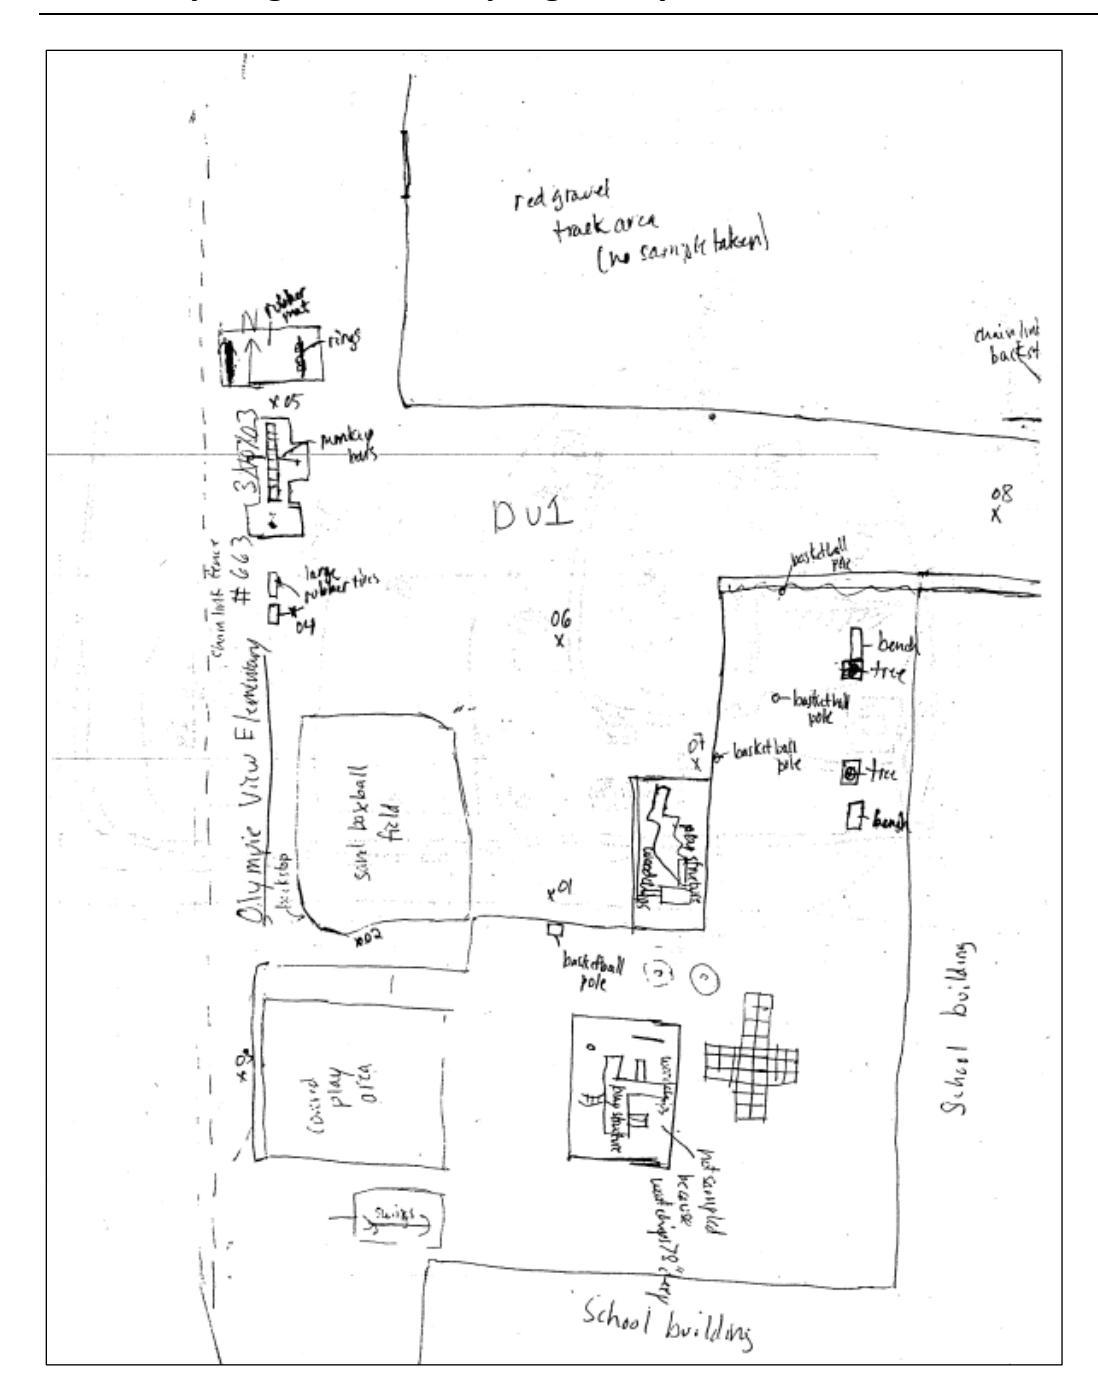
Soil Safety Program Soil Sampling in Play Areas

In 2003, Ecology sampled the children play areas at the school as part of the Soil Safety Program (SSP) with Ecology. Ecology collected eight samples from 0 to 2 inches bgs and eight samples from 2 to 6 inches bgs. Arsenic and lead concentrations were below their respective cleanup levels of 20 milligrams per kilogram (mg/kg) for arsenic and 250 mg/kg for lead. Ecology determined that no remedial actions were necessary in the play areas sampled. For more information on the SSP soil sampling, refer to Enclosure D.

DU	J1	D	U 2	D	U3 -
Boring	0-2 ·	2-6	0-2	2-6	0-2	2-6
1	4.73	2.49				· · ·
2	4.56	3.99				
3	5.44	3.98				
4	3.78	7.07			1	
5	4.90	2.45				
6	4.94	2.54				
7	3.95	3.29				
8	3.62	3.64				
Average	4.49	3.68				
Max	5.44	7.07

DU	J1 🕓	DI	J 2	D	13
Boring .	0-2	2-6	0-2	2-6	0-2	2-6
- 1	16.80	4.55				
2	11.60	6.52				
3	26.80	13.00	· · · · ·			
4	6.48	14.40				
5	10.20	3.59				
6	13.40	16.20				
7	12.80	6.41				-
. 8	6.64	7.23				
			-			
Average	13.09	8.99				
Max	26.80	16.20
