April 2025 Meydenbauer Bay Yacht Club

Sediment Characterization Report for Proposed Maintenance Dredging

February 2023 Meydenbauer Bay Yacht Club Maintenance Dredging Evaluation

Sampling and Analysis Plan

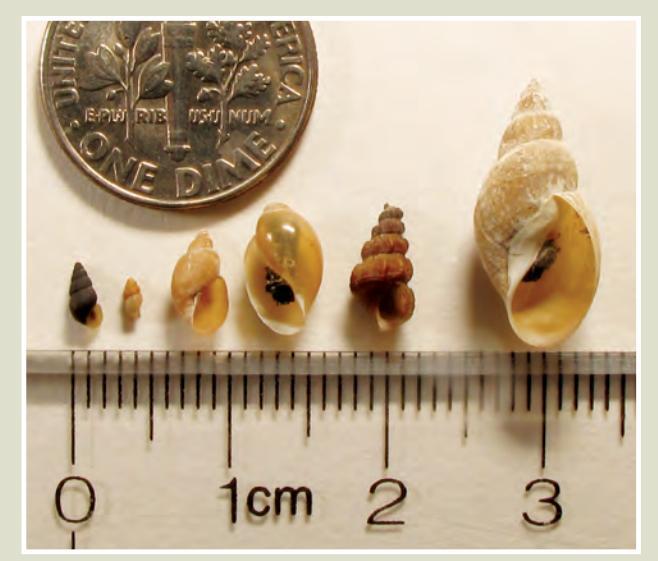
Snails found in local streams (left to right) NZMS, Pristinicola, Galba, Physella, Juga (juvenile), Stagnicola

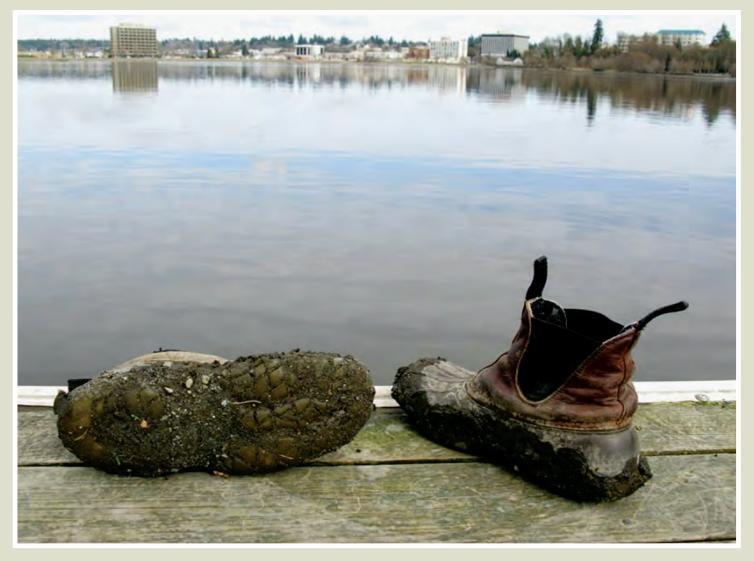
These boots were worn while walking in the mud at the edge of Capitol Lake in Olympia. Over 120 NZMS were found while cleaning the boots.
