October 19, 2015

Subject: Well Abandonment and Drum Removal Report Chevron Site No. 352300 State Route 274 Tekoa, Washington

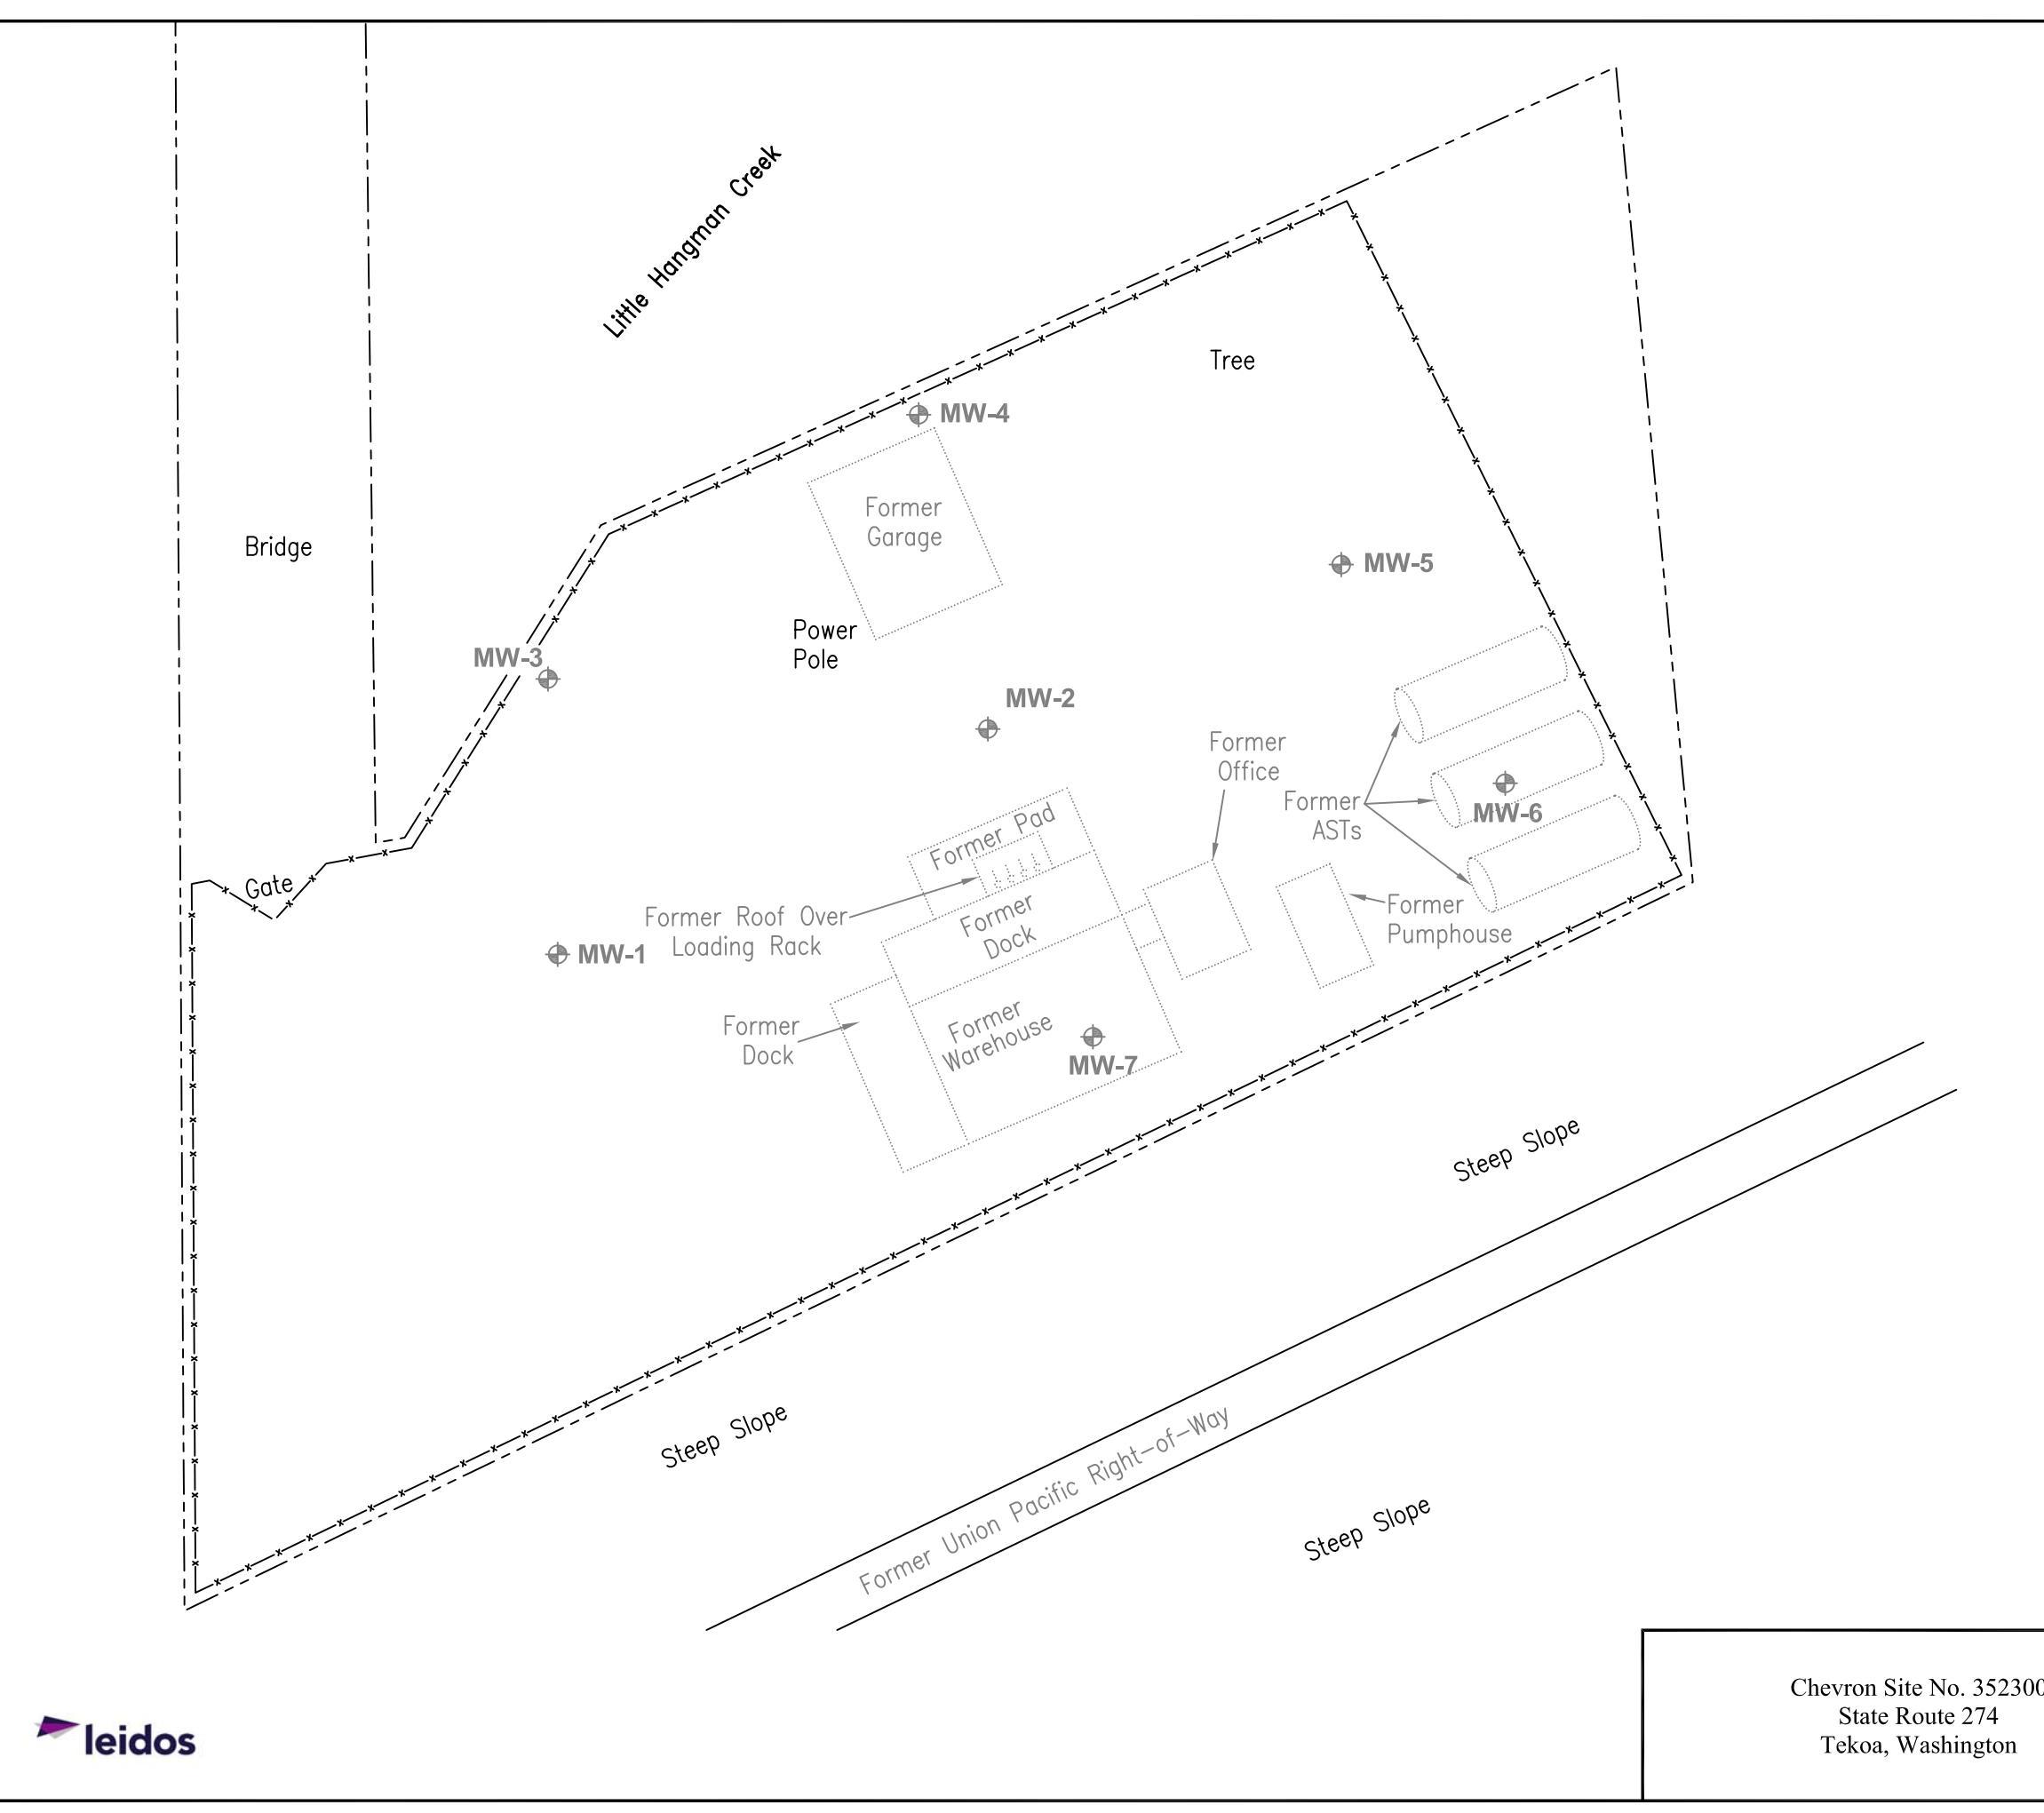
0		Figure 1 Site Map
	DATE: 10/22/2015	DRAWING: Tekoa Site Map.dwg

On behalf of Chevron Environmental Management Company's affiliate Union Oil Company of California (Union Oil), Leidos Engineering, LLC (Leidos), submits this report describing the abandonment of on-site groundwater monitoring wells and removal of a buried 55-gallon metal drum at the above referenced site. A site map showing the locations of the abandoned wells is presented on Figure 1.

Groundwater monitoring wells MW-1 through MW-7 were abandoned in place by a licensed driller (Stratus Corporation, Washington State Resource Protection Well License No. 3118). The well monument at each location was left in place. Hydrated bentonite chips were placed in the existing casing to approximately 3 feet below ground surface (bgs) and cemented to 6 inches bgs.
