Final Remedial Investigation/Feasibility Study Report

Former Brumfield-Twidwell Ecology Agreed Order DE2953 301 East Pioneer Avenue Montesano, Washington 98563

AEG Project #: 05-200 Date of Report: October 6, 2011

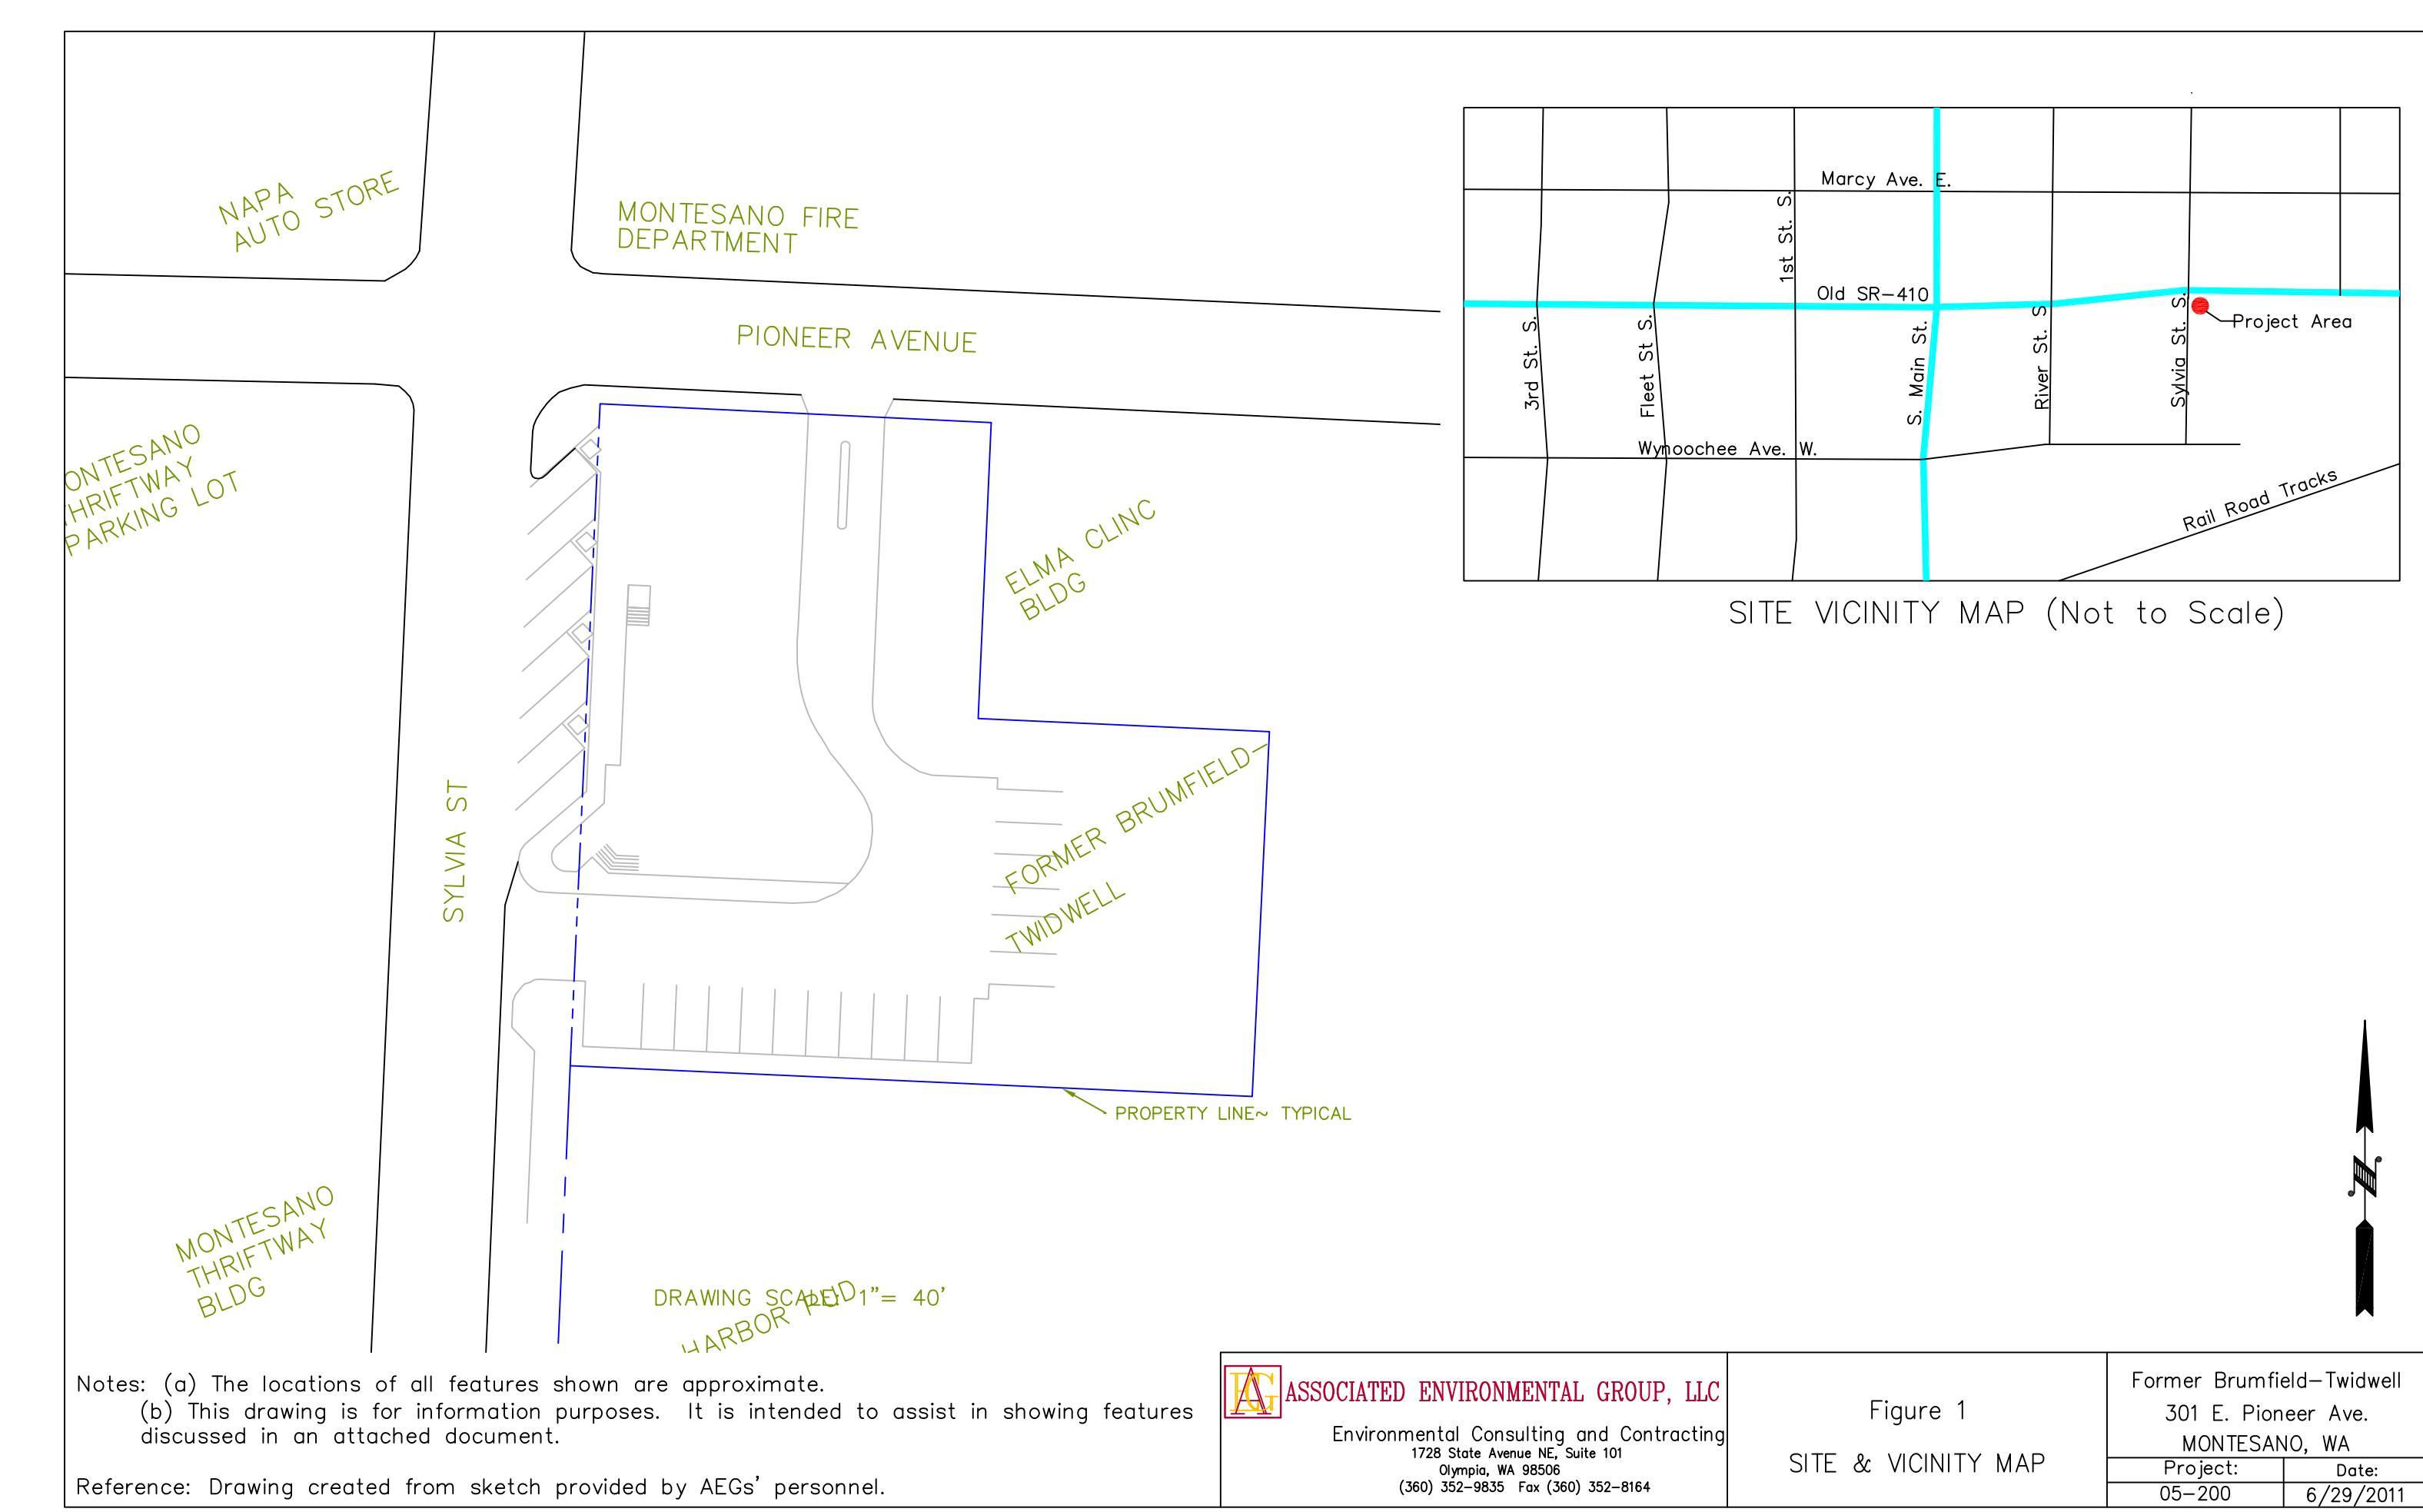
ora rimanon
Figure 1	301 E. Pion	eer Ave.
	MONTESAN	IO, WA
& VICINITY MAP	Project:	Date:
	05-200	6/29/2011

The immediate vicinity area is predominately retail/commercial with residential neighborhoods located on the adjacent city blocks to the north and east. Figure 1, *Site & Vicinity Map*, presents the general boundaries and vicinity area of the Site. Figure 2, *Site Characterization Map*, presents the layout of the property and locations of soil borings, monitoring wells, and test pits explored by AEG and previous consultants.

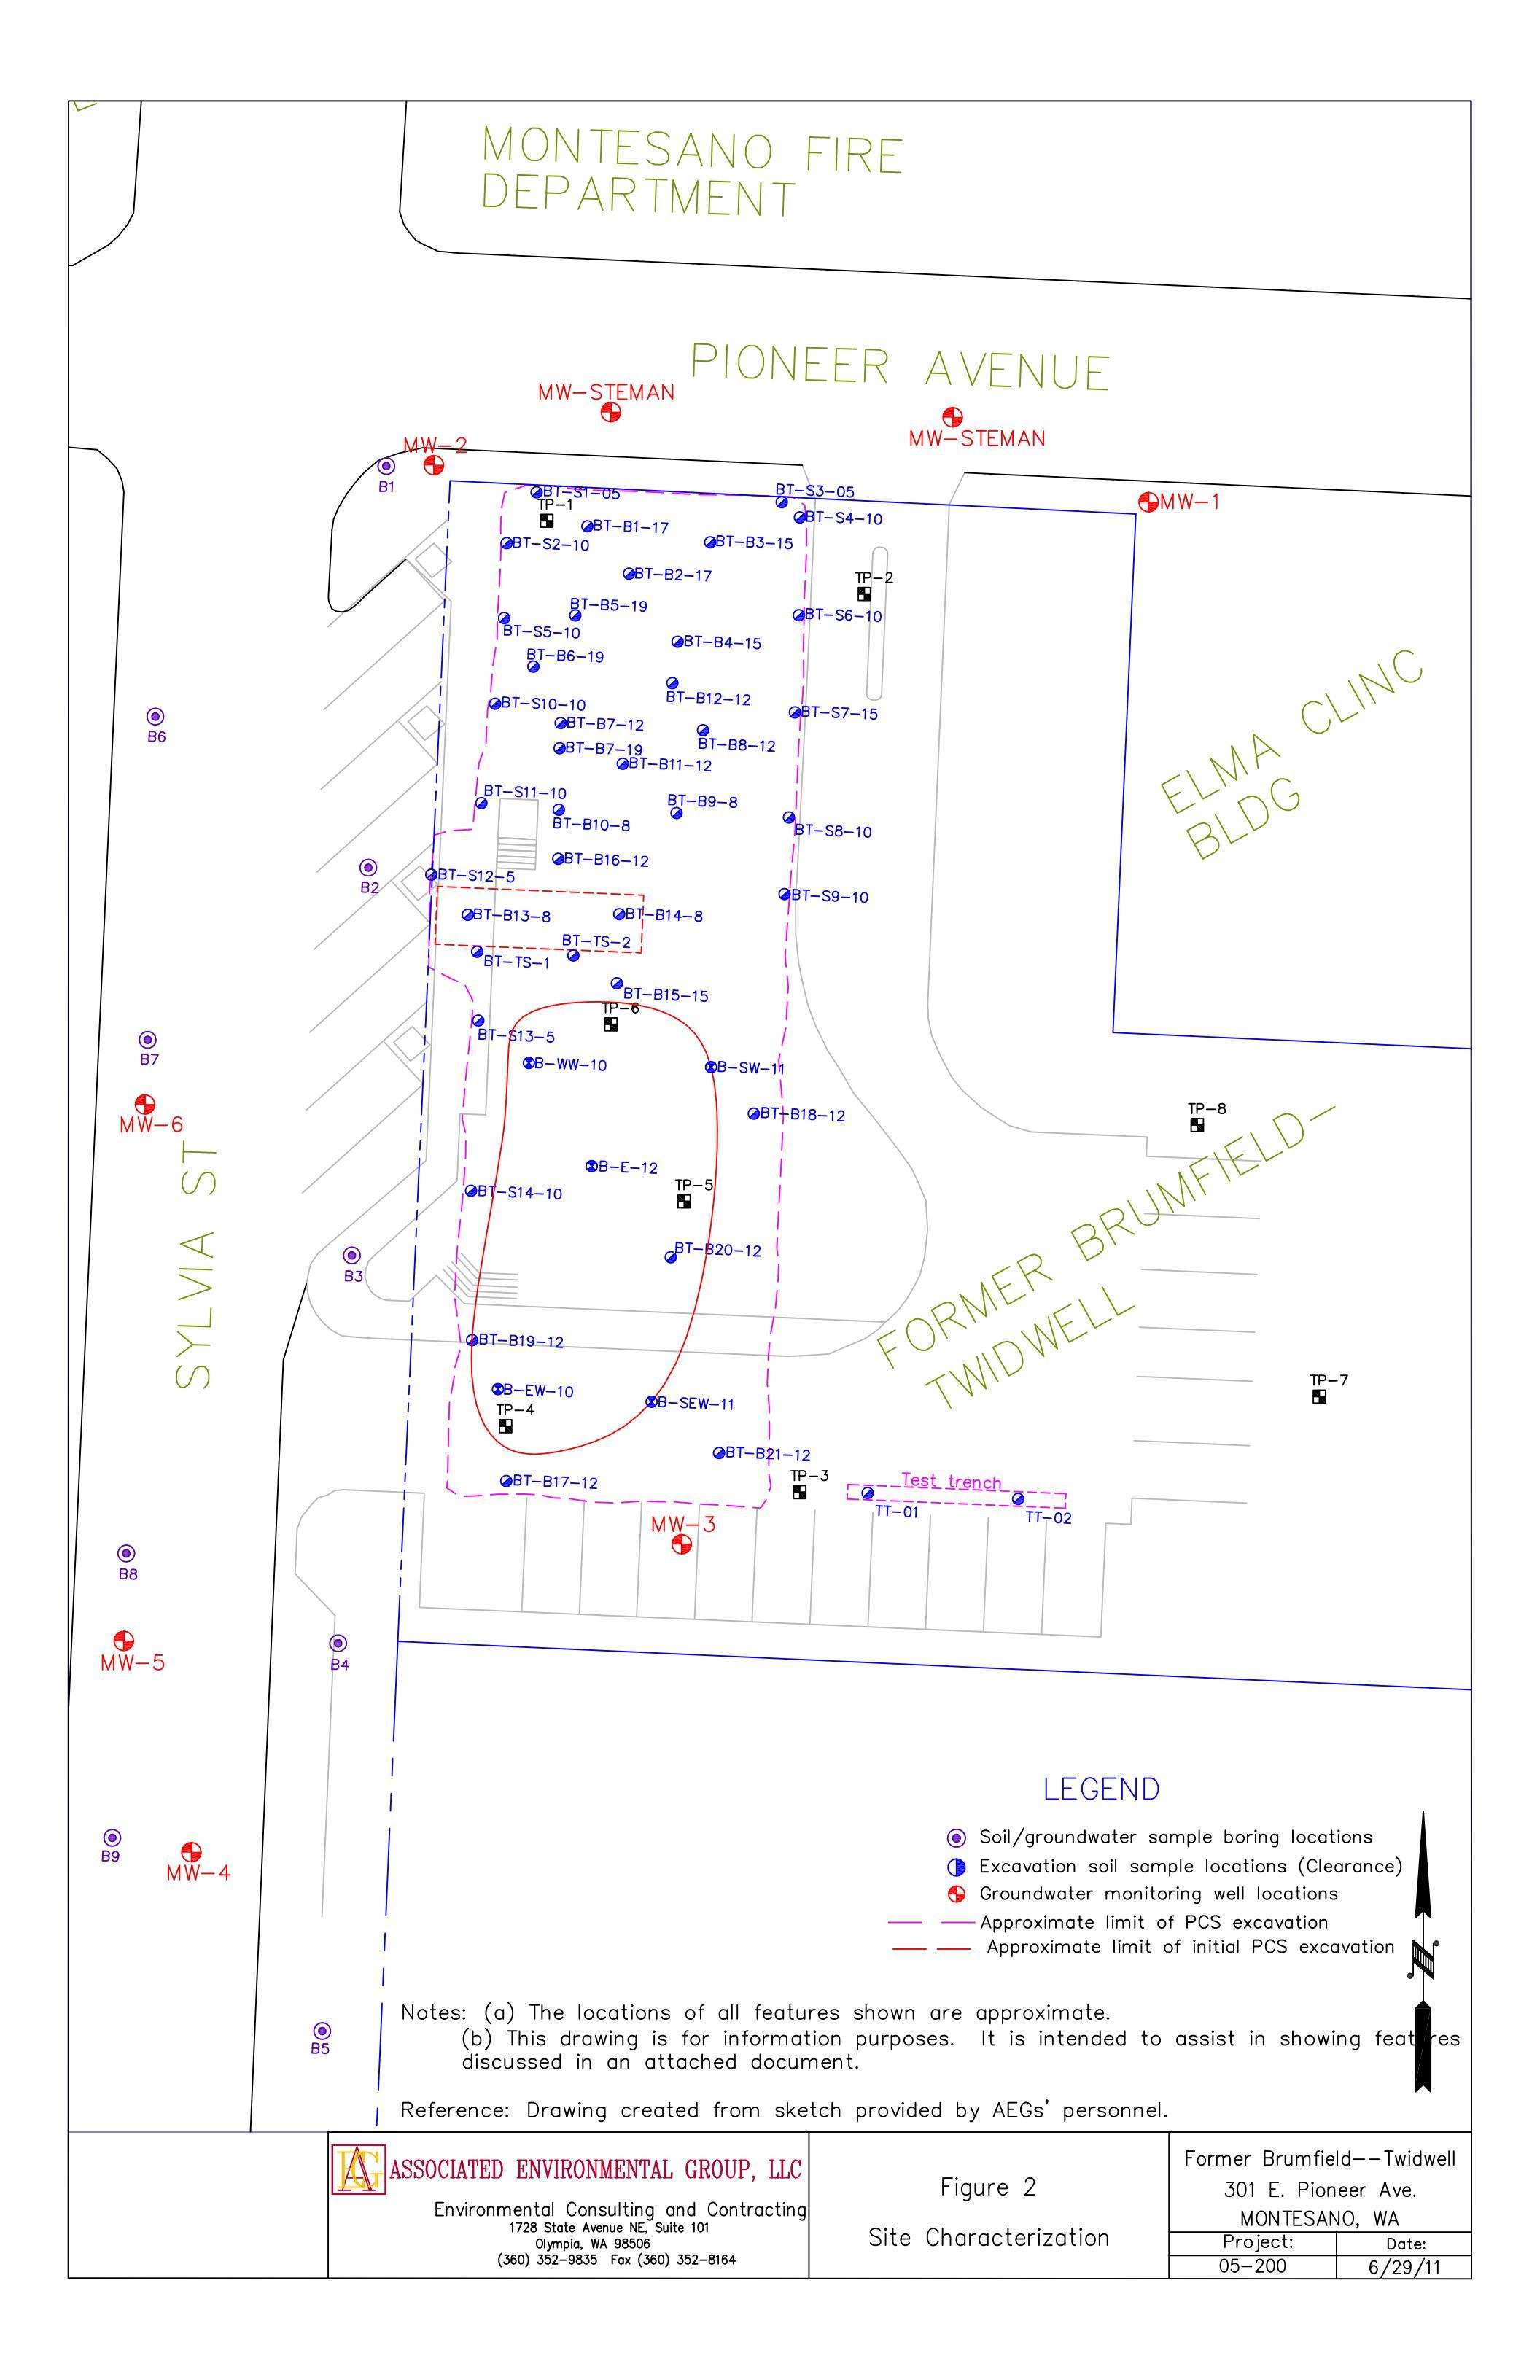
In April 2006 AEG and subcontractor Environmental Services Northwest (ESN) returned to the Site and advanced nine borings on Sylvia Street (adjacent west of the Site) to further characterize subsurface conditions in the area. Five borings on the east side of the street, closest to the Site, were evenly spaced in 60 foot intervals in the southward direction beginning from the corner of Pioneer Avenue. Four borings were advanced on the west side of the street; the placement of these were offset from the first five by starting 30 feet south of the intersection then spacing 60 feet apart moving south. Analytical results from soils collected during this phase of Supplemental Remedial Investigation at offsite areas indicated that the east side of Sylvia Street was impacted with a southerly extent to north of City of Montesano PUD property (near Boring B-3). The west side of Sylvia Street was also found to be impacted (near boring B-7) - to near the western property boundary of the Pick-Rite Thriftway grocery store (directly west of the Site across Sylvia Street). The locations of these borings and soil samples collected during various stages of subsurface investigation and Interim Remedial Action at the Site are shown in Figure 2, *Site Characterization*.

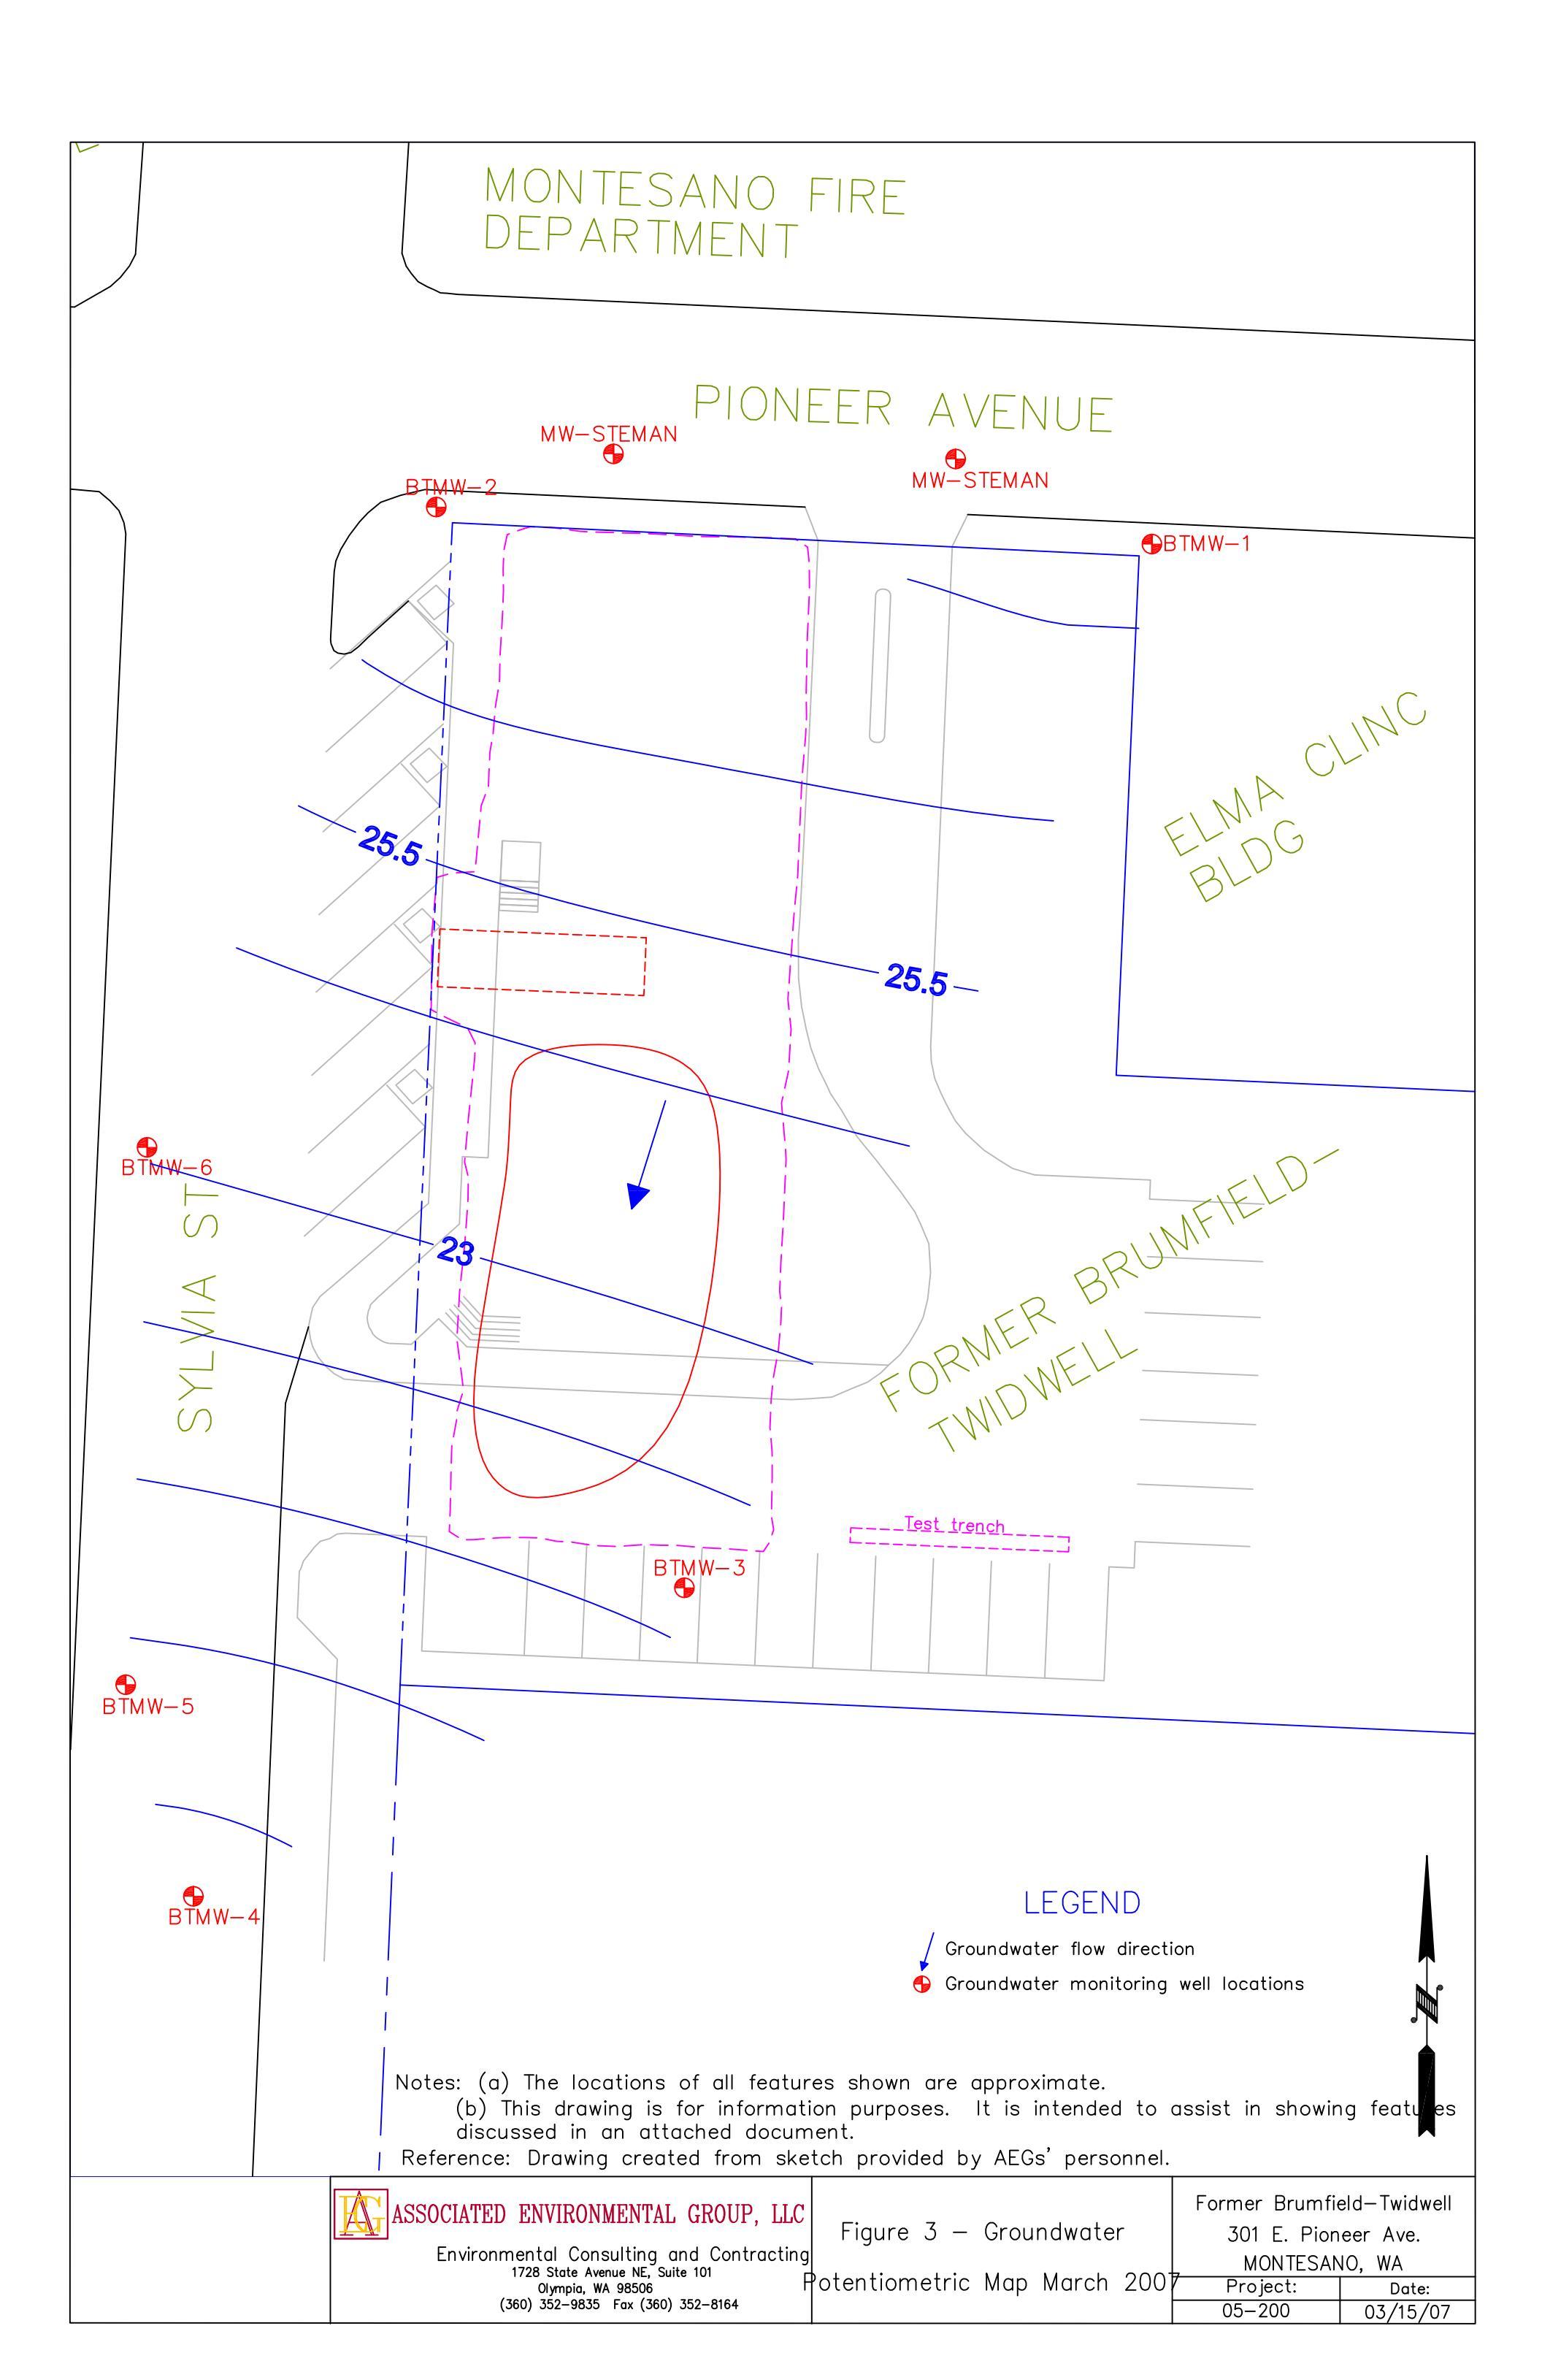
The direction of shallow groundwater migration at the Site and adjoining vicinity area throughout quarterly groundwater events from 2006 through 2009 has been to the south-southwest based on surveyed groundwater elevation data measured at monitoring wells onsite and offsite (BTMW-1 through BTMW-6) – refer to Figure 3.

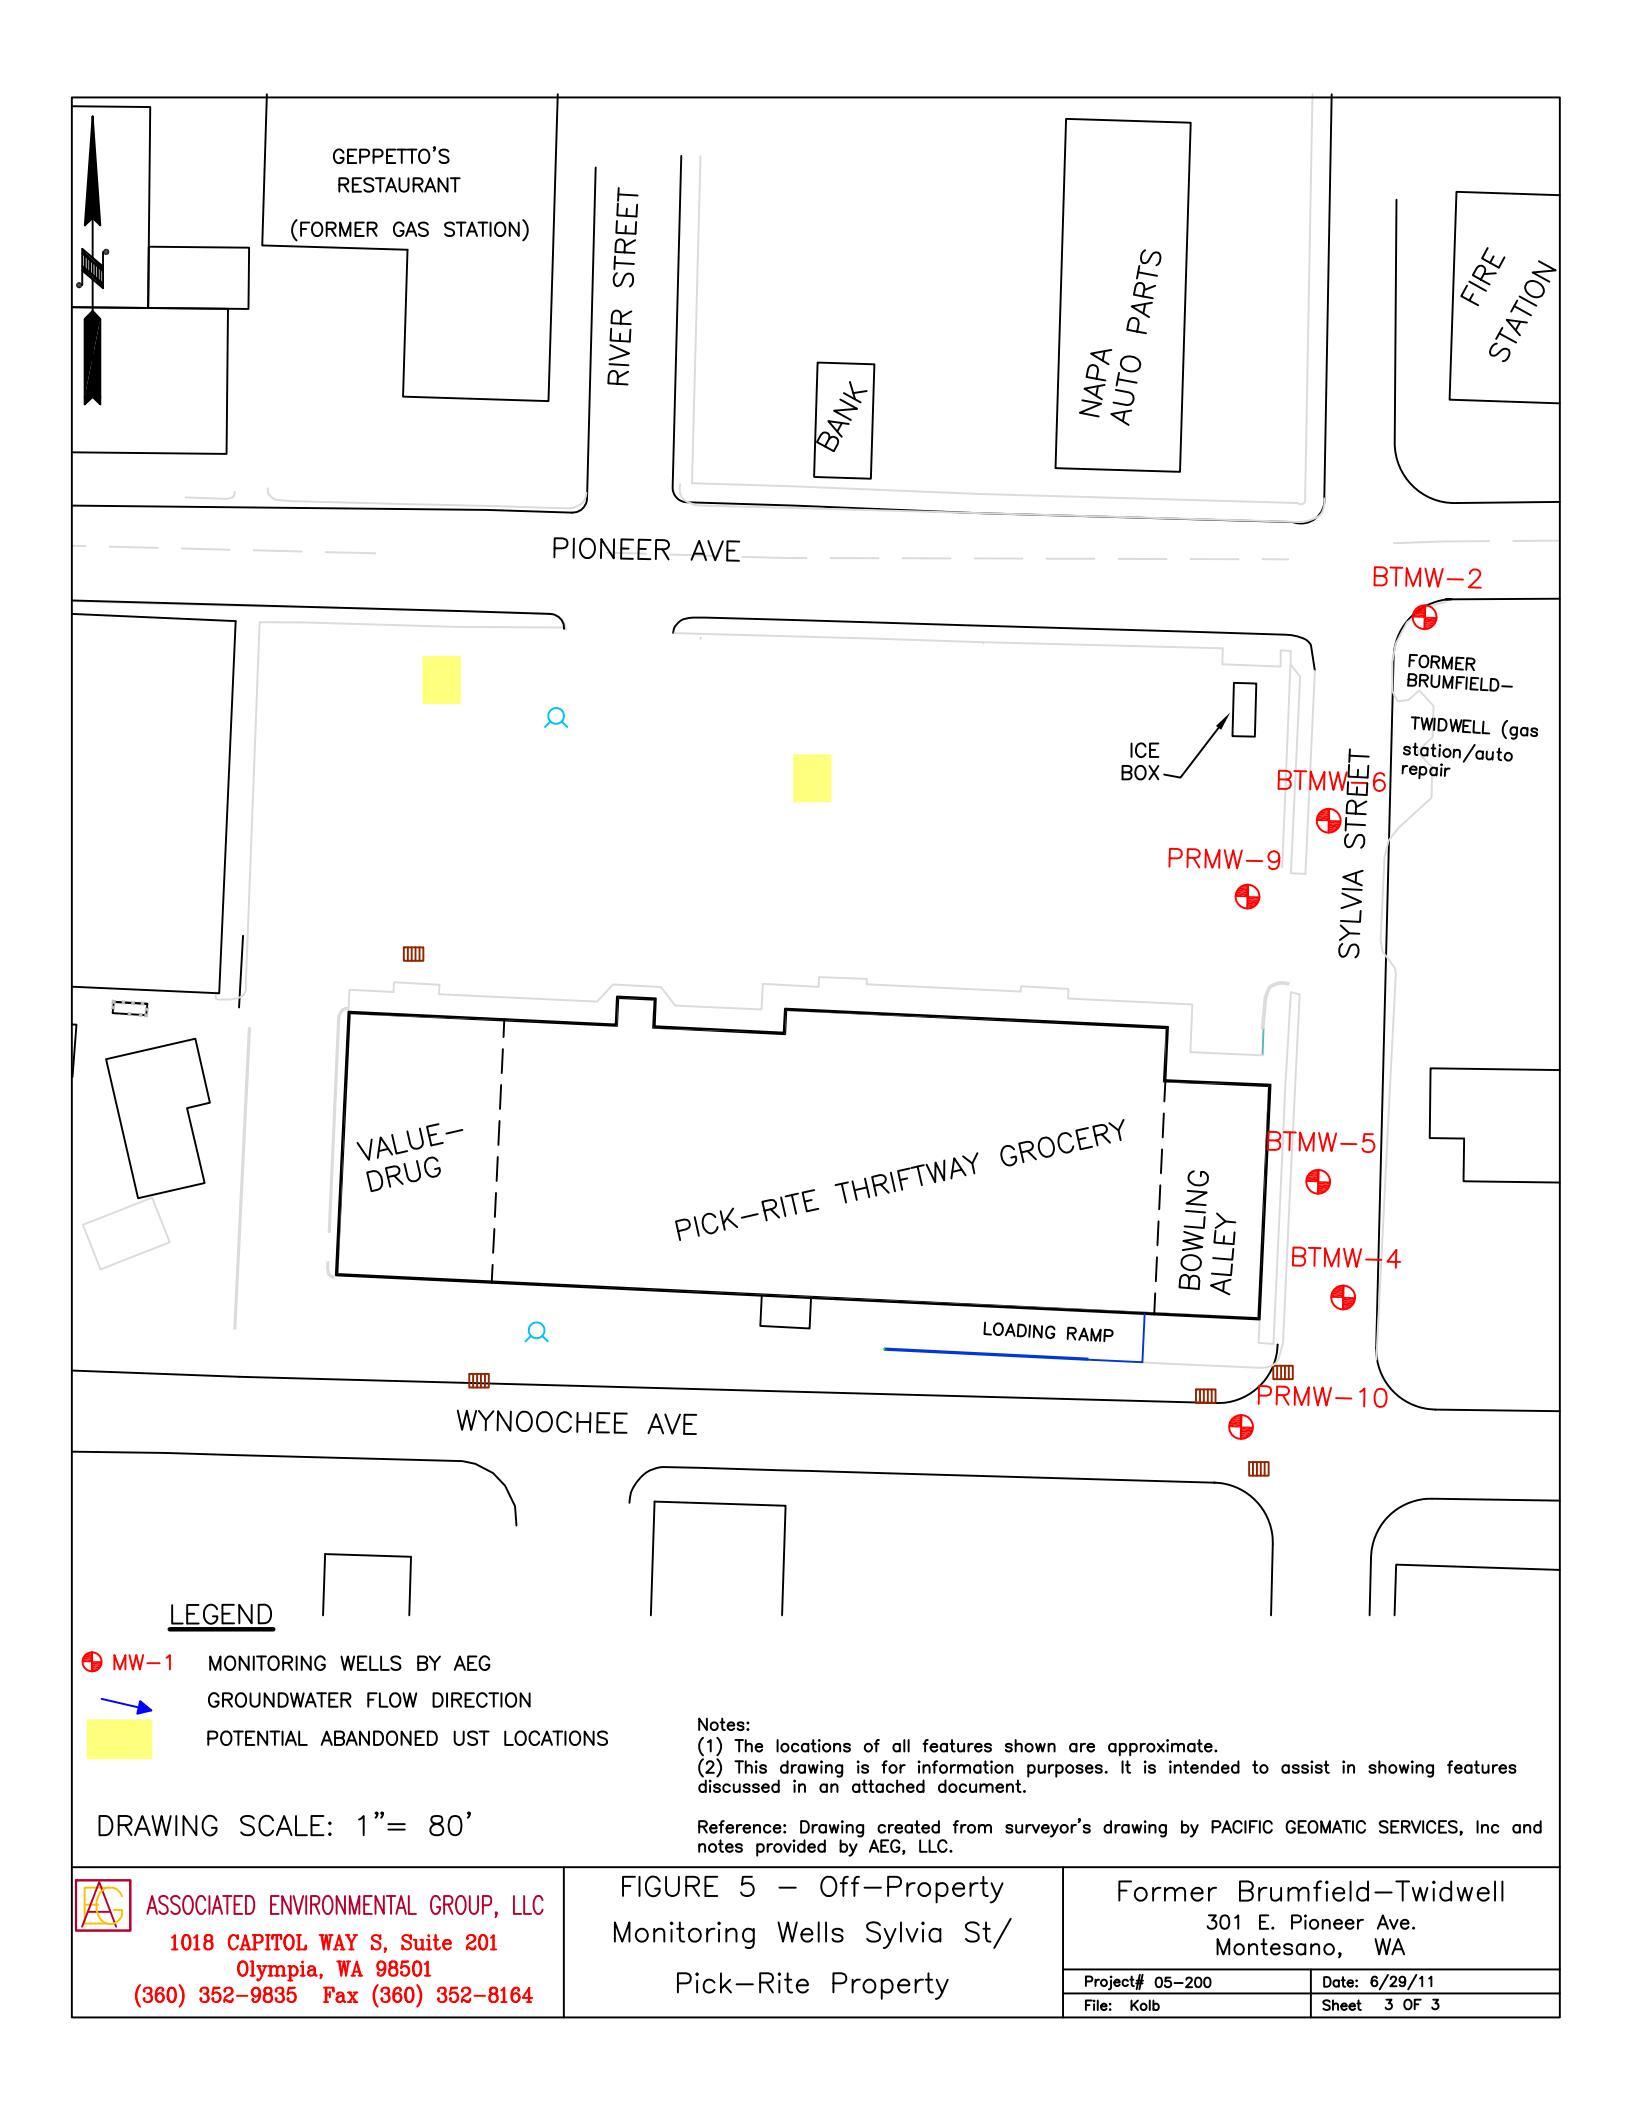
Figure 5, *Off-Property Monitoring Wells Sylvia Street/Pick-Rite Property*, presents the locations of these points of compliance for investigation of the distal end of the plume. As agreed with Ecology Toxics Cleanup Program Manager for the Site, monitoring well PRMW-9 (located along the eastern property boundary of the Pick-Rite Thriftway property) will represent the western lateral point of the plume associated with the Site. Monitoring well PRMW-10 (located at the intersection of Sylvia Street and Wynoochee Avenue to the south-southwest of the Site) will represent the south-southwestern distal end of the plume associated with the Site.

Groundwater analytical results, groundwater potentiometric maps, and subsurface investigations conducted at the Pick-Rite Thriftway property by AEG indicate that the lateral western extent of dissolved phase gasoline petroleum hydrocarbons impact extends from the central-southwest area of the Site (in the vicinity of the previous USTs) to off-property areas west-southwest of the property including areas on Sylvia Street, and near the eastern property boundary of the Pick-Rite Thriftway property (near the eastern entrance to the grocery store). It appears, based on five years (2006 through 2011) of groundwater analytical results from monitoring wells BTMW-4 and BTMW-5 (located on Sylvia Street to the southwest of the Site) and three quarters of results (from December 2010 through June 2011) at monitoring well PRMW-10 (located at the intersection of Sylvia Street and Wynoochee Avenue) that the southern distal end of the plume, (associated with the Site) has been fully characterized (refer to Figure 5 and Table 1).

A concise accounting of the work completed to drill and subsequently installed monitoring wells PRMW-9 and PRMW-10 is presented below (refer to Figure 5). A review of AEG's report, entitled "Supplemental Remedial Investigation – Pick-Rite Thriftway Property", dated January 11, 2011, in conjunction with this report is recommended for full details on environmental investigations completed at this adjoining property and these investigations' relevance to the Site's remedial investigation and proposed remedial action.

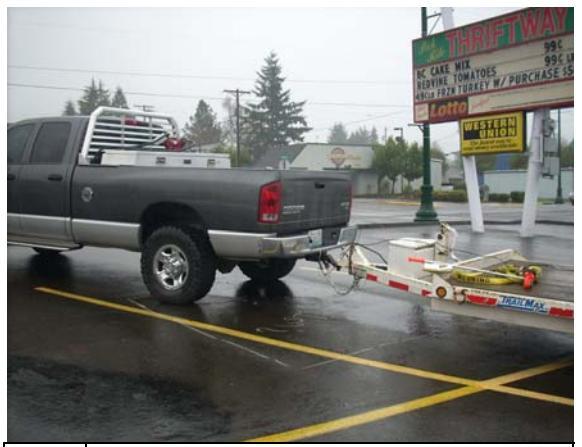
PhotoView of the subsequent identified potential fuel tank at
the northwest area of the Site (former Flying A gas
station).

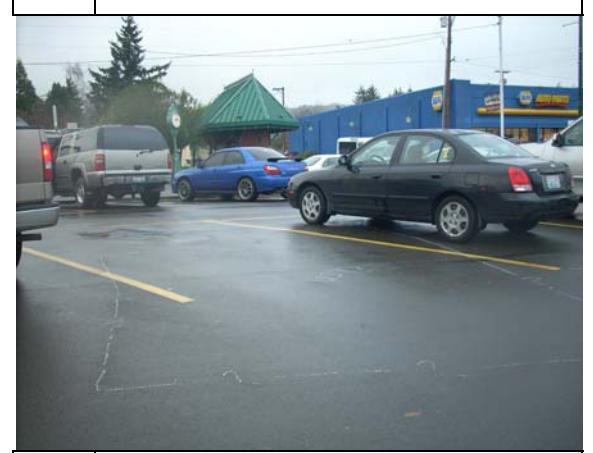
Photo View of the subsequent identified 1 or 2 locales identified as potential fuel tank at the former Boyer Phillips gas station).

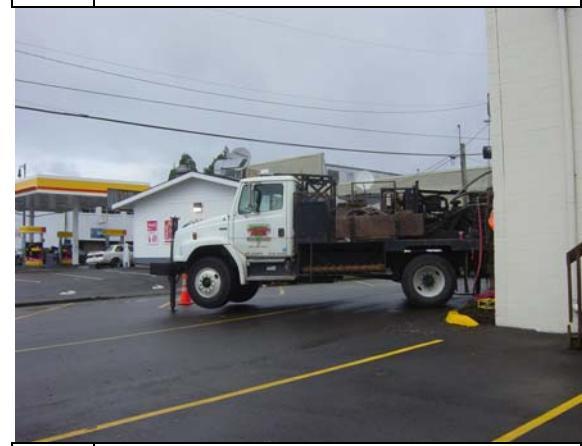
PhotoView of drilling at MW-2, southwest corner of
Thriftway-Value Drug Building, along the alley of the
City of Montesano sewer line/sewer lift stations.

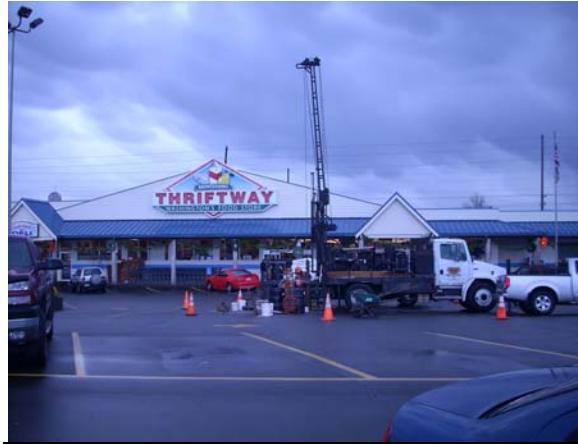
Photo View of drilling at boring MW-4, adjacent and southeast of potential abandoned fuel tank at the Site. Photo taken facing south.

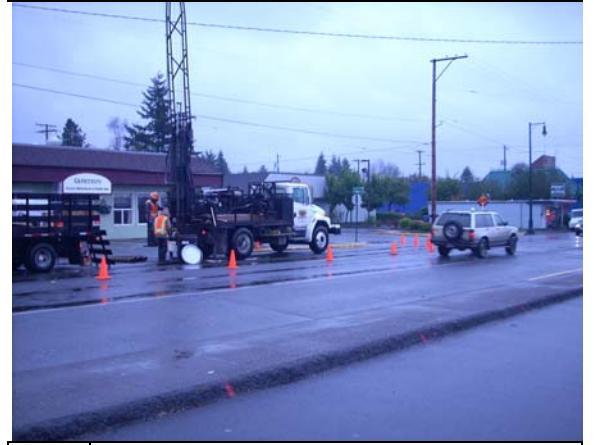
Photo
#9:View of drilling at boring MW-6, adjacent south of a
former gas station which is now occupied by Geppetto's
Restaurant. Photo taken facing east.

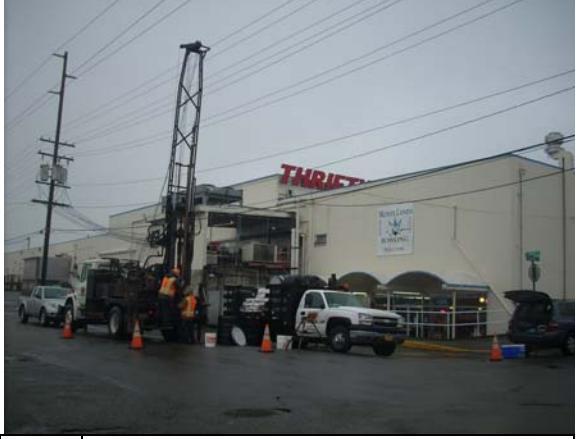
PhotoView of drilling at boring MW-10, in the City's right-of-
way on Wynoochee Ave.. Boring is south of the Pick-
Rite property. Note abundance of overhead power lines

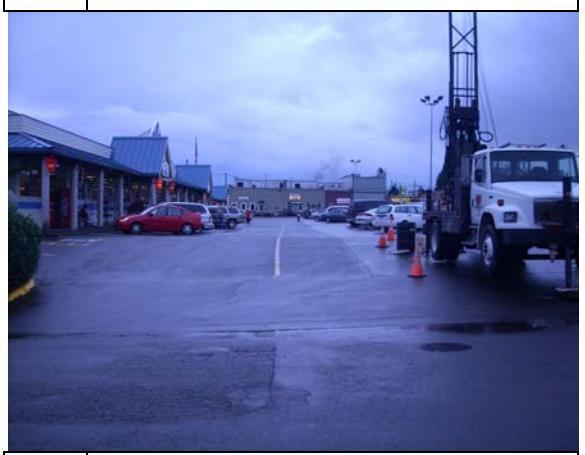
PhotoView of drilling at the eastern driveway of the Site, at
boring MW-9. Photo taken facing west.

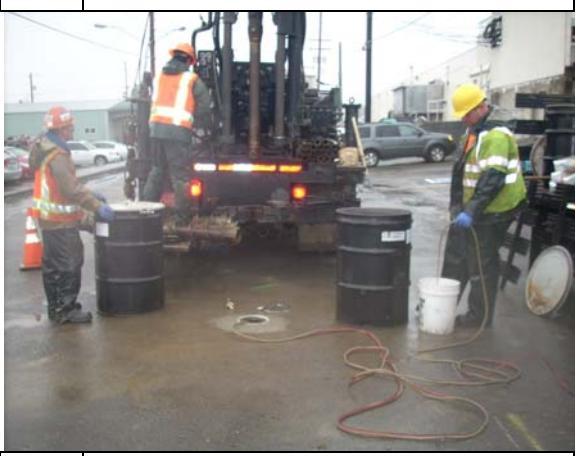
Photo View of pumping and purging as the second half of mechanical development activities at monitoring well MW-10. Mechanical swabbing and surging was already completed.
