ENVIRONMENTAL COVENANT

Post-Removal Site Control Plan Josephine Mill No. 1

CERCLIS ID No. WAN001002401 Pend Oreille County, Washington

Post Removal Site Control Plan

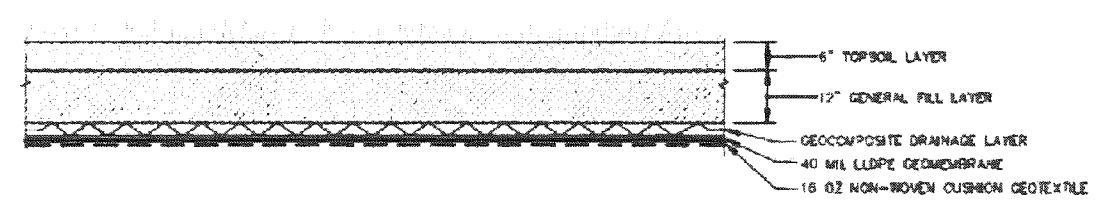
On September 13, 2012, construction of the mine waste repository was completed. The mine waste repository consists of consolidated mine tailings from across the site. The consolidated mine waste was compacted, graded and capped with a low-permeability cover system. The cover system consists of a 16ounce non-woven geotextile placed on the mine waste followed by a layer of 40-mil low-density polyethylene liner (LLDPE) that is protected by a geocomposite drainage layer and 18 inches of soil cover. Figure A presents a cross section of the cover system.

Perimeter under-drains were installed to route groundwater around the repository to help maintain stability of the mine waste. The surface of the repository is graded to shed stormwater towards the stormwater collection ditch located on the eastern side of the repository.
