INITIAL INVESTIGATION FIELD REPORT

Site Name (Name over door):	Site Address (including City, State and Zip):	<u>Phone</u>
Seattle Engine Rebuilders	6501 212th St SW Lynnwood, WA 98036	<u>Email</u>
<u>Site Contact, Title, Business:</u> David Baumgarten The Riley Group	Site Contact Address (including City, State and Zip): 17522 Bothell Way NE Bothell, WA 98011	Phone (425) 415-0551 Email dbaumgarten@riley-group.com
<u>Site Owner, Title, Business:</u> Mike Kosuljandic Horizon Communications	Site Owner Address (including City, State and Zip): 13718 Mukilteo Speedway Lynnwood, WA 98037	Phone Email
Site Owner Contact, Title, Business: Mike Kosuljandic MK HC Holdings LLC	Site Owner Contact Address (including City, State and Zip): 13718 Mukilteo Speedway Lynnwood, WA 98037	Phone Email
Previous Site Owner(s): James & Joyce Nichols <u>Alternate Site Name(s):</u>	Additional Info (for any Site Information Item):

The property owner's consultant reported contamination they found during a Phase II investigation that likely originated from a previous business called Seattle Engine Rebuilders. Contamination came from a leaking Oil/Water Separator found in the parking area.

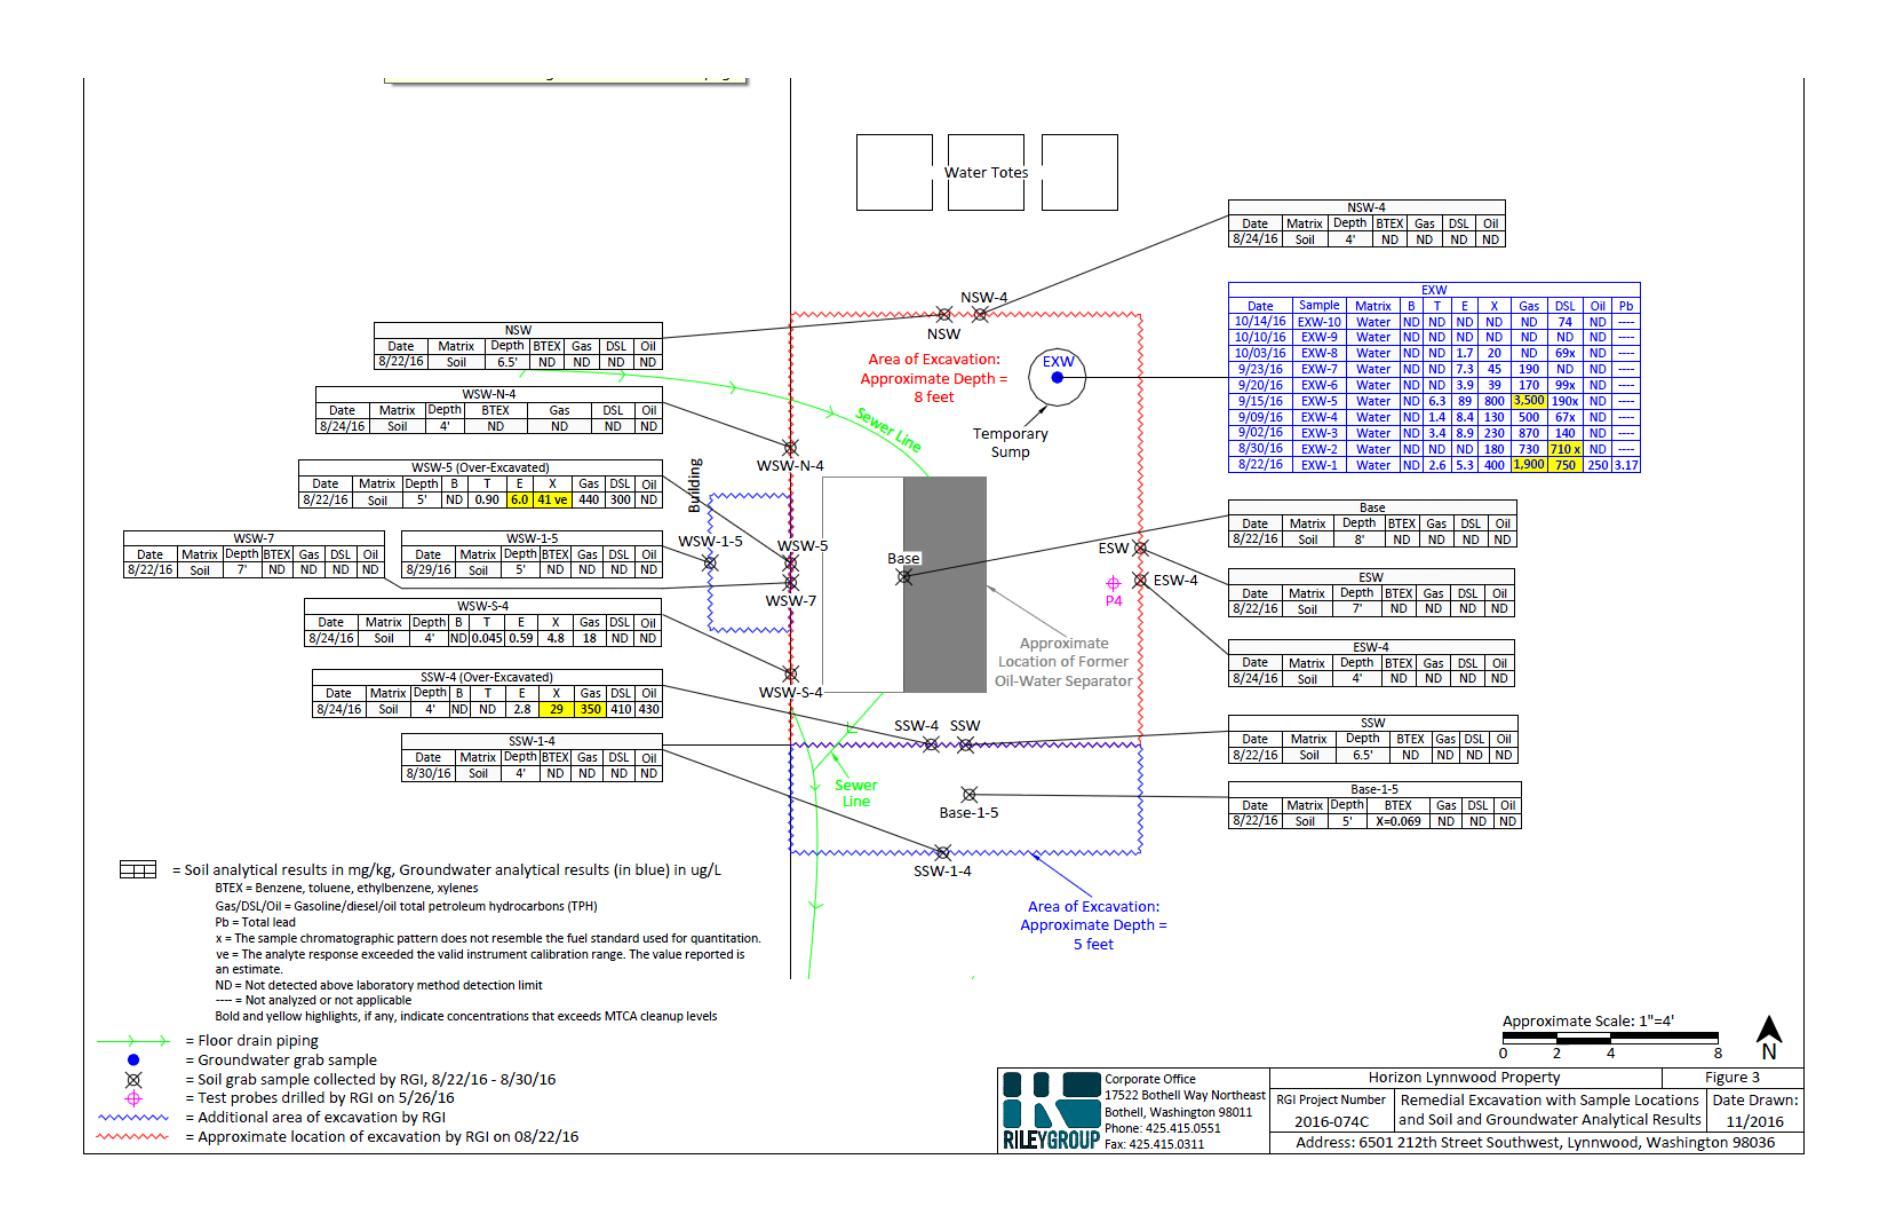
6/16/2016 Preliminary Phase II report shows only one soil probe location near the Oil/Water Separator has results exceed MTCA Method A cleanup levels.

Sample results and sample locations around sump take from Riley Group report 11/2013.

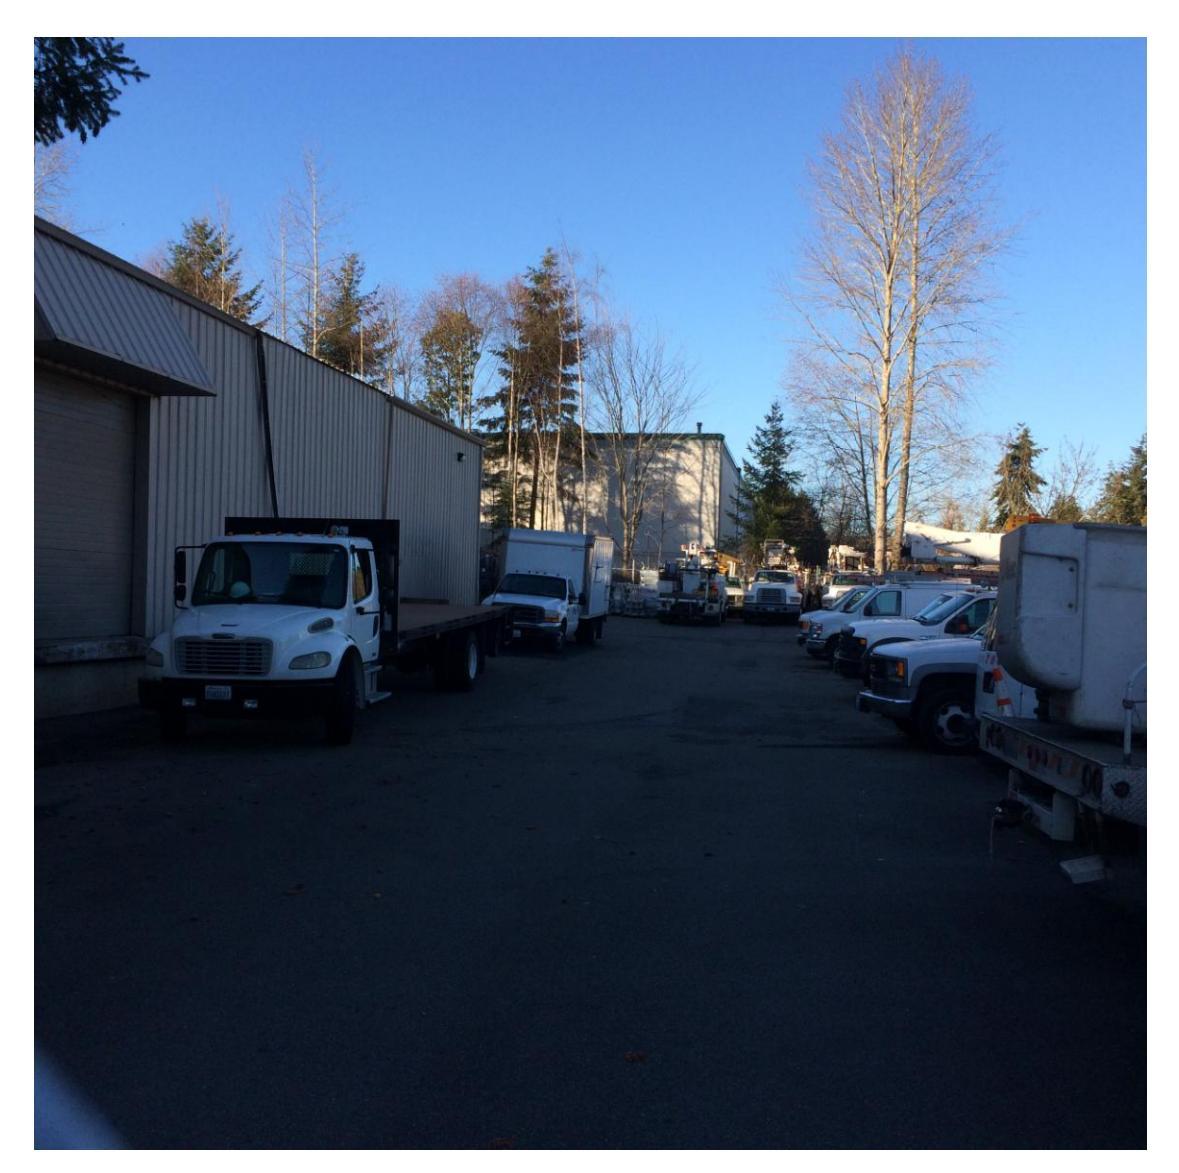
PHOTO NO:	2	ADDRESS:	6501 212th St SW Lynnwood, WA 98036
DATE:	2/13/2017		
TIME:	1PM		
CAMERA:	IPHONE	TAKEN BY:	MY
COMPLAINT #:	670598	WITNESS:	N/A
DESCRIPTION/COI	MMENTS:

8/19/2016 Remedial excavation of 90 CY petroleum contaminated soil removed.

8/25/2016 Start of 7 excavation dewatering events to recover contaminated groundwater at 7.5 feet below the surface. 10/14/2016 12 cleanup confirmation soil samples were collected and 10 groundwater cleanup confirmation grab samples were collected.

Area where excavation was made on side of building.

Removal & Remedial Action was done on behalf of the new owner Horizon Communications. The cleanup report states that 90 CY petroleum contaminated soil were removed and a total of 7,500 gallons of GW were pumped from the excavation. Soil samples and groundwater samples confirm that contamination has been successfully removed. We recommend an NFA for the specific contamination found around the oil water separator.

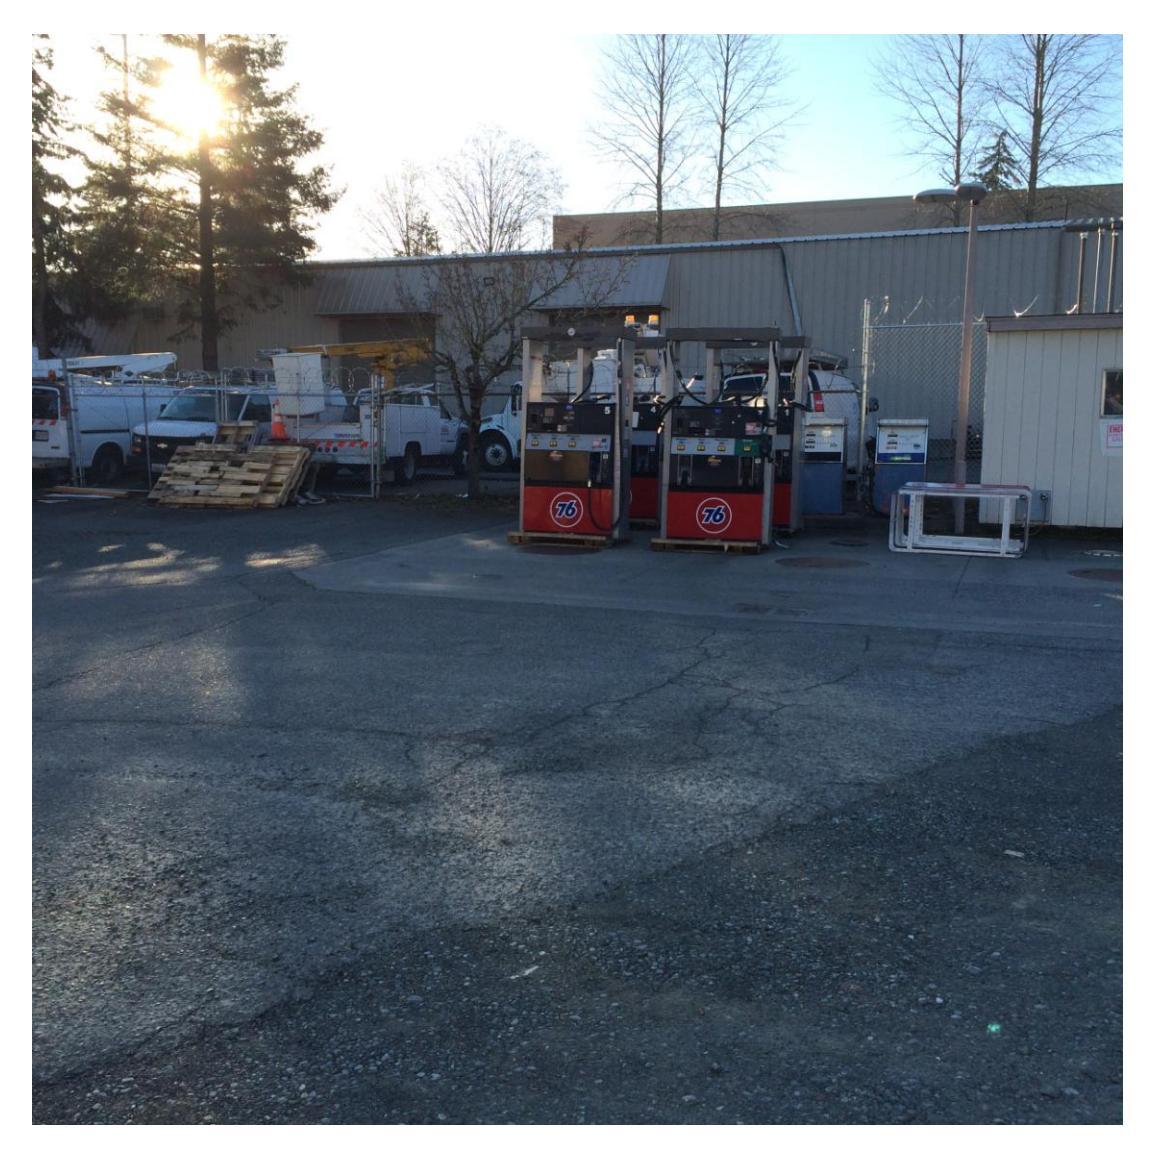
PHOTO NO:	3	ADDRESS:	6501 212th St SW Lynnwood, WA 98036	
DATE:	2/13/2017			
TIME:	1PM			
CAMERA:	IPHONE	TAKEN BY:	MY	
COMPLAINT #:	670598	WITNESS:	N/A	
DESCRIPTION/COMMENTS:

Property to the east of subject site has gas pumps and UST, and neighbor said these are not in use. Groundwater samples taken on the subject site were likely up-gradient and show no contamination.

Property east of subject site, UST was said not to be in use.
