# Able Clean-up Technologies, Inc.

RE: Cleanup and Site Assessment report for Coleman Oil regarding a diesel spill located at the Coleman Oil Company in Quincy, WA.

ACT Project #: 16056

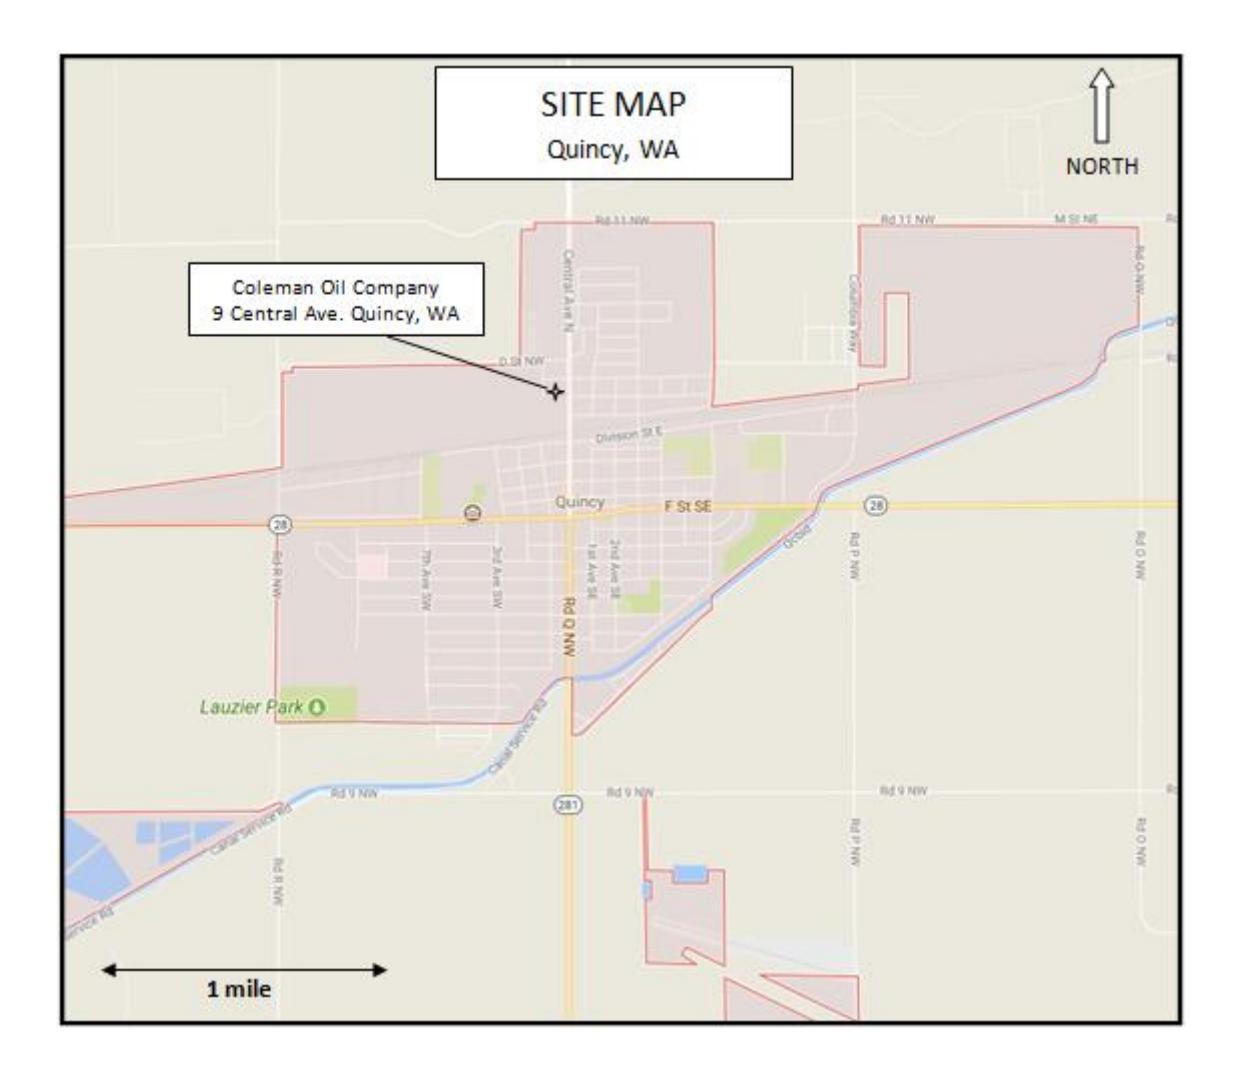
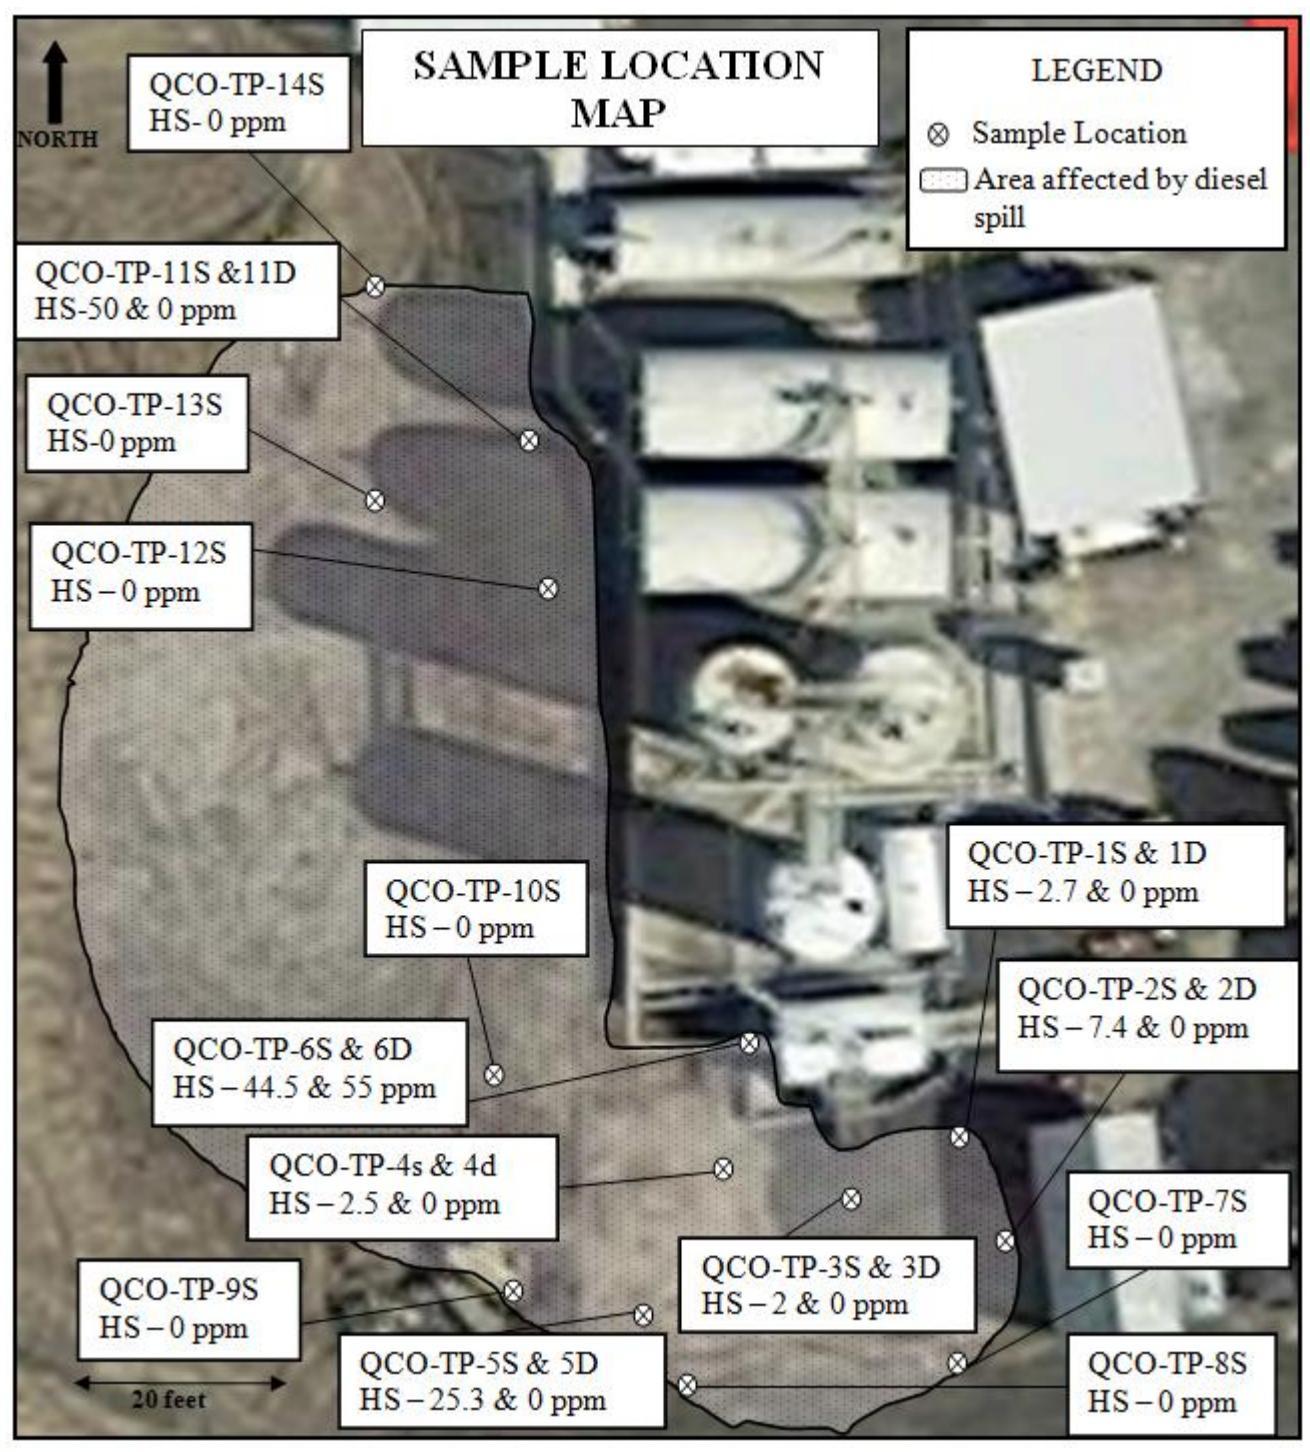
Figure 1. Image showing locations where soil samples were collected, HS indicates VOC readings using a photo-ionization detector.

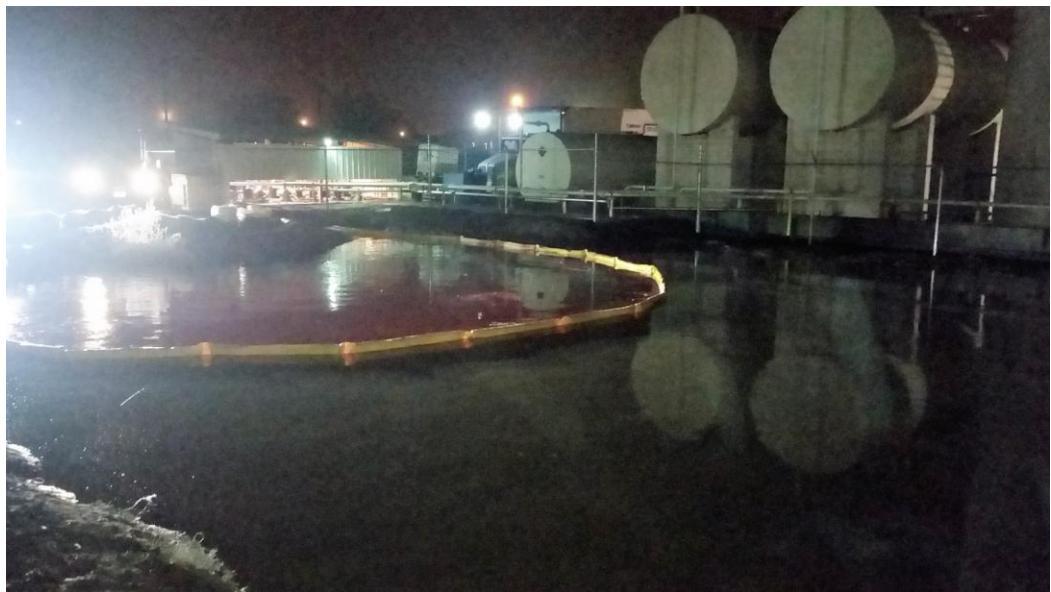
**Figure 1.** Image showing the boom deployed to contain diesel that spilled into the pond adjacent to the Coleman Oil facility

ACT received a call regarding the spill at 12:00 PM and the spill response team was onsite at 5:00 PM on January 24, 2016. ACT utilized marine skirts to contain the fuel and direct it towards the shoreline of the pond located to the west of the release site so it could be skimmed off. A vacuum truck was used to pump the fluids out of the ditch and containment pond. The mixture of water and diesel, totaling 7,000 gallons, was stored onsite in totes until it could be sent for recycling through Oil Re-Refining Company (ORRCO) based out of Portland, Oregon.

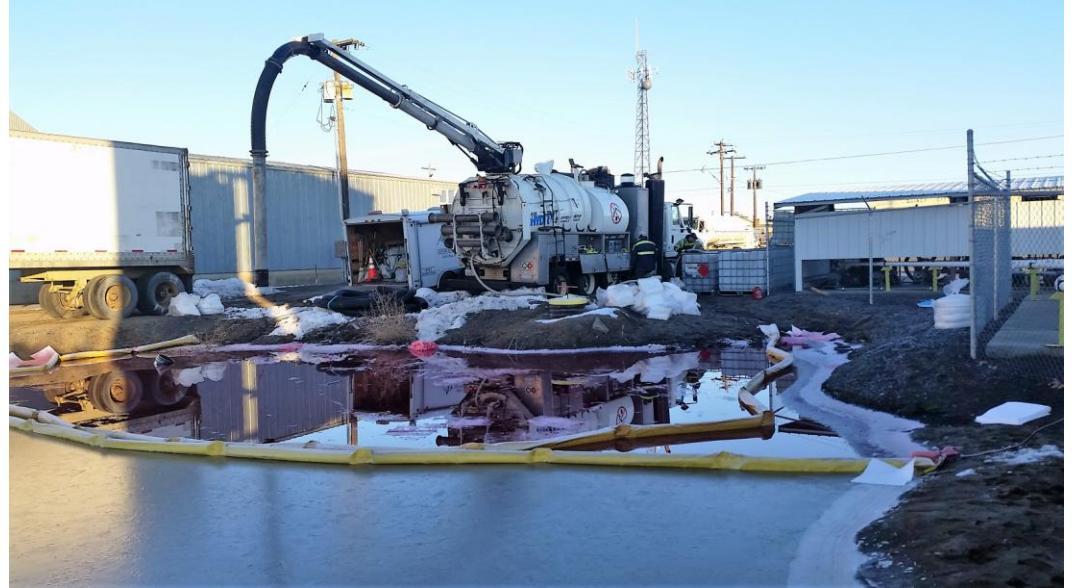
Figure 2. Image showing containment and cleanup techniques used by ACT to remediate the site

In addition to recovering fluids from the ditch and pond, ACT technicians utilized absorbent pads and booms to remove free product from the ground surface. This also served to contain the spill and prevent it from migrating down gradient from the spill site.

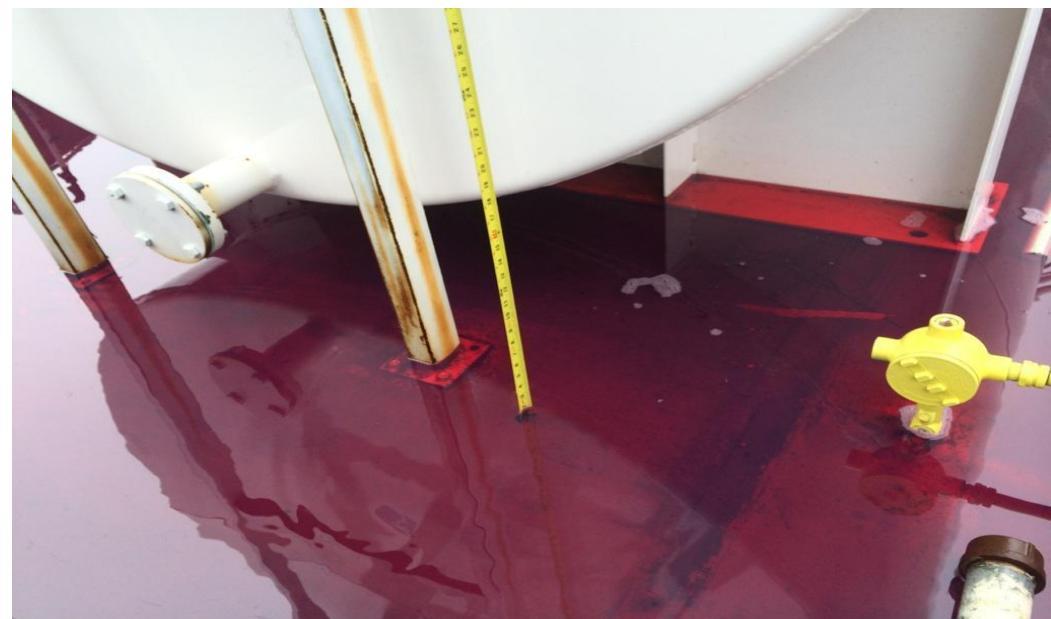
Figure 3. Image showing accumulation of red dyed diesel in secondary containment

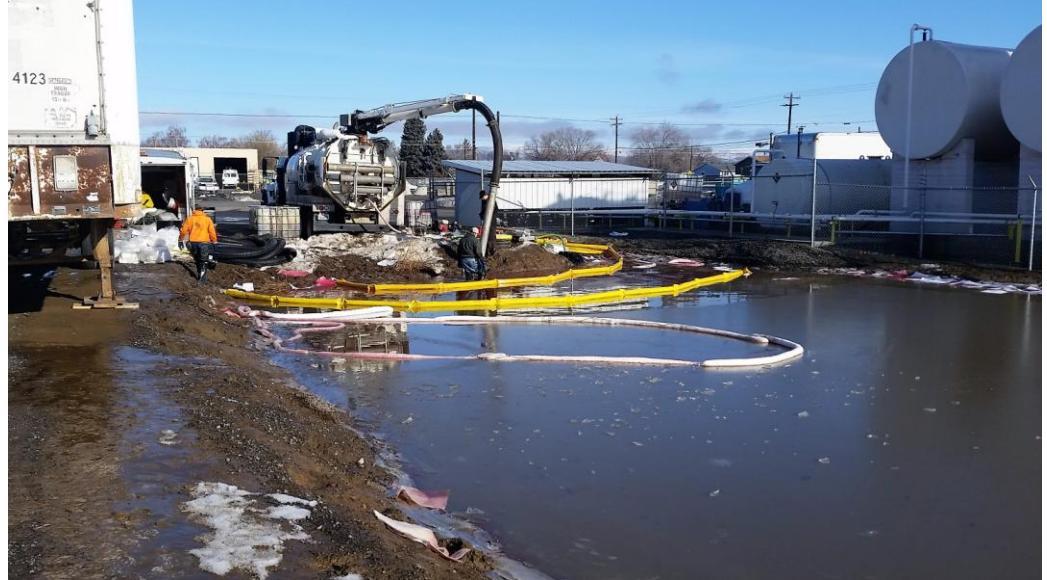
Figure 4. ACT utilized a Vacuum truck to remove 7,000 gallons of diesel/water from pond

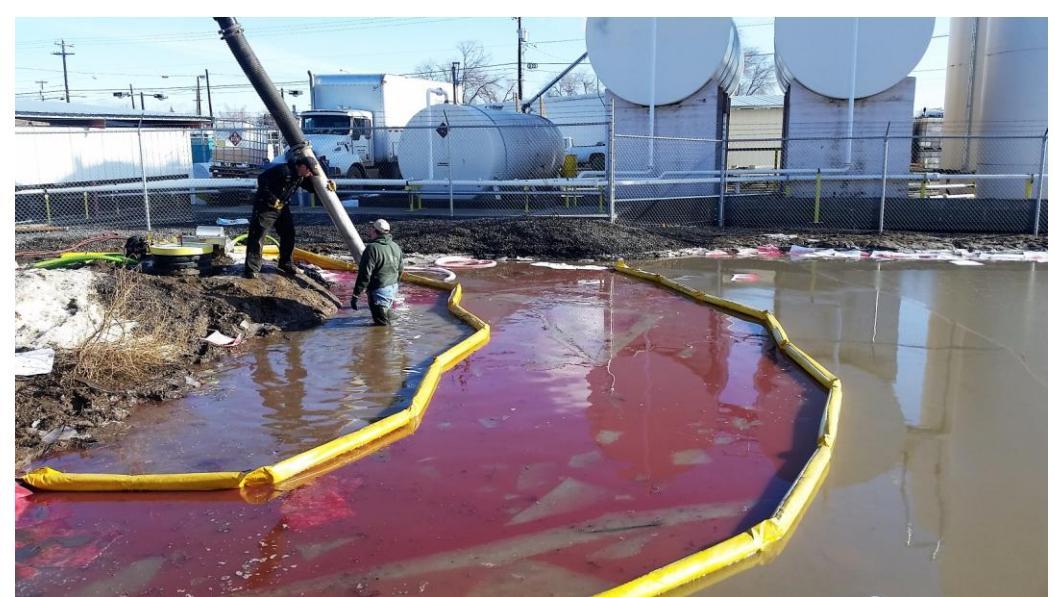
Figure 5. ACT personnel skimming red diesel off the pond using a Vacuum truck.

All light non-aqueous phase liquid (LNAPL) was contained using booms and skirts and skimmed off the pond until there was no observed sheen. There was some seepage observed coming from embankment separating the secondary containment and AST's from the pond. Absorbent pads were utilized to remove free floating product in areas inaccessible using the vacuum truck. The area was monitored, and pads were replaced as needed, by Coleman Oil onsite personnel. Coleman Oil personnel also monitored the pond

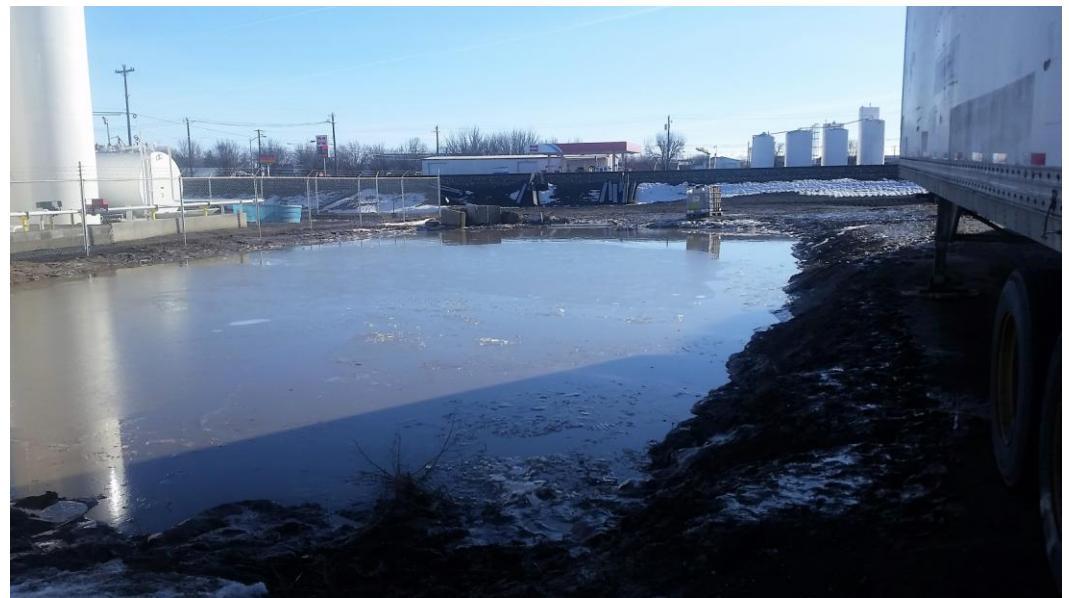
Figure 6. Image of pond post cleanup

It is the recommendation of Able Clean-up Technologies that no further site remediation take place at: the Coleman Oil Bulk Facility at 9 Central Ave. North, in Quincy, WA. This is based on visual appearance of the pond which includes no LNAPL or sheen and analytical sampling from the soils. This recommendation is only in relation to the Coleman Oil Co. fuel release on January 24, 2016.

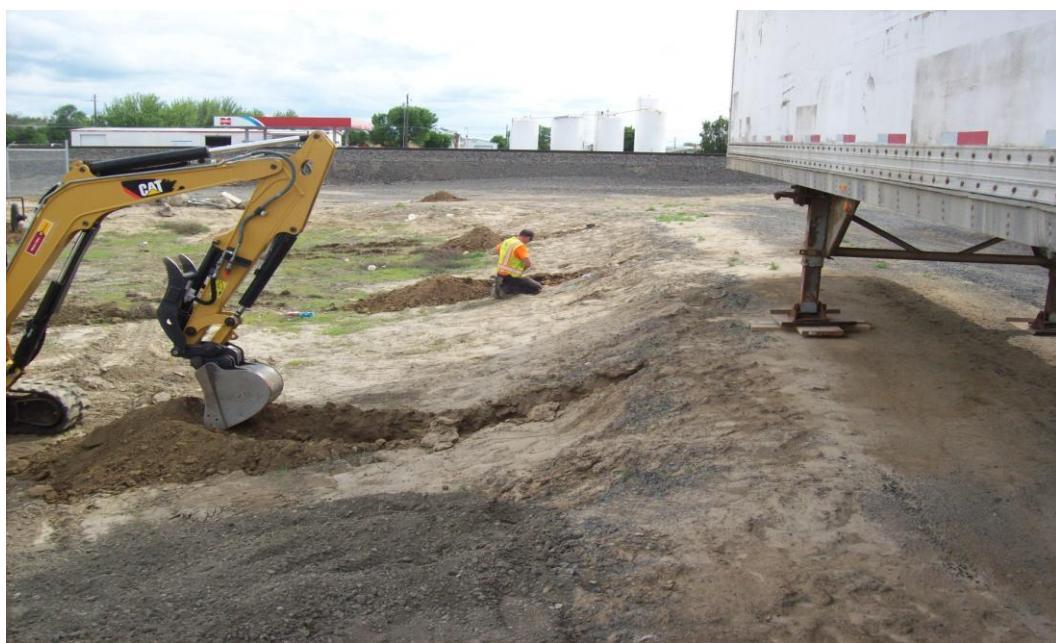
**Figure 7.** In May of 2016 ACT returned to the spill site and dug test pits to determine if contaminants were present in the soil

Due to the presence of piping extending beyond the secondary containment, excavation of contaminated soil was not recommended. After contacting WDOE and Coleman Oil Co., it was decided to continue taking periodical soil samples and to treat contaminated soils using bio-remediation.

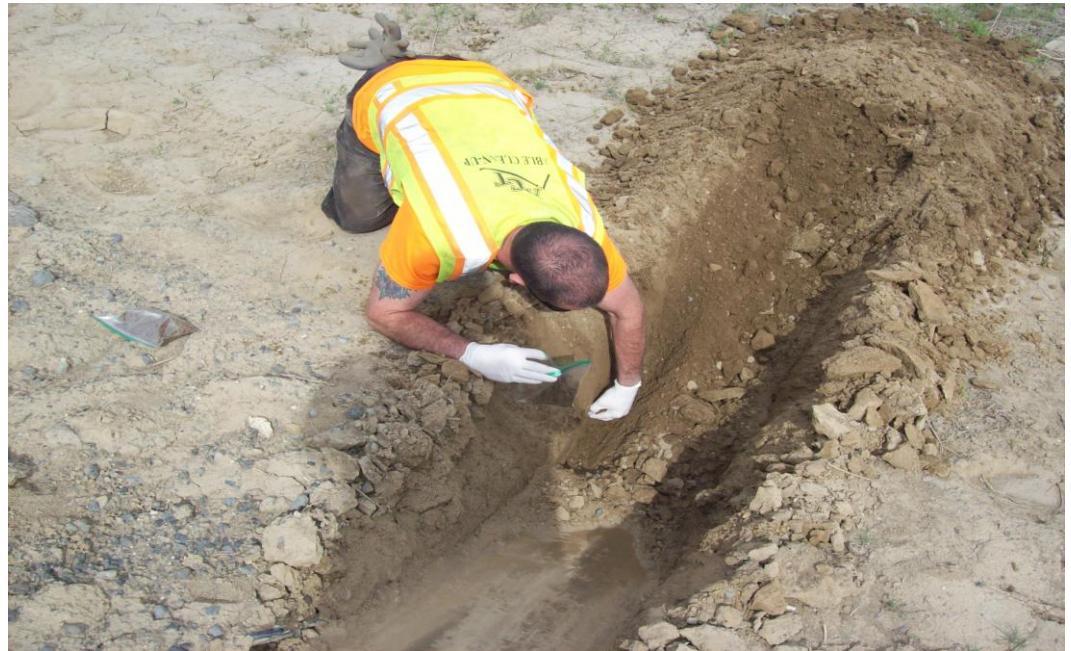
Figure 8. ACT personnel collecting soil sample for headspace analysis.

- 1. Select a clean, plastic zipper type air tight baggy.
- 2. Fill the baggy 1/3 full with a discrete soil sample.
- 3. Immediately place seal the baggy to prevent volatile components from escaping.
- 4. Place the soil sample baggy in warm to hot environment for 5-10 minutes (vehicle heater or sun rays). This causes the volatile components to become vapors and collect in the space above the soil. Very moist soils shall be allowed to sit in the sun for 10-15 minutes.
- 5. Remove the sample container from the warm/hot environment and insert the instrument probe through the plastic for vapor analysis. This must be accomplished within thirty seconds to prevent the sample from cooling and creating a vacuum in the sample container.
