Remedial Investigation, Feasibility Study, and Cleanup Action Plan

Meeker Former Gas Station Site 105 Washington Avenue N Kent, Washington

September 1, 2017

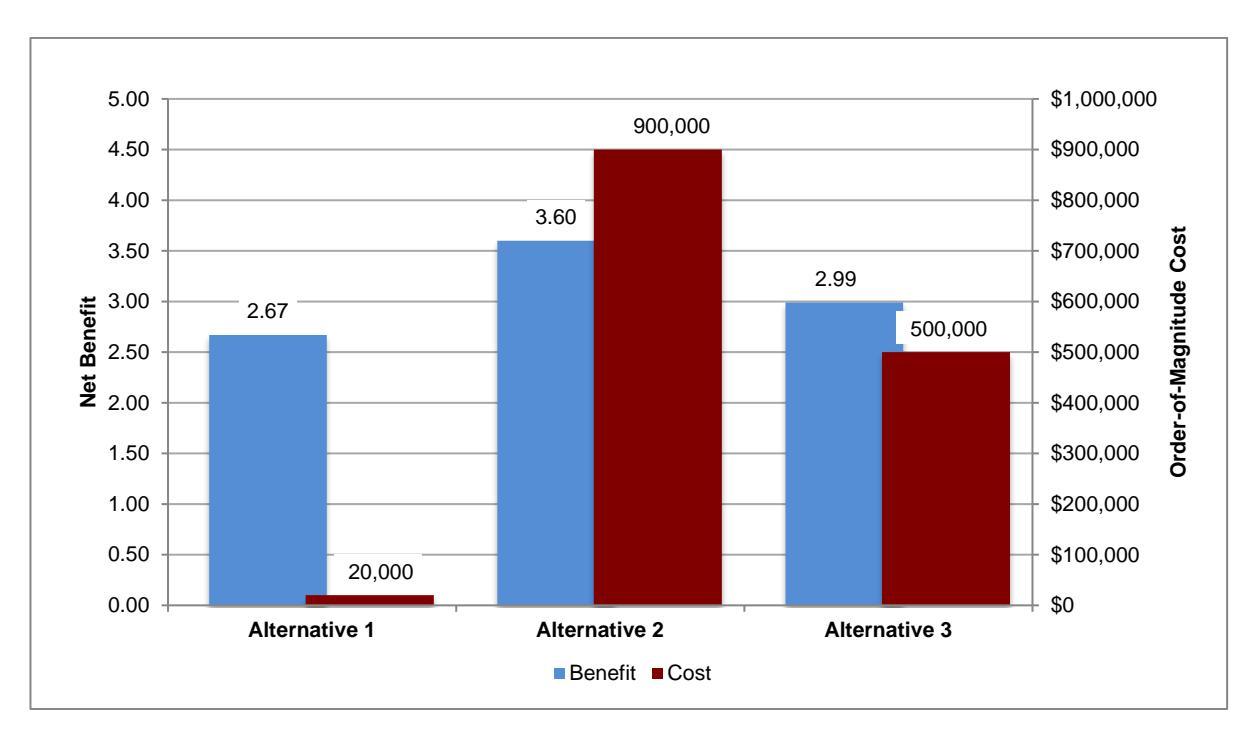
Cost-to-Benefit Analysis

Based on the remedial alternatives evaluation, Alternative 2 ranks highest overall in raw scoring for the non-cost criteria (i.e., a total of 3.60 compared to scores of 2.67 and 2.99 for Alternatives 1 and 3, respectively). However, the scores are not appreciably different between any of the remedial alternatives. Alternative 1 is significantly lower in cost than the other alternatives. While the weighted score for Alternative 1 is slightly lower than Alternative 2 and Alternative 3, the perceived benefit for the estimated cost of Alternative 1 is significantly greater, as shown in the above graph.

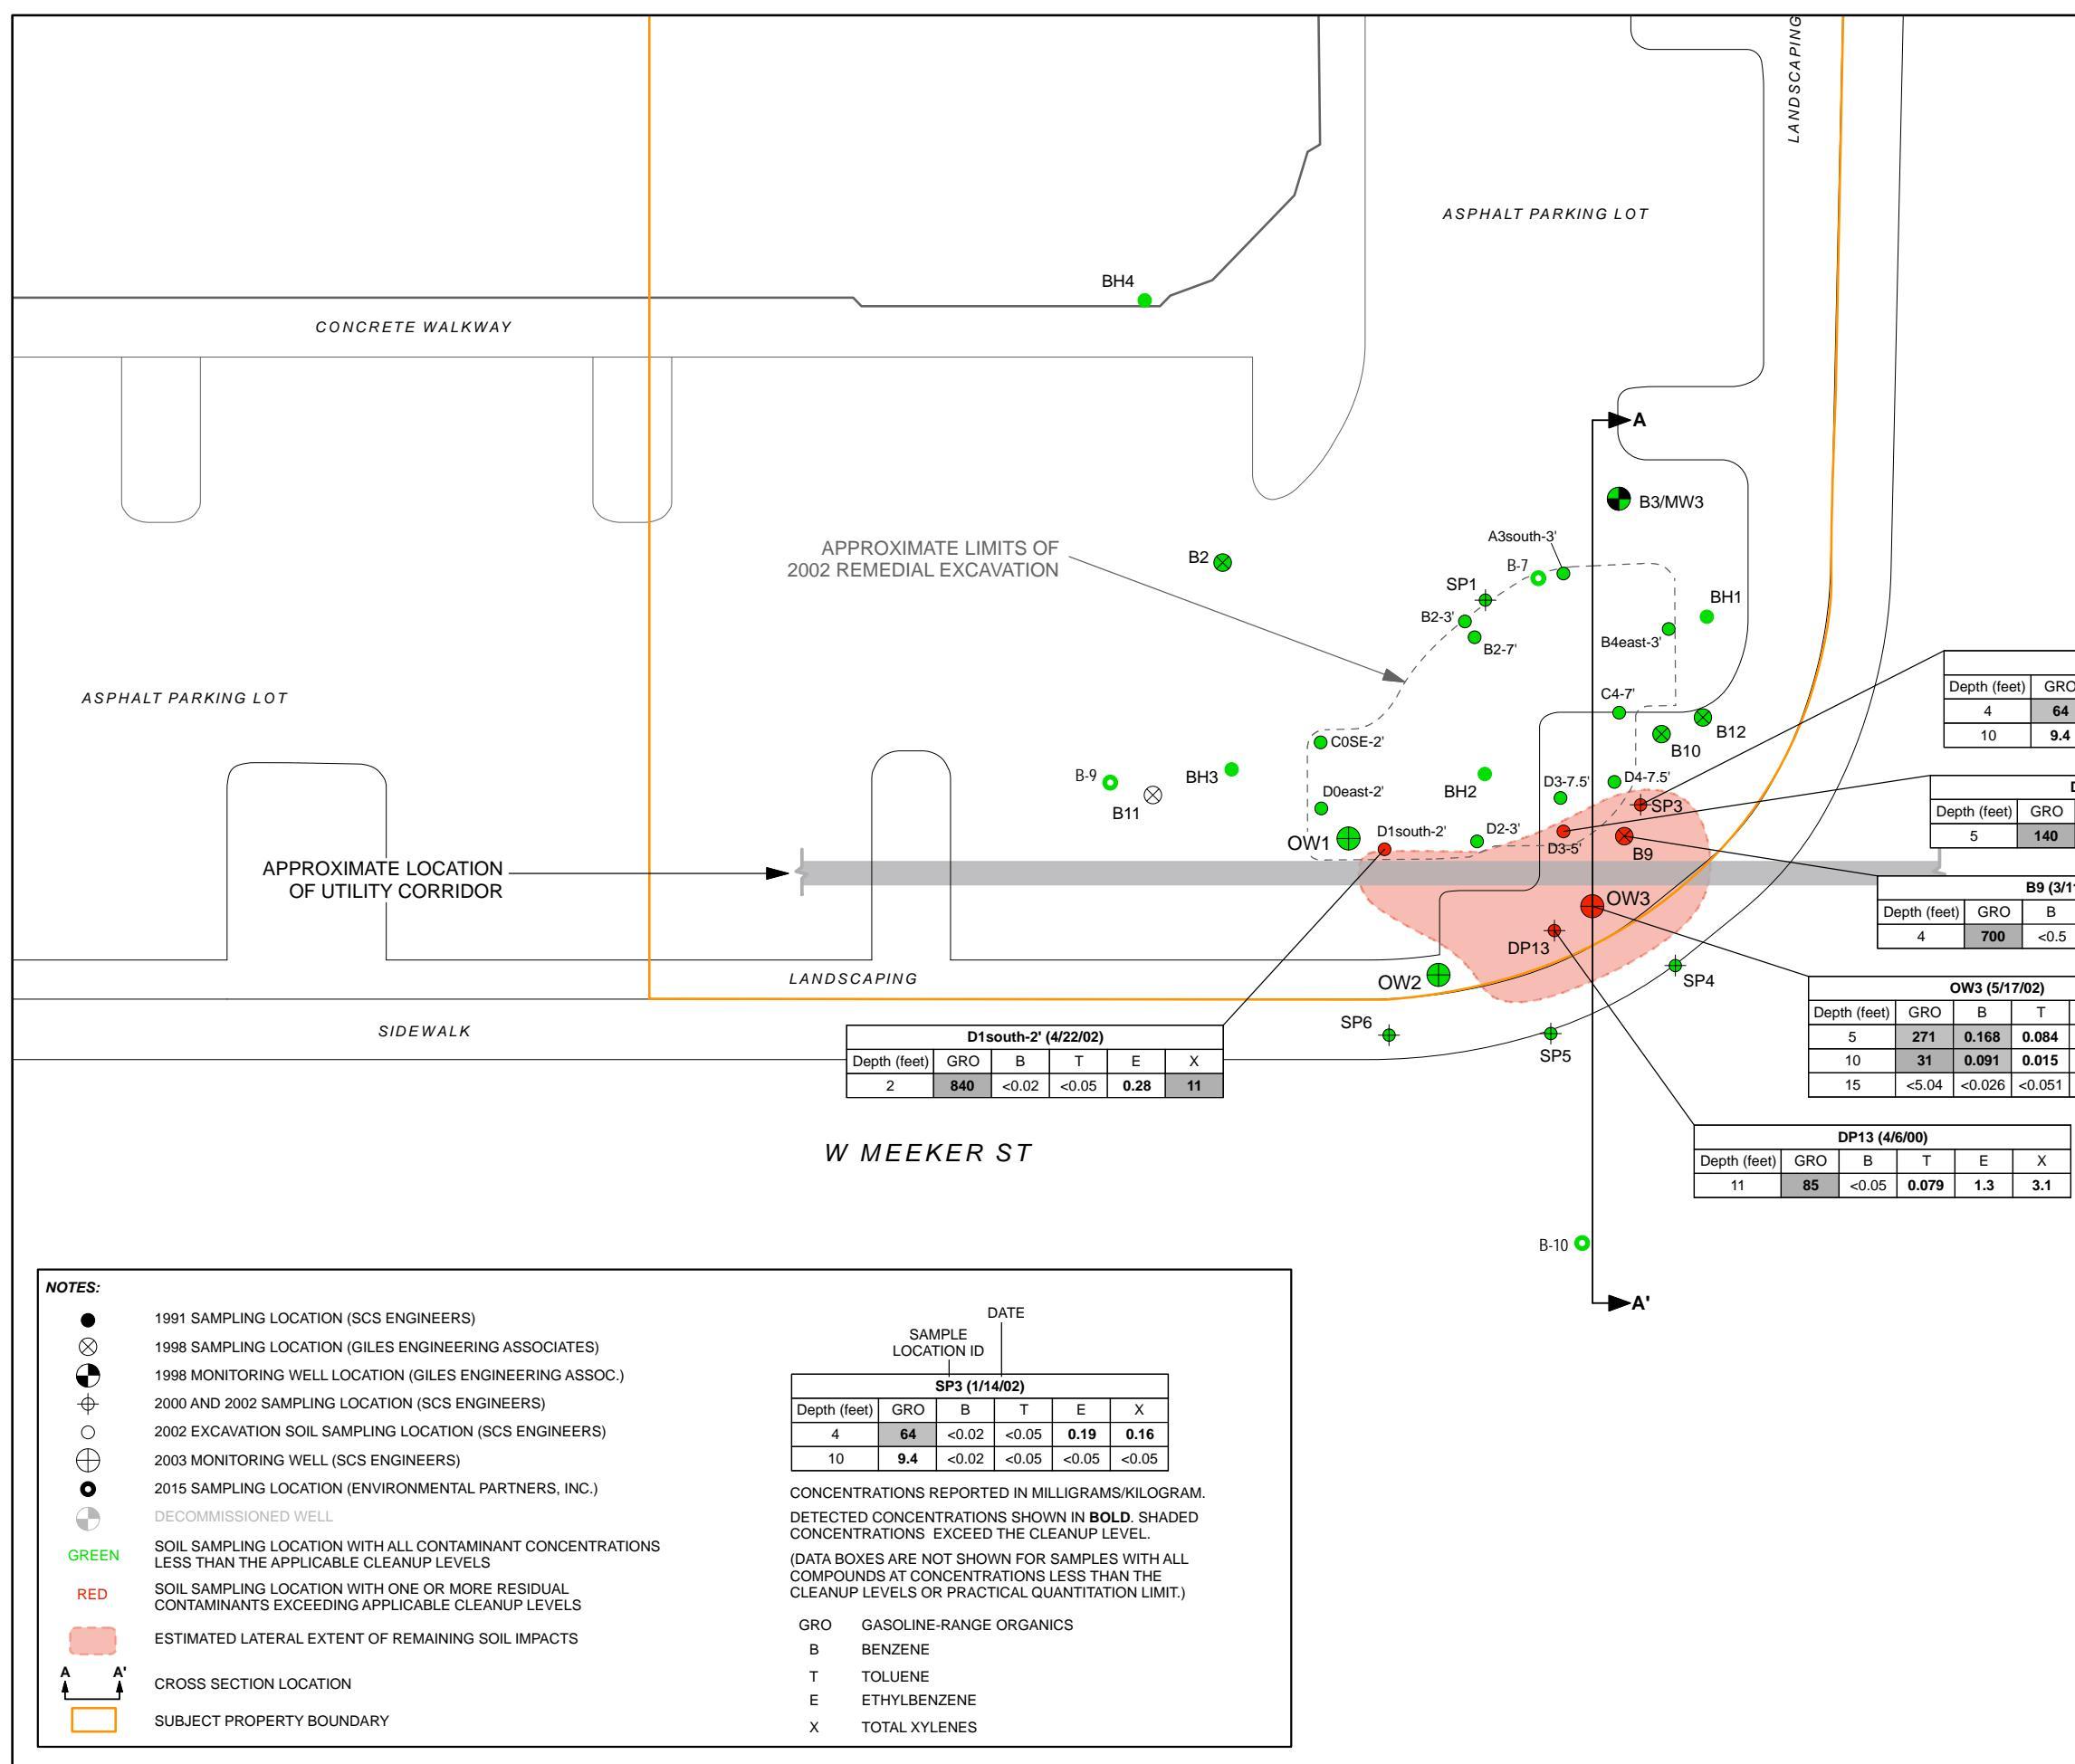
FIGURE 6 RESIDUAL PETROLEUM HYDROCARBONS IN SOIL					
PREPARED BY	ENVIRONMENTAL PARTNERS INC				
REPORT	REMEDIAL INVESTIGATION, FEASIBILITY STUDY, AND CLEANUP ACTION PLAN				
LOCATION	MEEKER FORMER GAS STATION SITE 105 WASHINGTON AVENUE N, KENT, WASHINGTON				
PREPARED

Soil and groundwater samples were collected from three direct-push boring locations (B-7, B-9, and B-10) in the vicinity of the former gas station during the investigation. Borings B-7 and B-9 were advanced on the subject property and boring B-10 was advanced within the roadway south of the subject property. It should be noted that due to extensive utilities within the roadway, B-10 was advanced as near as possible to the intersection. Due to existing infrastructure, it is not possible to advance borings any closer to the middle of the intersection or beyond. The sampling locations are shown on Figure 6 and copies of the bore logs are presented in Attachment B.

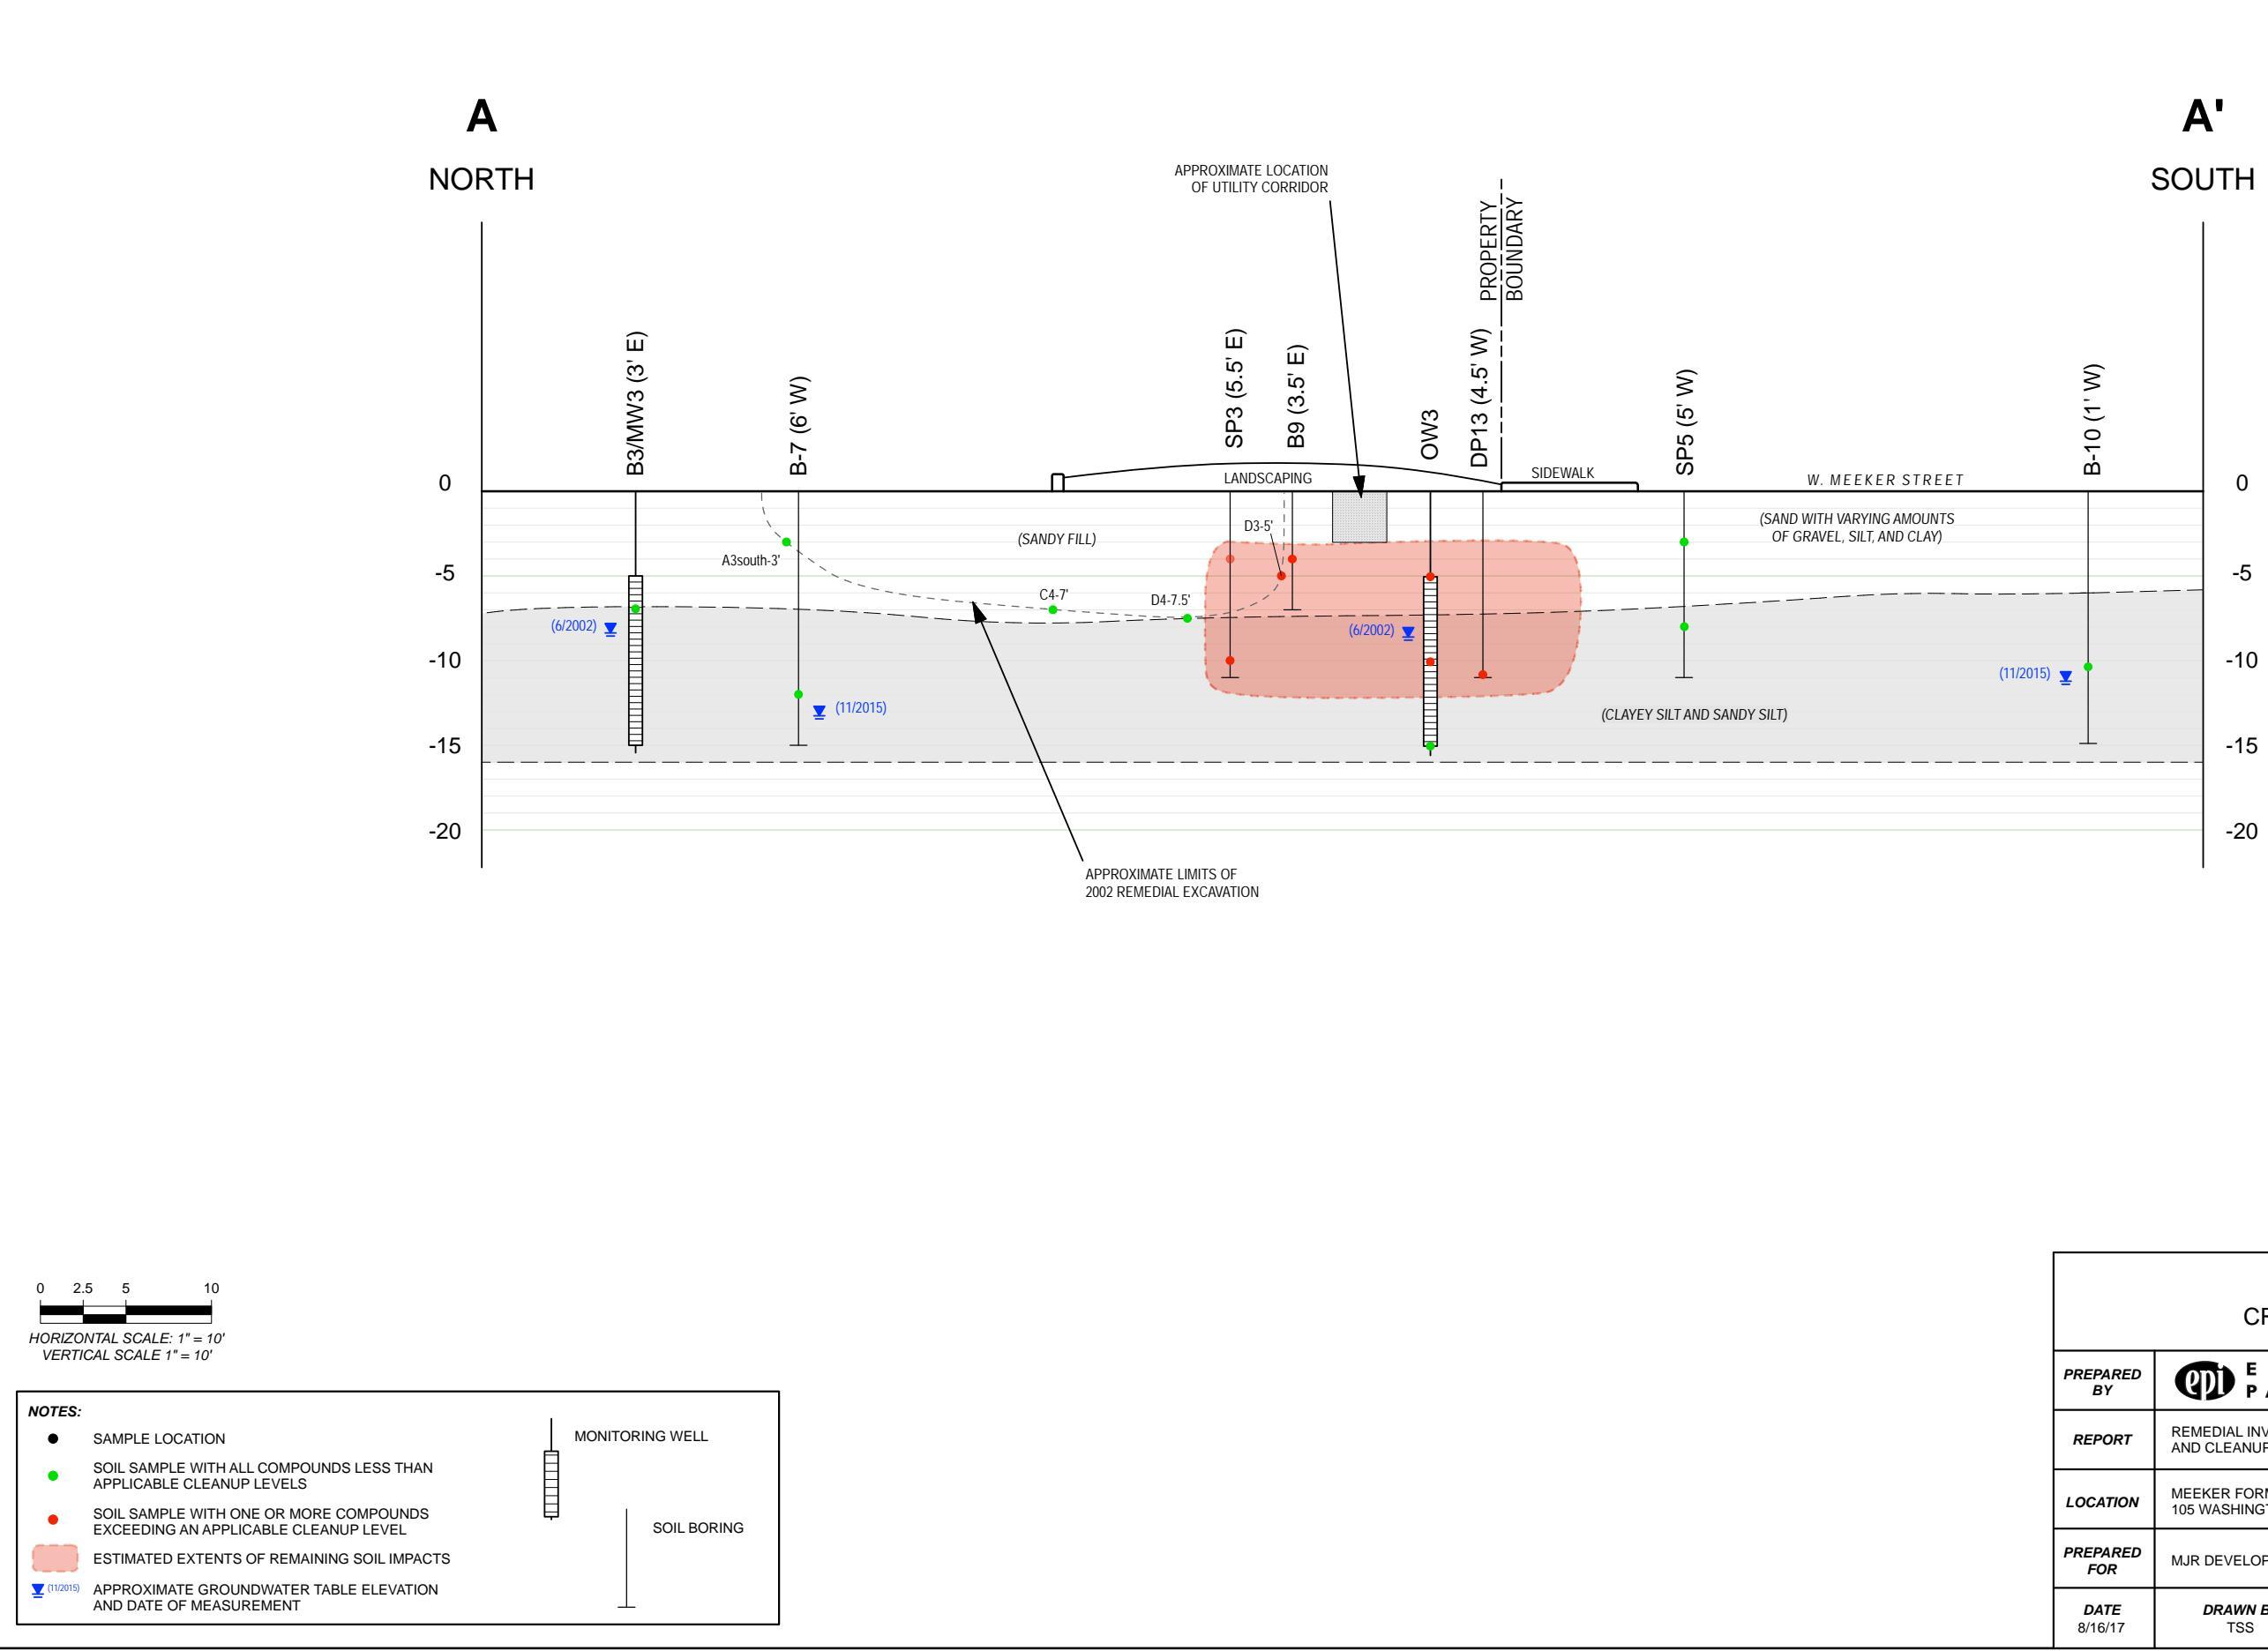
During the 2015 investigation, poorly-graded sand was observed on the subject property from approximately 1 foot bgs to depths ranging from 6 to 9 feet bgs. Silty sand and poorly-graded sand with silt was observed beneath the shallower sand layer and extended to the maximum depth explored of 15 feet bgs. Soils beneath Meeker Street south of the subject property consist of silty sand to a depth of approximately 6 feet bgs, which is underlain by sandy silt to the maximum depth explored of 15 feet bgs. Consistent with historical findings, the deeper siltier soils became saturated at depths ranging from 9 to 13 feet bgs.

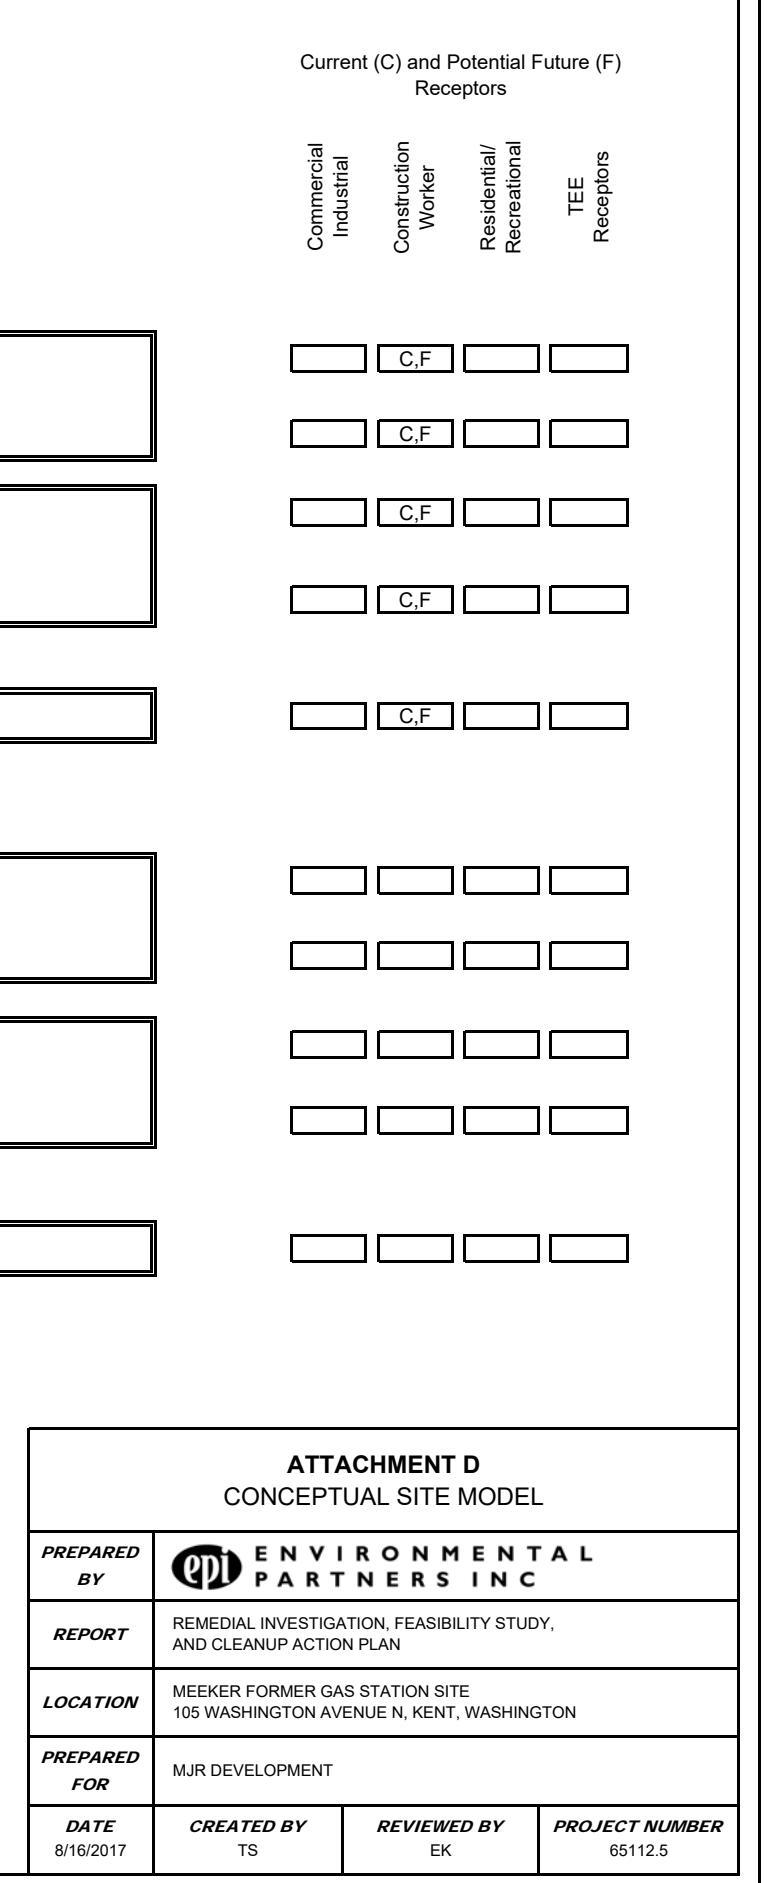
Attachment D Conceptual Site Model Diagram

Primary Sources	Contaminants of Potential Concern	Media of Concern	Transport Mechanisms	Exposure Media	Exposure Pathway
	Gasoline-Range Organics (GRO) and Benzene, Toluene, Ethylbenzene, and Xylenes	Surface Soil (0-2 feet bgs)	<ul> <li>Direct release to soil</li> <li>Migration to subsurface soil</li> <li>Migration to groundwater</li> <li>Volatilization</li> <li>Runoff or erosion</li> <li>Utake by plant or animal</li> <li>Other (list)</li> <li>X Direct release to soil</li> <li>X Migration to groundwater</li> </ul>	X     Soil       X     Groundwater	X       Ingestion         X       Dermal Exposure         X       Ingestion         X       Dermal Exposure
Fuel releases from former undergound storage tanks and piping associated with former gas station	(BTEX)	X Groundwater	<ul> <li>X Volatilization</li> <li>Other (list)</li></ul>	X Air	Inhalation
	<ul> <li>X Adsorbed onto soil</li> <li>X Dissolved in water</li> <li>Non-aqueous phase</li> </ul>	Surface Water		Sediment	Ingestion Dermal Contact

Resuspension or erosion     Uptake by plant or animal     Other (list)	Indoor Air	Inhalation
