Phase II Environmental Site Assessment

# Montlake Market and Gas Station Properties

2625 East Montlake Place East and 2605 22<sup>nd</sup> Avenue East Seattle, Washington

January 30, 2019 19426-00

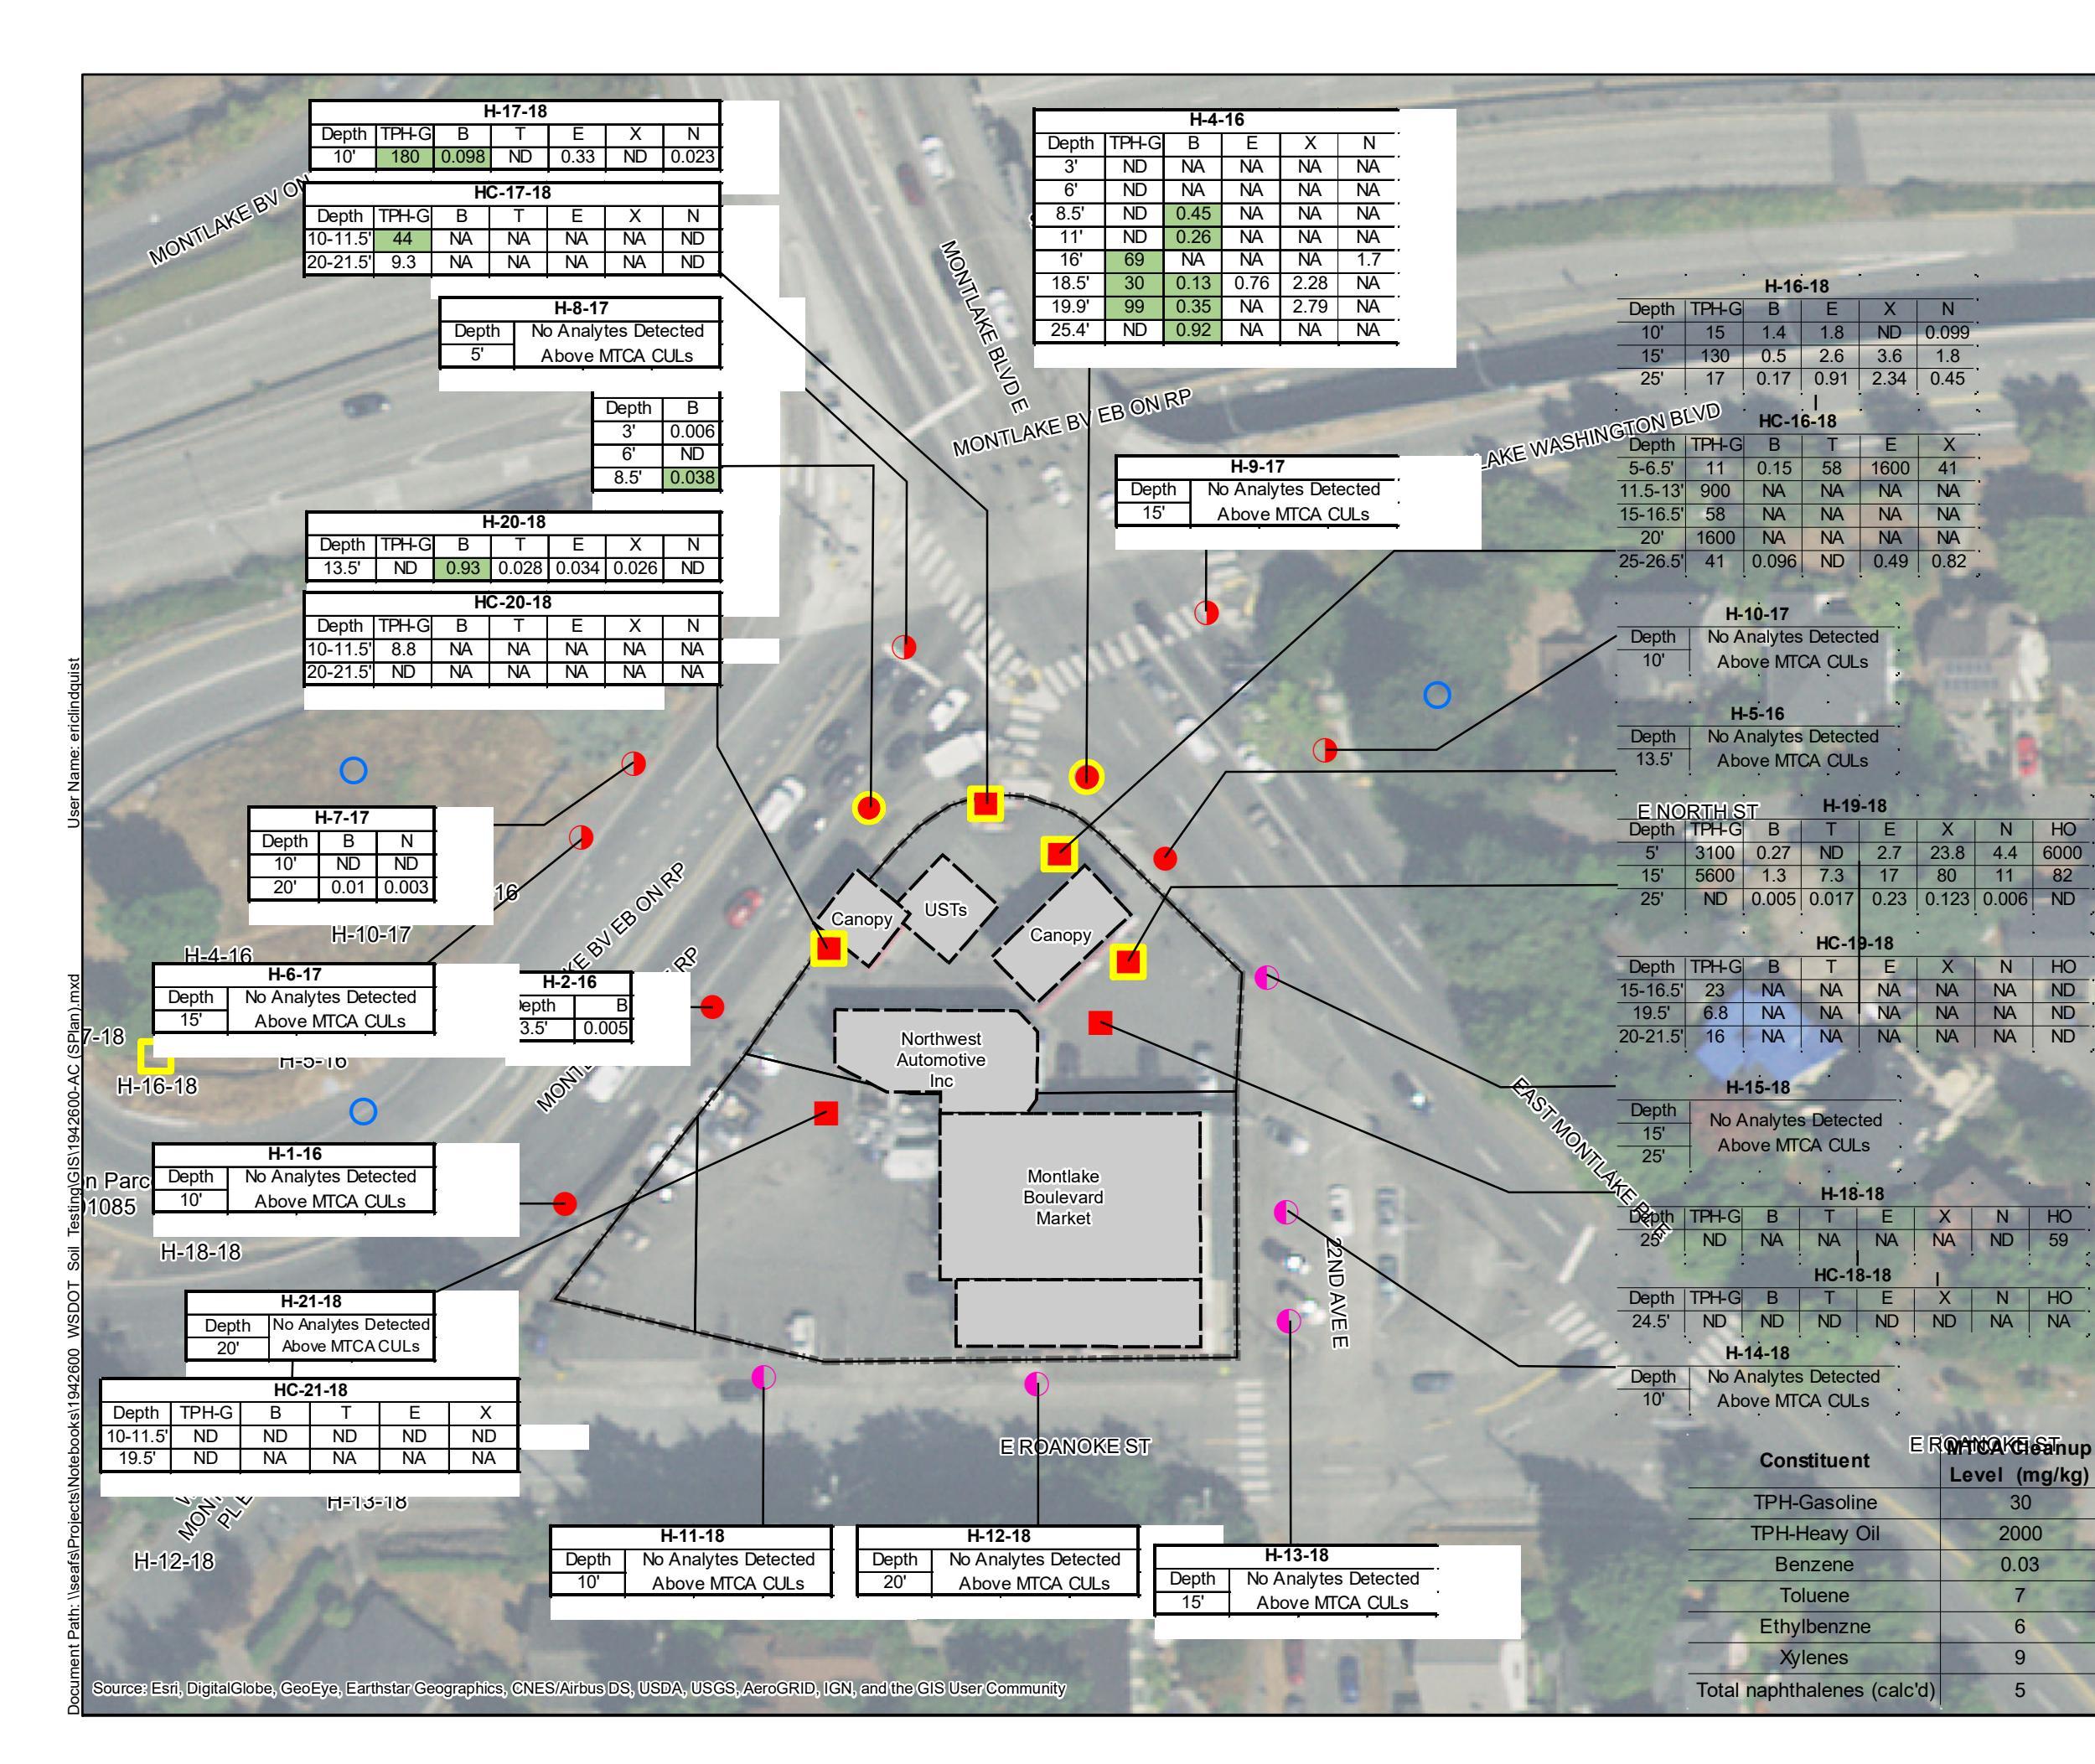
The WSDOT investigations detected subsurface soil exceeding MTCA cleanup levels for gasoline-related constituents in borings in a limited area within and immediately north of the Gas Station Parcel. Based on the soil and groundwater sampling and analysis, there is no evidence of soil contamination on the Market Properties that contain the Market and cell towers. Petroleum contaminated soil appears to be limited to the Gas Station Parcel where the gas station and associated UST system are located. This limited area of contamination is bounded by "clean" soil borings in which MTCA cleanup levels are not exceeded (see Figure 2). Current groundwater data is limited in areal extent and is very likely biased high since samples were not collected from properly constructed and developed monitoring wells. Nonetheless, the overall pattern of groundwater exceedances generally mirrors the soil results (see Figure 3).

The highest Photoionization detector (PID) soil field screening readings by Hart Crowser were of the soil samples from boring H-16-18, which was located closest to the USTs in the Gas Station Parcel. All of the soil samples (5) analyzed in this boring (to a maximum depth of 26 feet) exceeded the MTCA Method A unrestricted cleanup levels for TPH-G and/or benzene.

The second highest PID soil field screening readings on soil samples collected were from boring H-19-18, which is also in the Gas Station Parcel near the gasoline pumps in the northeast area of the Property. However, none of the three soil samples Hart Crowser analyzed had concentrations of TPH-G or benzene exceeding MTCA Method A unrestricted cleanup levels though WSDOT contractor's results indicated two of three soil samples analyzed had exceedances of TPH-G and benzene exceeding MTCA Method A unrestricted cleanup levels.

Boring H-17-18, also located in the north end of the Gas Station Parcel and near the gas station USTs, had lower PID readings though 2 of the 5 soil samples analyzed and had exceedances above MTCA Method A unrestricted cleanup levels for TPH-G and benzene in both Hart Crowser and WSDOT contractor's results.
