## Landmarc Technologies, Inc.

## Re: REPORT OF COMPLETION OF NEWCASTLE SURFACE WATER INTERCEPTION TRENCH

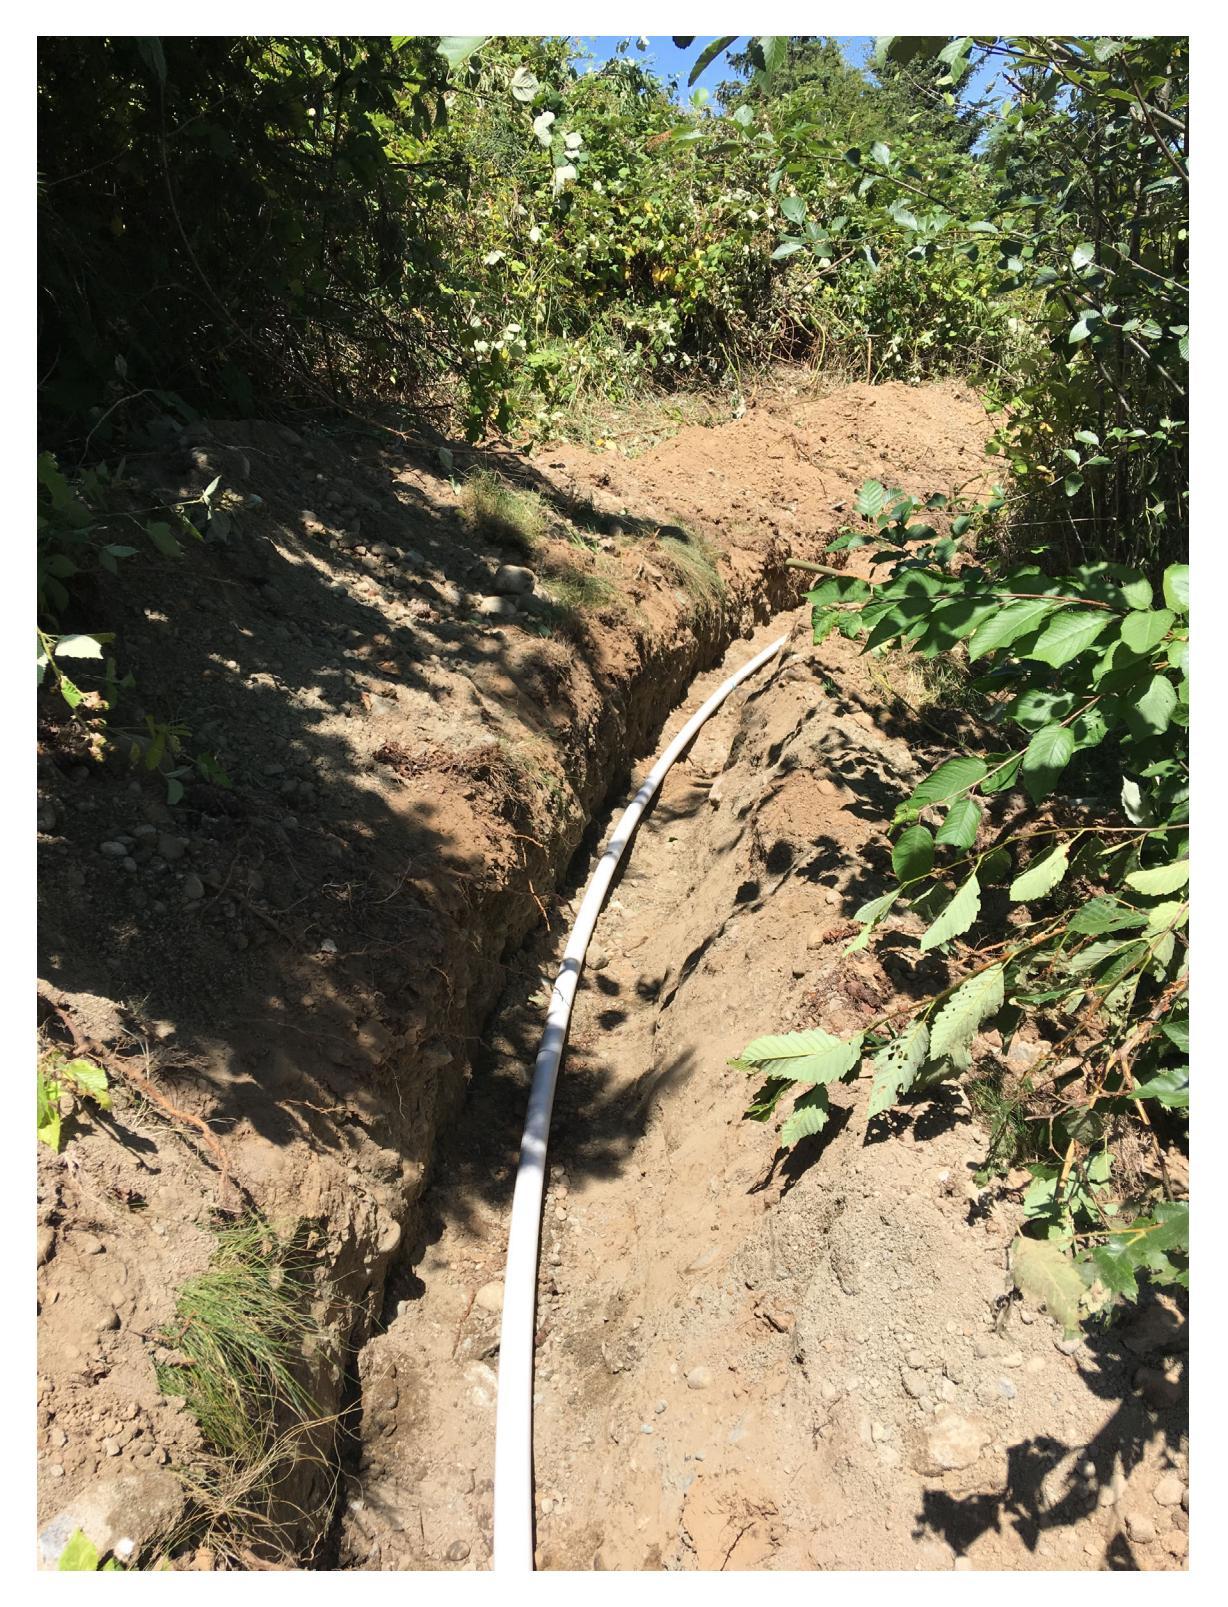
PVC Discharge Pipe to Leachate Manhole

- A rock wall was added to support the steep slope created by cutting into the slope to construct the interception trench. Gravel and perforated pipe were installed behind the wall and the perforated pipe was connected to a pipe in the interception trench. This allows any seep collected behind the wall to be directed to the interception trench and pumped into the leachate manhole.
- The plan was to use an existing pipe behind the retaining wall along 156<sup>th</sup> Ave SE for a portion of the discharge connection to the leachate manhole. That proved to be infeasible during construction so a buried PVC pipeline was installed from the interception trench all the way to the leachate manhole.

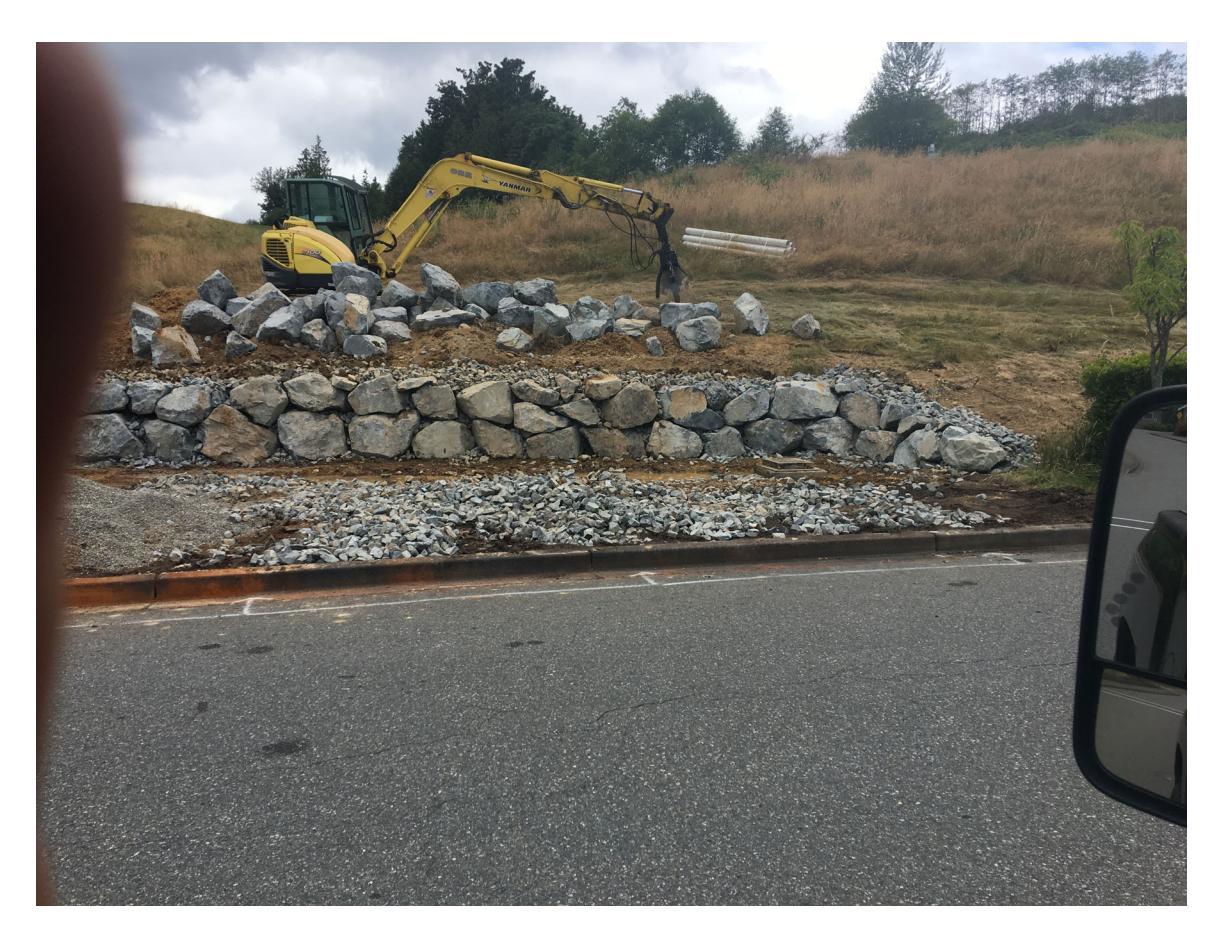
Construction of Rock Wall

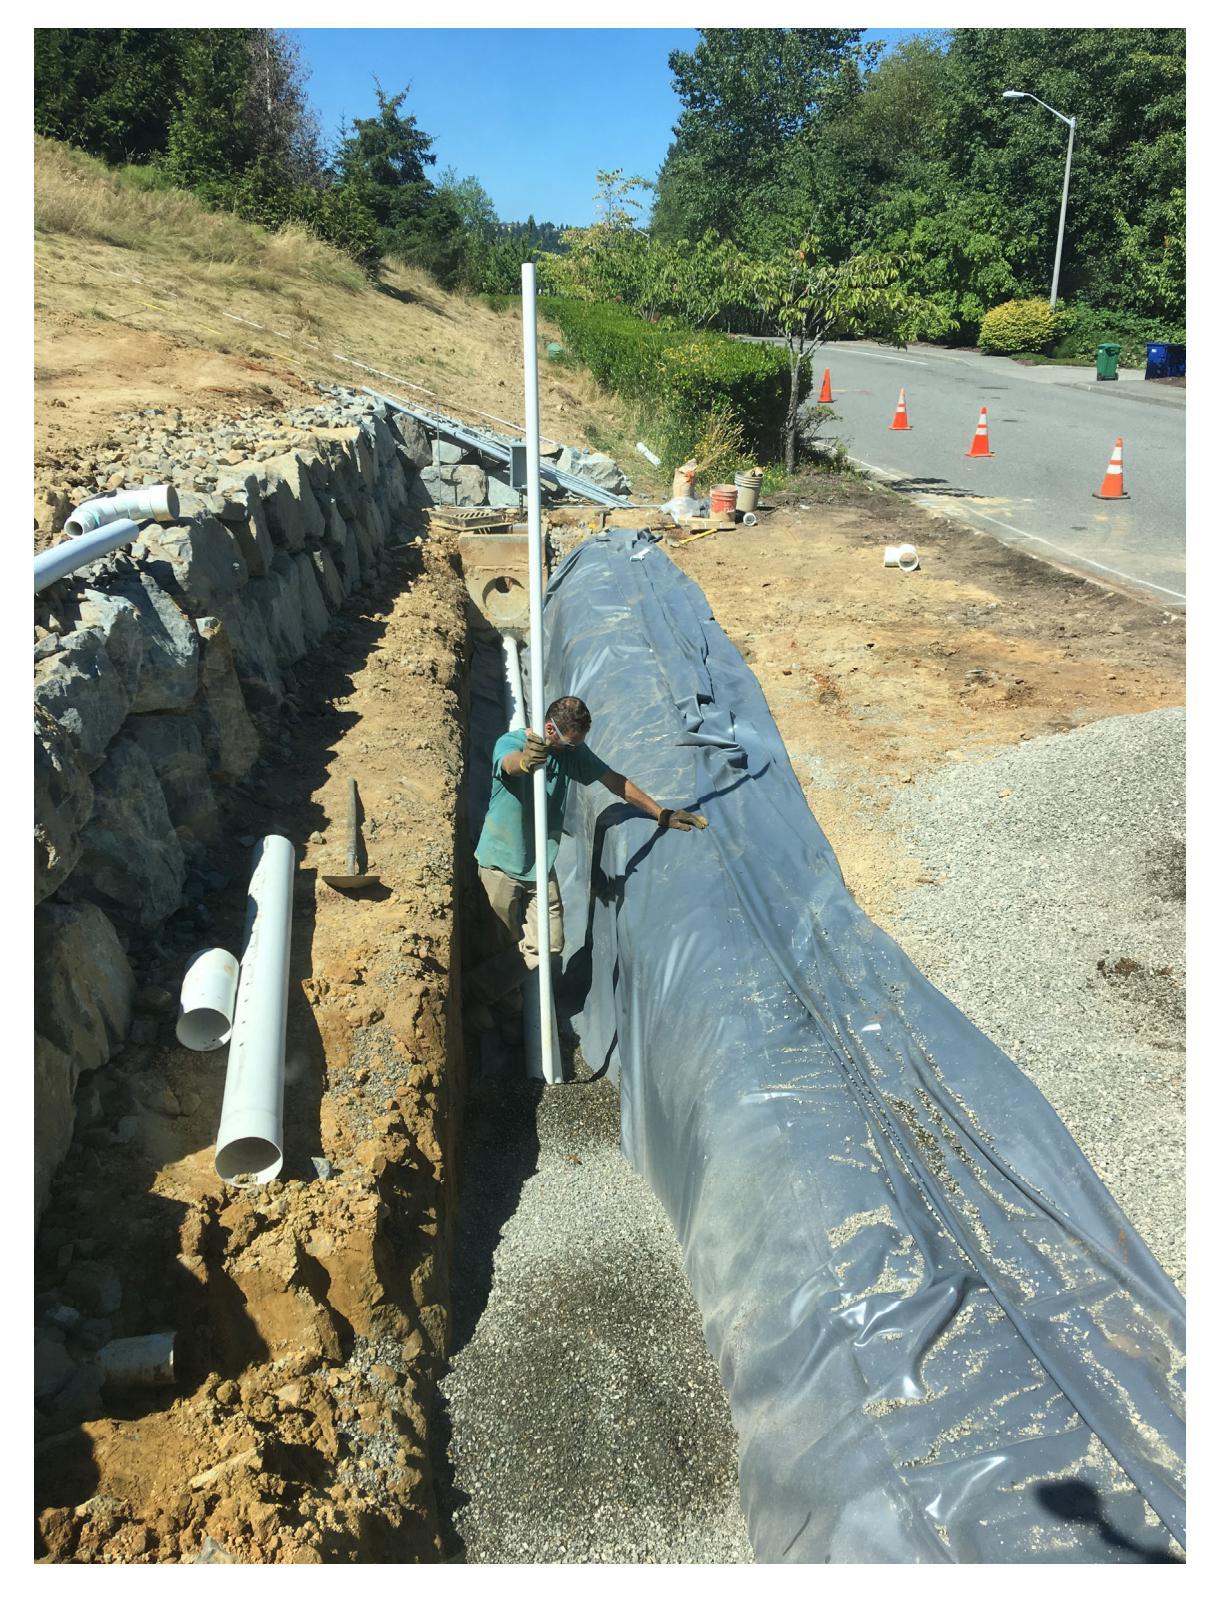
Gravel Backfill of Interception Trench (note rock wall drain pipe in lower left corner)

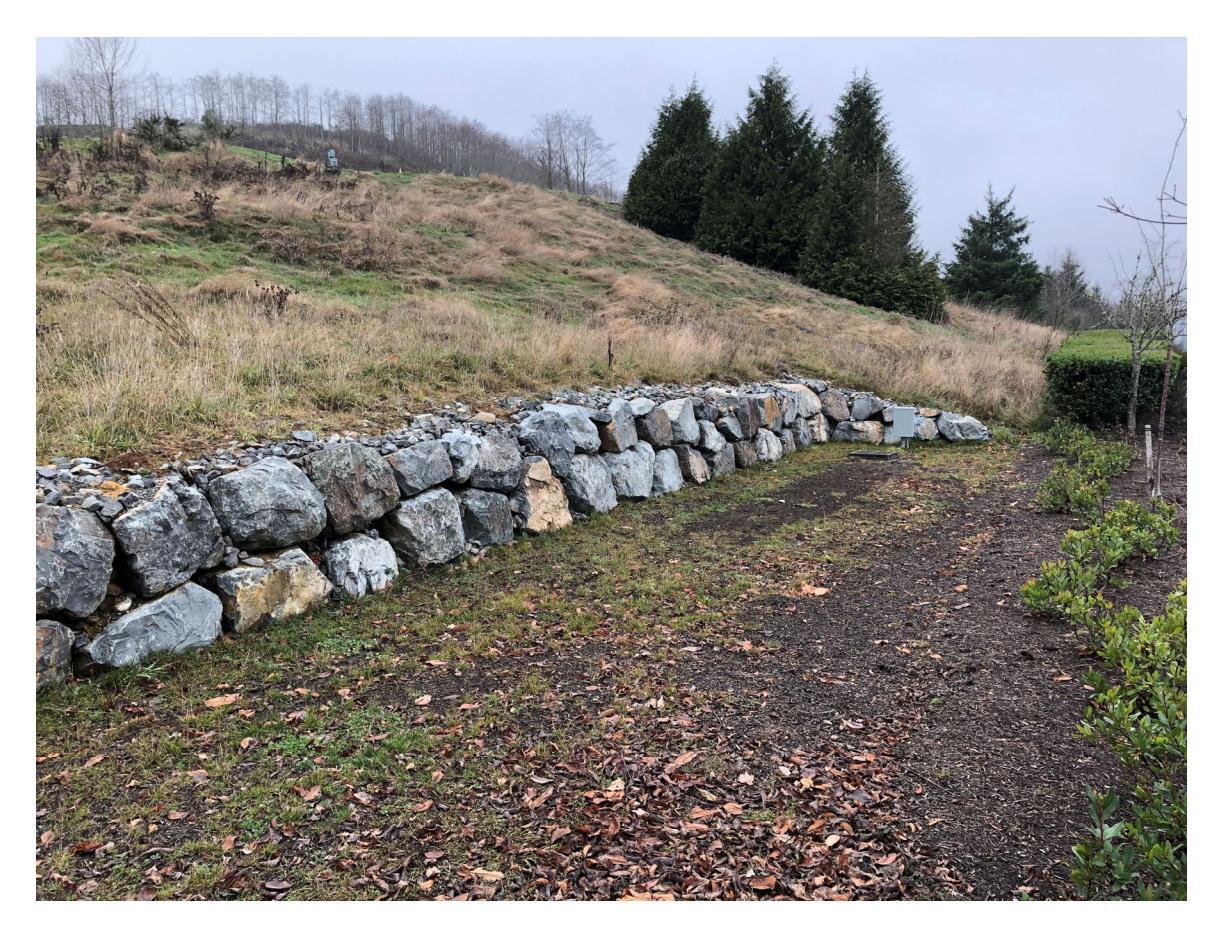
Completed Interception Trench (Dec. 5, 2019)

The system has been in operation for over a year to date. Two maintenance actions were undertaken last winter when the interception trench was not working. A new submersible pump was installed on one occasion and the discharge pipe was jetted to remove a blockage that plugged the discharge on the second.
