Subject: Petroleum Release Report Henningsen Cold Storage Co. 2025 Saint Street Richland, Washington 99352

This letter is to notify the Washington Department of Ecology (DOE) of a recent discovery of a petroleum release associated with a sub-floor heating system at our Richland, Washington facility. Henningsen Cold Storage Co. (Henningsen) operates a cold storage warehouse at 2025 Saint Street in Richland, WA, 99352, Benton County.

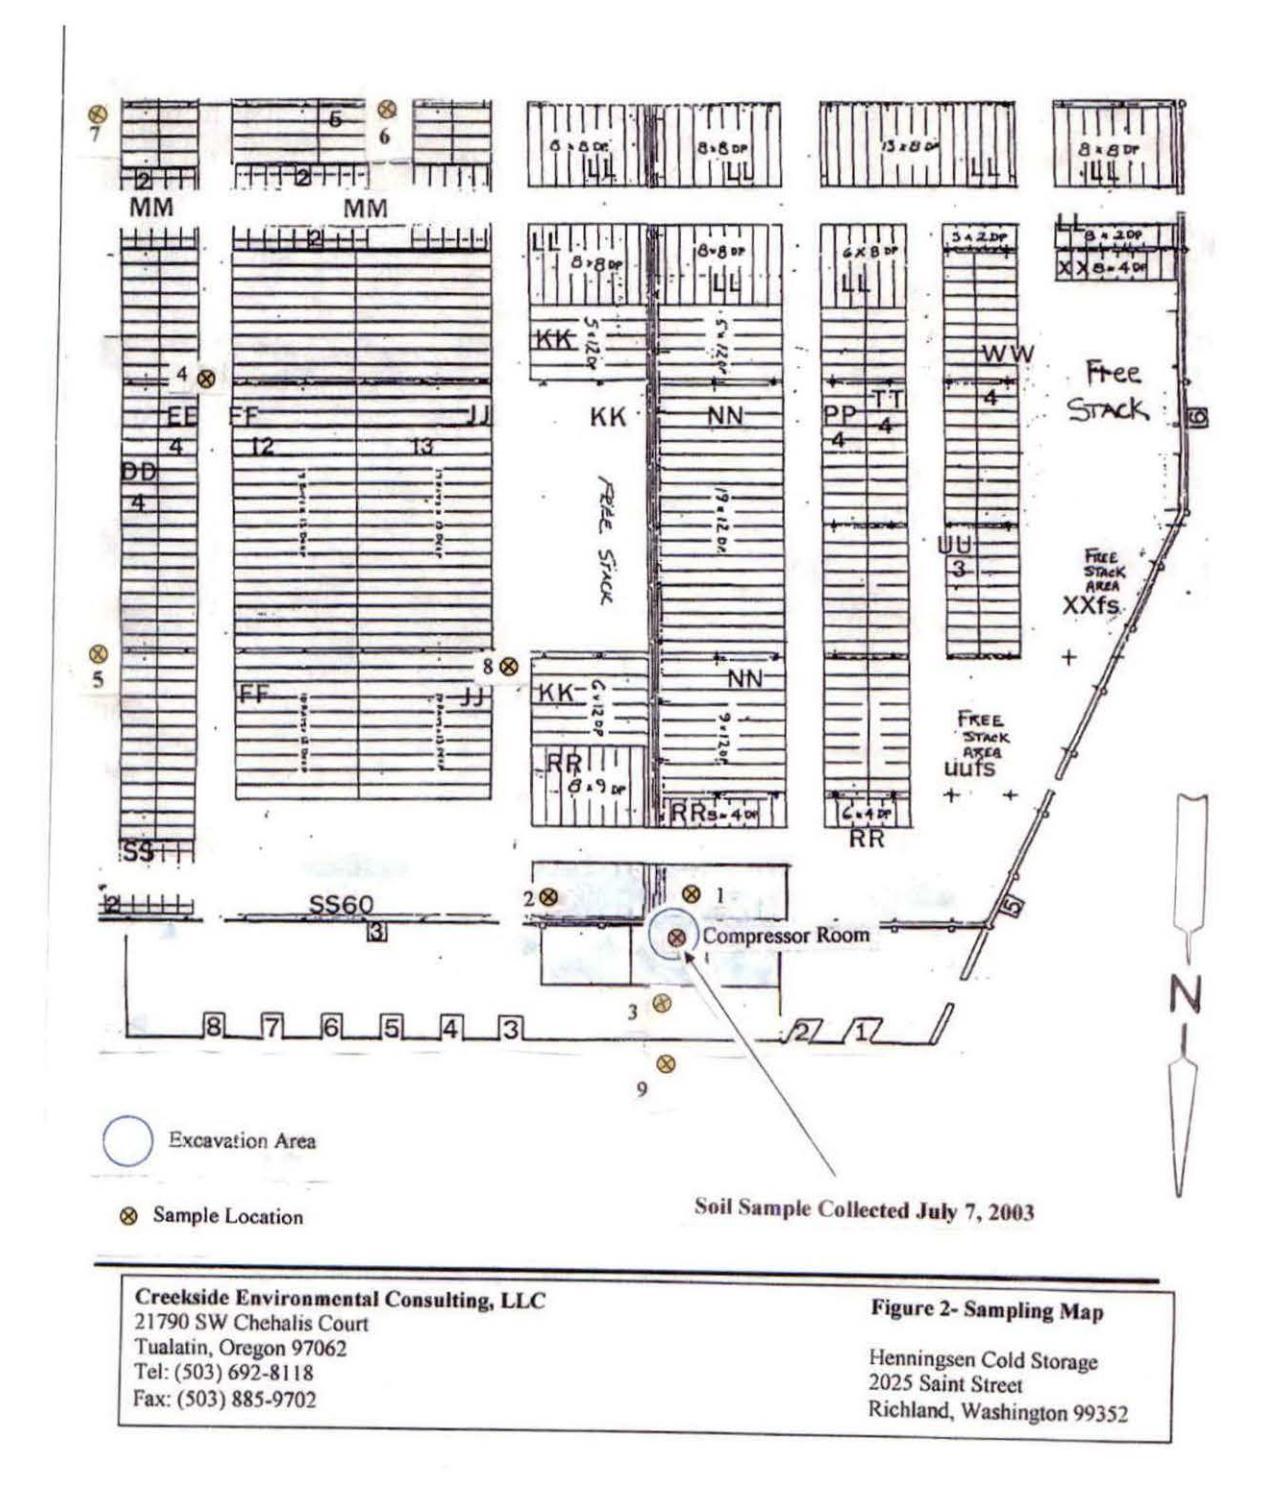
A confirmatory sample was collected by Creekside from the "worst case" area beneath the release area. This boring was hand augered on July 7, 2003 (sample location is not numbered but is shown

inside the excavation area in the compressor room, refer to Figure 2 attached). The sample was laboratory analyzed for total petroleum hydrocarbons using method NWTPH-Dx by Specialty Analytical Laboratory located in Tualatin, Oregon. Laboratory analysis indicated that the sample contained 17,300 parts per million (ppm) petroleum hydrocarbons in the diesel range (TPH-Dx). The sample was also analyzed for BTEX and PAHs. Benzene was not detected in the sample; naphthalene was present at 27.3 ppm.
