Alternative Bank Protection Methods for Puget Sound Shorelines

Ian Zelo, Hugh Shipman, and Jim Brennan

May, 2000

Ecology Publication # 00-06-012

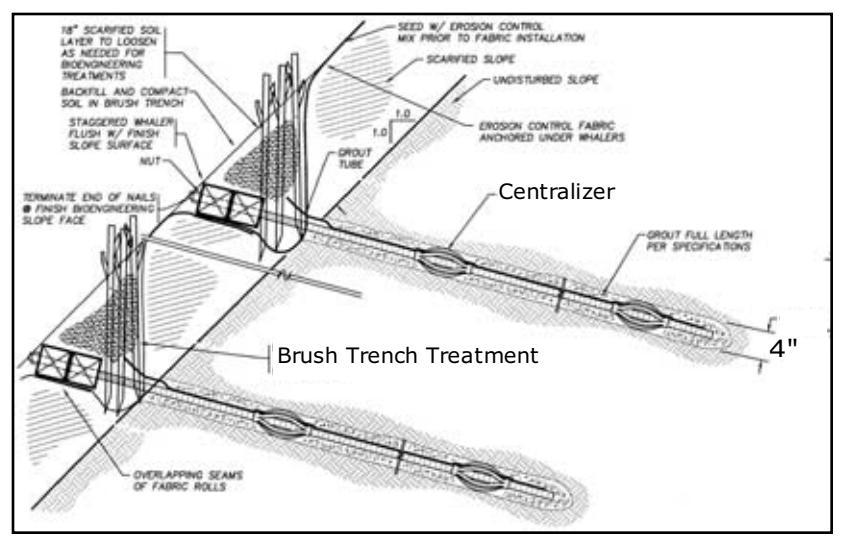
Detail: Soil Nailing

Soil nailing is the process of running re-bar into the slope to help hold it together. Holes were drilled back into the slope using a drill rig lowered down the bluff from a boom truck. These holes were 4" in diameter and ranged from 15-32' deep. The nails are epoxy-coated rebar with "centralizers" (4" donut-like spacers) placed every few feet to keep the nails in the

The soils on the site were glacially compacted and the slope is failing in blocks. Soil nails prevent this. At the face of the bluff each nail has a zone of support about 6-8' in diameter. The amount of support decreases depper into the slope. Similarly, the slope is under is the greatest pressure to fail at the face and becomes less stressed at depth. Nails are placed so that their areas of support overlap or touch at the slope surface (6' on center). The upper portion of the slope was secured using the following method.

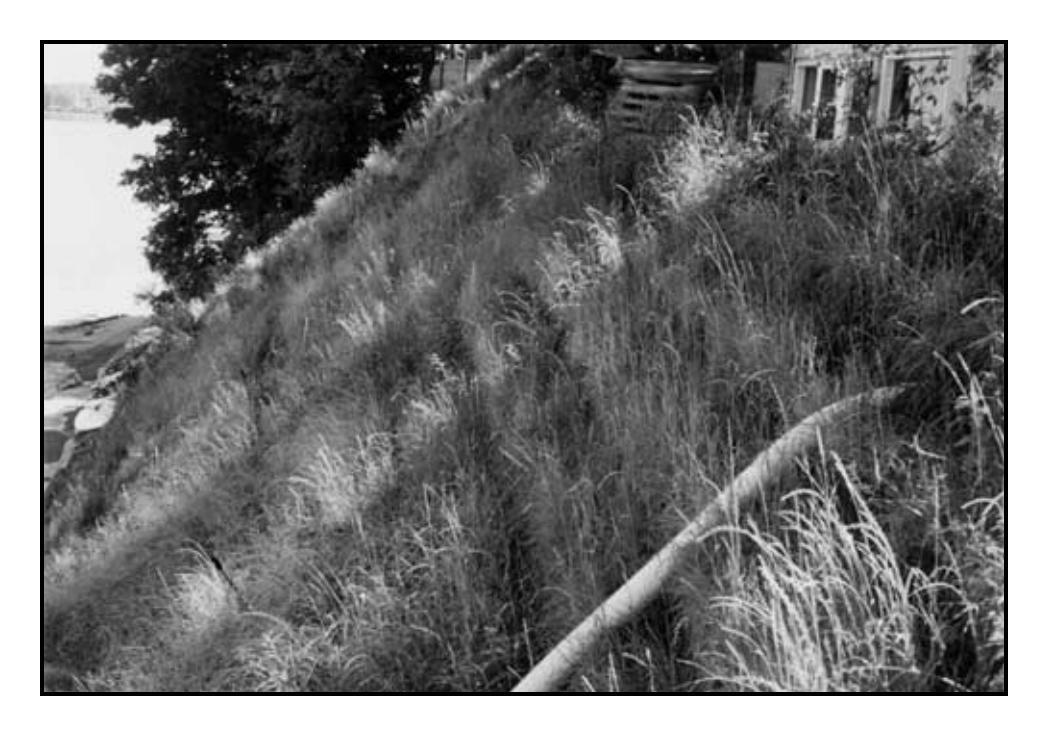
Figure 1. Vegetative slope stabilization. The bands of vegetation correspond to individual geogrid lifts. The hose in the foreground is part of new drainage system and flows into a diffuser behind the bulkhead.

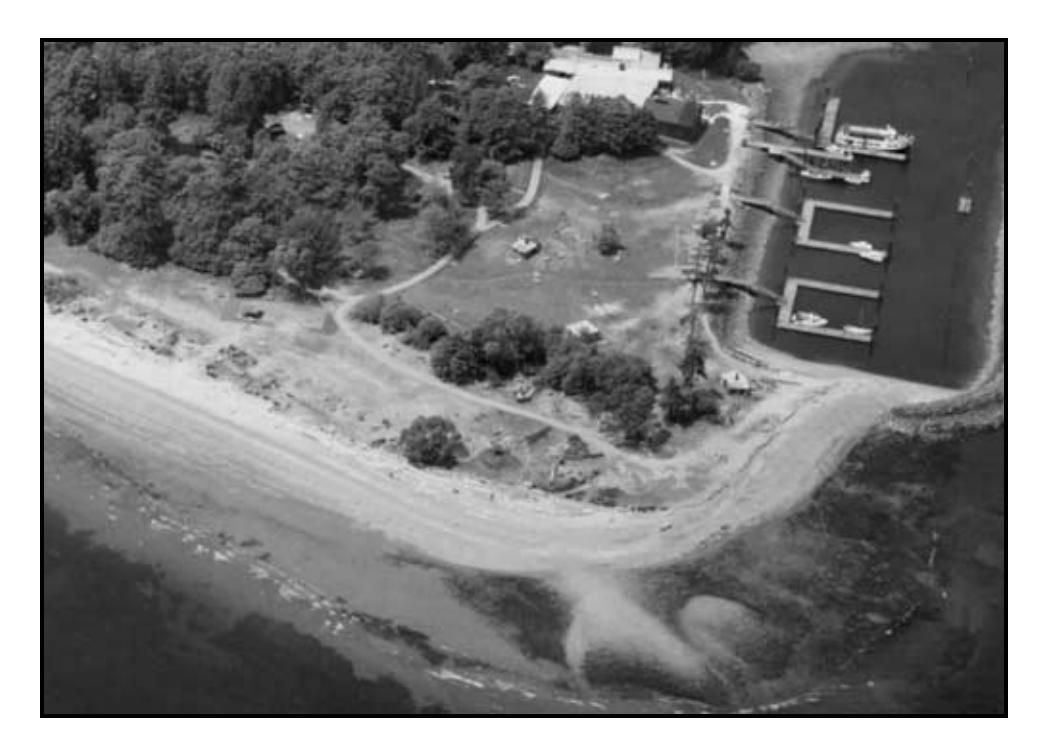
Figure 1. Aerial view of Blake Island site. *Photo: Ecology, KIT*#707, 5-20-1992.

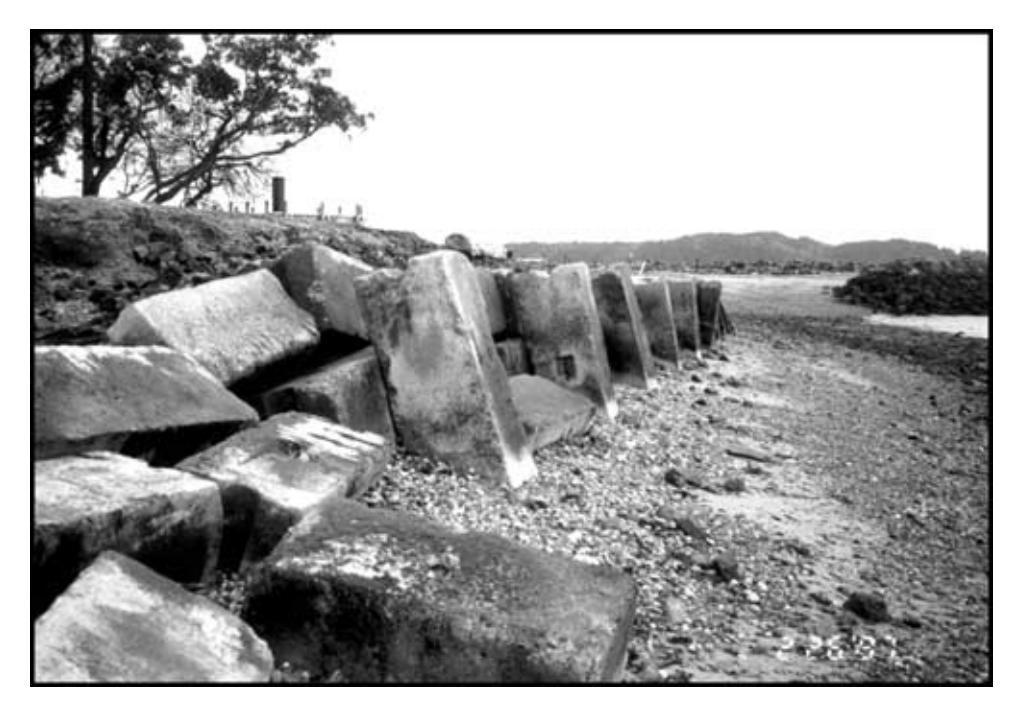
Figure 2. View northwest showing temporary "ecology block" erosion protection. Note significant damage done to temporary structure. Breakwater for boat basin is in background.
Blomquist Residence

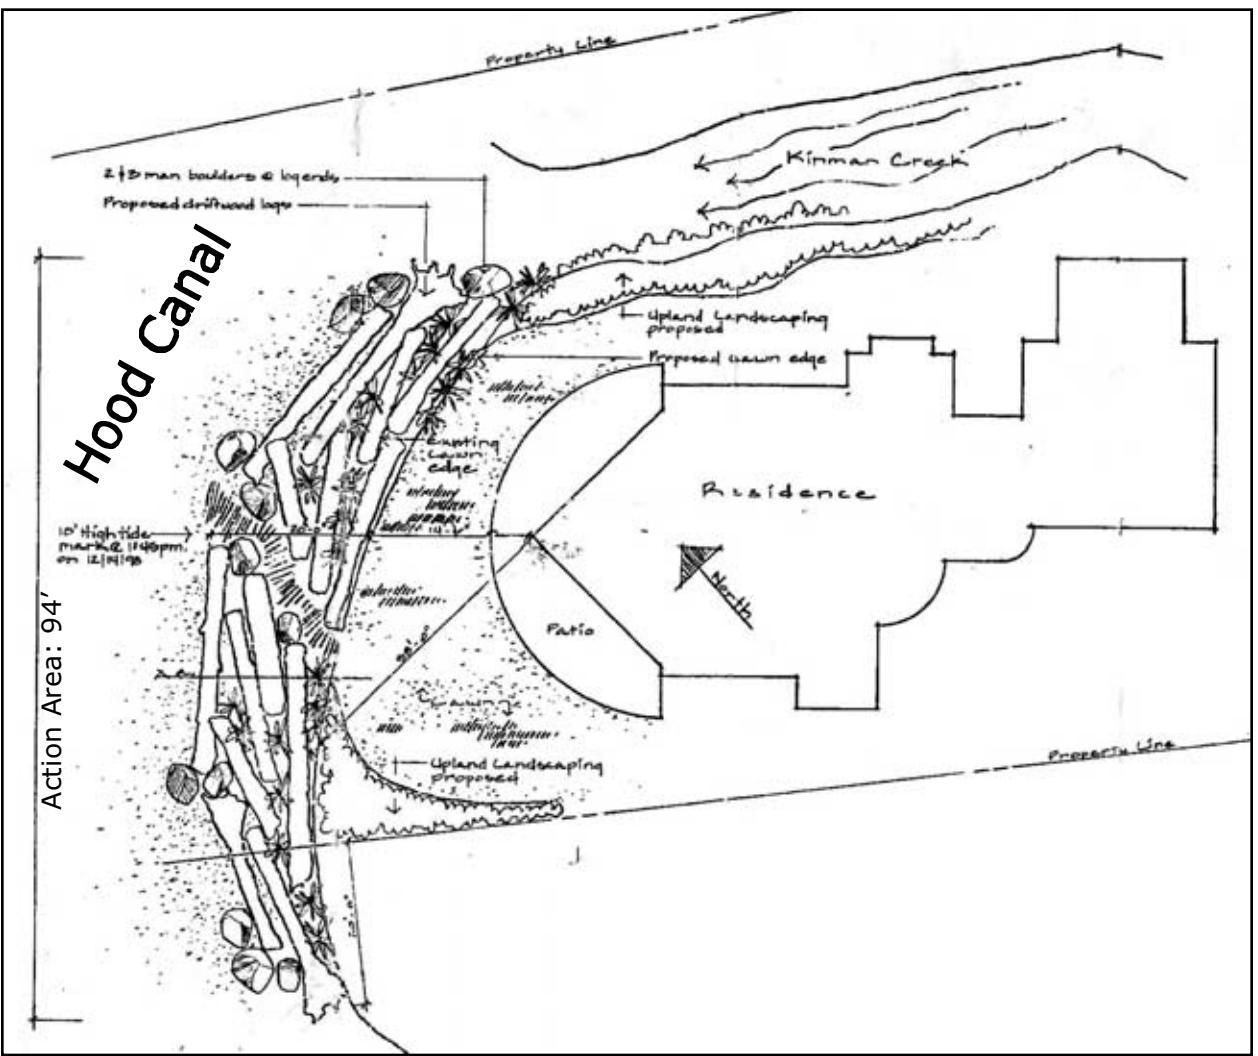
Site Plan: Blomquist Residence

The project area begins at Kinman Creek and stretches south for 94'. This extends the project area into the neighboring, undeveloped lot which the homeowner would like to purchase. The project entails filling the beach with a 7/8" gravel mix and anchoring coarse woody debris to dissipate wave energy and retain sediment. The logs are anchored with concrete parking curbs or ecology blocks depending on their size. The ecology block can be used on this site because access to the beach by heavy machinery is not limited and large blocks could be brought in. They allow the larger logs to be anchored with just two cables (4 curbs would have been needed). The owner was concerned that the cables would ruin the

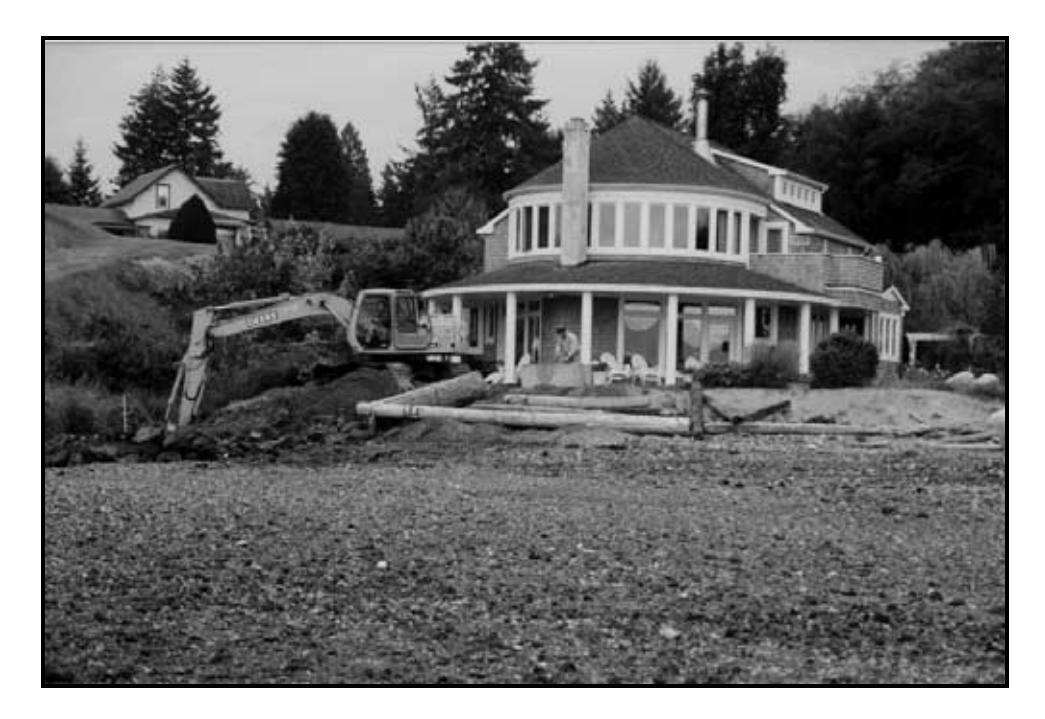
Figure 2. Construction. Note minimal setback and broad gravelly beach.

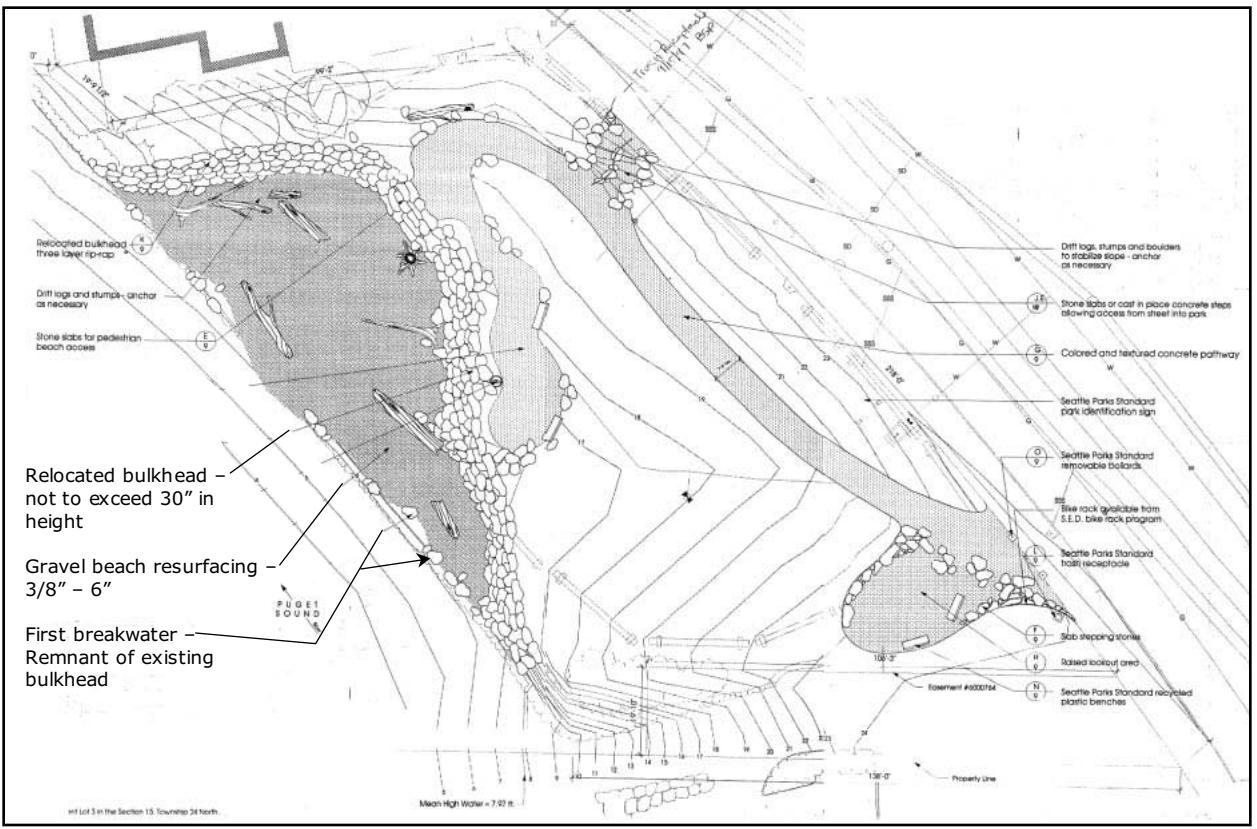
Site Plan: Cormorant Cove

The Cormorant Cove project will result in the creation of a perched, pocket beach by removing most of the existing bulkhead, reestablishing the bankline landward of the existing bulkhead, and adding sand and gravel to the regraded beach. The addition of a sloping, partially buried revetment along the bankline will be added to prevent further toe erosion, and woody debris will be incorporated into the beach to add stability and habitat structure. The bankline and uplands will be landscaped to include a path to the beach, a narrow vegetative buffer at the top of the bank, and lawn and landscape plantings on the upland portion of the site. A southern promontory will be maintained on the uplands as a view point and picnic

The project will begin by removing all but the lowest tier of the existing vertical rock bulkhead. This last level of rock, which is presently found below beach grade, will be left in place to act as a sill for the new pocket beach. A new rip-rap revetment will be built up to 45' landward of the present bulkhead. The structure will be no more than 30" tall and the face will be angled at a minimum of 2H:1V.

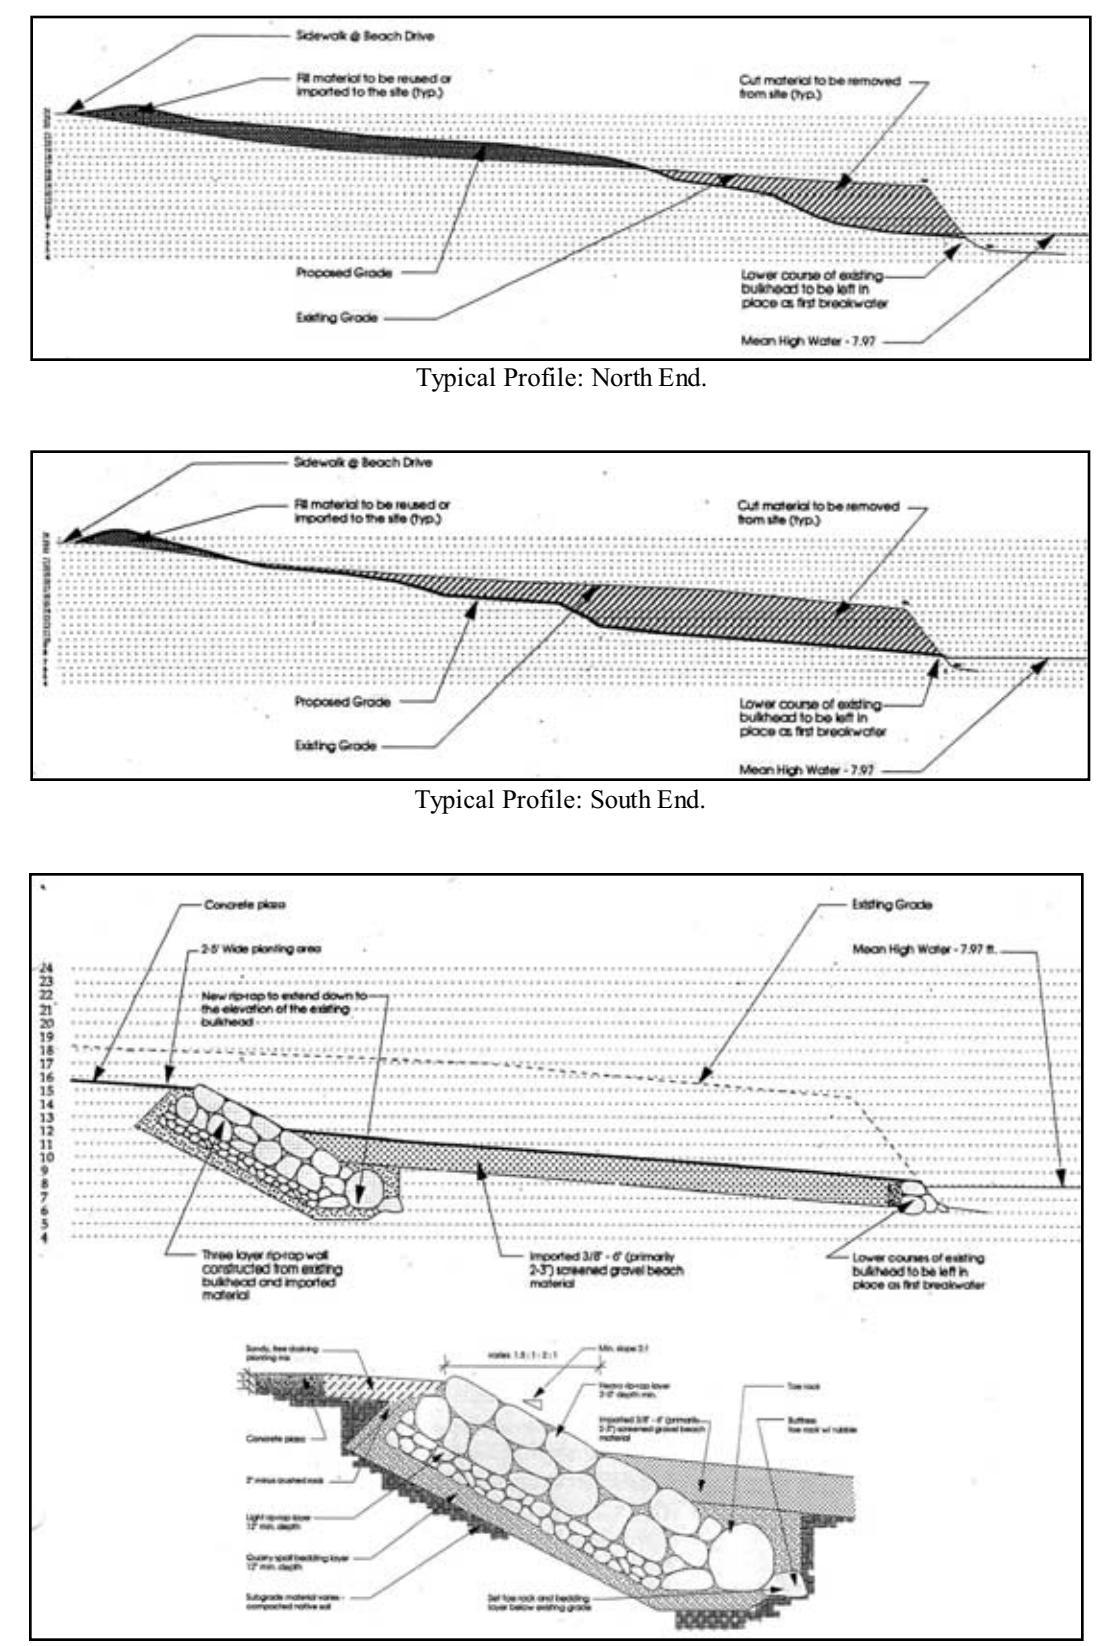
Rip-Rap Revetment: Three layer design with first breakwater

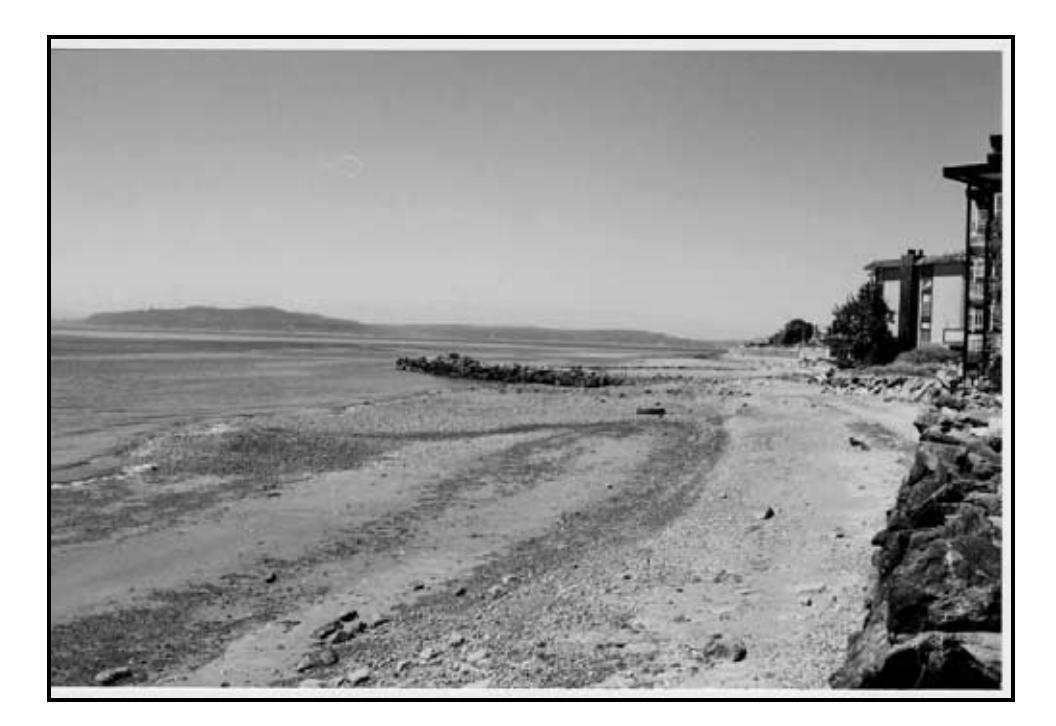
Figure 2. View to the north from 3701 Beach Drive, showing hardened shoreline and intrusion of bulkhead onto upper beach.

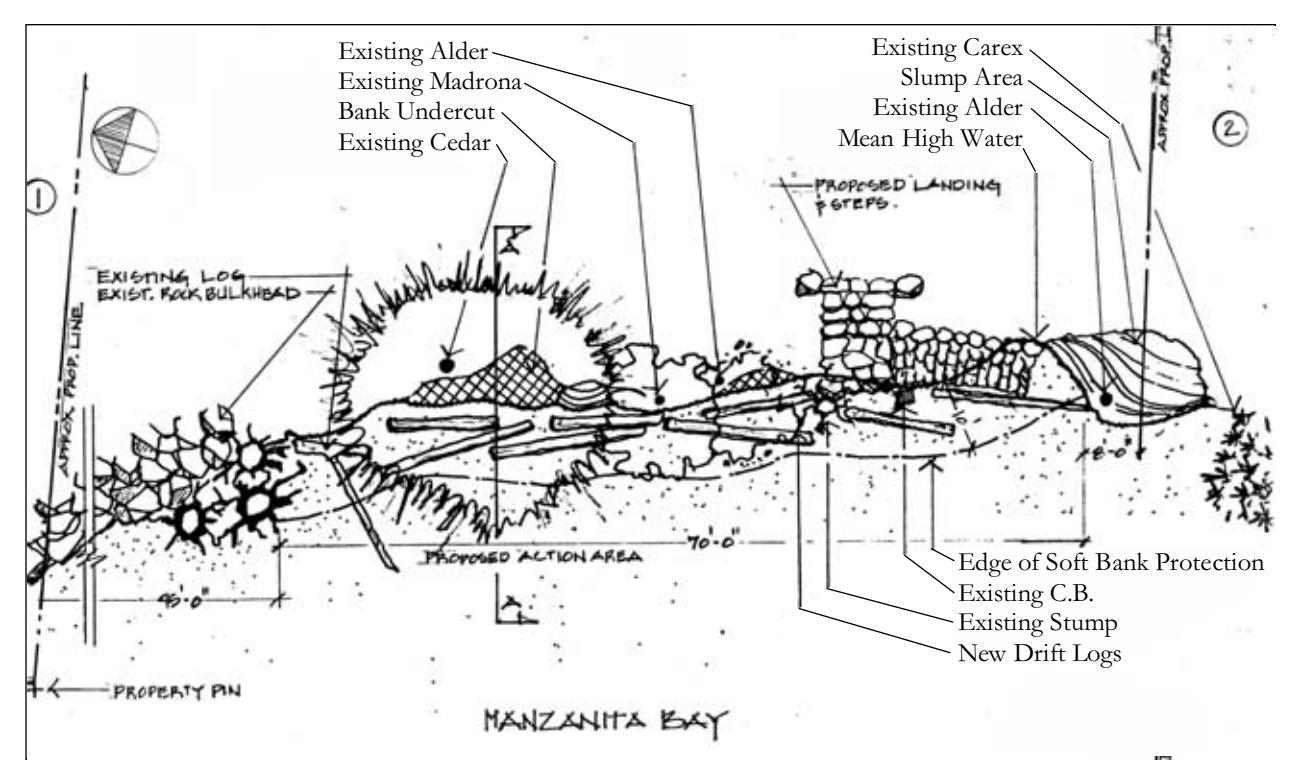
Dick Residence: Bird's Eye View of the Site.

Bainbridge Island. The steep, 14-foot bank is topped by several existing trees (cedar, madrone, and alder). An existing riprap revetment, placed as an emergency action for bank failure on the adjacent property several years earlier, lies to the north.

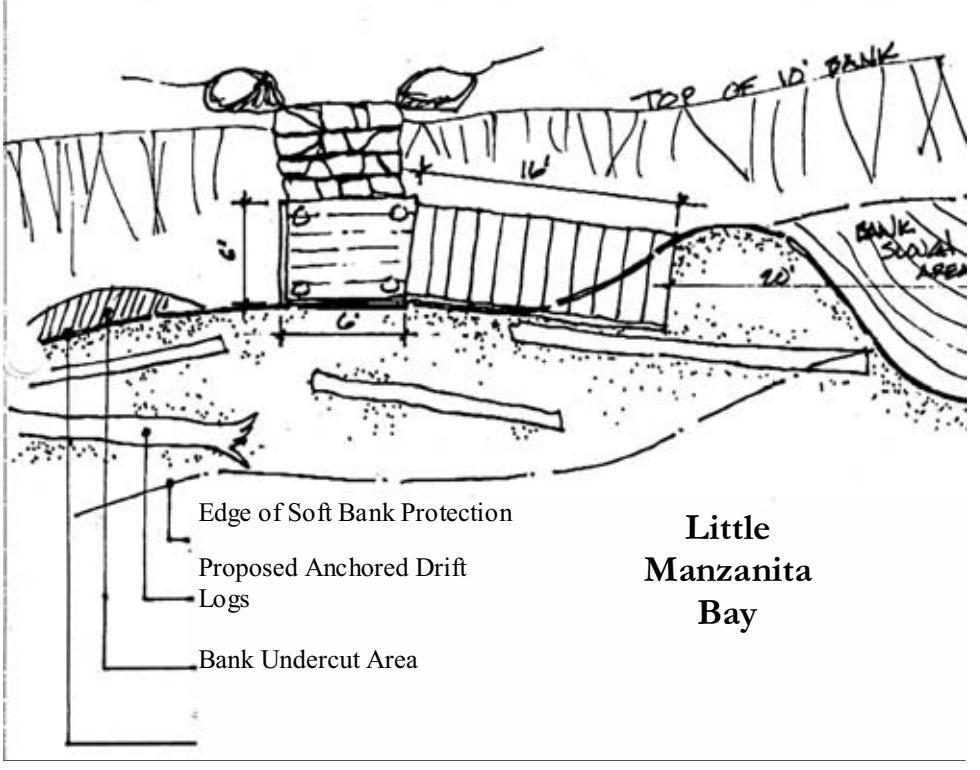
Dick Residence: Project Proposal

The project was constructed in several stages. The undercut areas were protected with geotextile and hand-packed 4-6 inch basalt quarry spalls. Bank protection was accomplished by burying and anchoring logs into the beach. The beach and spalls were then capped with sand and gravel that slightly increased beach slope and elevation. The logs helped retain the beach sediment. American dune grass (*Elymus*) was planted to help stabilize the upper portion of the beach and the toe of the bank.

colluvium was lined with quarry spall and gravel to dissipate wave energy and reduce erosion. Finally, a rock stair was added to provide the homeowner access to the beach.

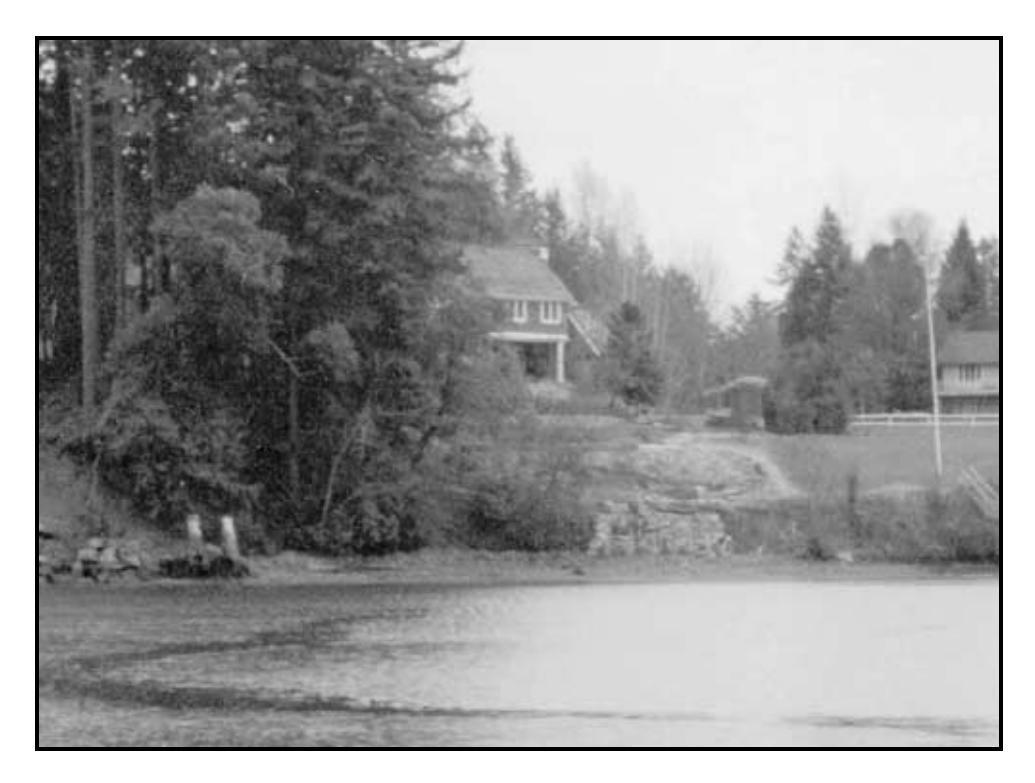
Figure 1. The Dick residence is sited well back from the water and trees north of the house were left. The riprap bulkhead on the north end of the site was installed by neighbors as an emergency measure prior to construction of the Dick's home (*Photo: Jim Brennan*).

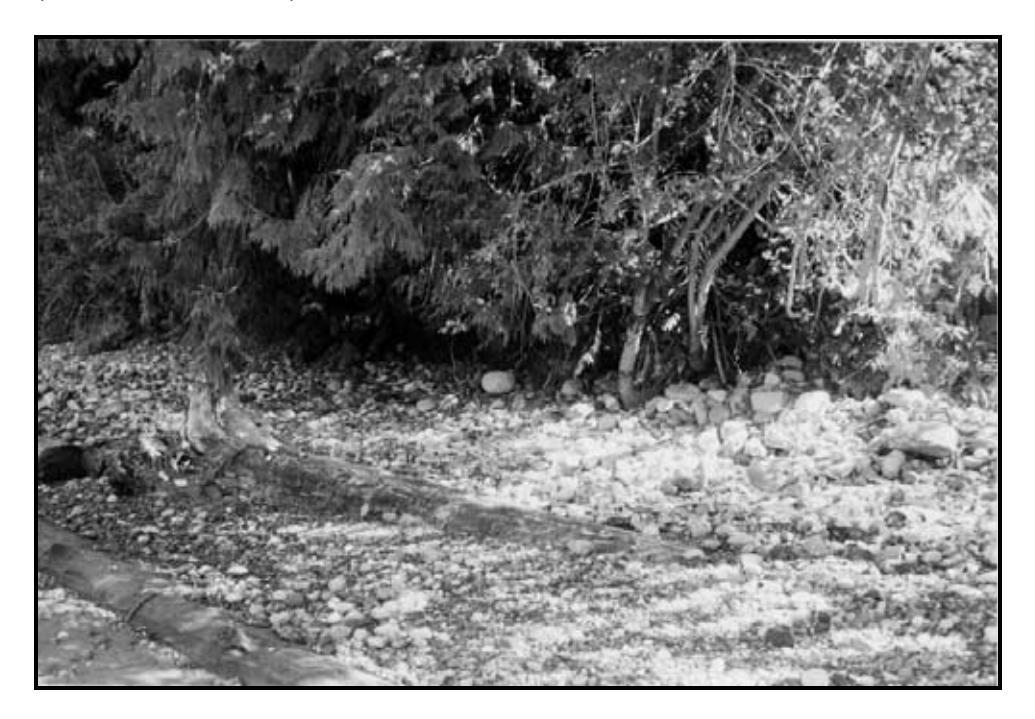
Figure 2. The toe of the bank had been undercut prior to construction. Quarry spall was placed in undercut area and logs anchored into the beach. Anchor cables are just visible.

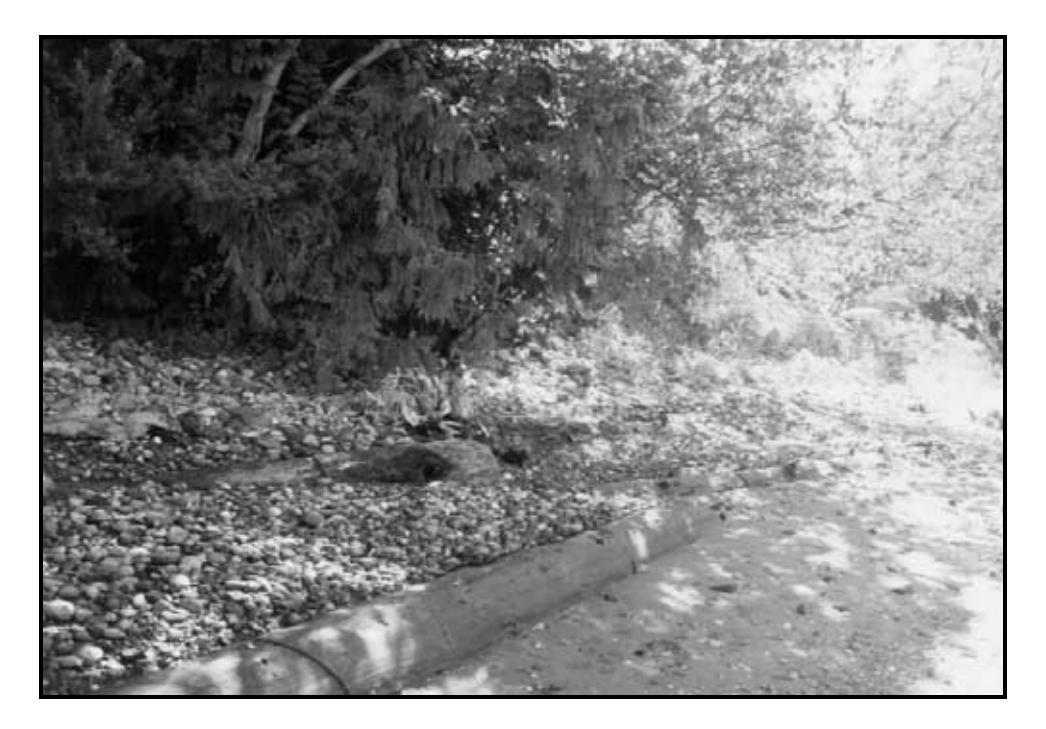
Figure 3. View southeast along beach shows anchored logs and added gravel. Compare to Figure 4 below of property to the north.

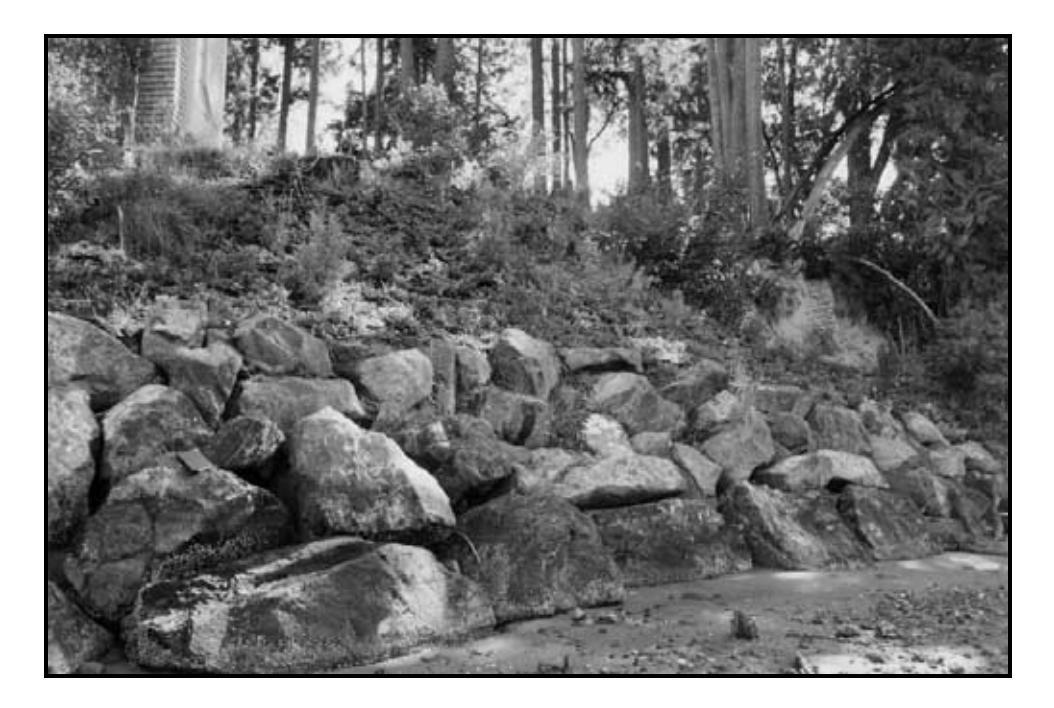
Figure 4. Riprap bulkhead/revetment located on northern end of Dick property and neighboring property.

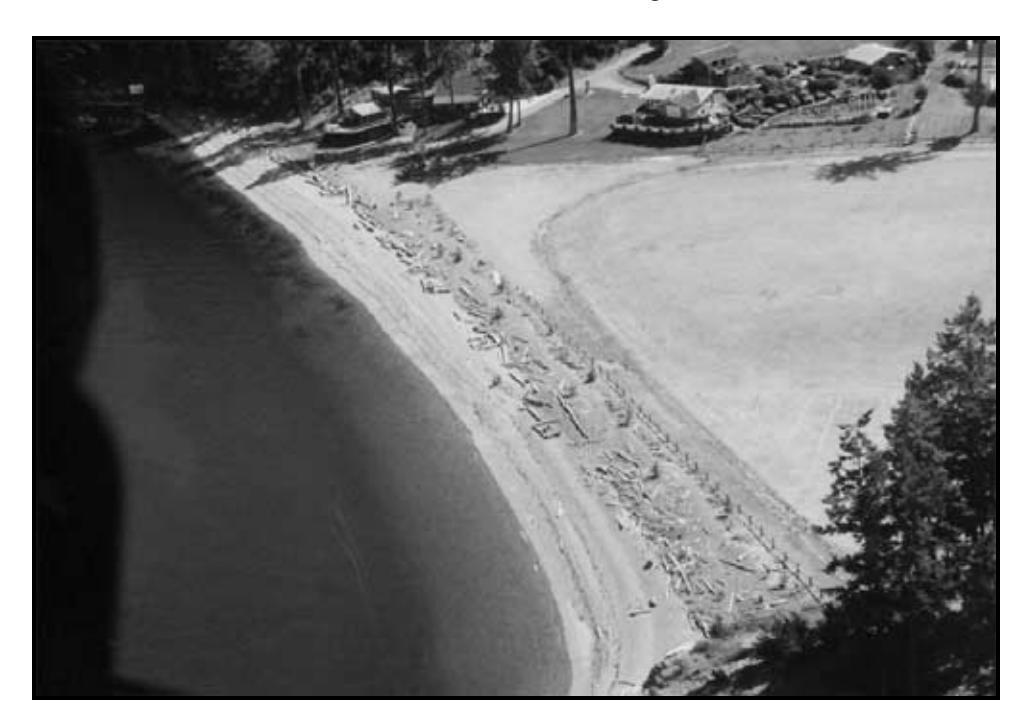
Figure 1. Aerial view of Driftwood Beach. Upland revegetation and restoration extends entire length of beach, whereas beach nourishment was limited to area indicated by arrows. Lawn area on right side of photo was marsh prior to filling several decades ago.

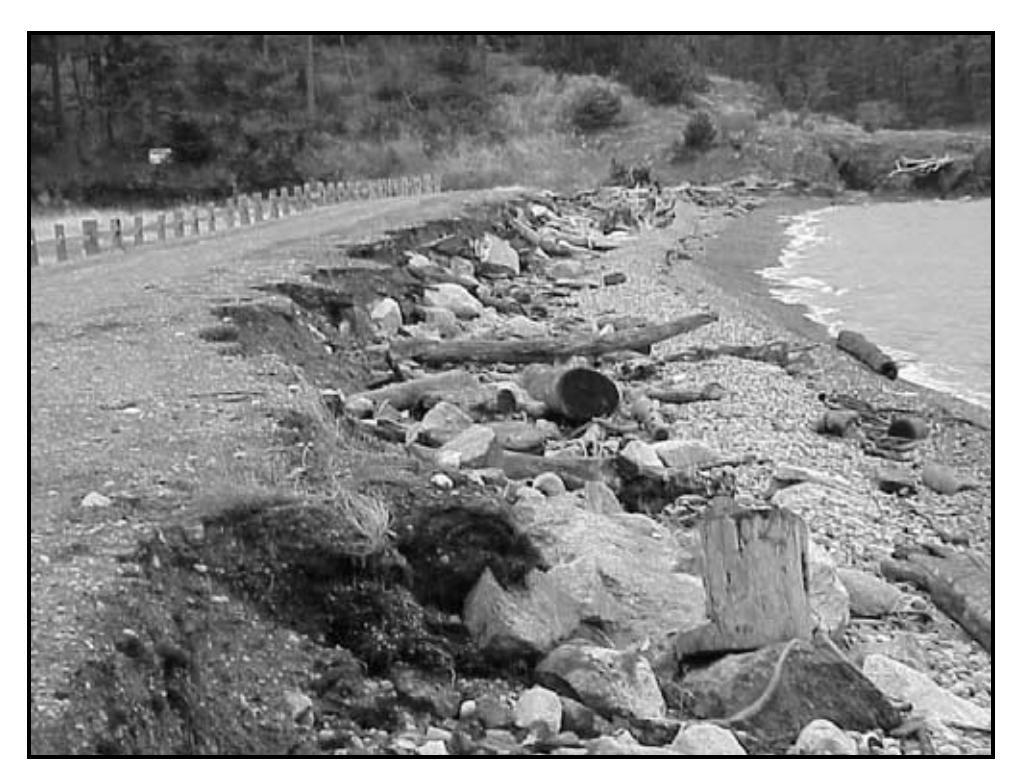
Figure 5. View north of project area prior to construction, showing erosional scarp in old fill, damage to road, and riprap (*Photo: provided by Jim Johannessen, Coastal Geologic Services, and Blakely Island Maintenance Commission*).

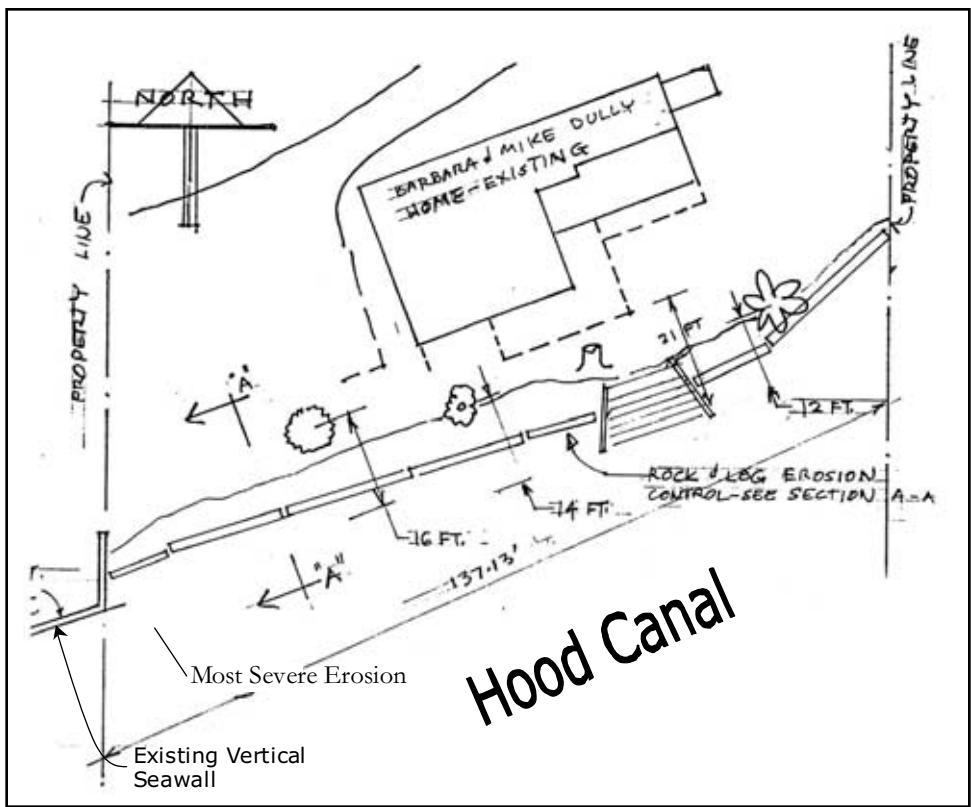
Dully Residence: Site Plan

The rock revetment is about 10' wide and was cut into the beach. It begins where the beach surface is at +11.8' and ends at +14'. The bottom of the revetment is approximately level at the +10' elevation. At +11.8' the revetment it is cut in two feet into the beach and by +14' the revetment is 4' beneath the sand. After placement the rock was covered with six inches of gravel and the beach was brought back up to its original grade. This structure runs for almost the entire width of the property.

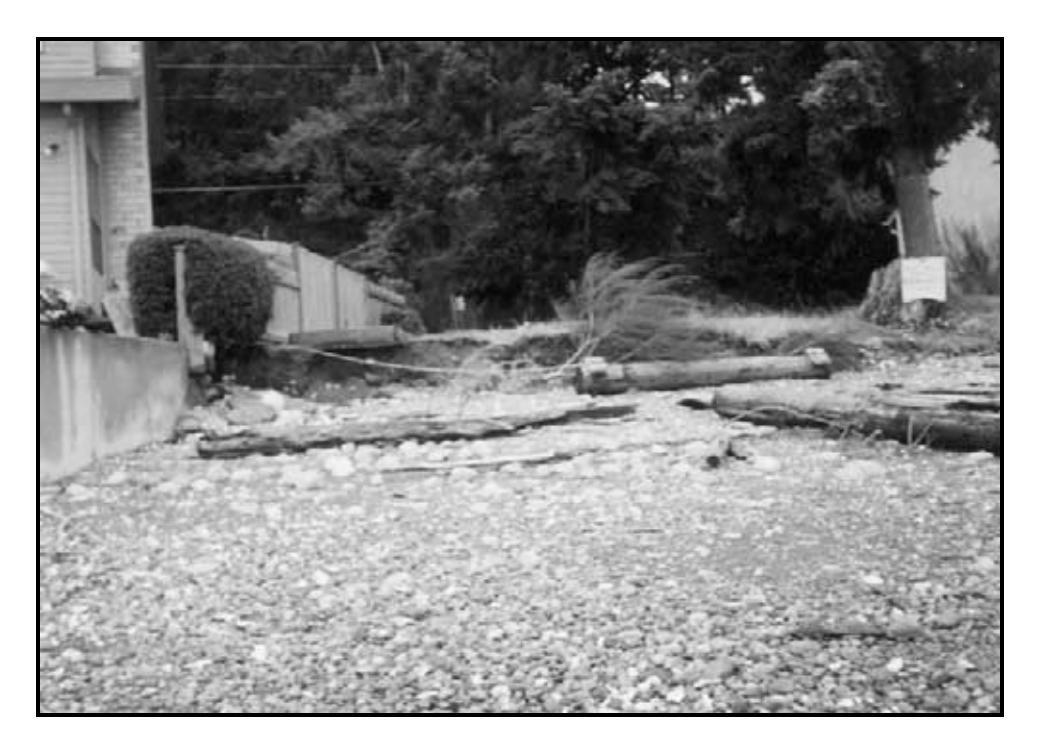
Figure 1. West end of site prior to construction. Note significant scarping and the amount of the neighboring bulkhead's wing wall that is exposed.

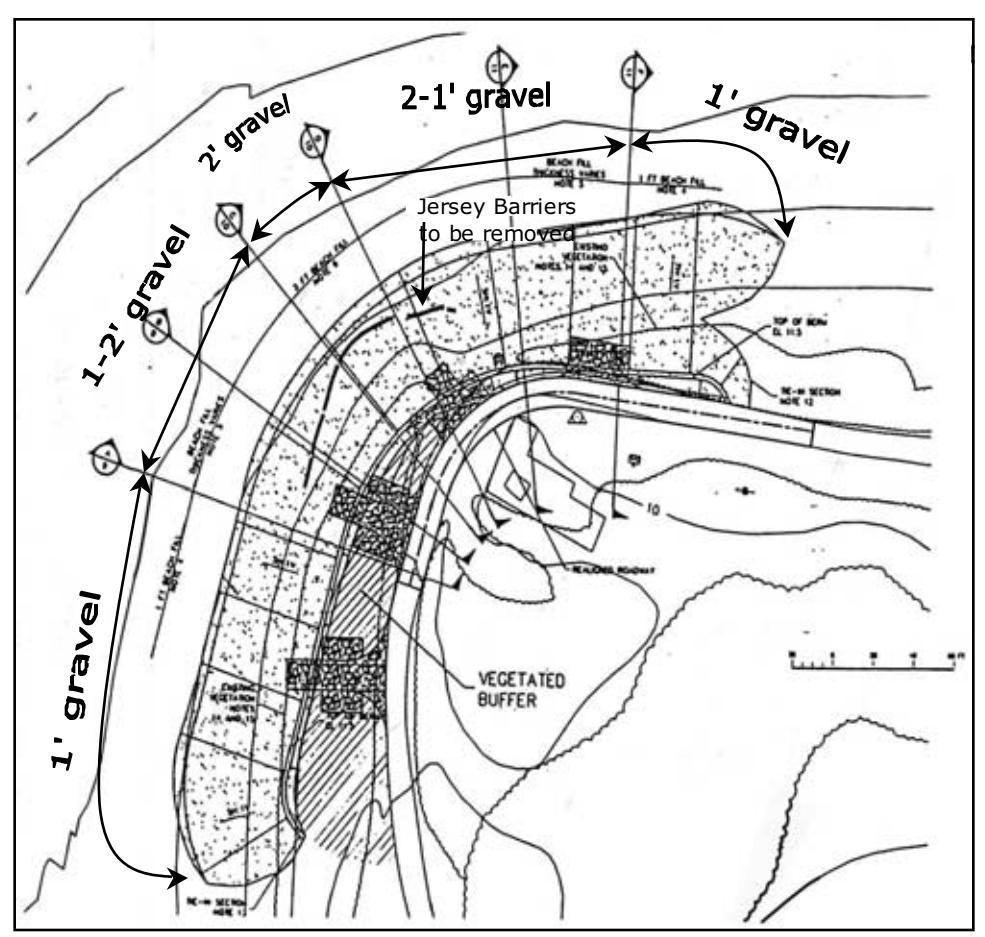
Site Plan: Floral Point, Bangor Submarine Base

The purpose of the upland fill was to cap the contaminated soils to prevent any possible future contact with the hazardous material and create a marsh habitat. A one-foot thick cap was built over the former landfill. It consisted of a 2832 yd³ of topsoil mix that was compacted in 4-inch layers. When the cap was in place, 200 yards of mulch ere spread on the surface and 5100 plants were used to vegetate the berm and build a wetland area.

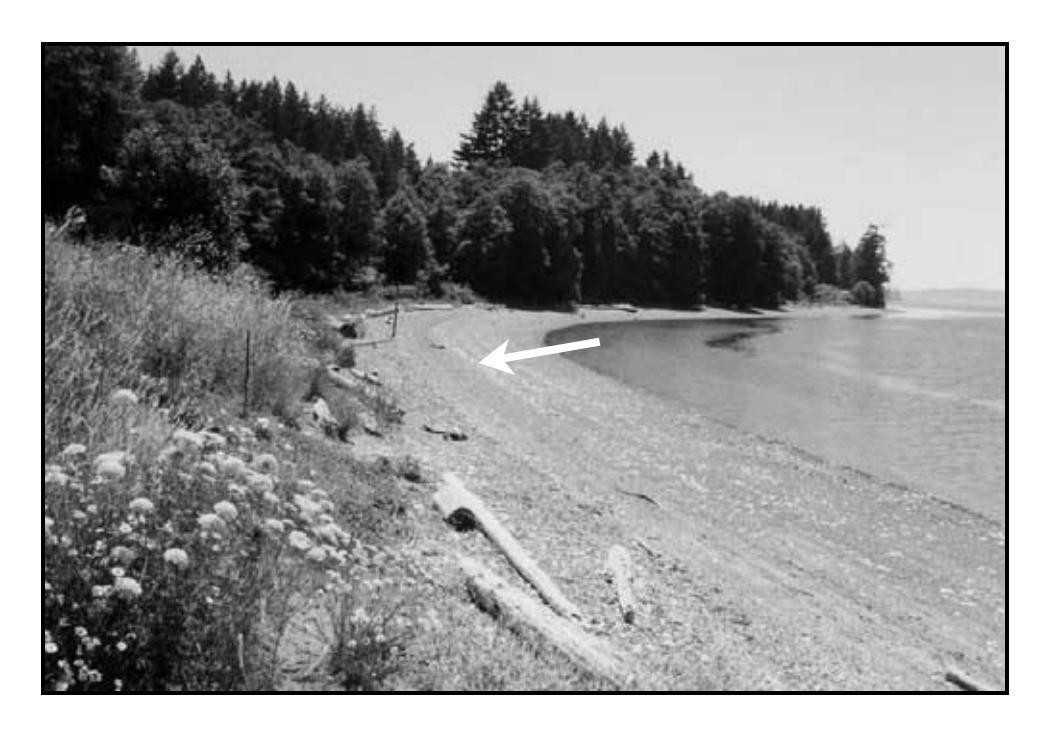
Figure 1. Southwest facing portion of site. Southern limit of project area is marked with arrow.

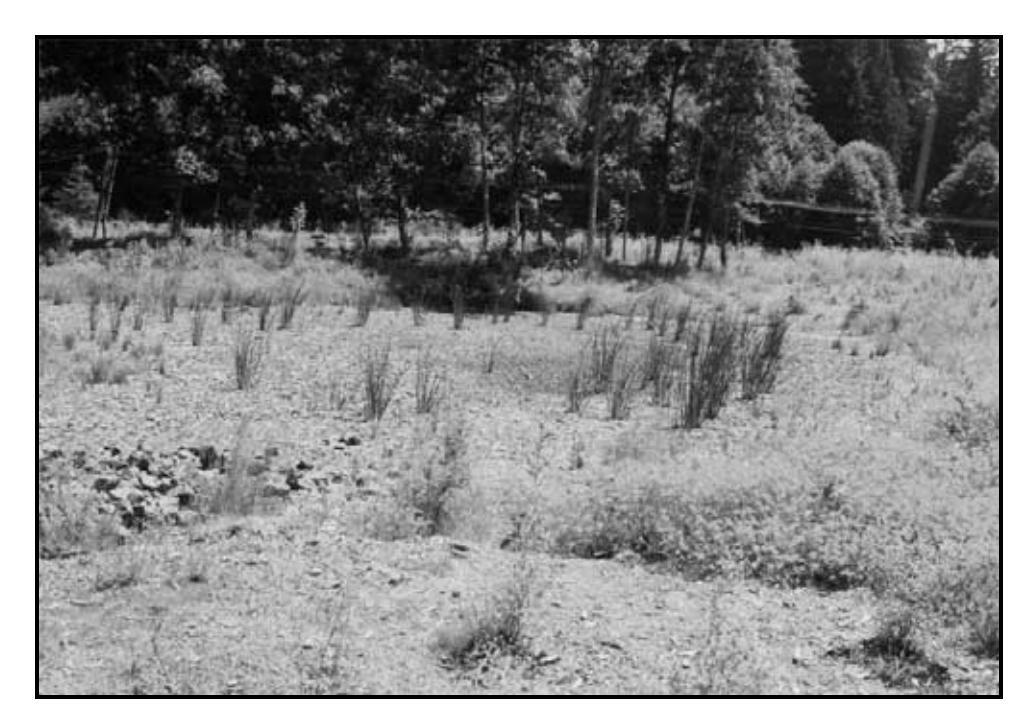
Figure 3. Wetland reconstruction on cap. This area was relatively dry when photos were taken (July), but the area in the center is wet and marshy earlier in the year.

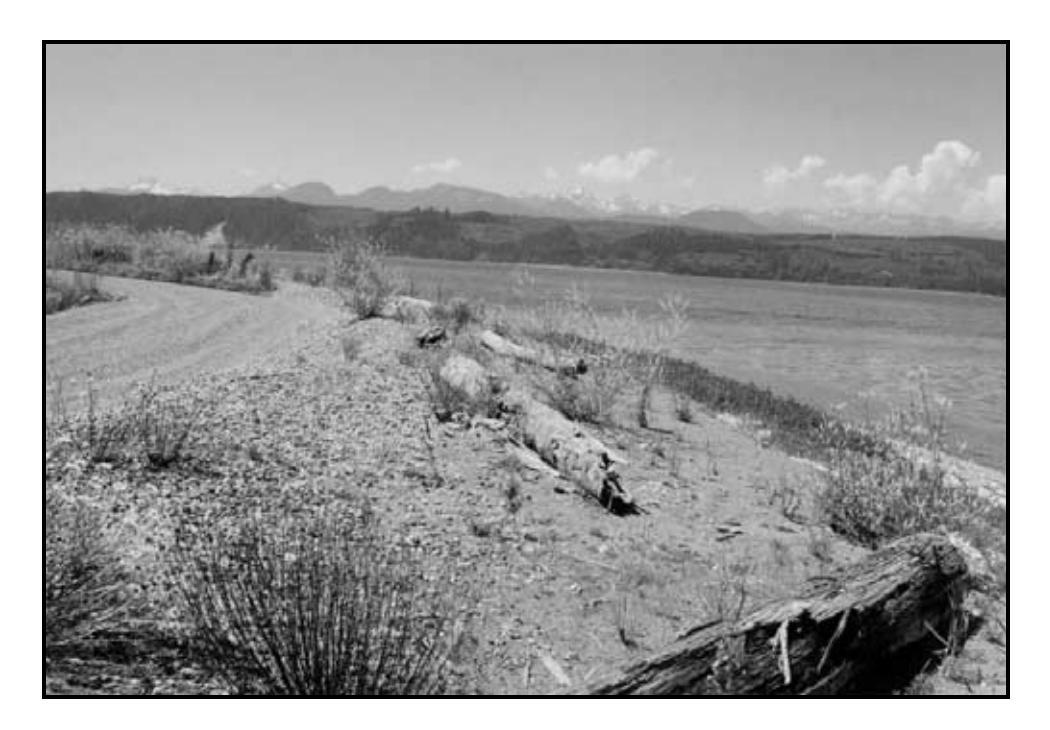
Figure 4. Slope and backshore with road. The position of the road affected the overall design of the project and the grade chosen for the upper beach.

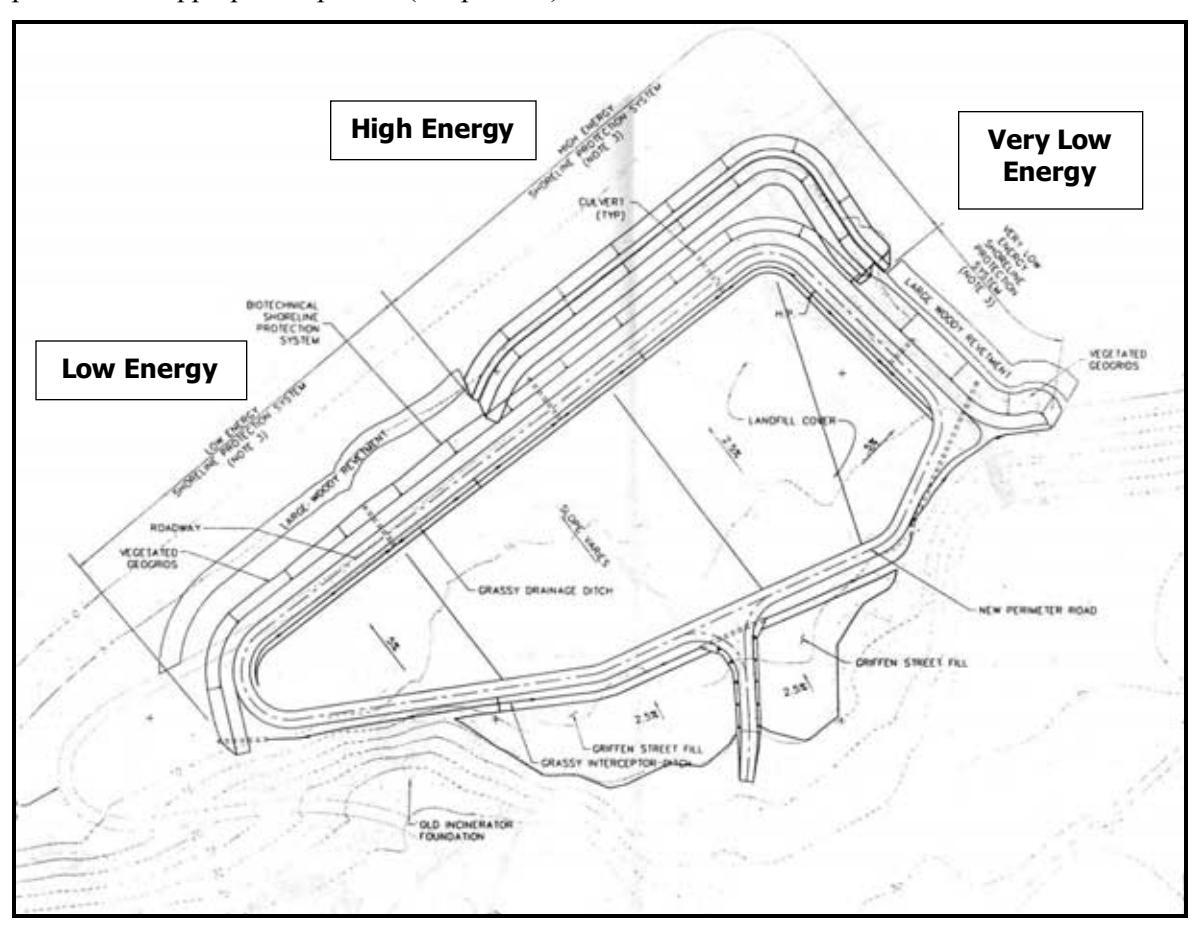
Site plan, showing areas of different wave exposure.

<u>Very Low Energy</u>: The final section, adjacent to the tidal lagoon, is very similar to the low energy solution. It differs in that it uses a larger quarry spall toe and has reduced quantities of woody debris.
