Alternative Bank Protection Methods for Puget Sound Shorelines

Ian Zelo, Hugh Shipman, and Jim Brennan

May, 2000

Ecology Publication # 00-06-012

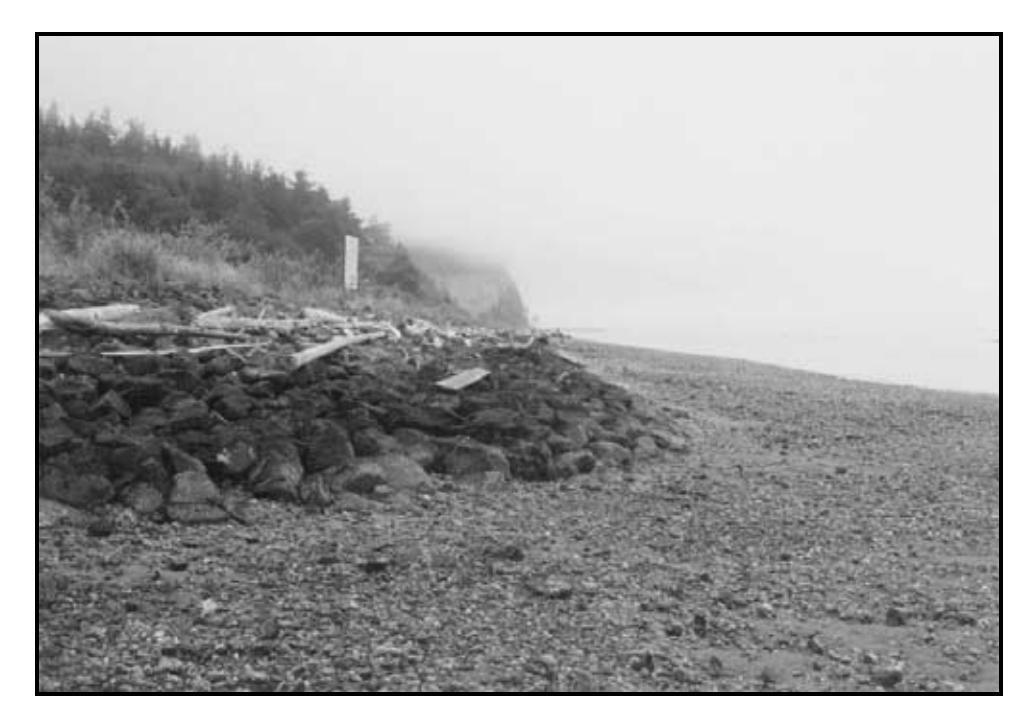
Photo 2. View southwest from northern end of project. A rock revetment is used in the high energy zone.

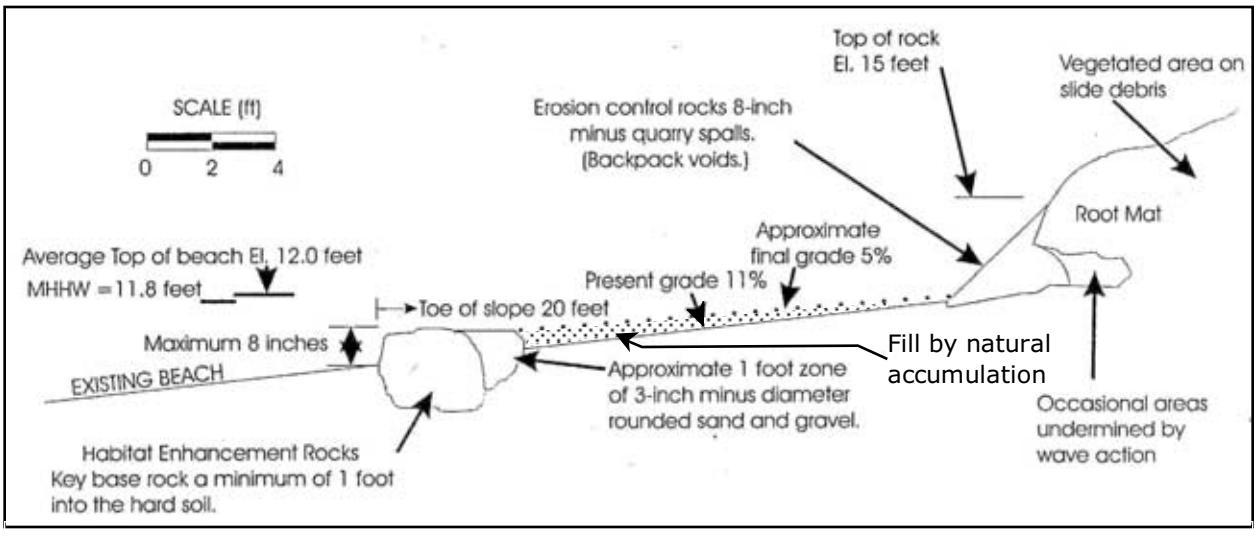
Profile: West end of the site - toe protection and habitat enhancement rocks

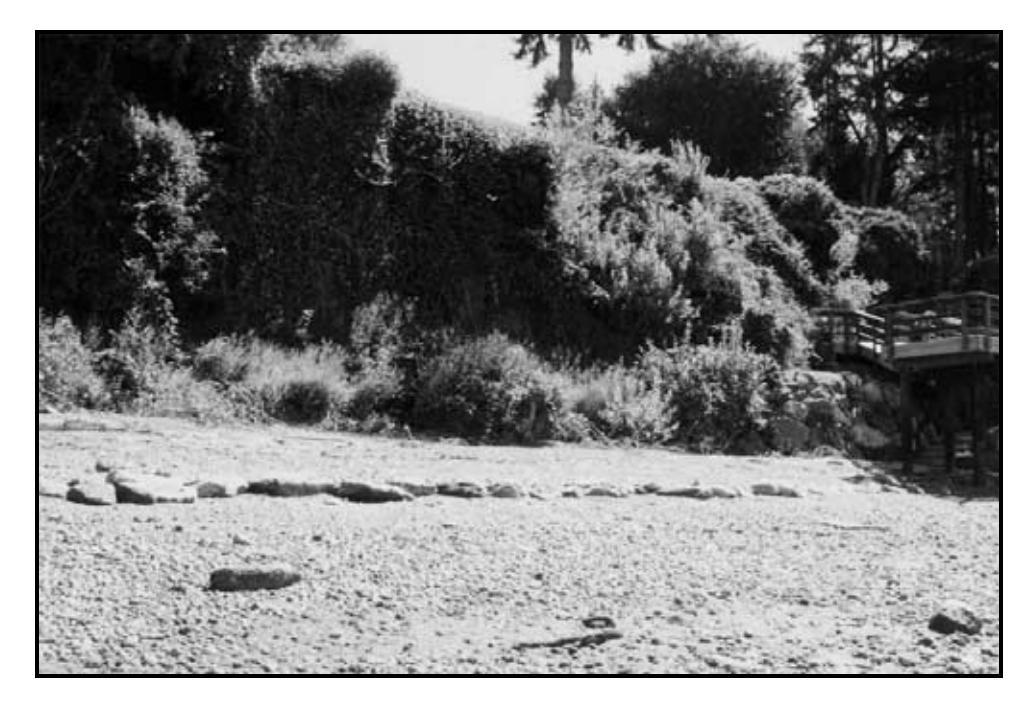
Figure 1. View of Odermat site showing bluff, base of pier, and row of rocks buried in the beach.

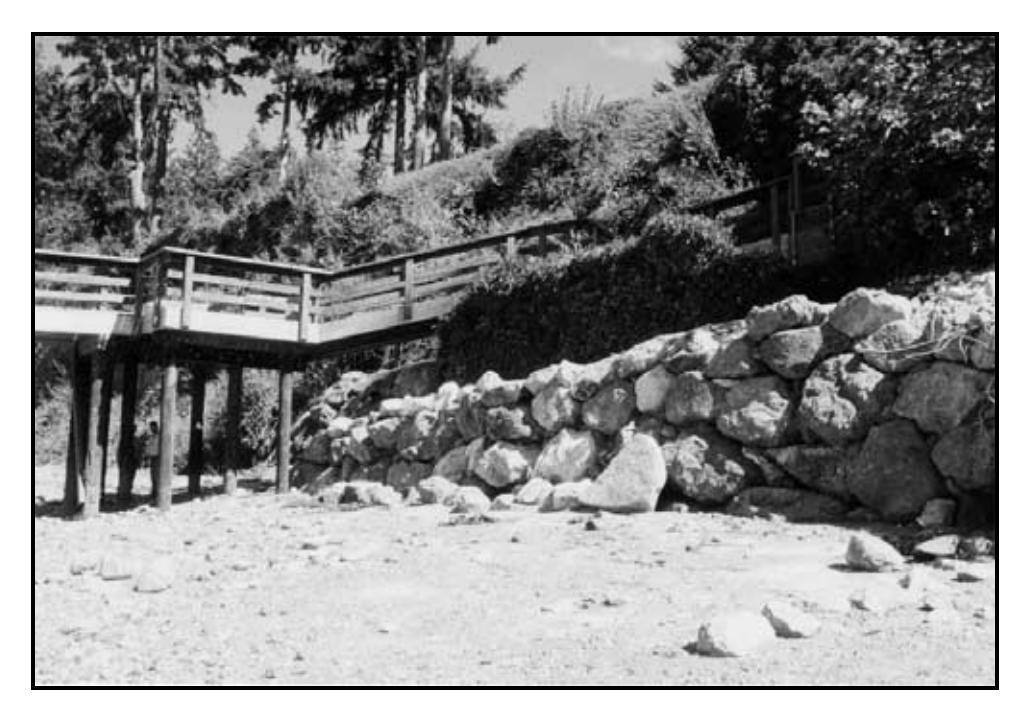
Figure 2. Rock bulkhead constructed on shore south of pier.

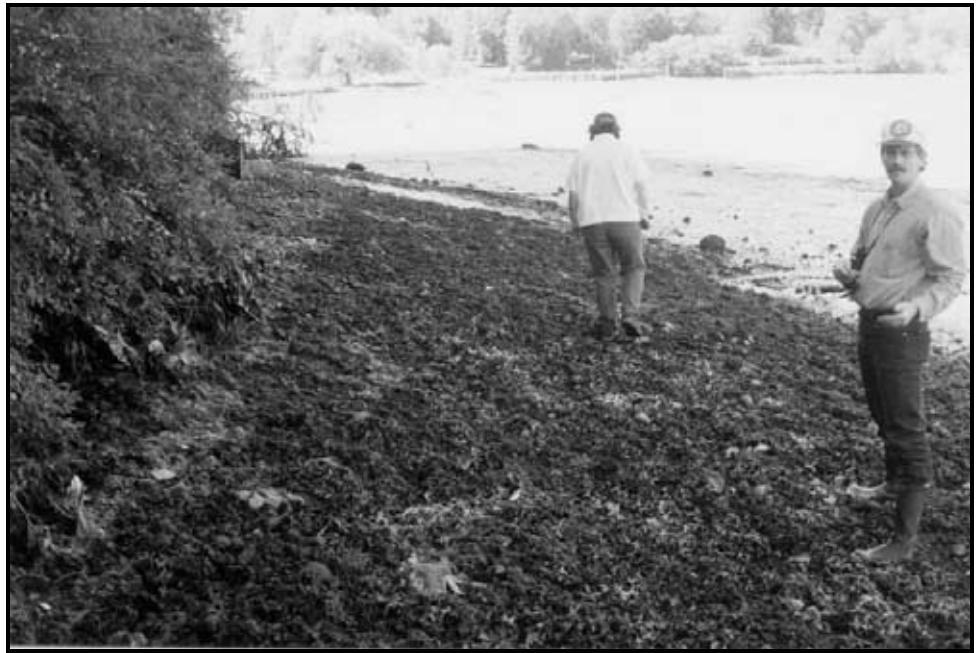
Figure 1. Gravel beach and vegetated bank. Quarry spall was placed at the toe of the slope and is largely covered with gravel. Aquatic vegetation is colonizing the coarse gravel, which is relatively stable in this low energy environment.

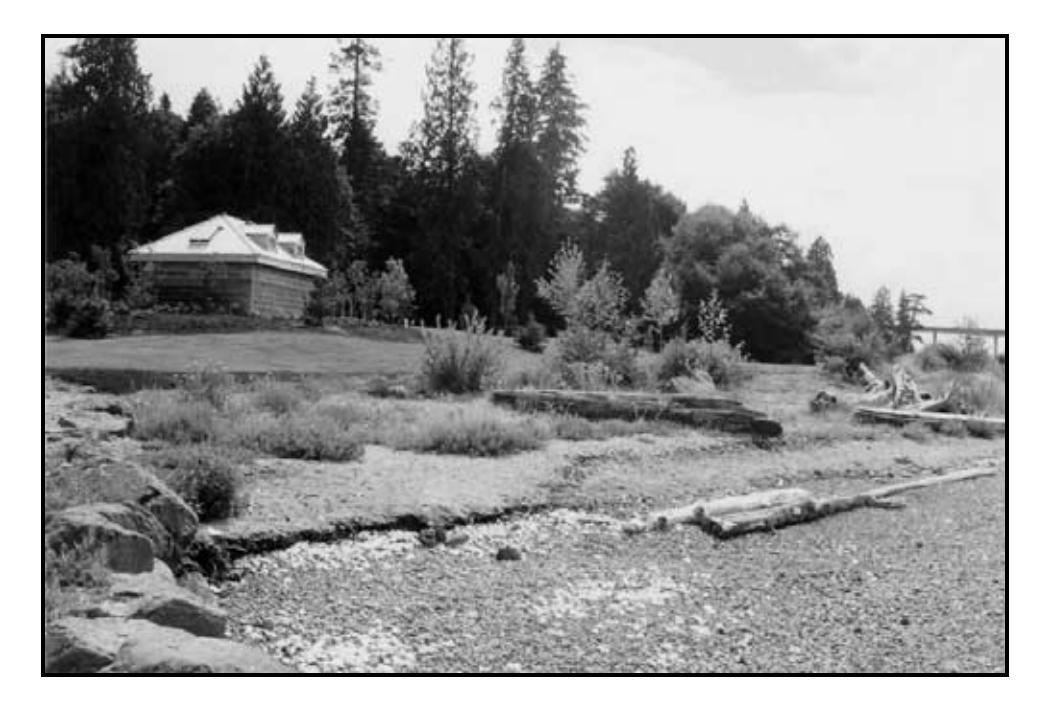
Figure 1. View west showing gravel beach and backshore. Large logs in the backshore were placed at construction, whereas most vegetation has reestablished naturally (1999).

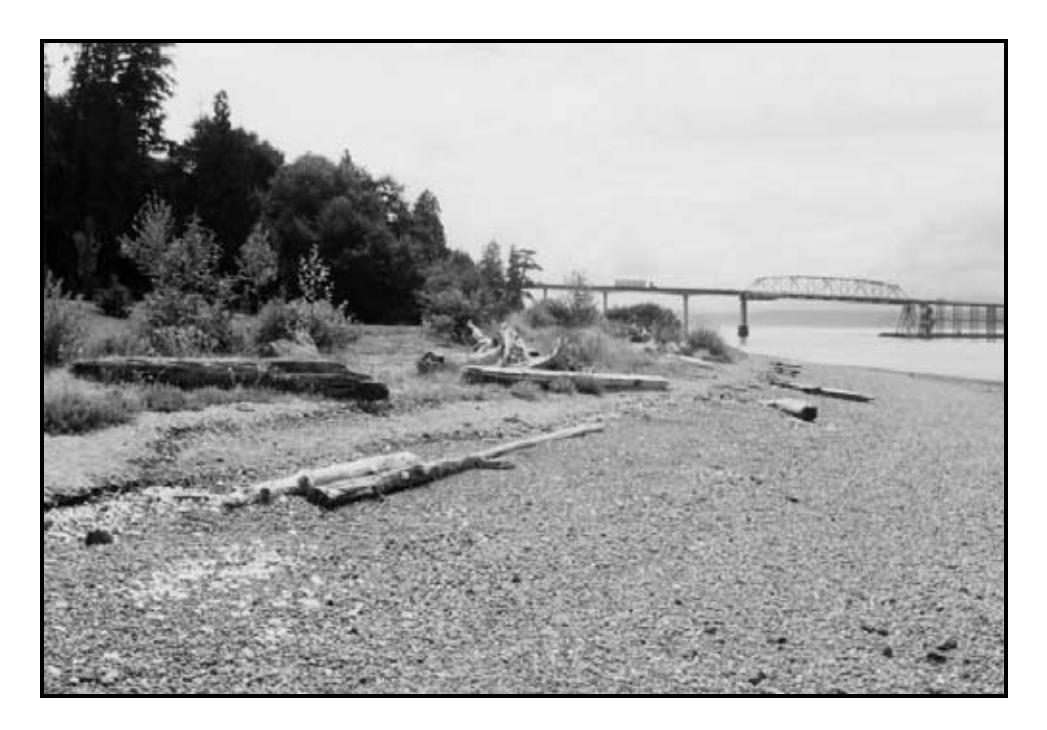
Figure 2. Second view to west, showing more of beach and Hood Canal Bridge in background (1999).

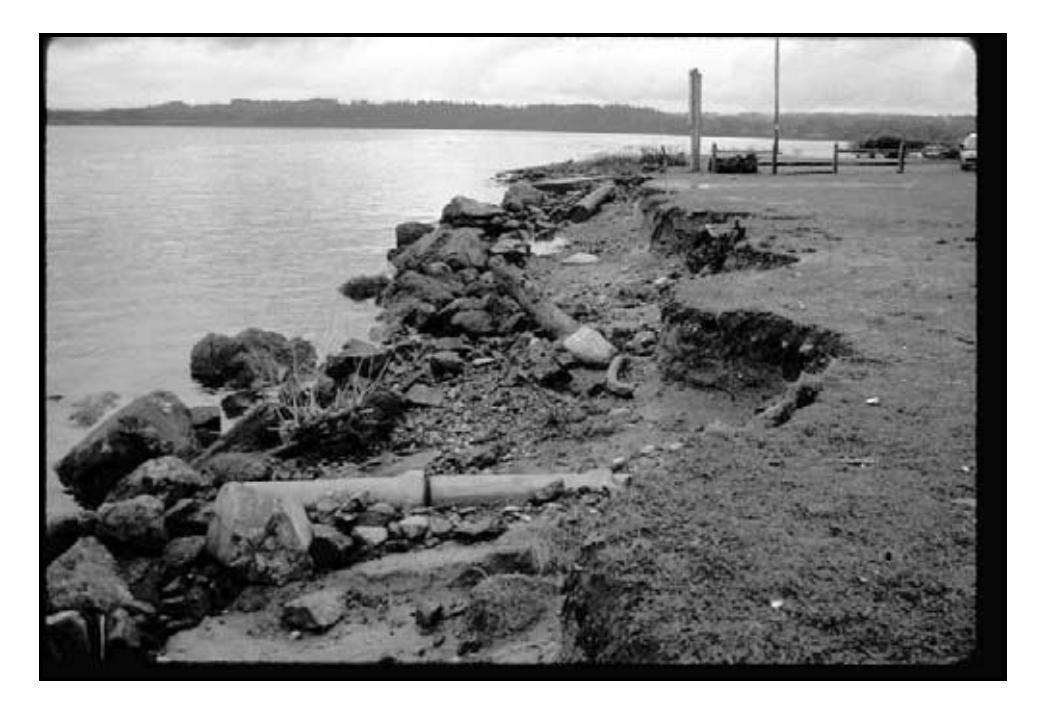
Figure 3. View east of project area prior to nourishment. Note scarp in eroding artificial fill and rocks placed in effort to reduce erosion (1995).

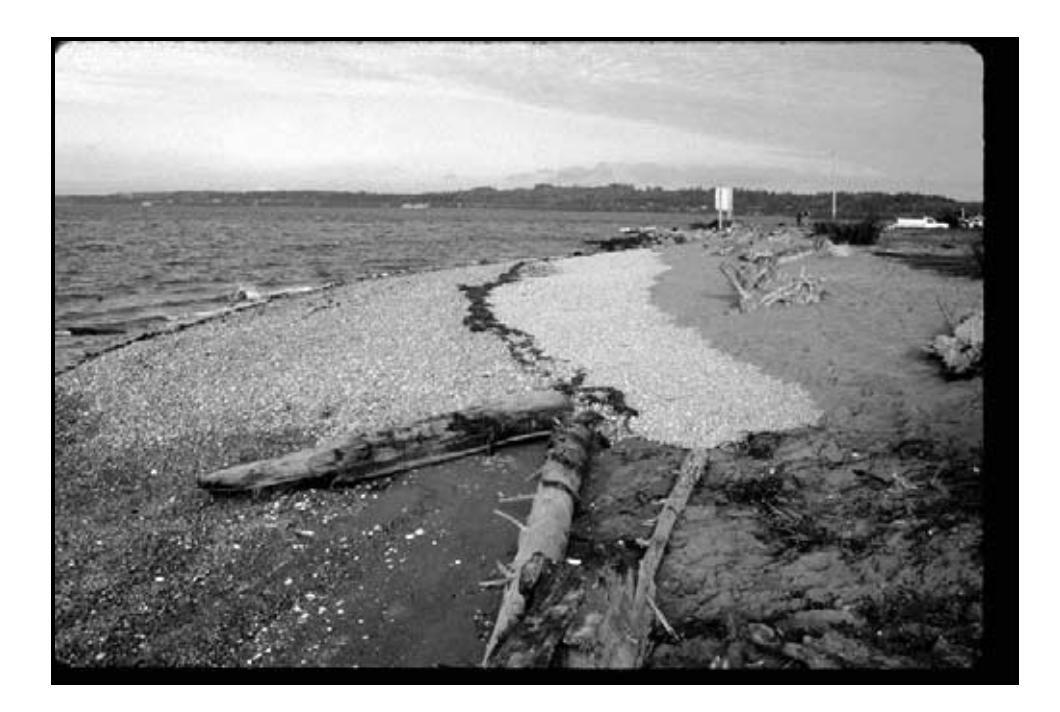
Figure 4. View to the east immediately following construction (Fall, 1995), showing gravel beach and recent high tide line. Note sand placed on landward portion of the berm.

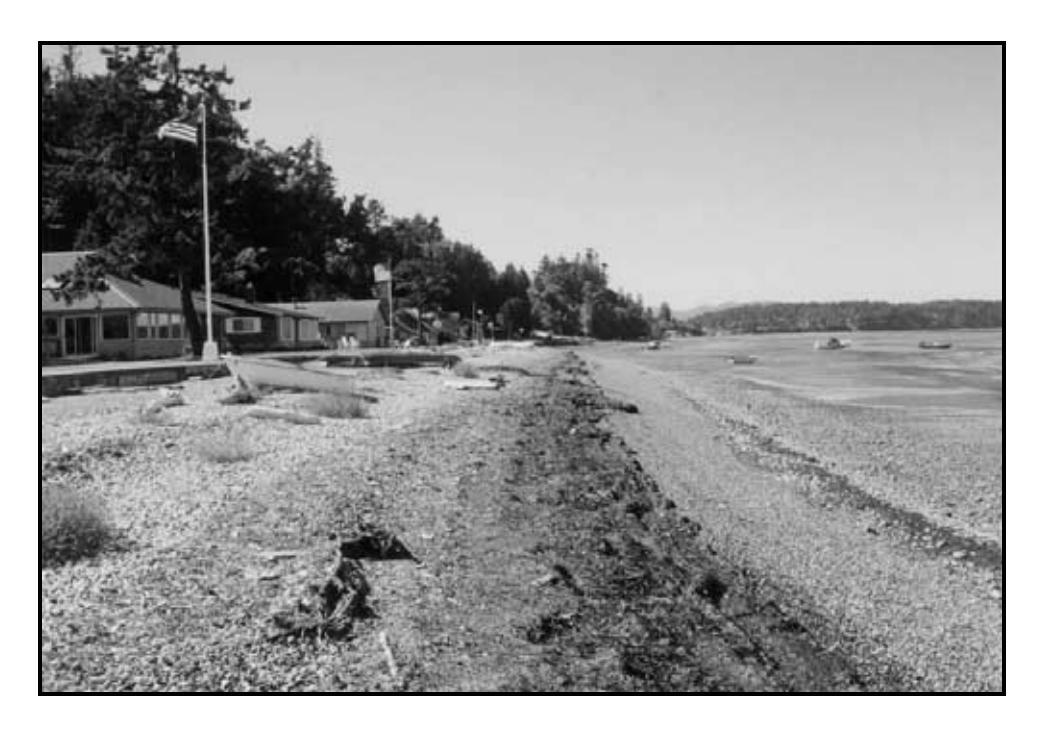
Figure 1. View west from the east end of the project. Note broad gravel berm and recent accumulation of beach wrack. Prior to nourishment, the bulkheads at the left were in danger of undermining.

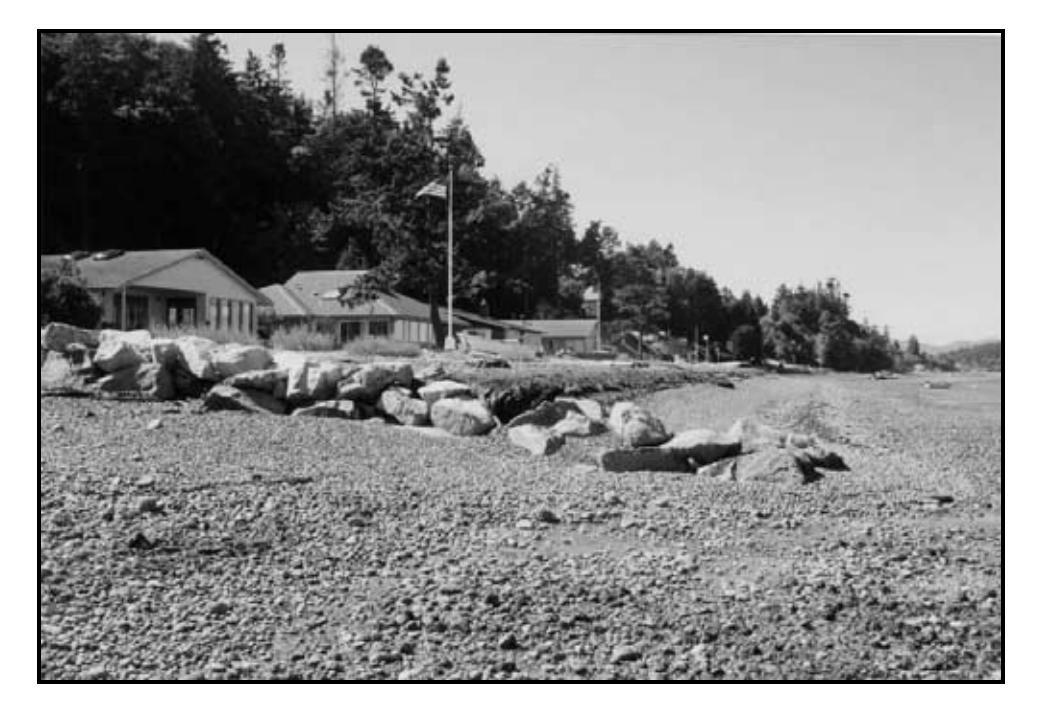
Figure 2. Looking west at project, including drift sill (groin) that forms eastern end of nourishment. Note that beach is considerably lower on east (left) side of structure. It is important that gravel be able to continue to bypass the structure in order to feed downdrift beaches.
Alternative Bank Protection Methods on Puget Sound

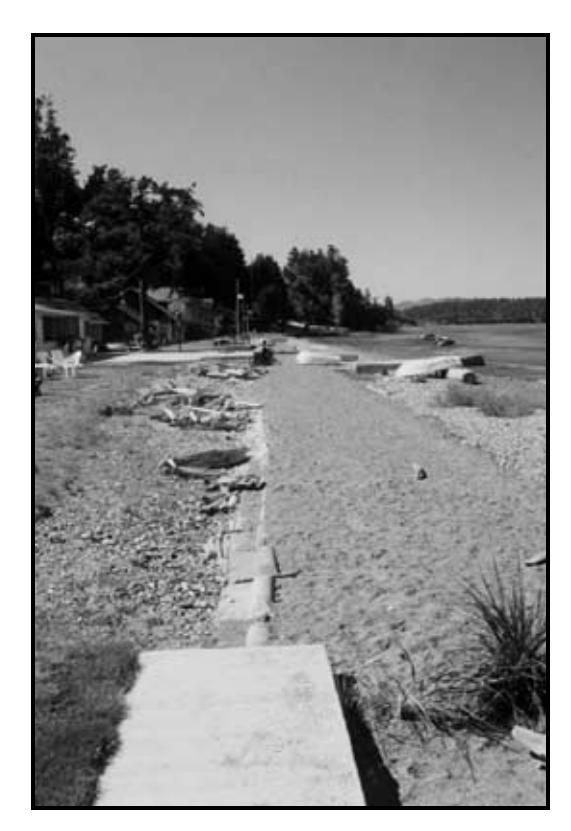
Figure 3. View west along bulkhead line in central portion of project. The bulkhead in the foreground failed in the winter of 1996-1997 (see Figure 6). Note elevation of backshore and placement of sand to facilitate revegetation.

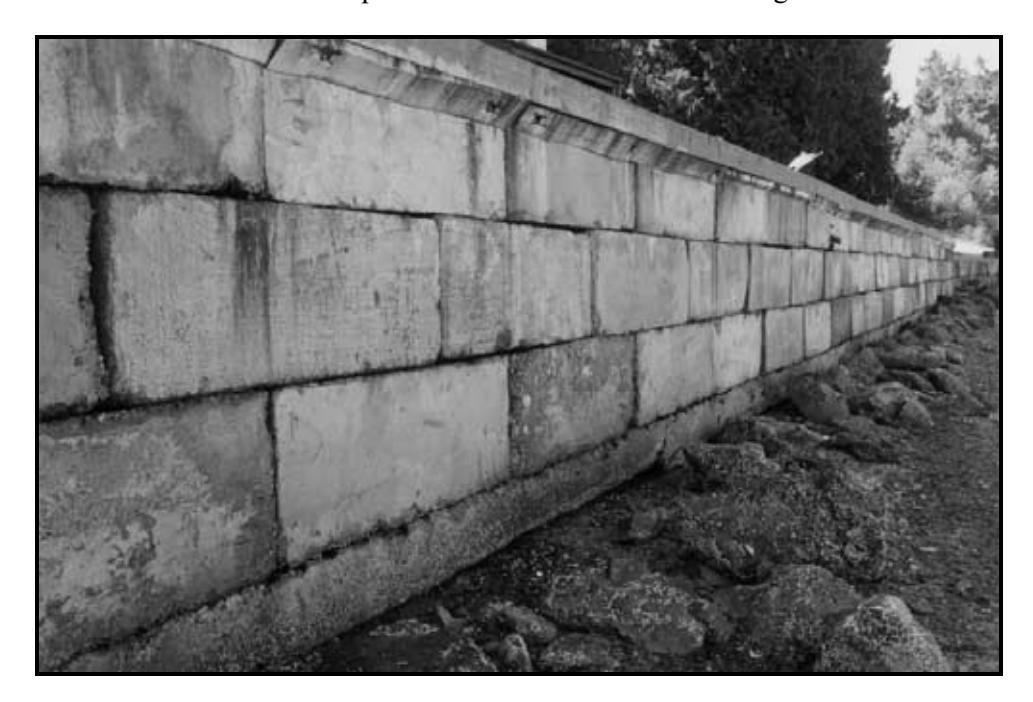
Figure 4. Ecology-block bulkhead located immediately west of project area.. Riprap has been added to protect base from scour.

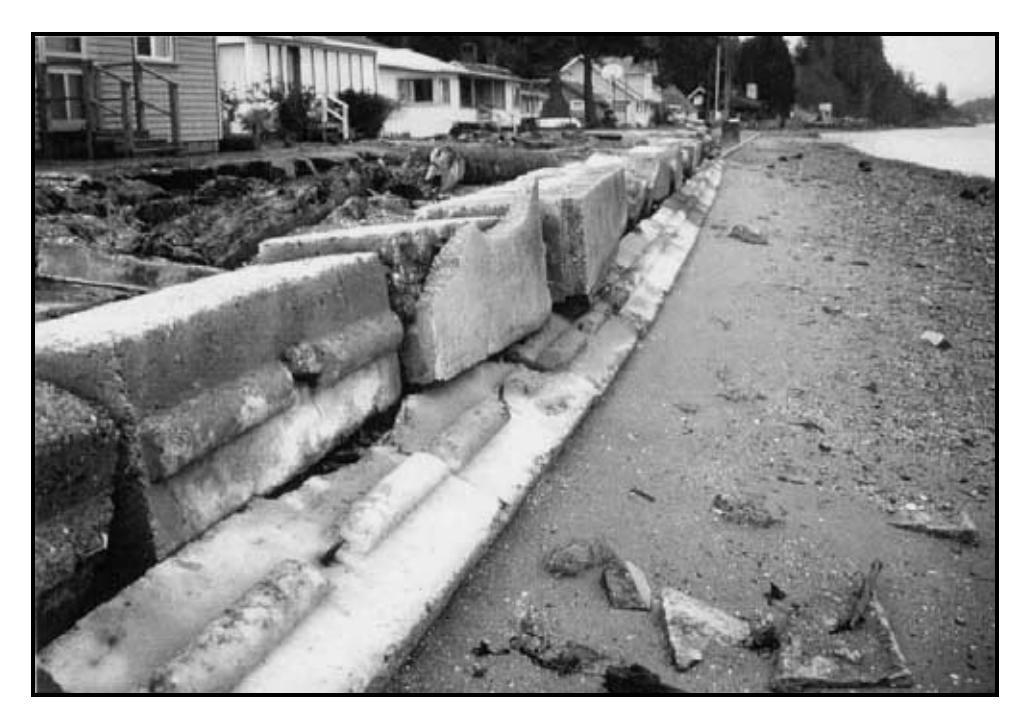
Figure 6. Ecology-block wall prior to nourishment. Failure occurred in the winter of 1996-1997 by undermining and excess hydrostatic pressure - upper tier has been restacked in this photo. Note erosion of upland area behind wall.

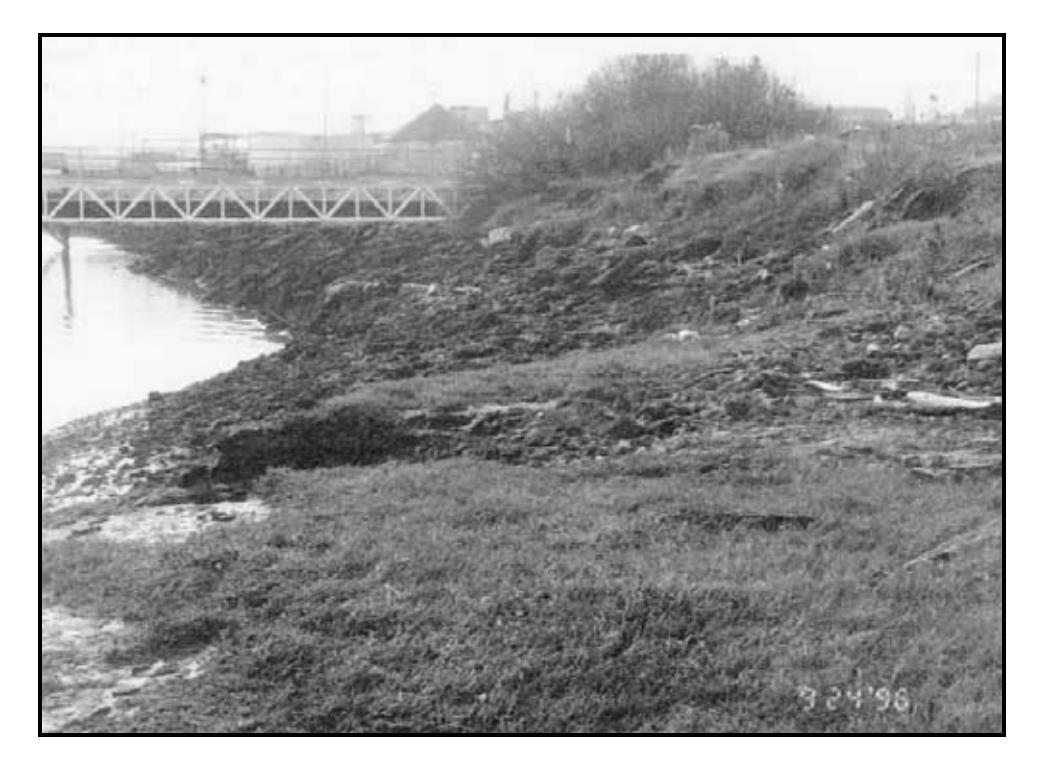
Figure 1. View south of site prior to construction. Note vegetated upper intertidal benches.

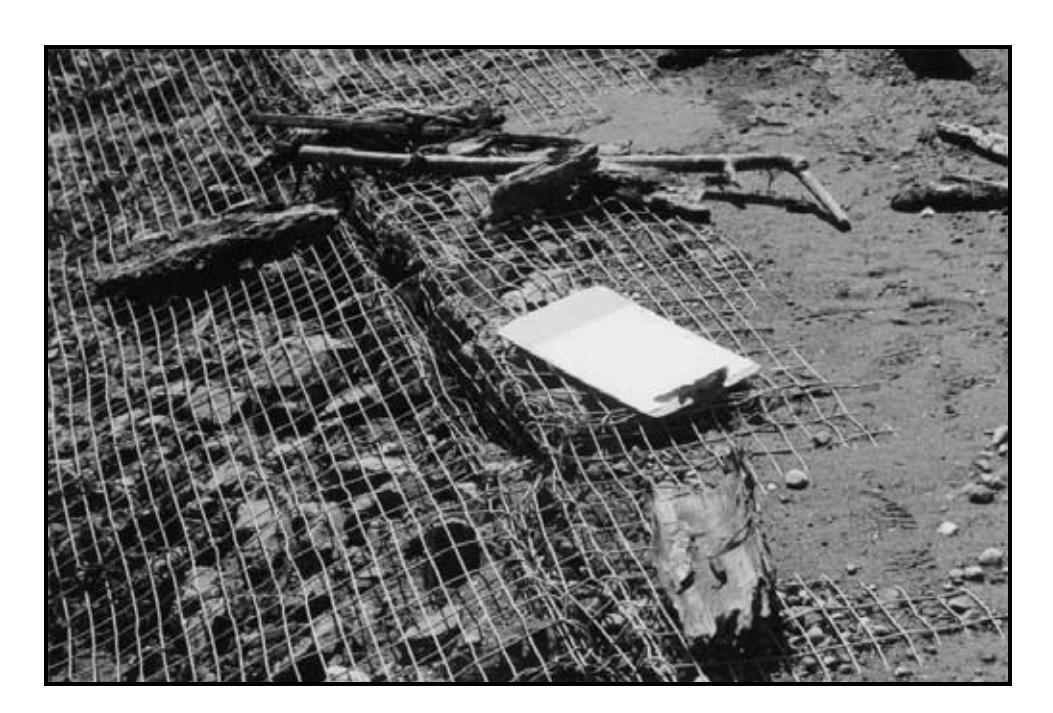
Figure 4. Detail at waterward edge of bench showing exposure of gabions.

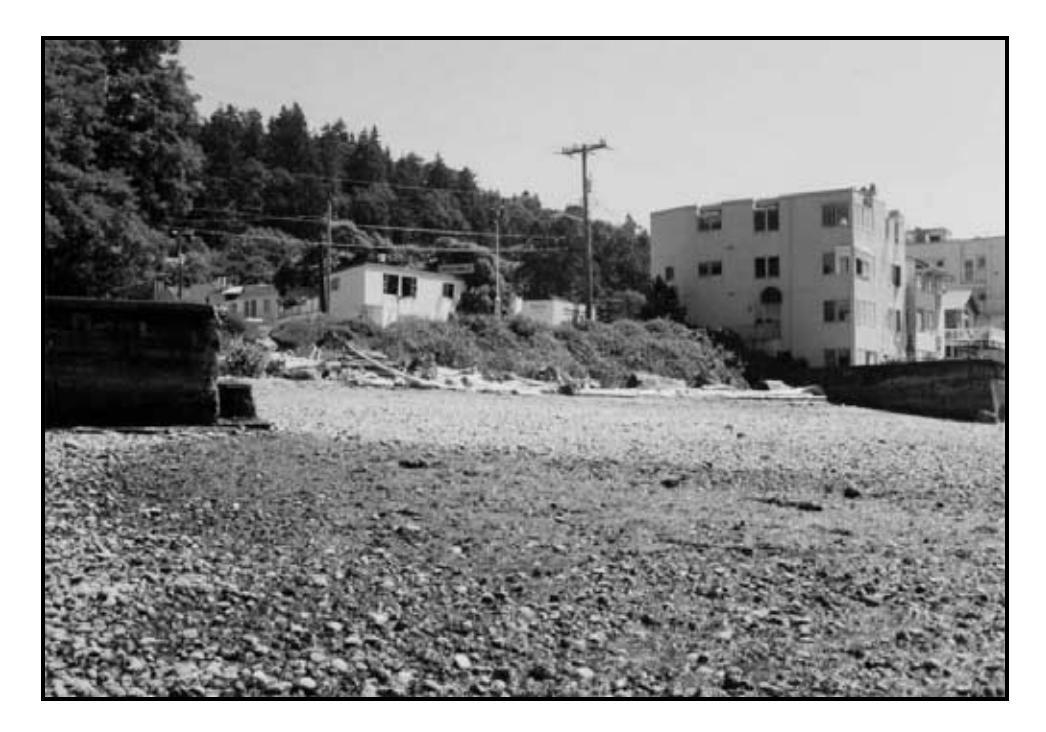
Figure 2. View of park illustrating adjacent bulkheads. This photo emphasizes why it is difficult to restore, or maintain, natural beaches when human action has encroached into the intertidal.
