Stream Discharge Technical Notes

Station ID: 05A105

Station Name: South Fork Stillaguamish River at Jordan Road bridge

Water Year: 2022

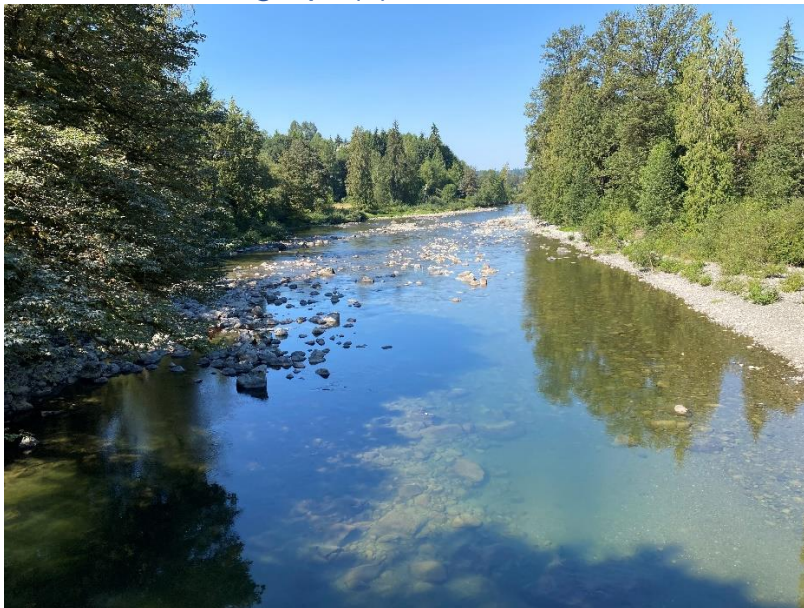
Figure 1: South Fork Stillaguamish River looking downstream toward the boulder control structure.
