# Washington State Department of Ecology

## Stream Discharge Technical Notes

**Station ID:** 05B090

**Station Name:** North Fork Stillaguamish River at Oso

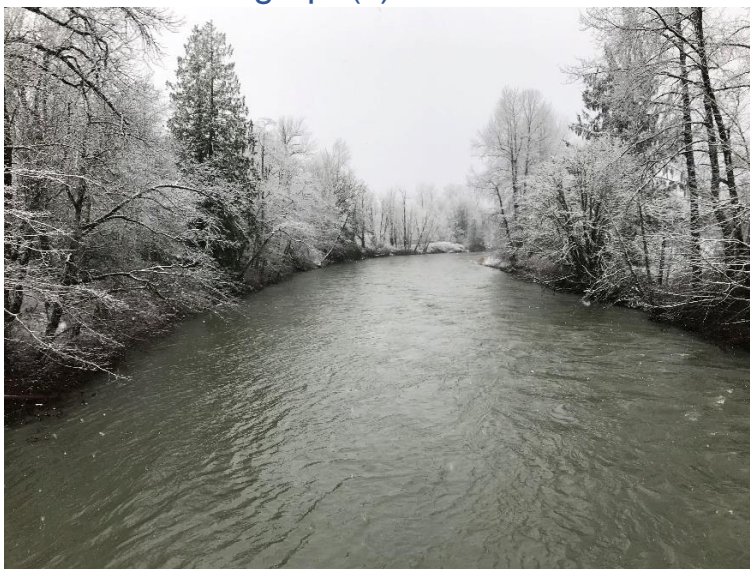
*Figure 1: Downstream view of the North Fork Stillaguamish River at Oso during winter flows.*
