# Washington State Department of Ecology

## Stream Discharge Technical Notes

**Station ID:** 05B090

**Station Name:** North Fork Stillaguamish River at Oso

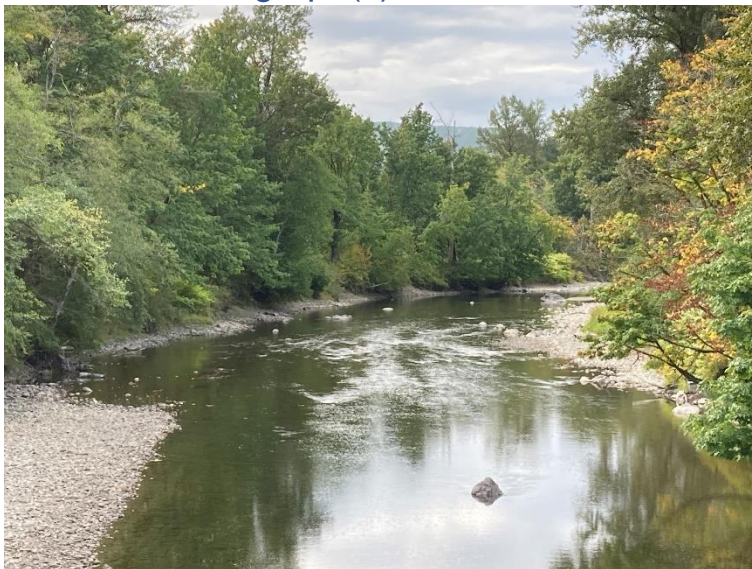
*Figure 1: Downstream view of the North Fork Stillaguamish River at Oso during summer flows.*

The gage is located on the right bank of the North Fork Stillaguamish River at the north end of Whitman Road bridge. The gage house is at the same elevation as the roadway; and the slant-pipe drops about 25 feet along the side of an old bridge abutment into the river. The terminal end of the pipe extends into a deep portion of the channel a few feet offshore.
