Sampling and Analysis Plan

Soil and Groundwater Sampling

Lots 25 and 26
Seitz Property
Brian Lane NW
Silverdale Washington

April 26, 2021

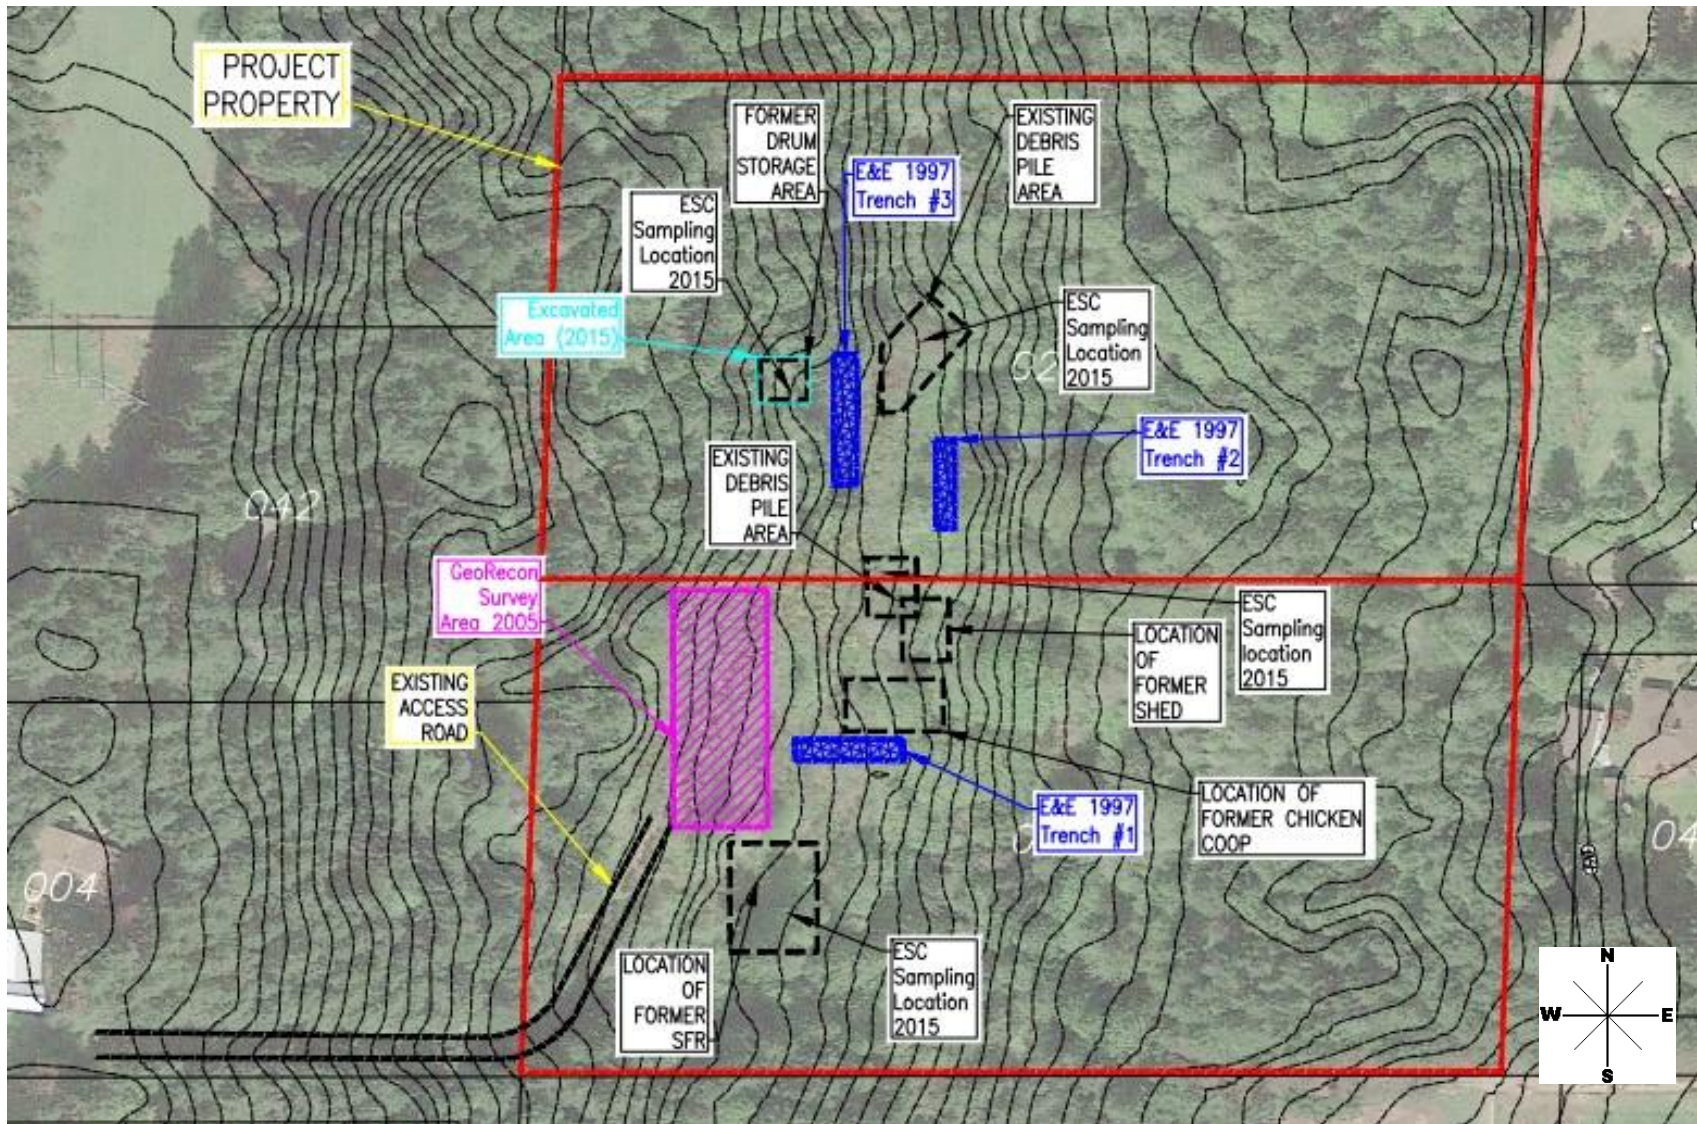
SITE DEVELOPMENT ENGINEERS <i>Conducting Assessments Nationwide</i>
	Drawn by: CB	Approved by: SEW	
	Project No. 104-21018	Figure No. 2

SITE MAP Seitz Property – Lots 25 & 26 Sampling and Analysis Plan Brian Lane Silverdale, Washington	Scale: 1"=100'	Date: April 2021

The Property was undeveloped land since as early as 1891. An aerial photograph in 1981 shows that the central portion of the Property was cleared at the time, with a building structure and a primitive road entering from the west; aerial photographs from 1990 to present show that the southwestern portion of the Property was cleared (AEG 2020). A historic report indicated that three abandoned building structures were present on the Property in 1997 (E&E 1997). Other historic reports indicated that the abandoned building structures were a house, a chicken coop, and a shed. The building structures were reportedly removed from the Property (decayed at the time) in June 2005 (EnviroSound 2015). The Property has been vacant and undeveloped since that time. The locations of the former building structures are depicted on Figure 2.

- The investigation included clearing brush and debris, conducting a geophysical survey, and digging three trenches to a maximum depth of 11 feet below ground surface (bgs) on the Site. The locations of the trenches are depicted as “E&E 1997 Trench #1, 2, and 3” on Figure 2.

- One 55-gallon drum discovered west of the former house was reportedly approximately ¼ full (Figure 2). One sample was collected from the drum. The analytical results were consistent with a diesel or heating oil type of petroleum product. The drum was emptied and recycled at the time.

- On March 25, 2005, the current owner informed KCHD that additional brush-clearing activities revealed a 10-foot by 10-foot area where 18 55-gallon drums were discovered. The area is depicted as “Former Drum Storage Area” on Figure 2. KCHD inspected the drums on March 28; all drums were full or close to full. Four of the drums reportedly showed signs of leakage or spillage. Several drums were labeled with “Roybond Primer.” The area around the drums reportedly smelled of solvents. KCHD provided the information to Ecology.

- A ground-penetrating radar and magnetic survey was conducted in August 2005 in areas that were not covered by the 1997 survey and trenching. No buried metallic objects and no signs of excavation were found. The 2005 survey area is depicted on Figure 2.

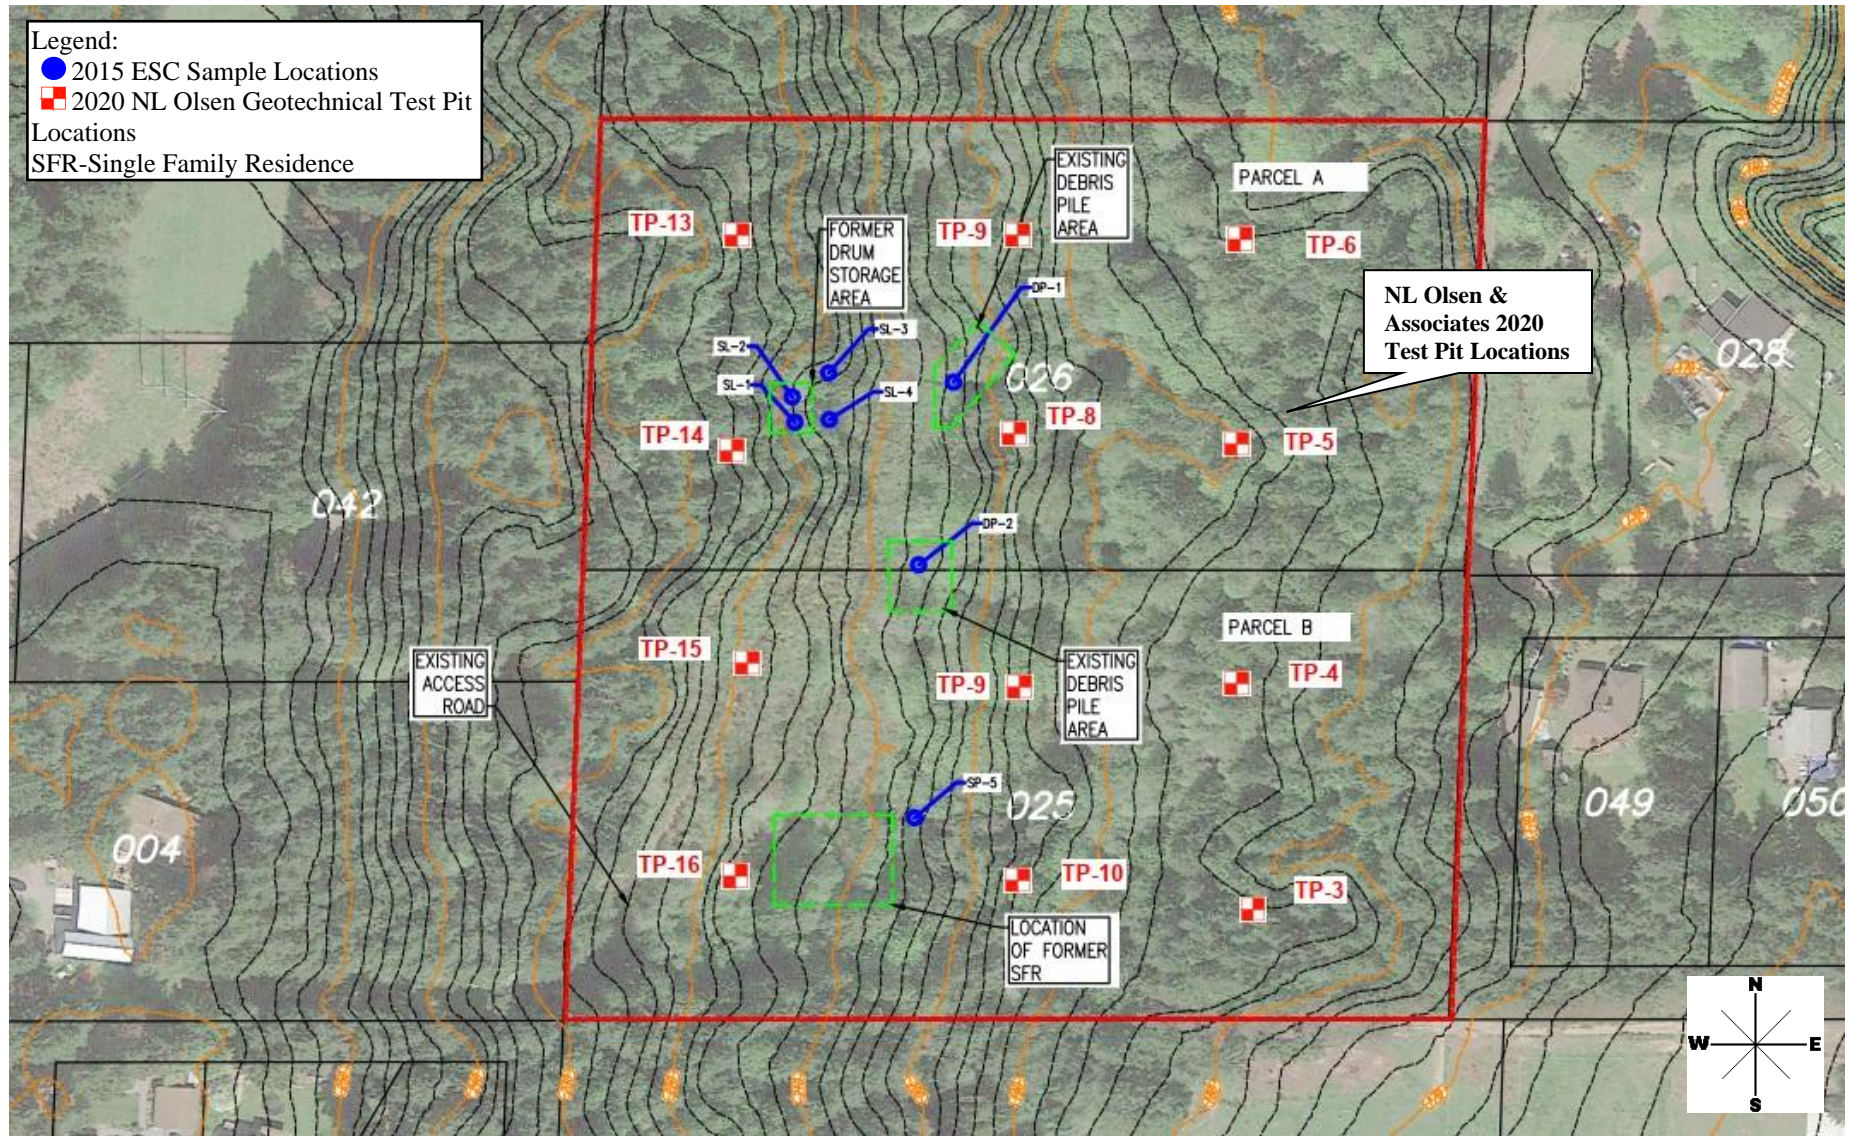
Krazan SITE DEVELOPMENT ENGINEERS <i>Conducting Assessments Nationwide</i>
	Drawn by: CB	Approved by: SEW	
	Project No. 104-21018	Figure No. 4

SITE MAP-Previous Sampling Locations Seitz Property – Lots 25 & 26 Sampling and Analysis Plan Brian Lane Silverdale, Washington	Scale: 1"=100'	Date: April 2021

- Two soil samples (DP1-S5-SL-09 and DP2-S6-SL-11) were collected from the areas of the two debris piles, respectively. One soil boring (SP5-S7-SL-13) was collected near the former house. All three soil samples were collected at the ground surface, and all contained arsenic concentrations above the MTCA Method A soil cleanup level. The areas where these samples were collected are depicted on Figure 4.

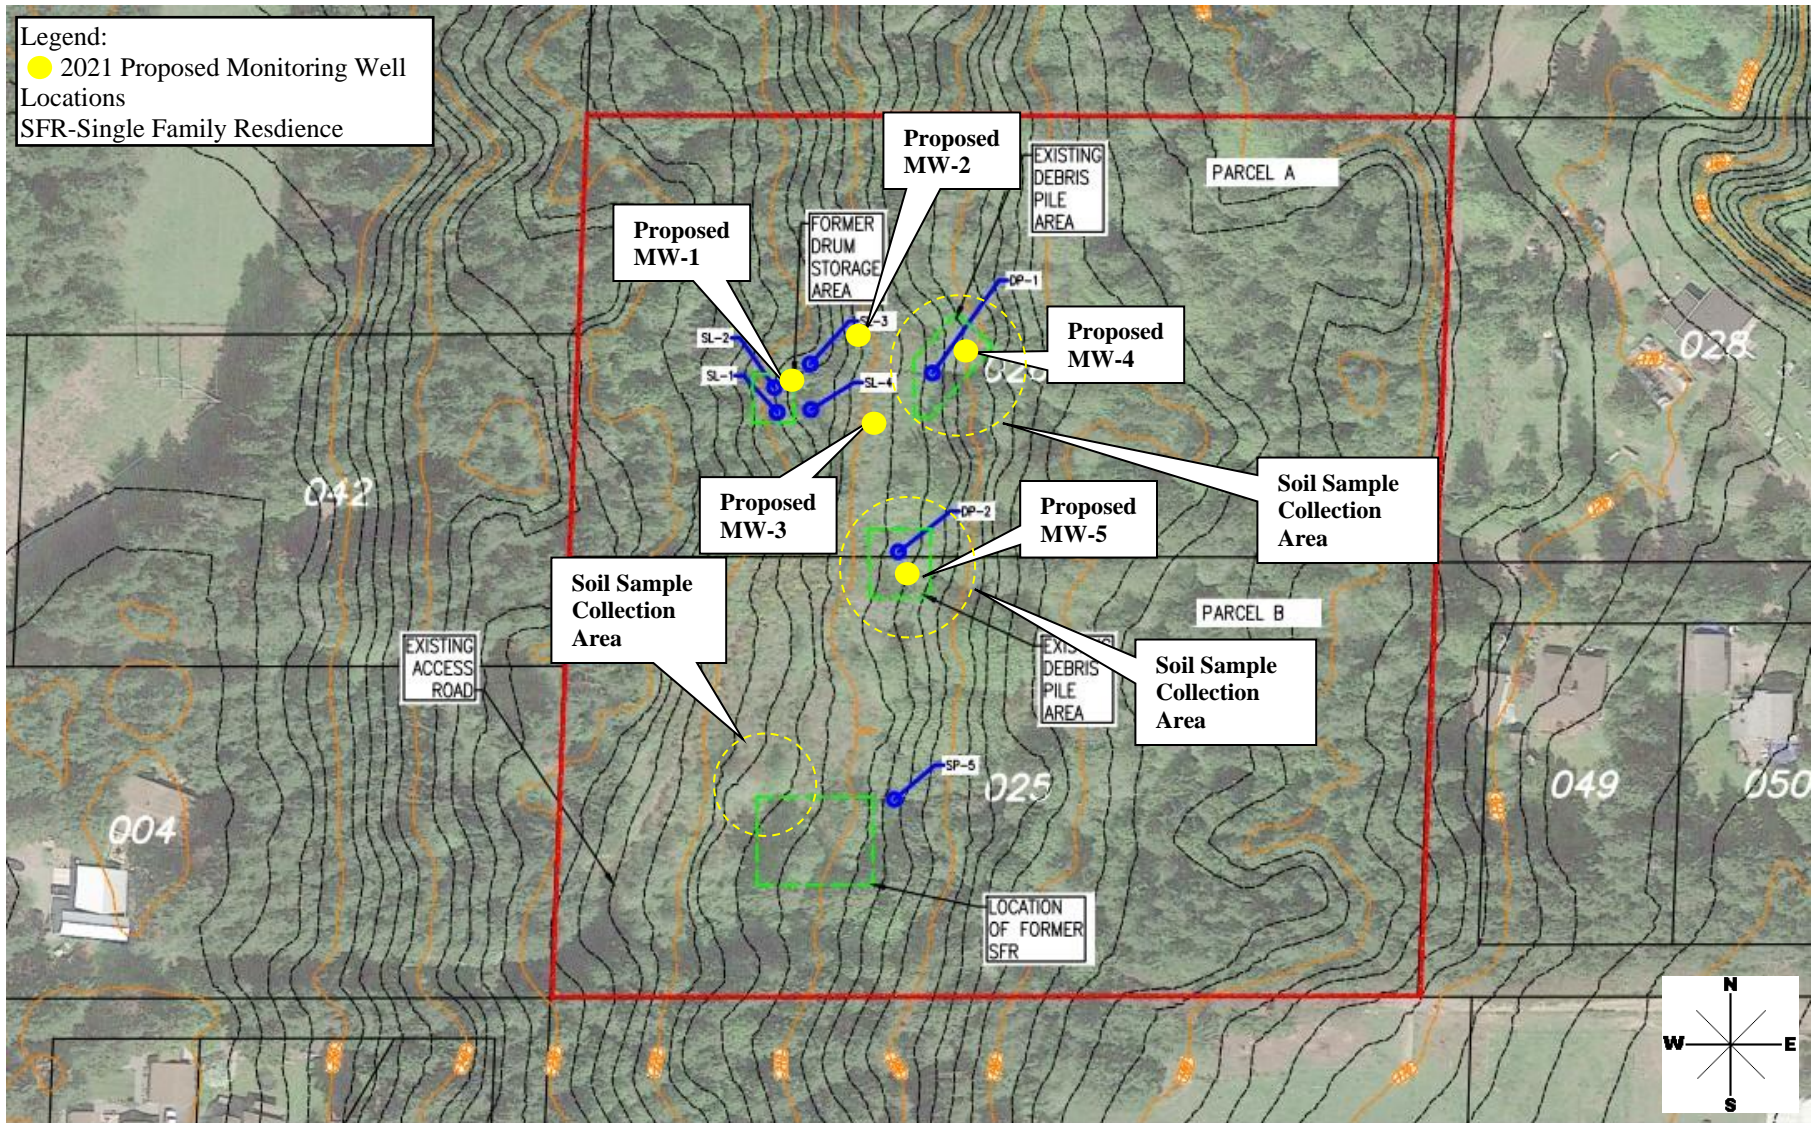
SITE MAP-Proposed Sampling Locations Seitz Property – Lots 25 & 26 Sampling and Analysis Plan Brian Lane Silverdale, Washington	Scale: 1"=100'	Date: April 2021

sample collection are shown in Figure 6. This Table details each location, analyses to be performed, and projected QC samples for 5 events. Events are defined as follows:
