June 17, 2021

Re: Groundwater Monitoring Report, Former Cascade Timber No. 3 Sort Yard
Consent Decree No. 94-2-03590-3
Washington State Department of Ecology Facility Site ID No. 1206
Monitoring Date: February 19, 2021

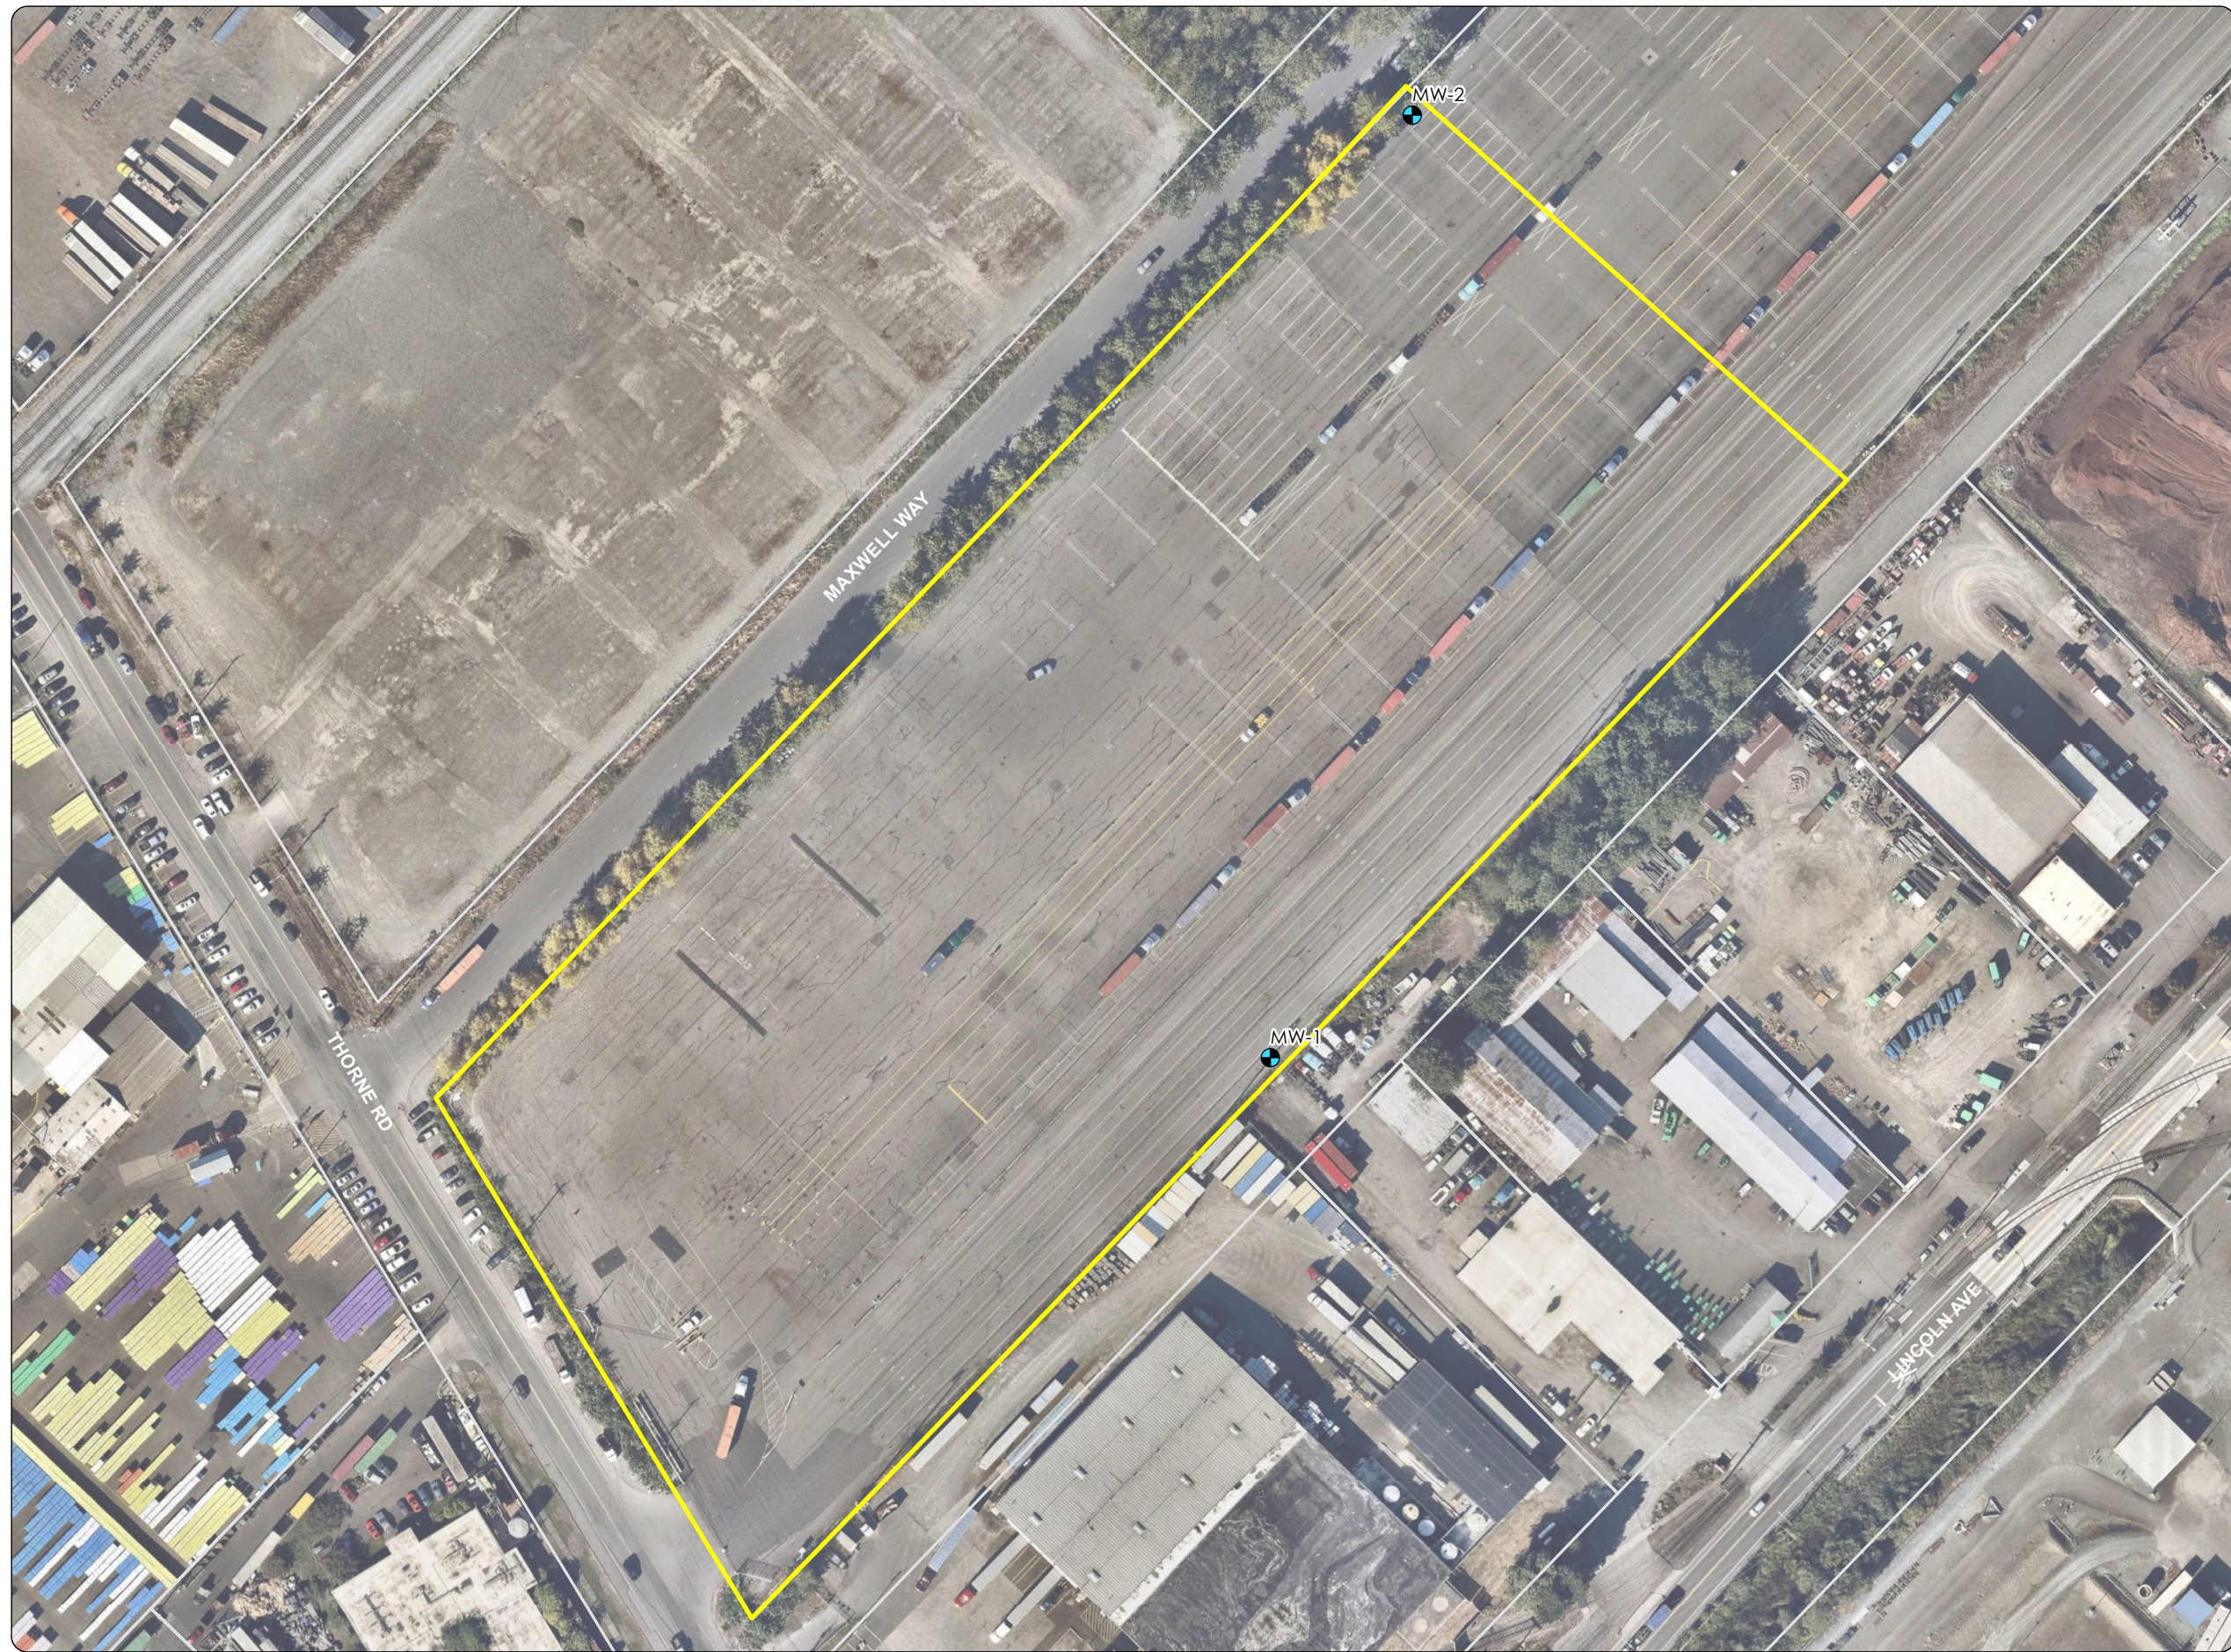
Figure 2
Site Features
 Port of Tacoma
 Cascade Timber

MFA conducted a groundwater-monitoring event at the Site on February 19, 2021. Water level data are summarized on Table 1. The locations of MW-1 and MW-2 are shown on Figure 2.

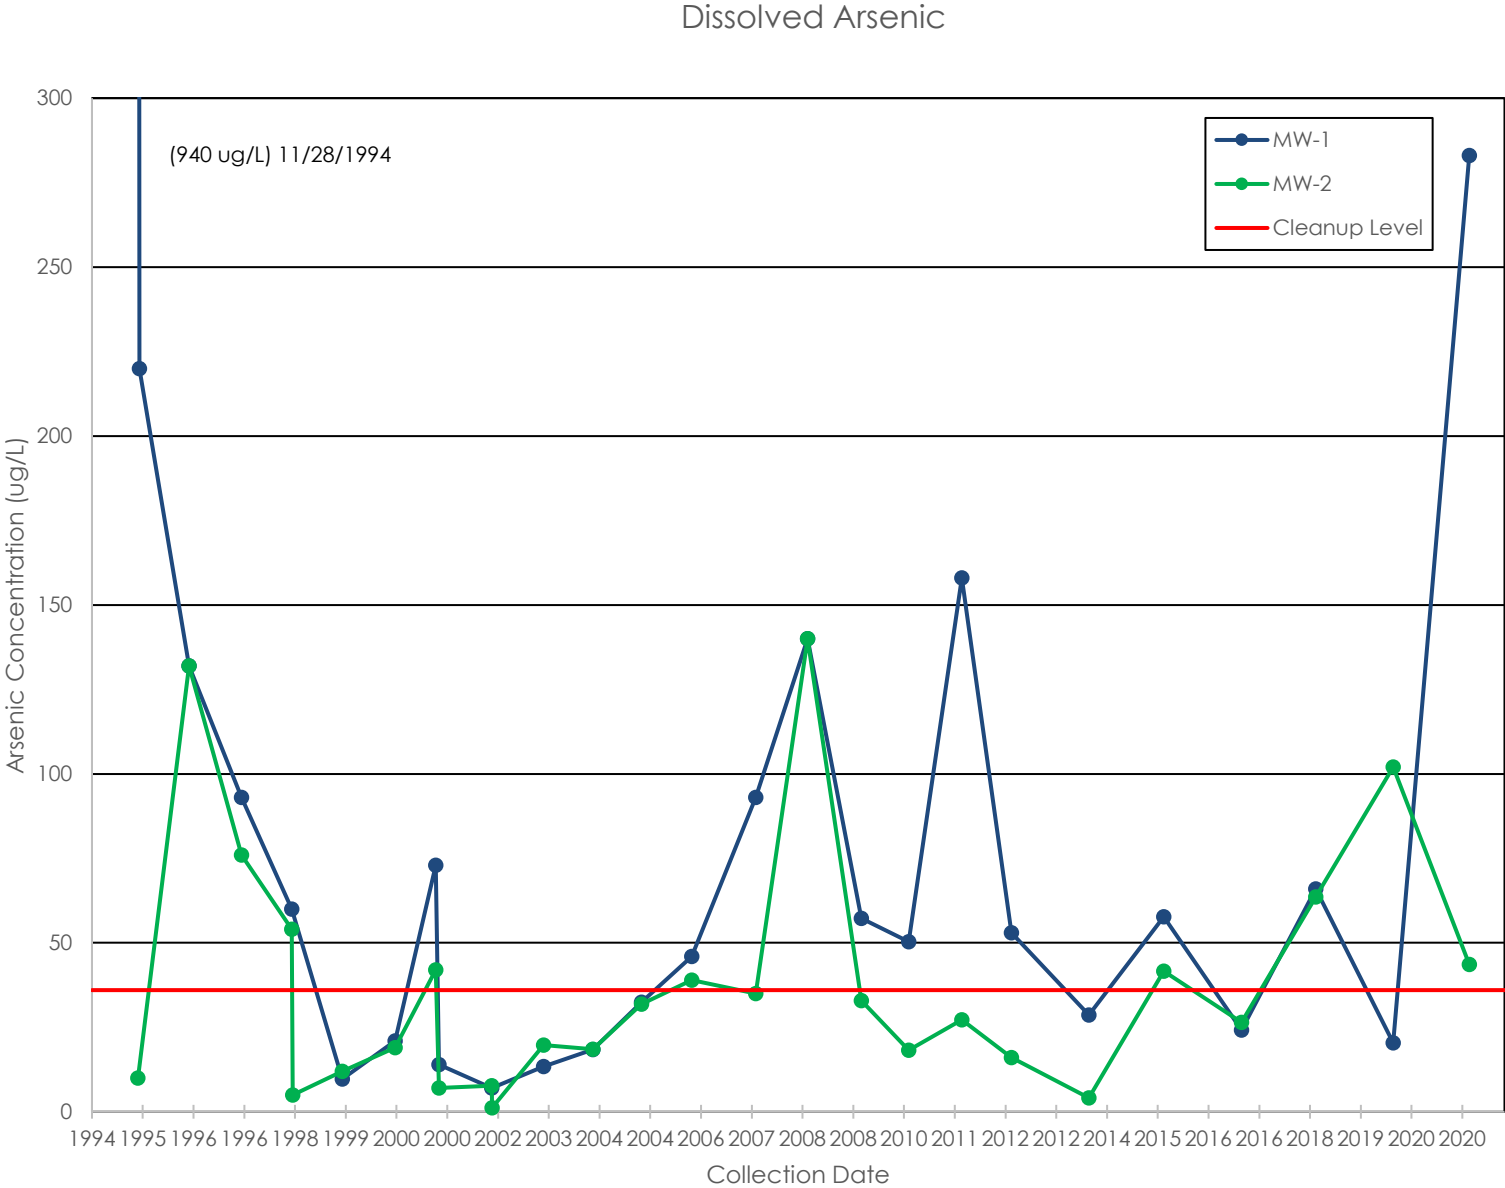
Figure 3
Dissolved Arsenic Concentration Trends
Former Cascade Timber No. 3 Log Sort Yard

- Dissolved arsenic was detected at a concentration of 283 micrograms per liter ($\mu\text{g/L}$) in MW-1 and 43.6 $\mu\text{g/L}$ in MW-2. Both values exceed the groundwater cleanup level of 36 $\mu\text{g/L}$ for dissolved arsenic.
- Dissolved copper was not detected at the method detection limit (2.5 $\mu\text{g/L}$) in either MW-1 or MW-2. The groundwater cleanup level is 2.9 $\mu\text{g/L}$.
- Dissolved lead was not detected at the method detection limit (5 $\mu\text{g/L}$) in either MW-1 or MW-2. The groundwater cleanup level is 8.5 $\mu\text{g/L}$.

Plots of dissolved arsenic, copper, and lead versus time for MW-1 and MW-2 are presented in Figures 3 through 5, respectively.

We believe the elevated arsenic is the result of surface water infiltration that occurred during construction activities in May and June 2020. The Site is operated as a trucking queue, in 2020 the Port's tenant, ITS Husky, installed a new remote truck gate and utilities. Ecology was briefed prior to construction and approved the scope of work on December 30, 2019. The work included excavation within the cap limits. Cap integrity was restored after subsurface work was completed. It appears that surface water infiltration during the excavation period caused a release, as observed in the arsenic results from monitoring well MW-1. We anticipate that the higher arsenic concentration will attenuate over time and naturally recover.
