**RE: No Further Action at the following Site:**

- **Site Name:** Ellensburg City W 8<sup>th</sup> Ave ROW
- **Site Address:** W. University Way, Ellensburg
- **Facility Site ID No.:** 77737583
- **Cleanup Site ID No.:** 1928

**Enclosure A**

**Site Diagram**

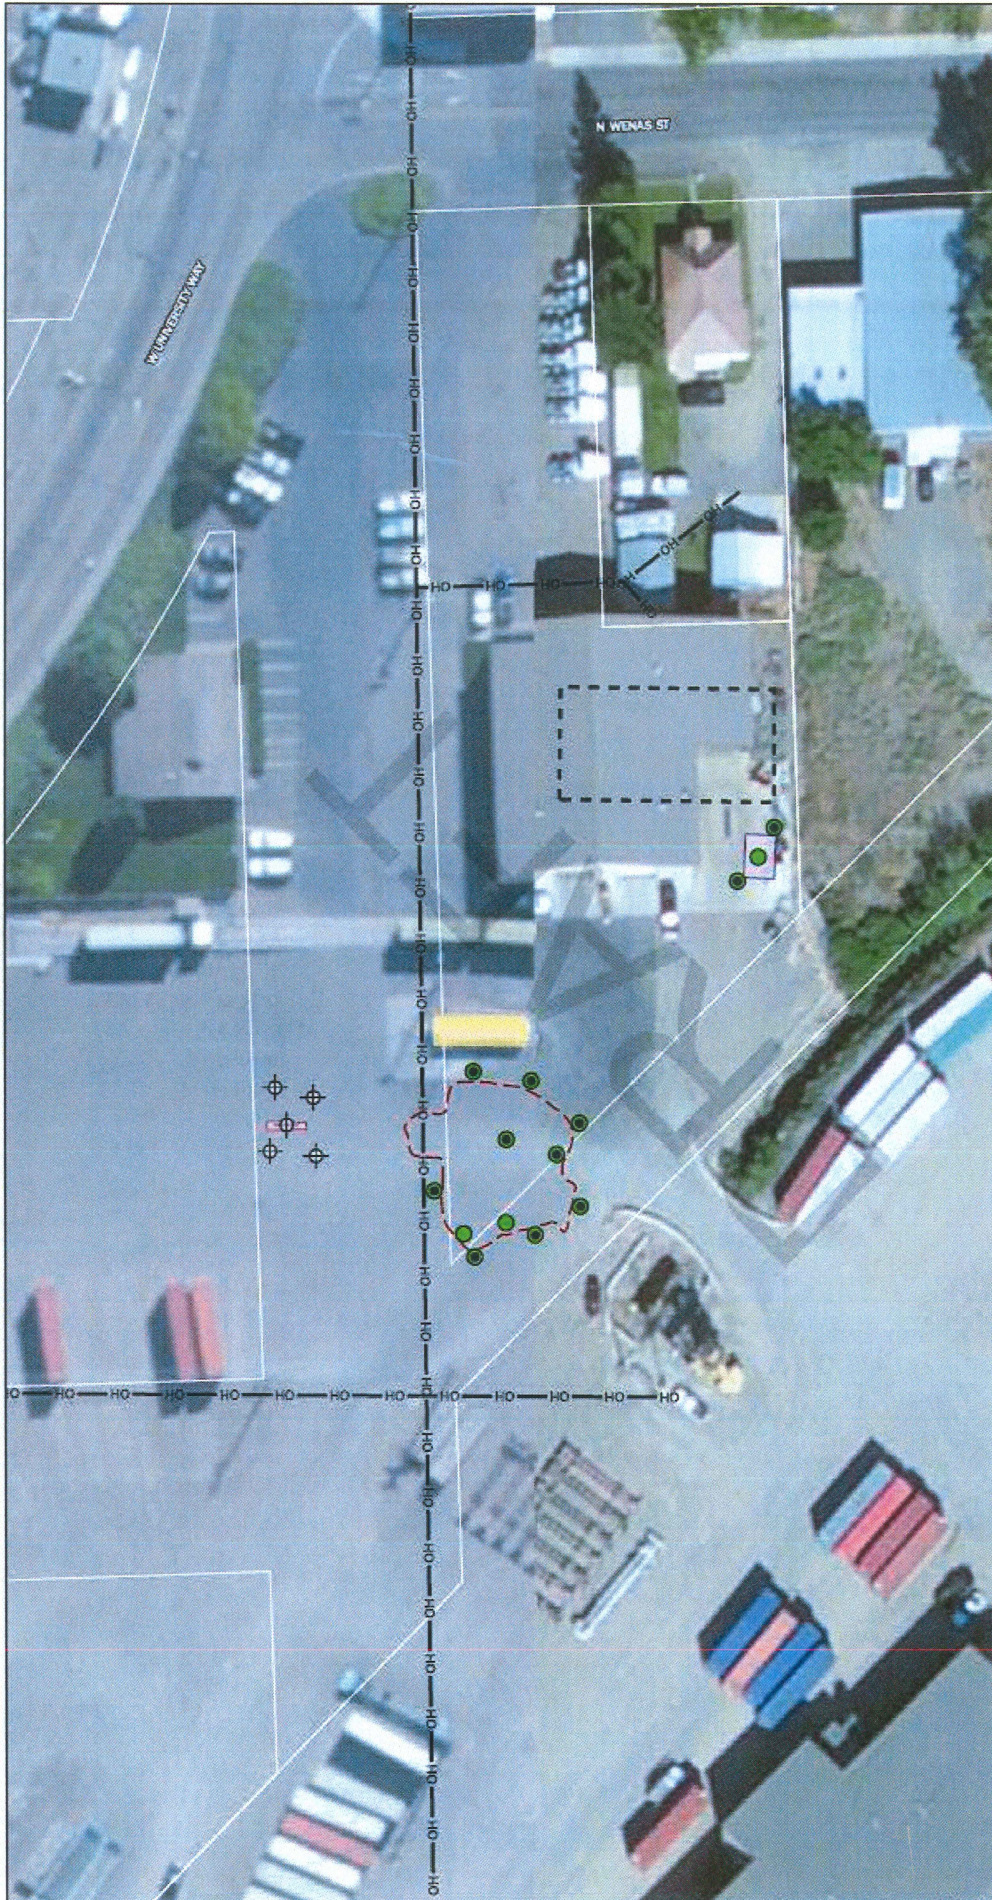
**GEOENGINEERS** Figure 2

**Enclosure A** is a diagram of the Site, as currently known to Ecology. Please note a parcel of real property can be affected by multiple sites. At this time, we have no information that the parcel(s) associated with this Site are affected by other sites.

The Site is located within the West 8<sup>th</sup> Avenue Right-of-Way (ROW), west of North Wenas Street, and South of University Avenue in Ellensburg, WA. Ecology understands that the City of Ellensburg is in the process of abandoning this ROW, which will become the property of Ward Rugh, Inc., which surrounds the W 8<sup>th</sup> Ave ROW west of North Wenas Street. The ROW is surrounded by commercial land uses.

**Site Plan**  
 Ellensburg City West 8th Street ROW  
 Ellensburg, Washington
