**Re: Sampling Activities –Strawberry Plant Shoreline Restoration Project,
Bainbridge Island, Washington**
Project No. 080011-001-01

This letter report presents the results of the sampling activities completed by Aspect Consulting, LLC at the Strawberry Plant Site on Bainbridge Island, Washington. The Site is located in the back reaches of Eagle Harbor and was once the center of a thriving strawberry industry. The property is currently owned by the City of Bainbridge Island and will eventually be transferred to the Bainbridge Island Metro Park and Recreation District to be used as a park.

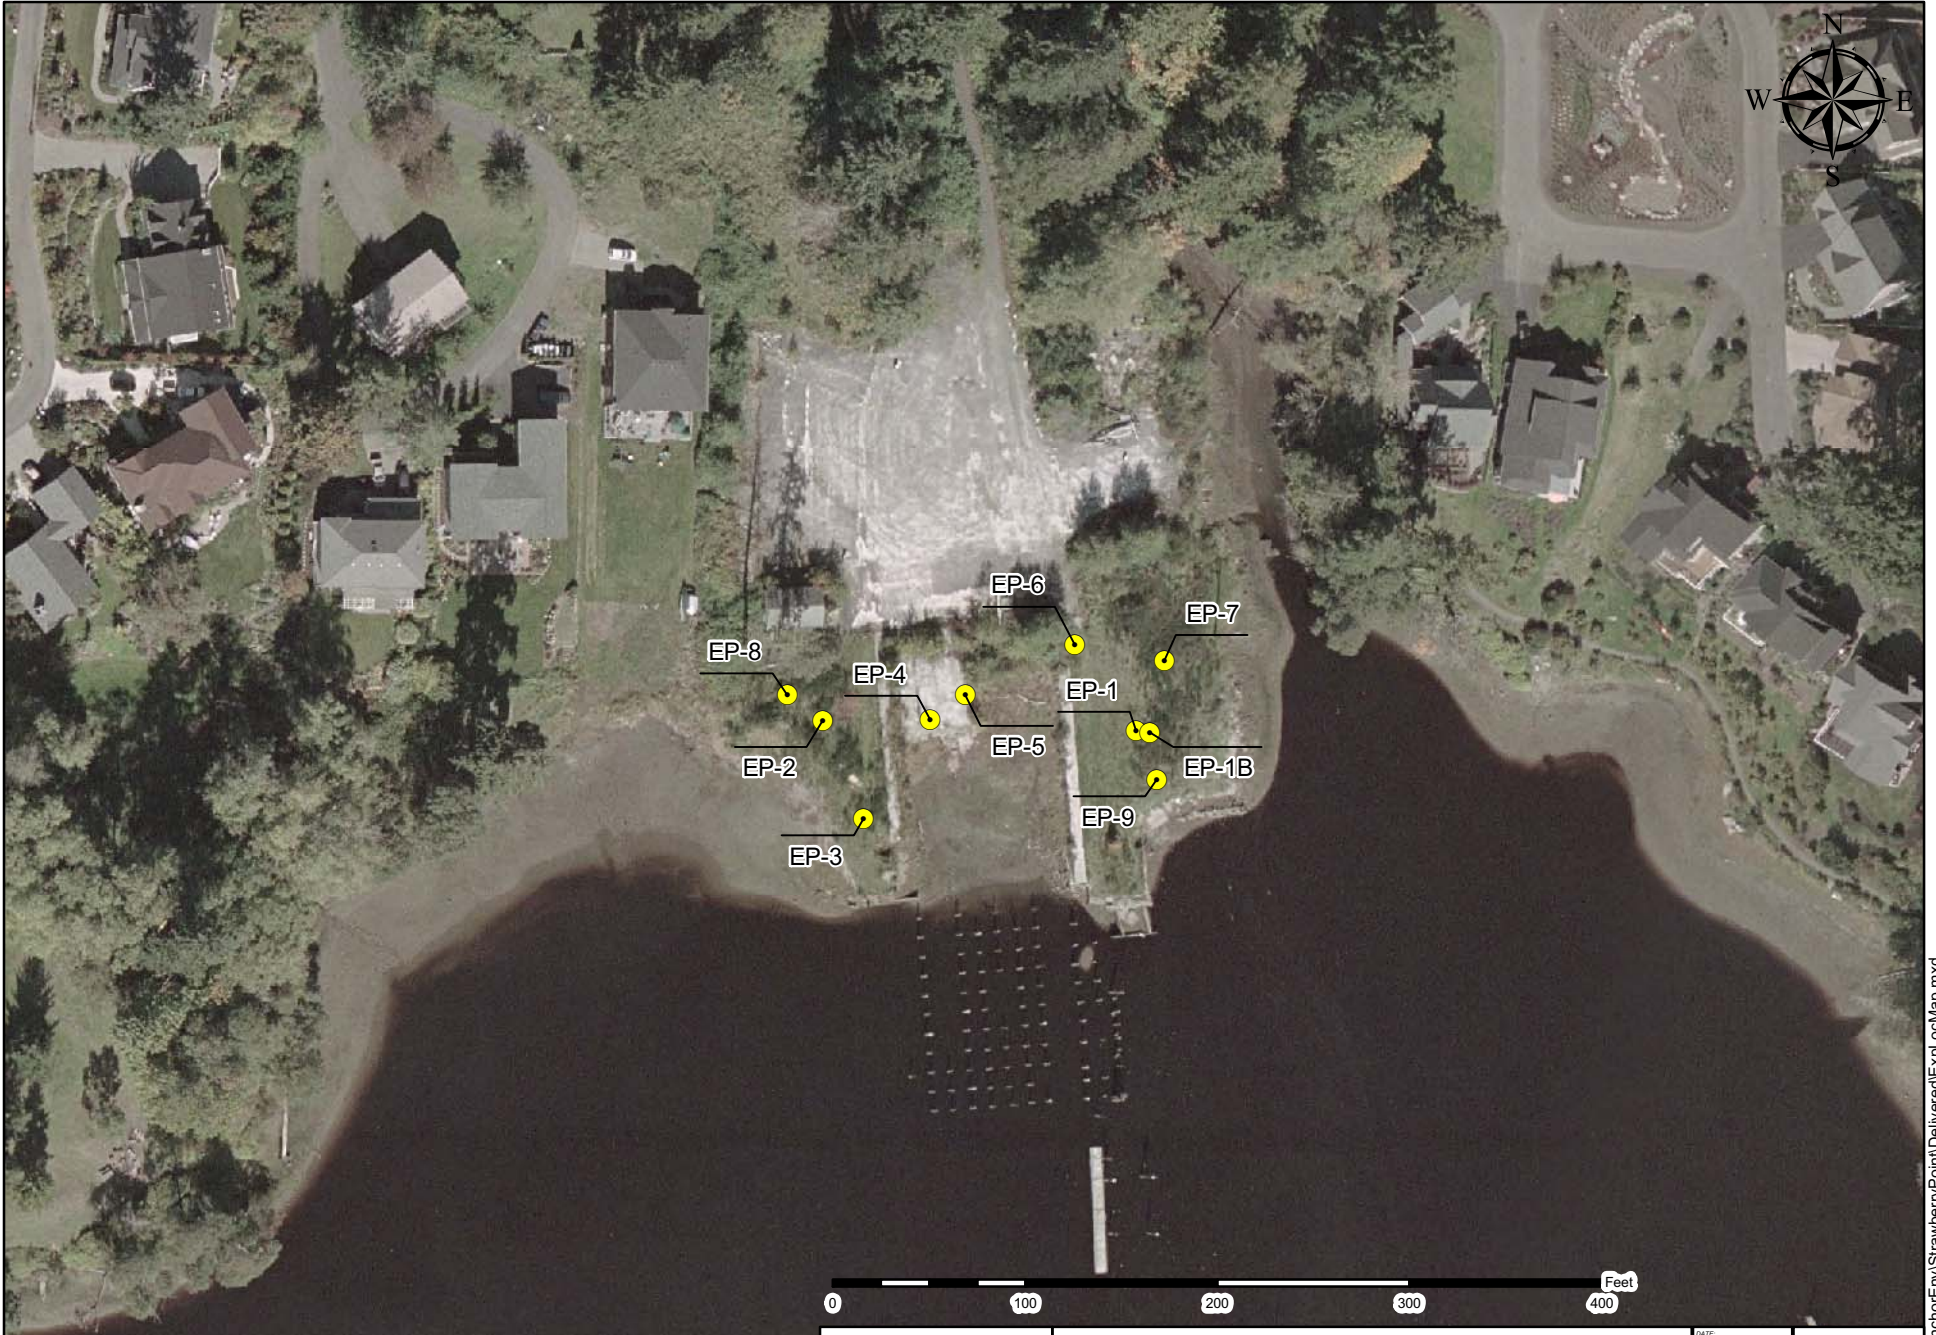
PROJECT NO.	080011
FIGURE NO.	1

On August 25, 2008, nine (9) direct-push soil probe exploration borings were accomplished. The approximate locations are shown on the attached Field Exploration Location Map. GPS coordinates obtained for the boring locations are as follows:

A groundwater sample was collected from boring EP-4 (see Figure 1) using a peristaltic pump and disposable polyethylene tubing. Low flow purging of groundwater (<500 milliliters per minute) from the boring was conducted to reduce the turbidity of the samples. Groundwater samples were discharged directly into laboratory-supplied containers. Due to the tide dependence of groundwater elevation at the Site, no groundwater elevations were surveyed within the scope of this work.

Exploration Location Map
