**Re: Opinion on Proposed Cleanup of the following Site:**

- **Site Name:** Lacey Urban Center
- **Site Address:** 7131 - 7239 Martin Way E, Olympia, Thurston County, WA 98516
- **Facility/Site ID:** 67913
- **Cleanup Site ID:** 15414
- **VCP Project ID:** SW1745

Diagrams and Tables of the Site

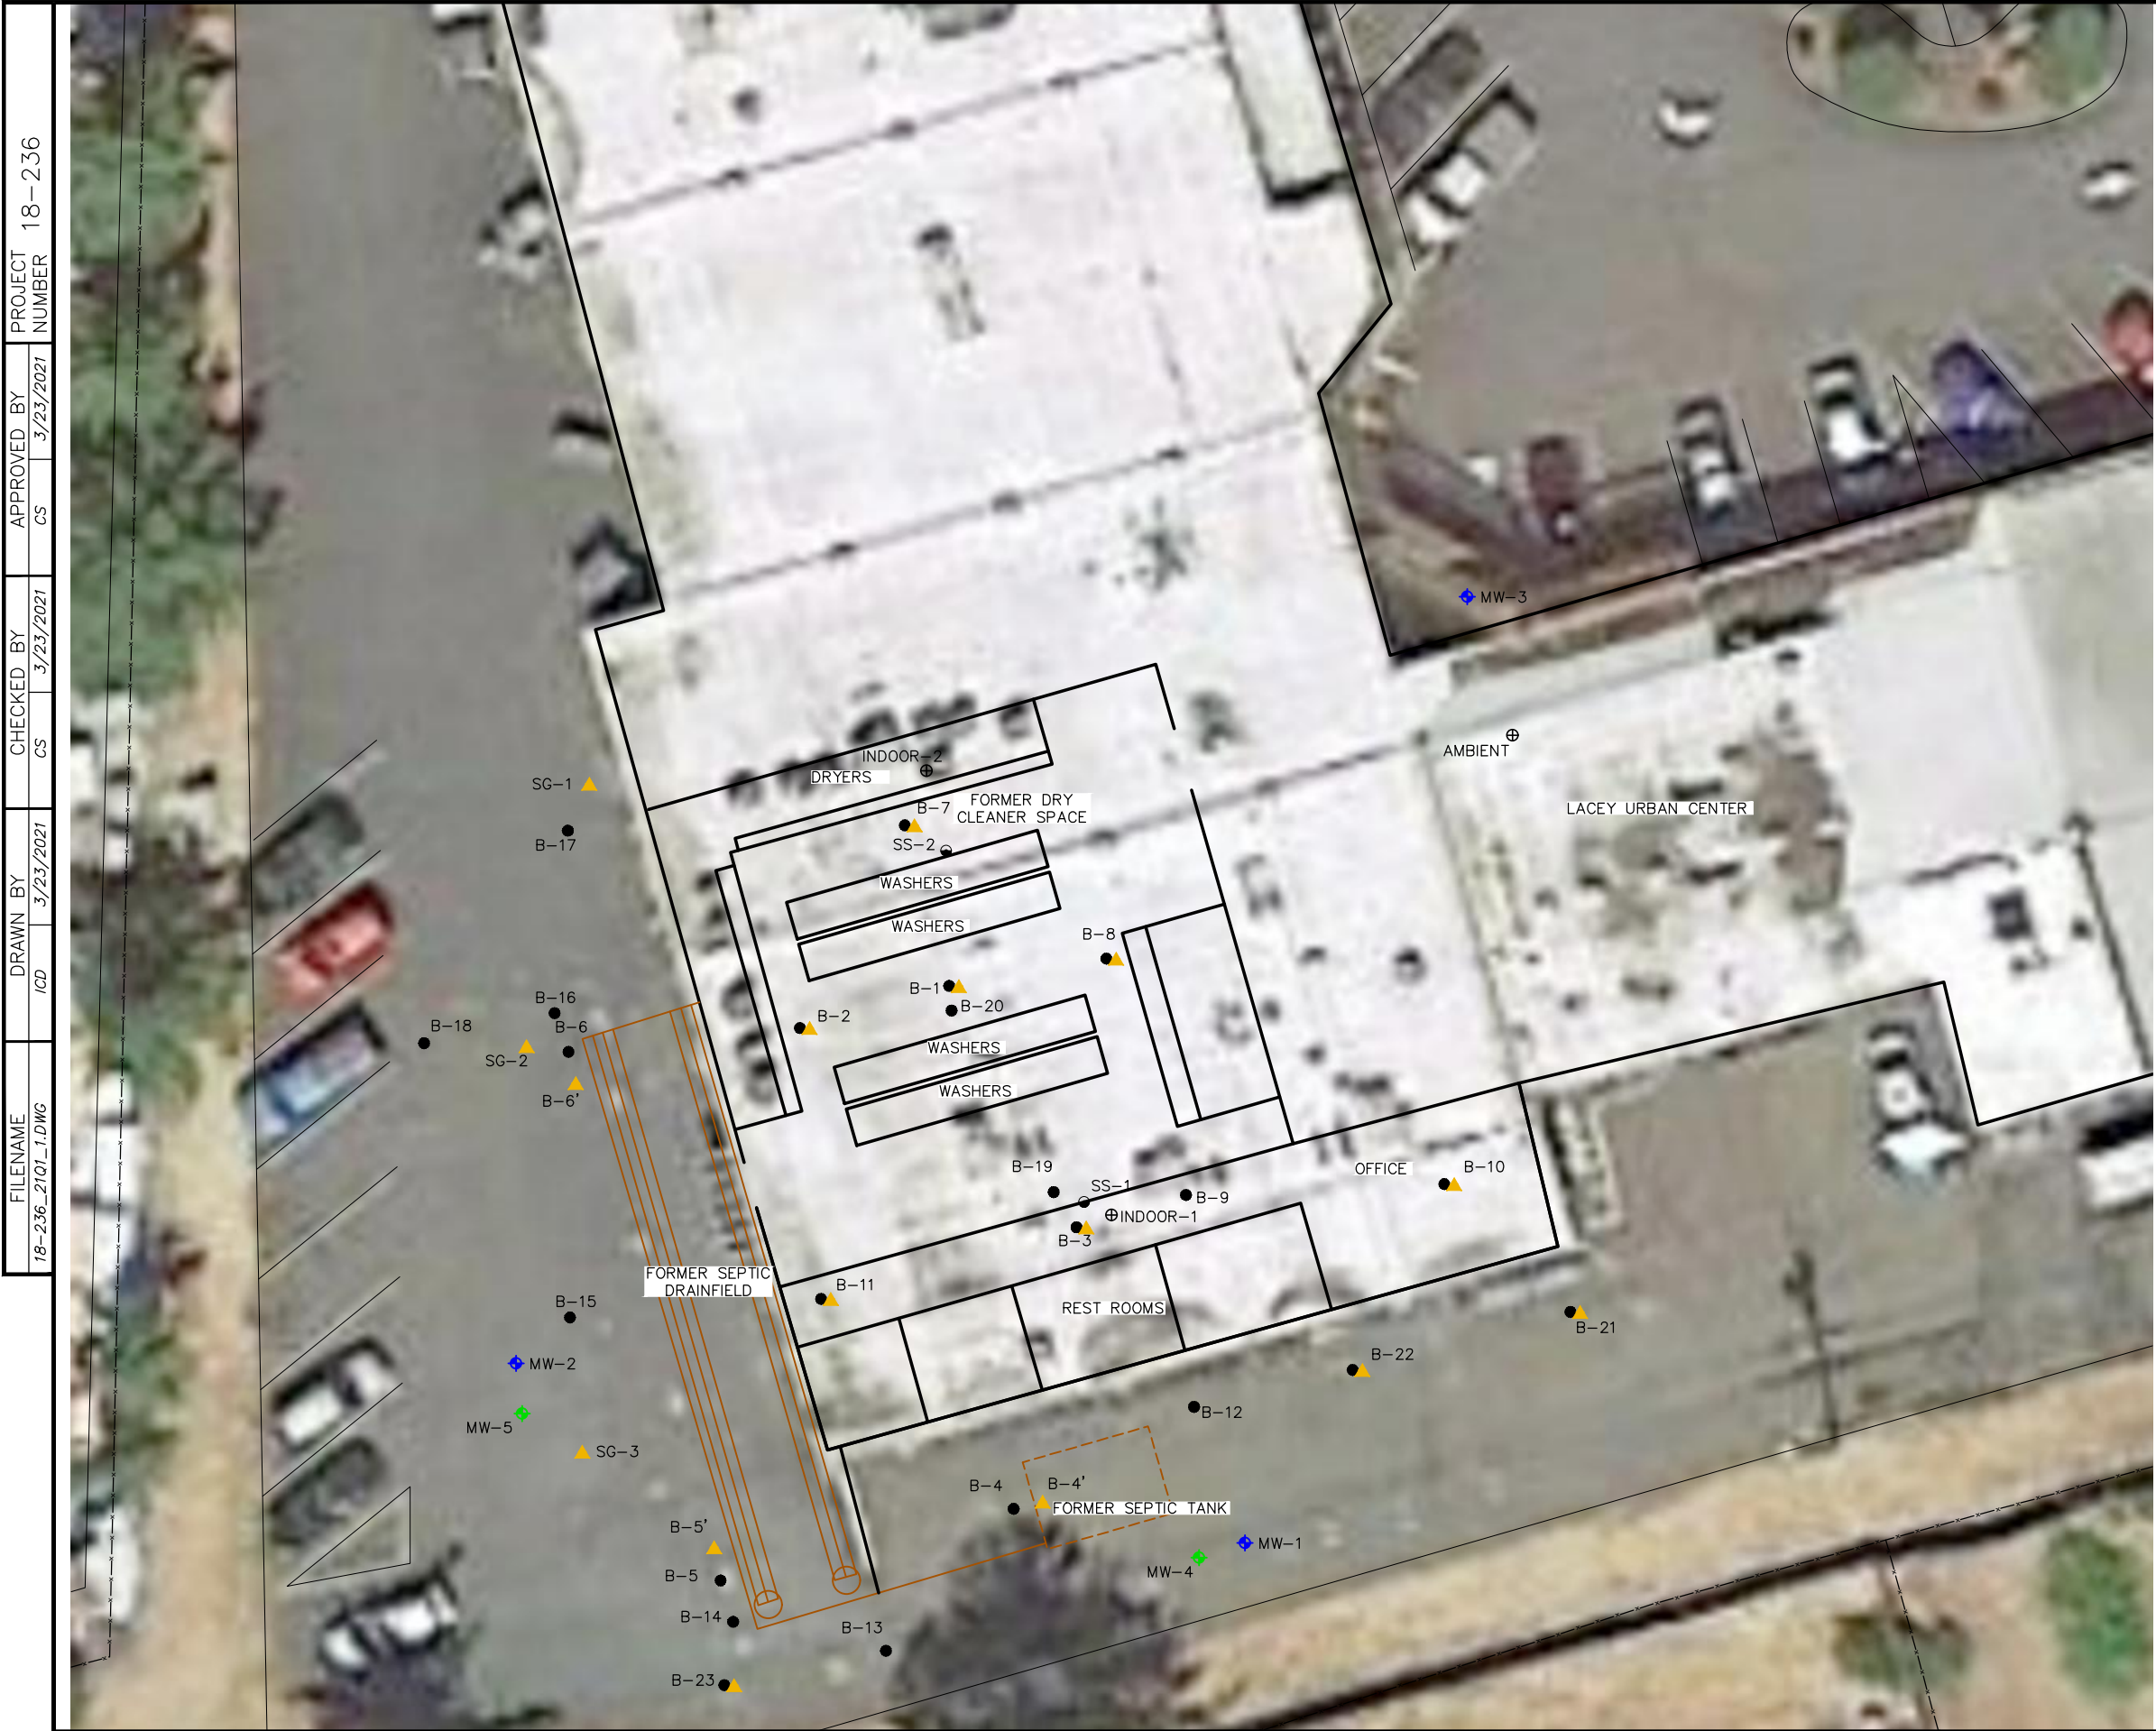
FIGURE 2  
SITE MAP

Figure 2.....Site Map

In July 2018, Envitech advanced 18 soil borings (B-1 through B-18) and collected 11 soil gas borings (SG1 through SG11) to determine whether a release had occurred from the former dry-cleaning operation. Soil samples were collected from each boring, soil gas samples were collected from ten borings (B-1 through B-8, B-10, and B-11), and groundwater was sampled from one boring (B-14) at about 26 feet below ground surface (bgs). Analytical results indicated the presence of PCE in soil and soil gas samples above MTCA Method A/B cleanup screening levels (AEG Table 4, Figure 4).

In July 2020, AEG advanced additional borings to complete the remedial investigation. Two borings (B-19 and B-20) were advanced inside the laundromat adjacent to borings B-3 and B-1, respectively, to define the vertical extent of PCE in soil. Borings B-21, B-22, and B-23, and monitoring well MW-1 were advanced on the south and southwest sides of the building to laterally define the extent of PCE in soil. Three soil gas borings (SG-1, SG-2, and SG-3) were advanced west of the former leach field to laterally define soil gas impacts in this area, and soil gas samples SG-4, SG-5, and SG-6 were collected from borings B-23, B-22, and B-21, respectively, on the south side of the building to laterally define soil gas impacts in this area.

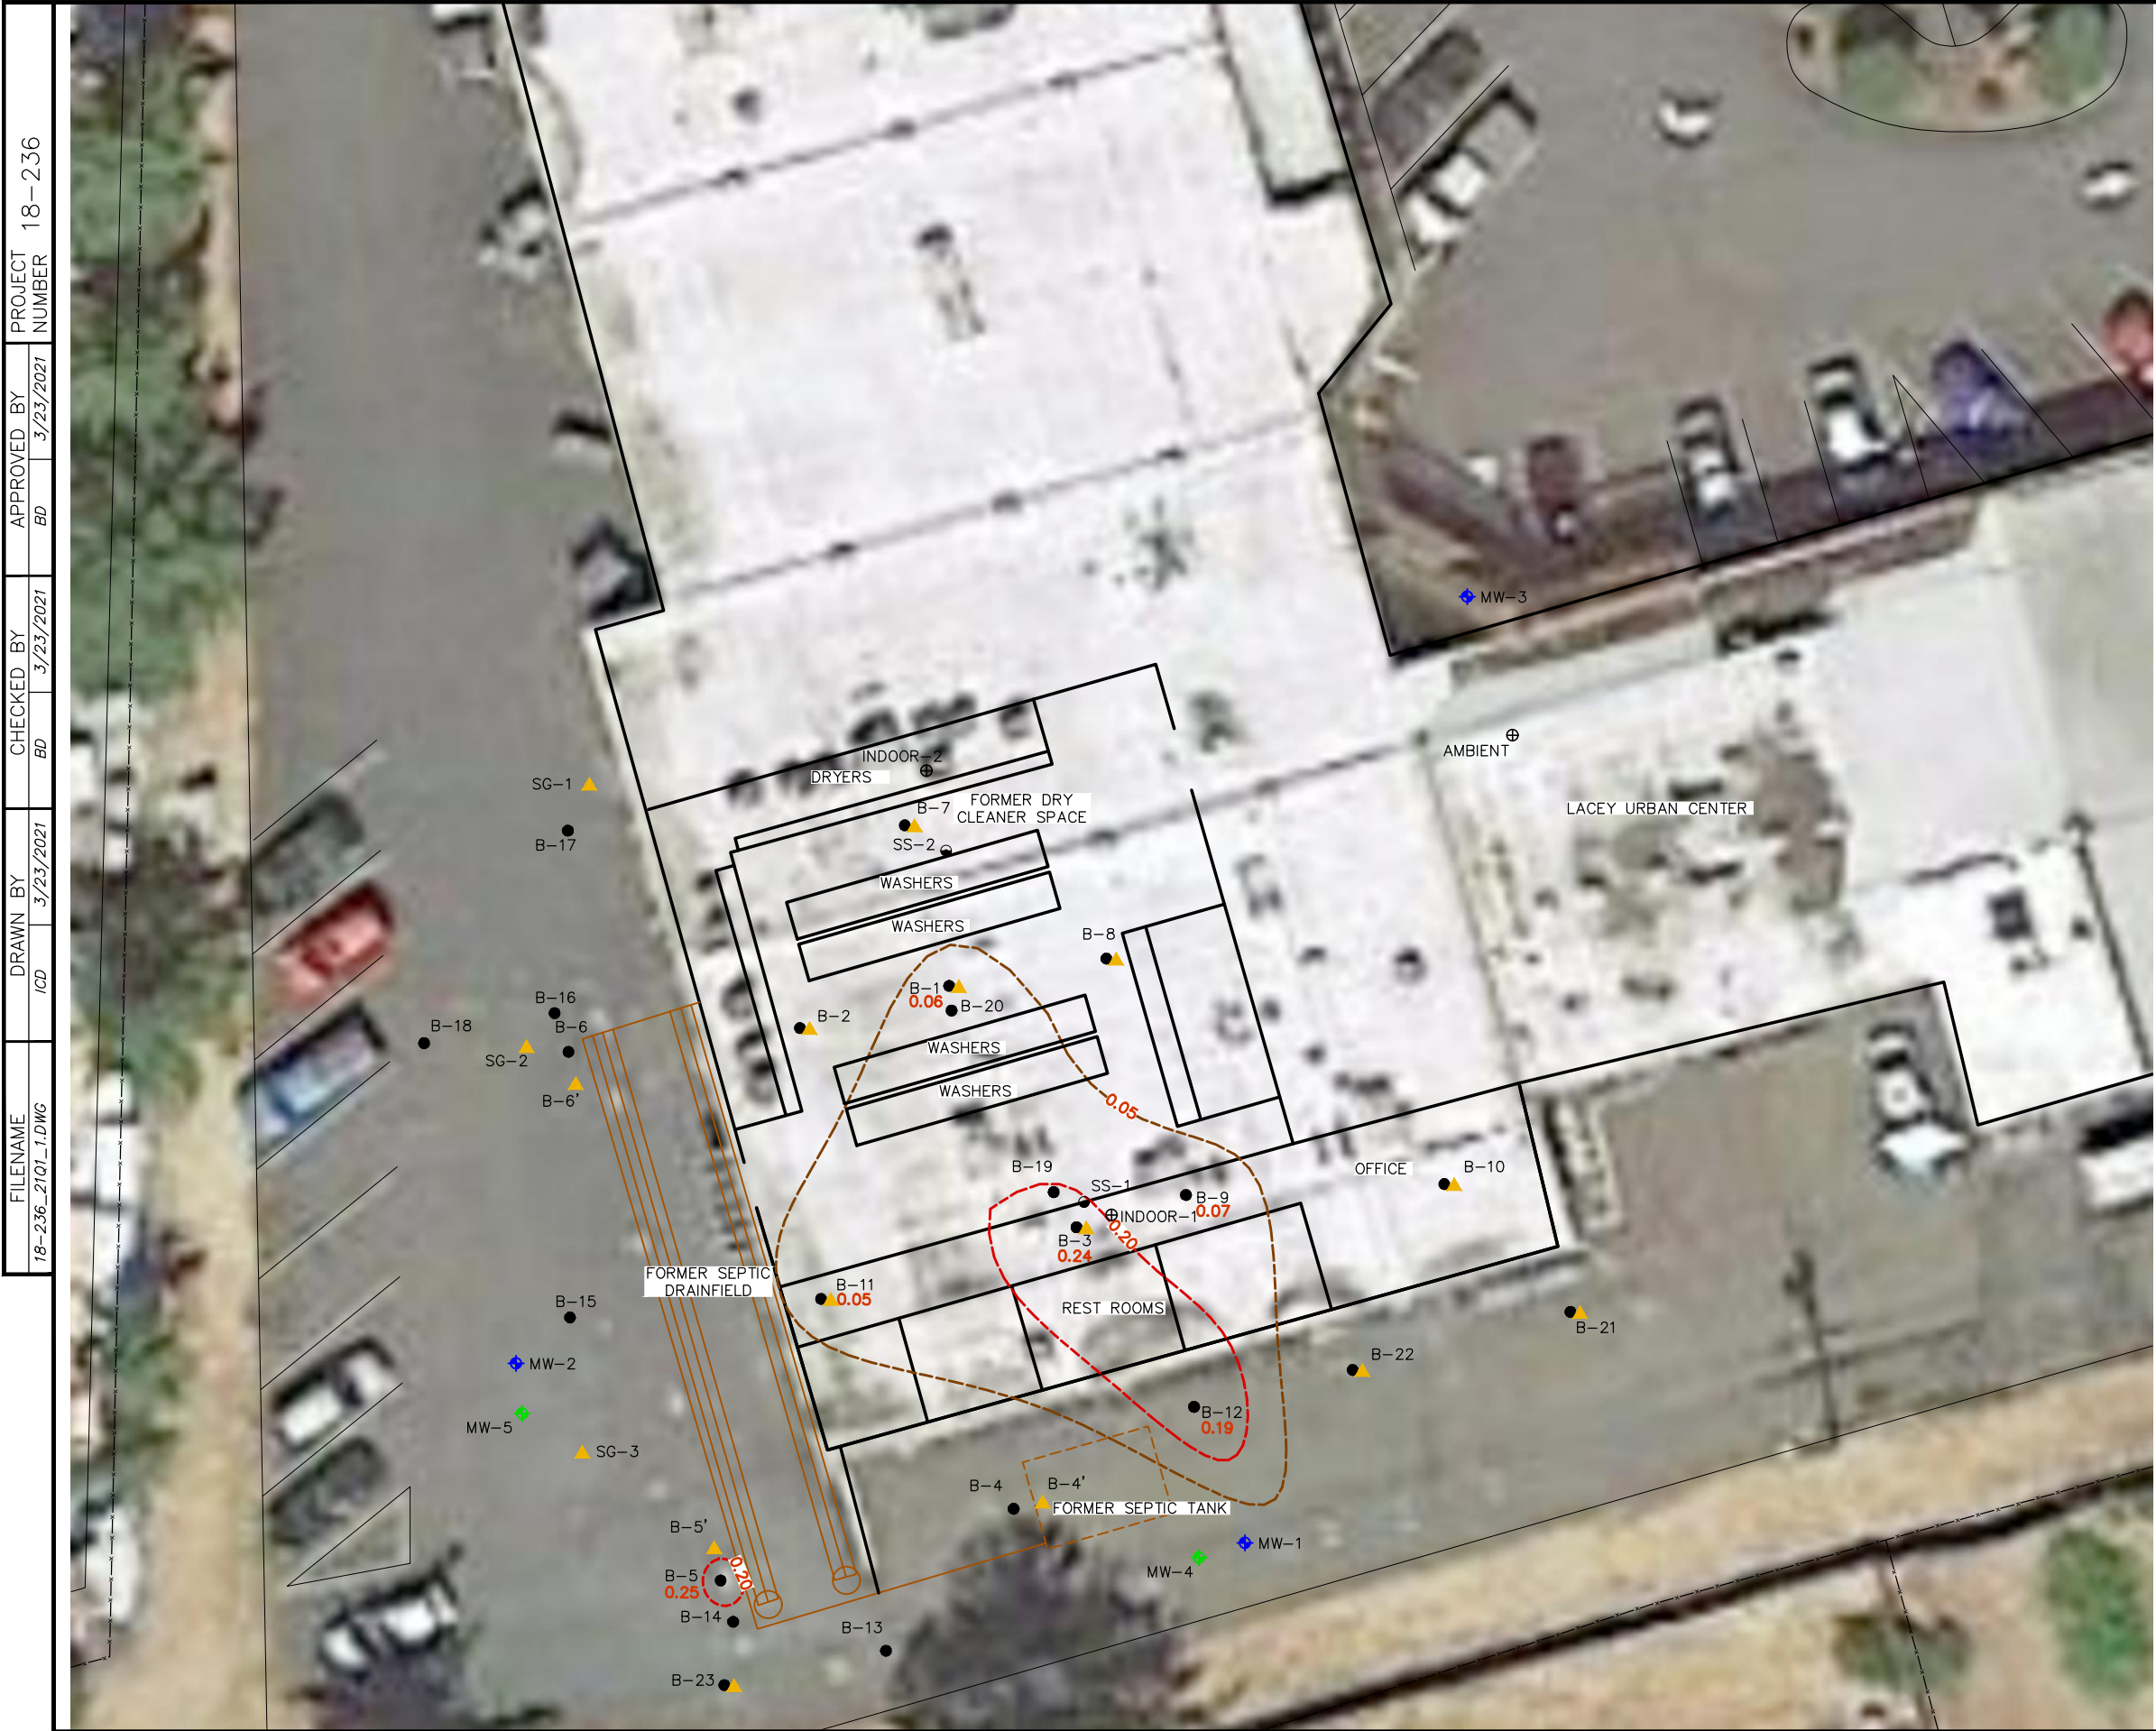
FIGURE 3  
PCE IN SOIL PLUME MAP

Figure 3.....PCE in Soil Plume Map

Three monitoring wells (MW-1, MW-2, and MW-3) were installed to determine potential impacts to shallow groundwater. Groundwater was encountered at about 31 feet bgs, and the monitoring wells were screened from 25 to 35 feet bgs. All samples were submitted for analysis for PCE and daughter products. Laboratory results for all constituents analyzed in soil, groundwater, and soil gas samples were either non-detect or were detected below their respective MTCA Method A/B cleanup screening levels (AEG Table 1, Figure 3).

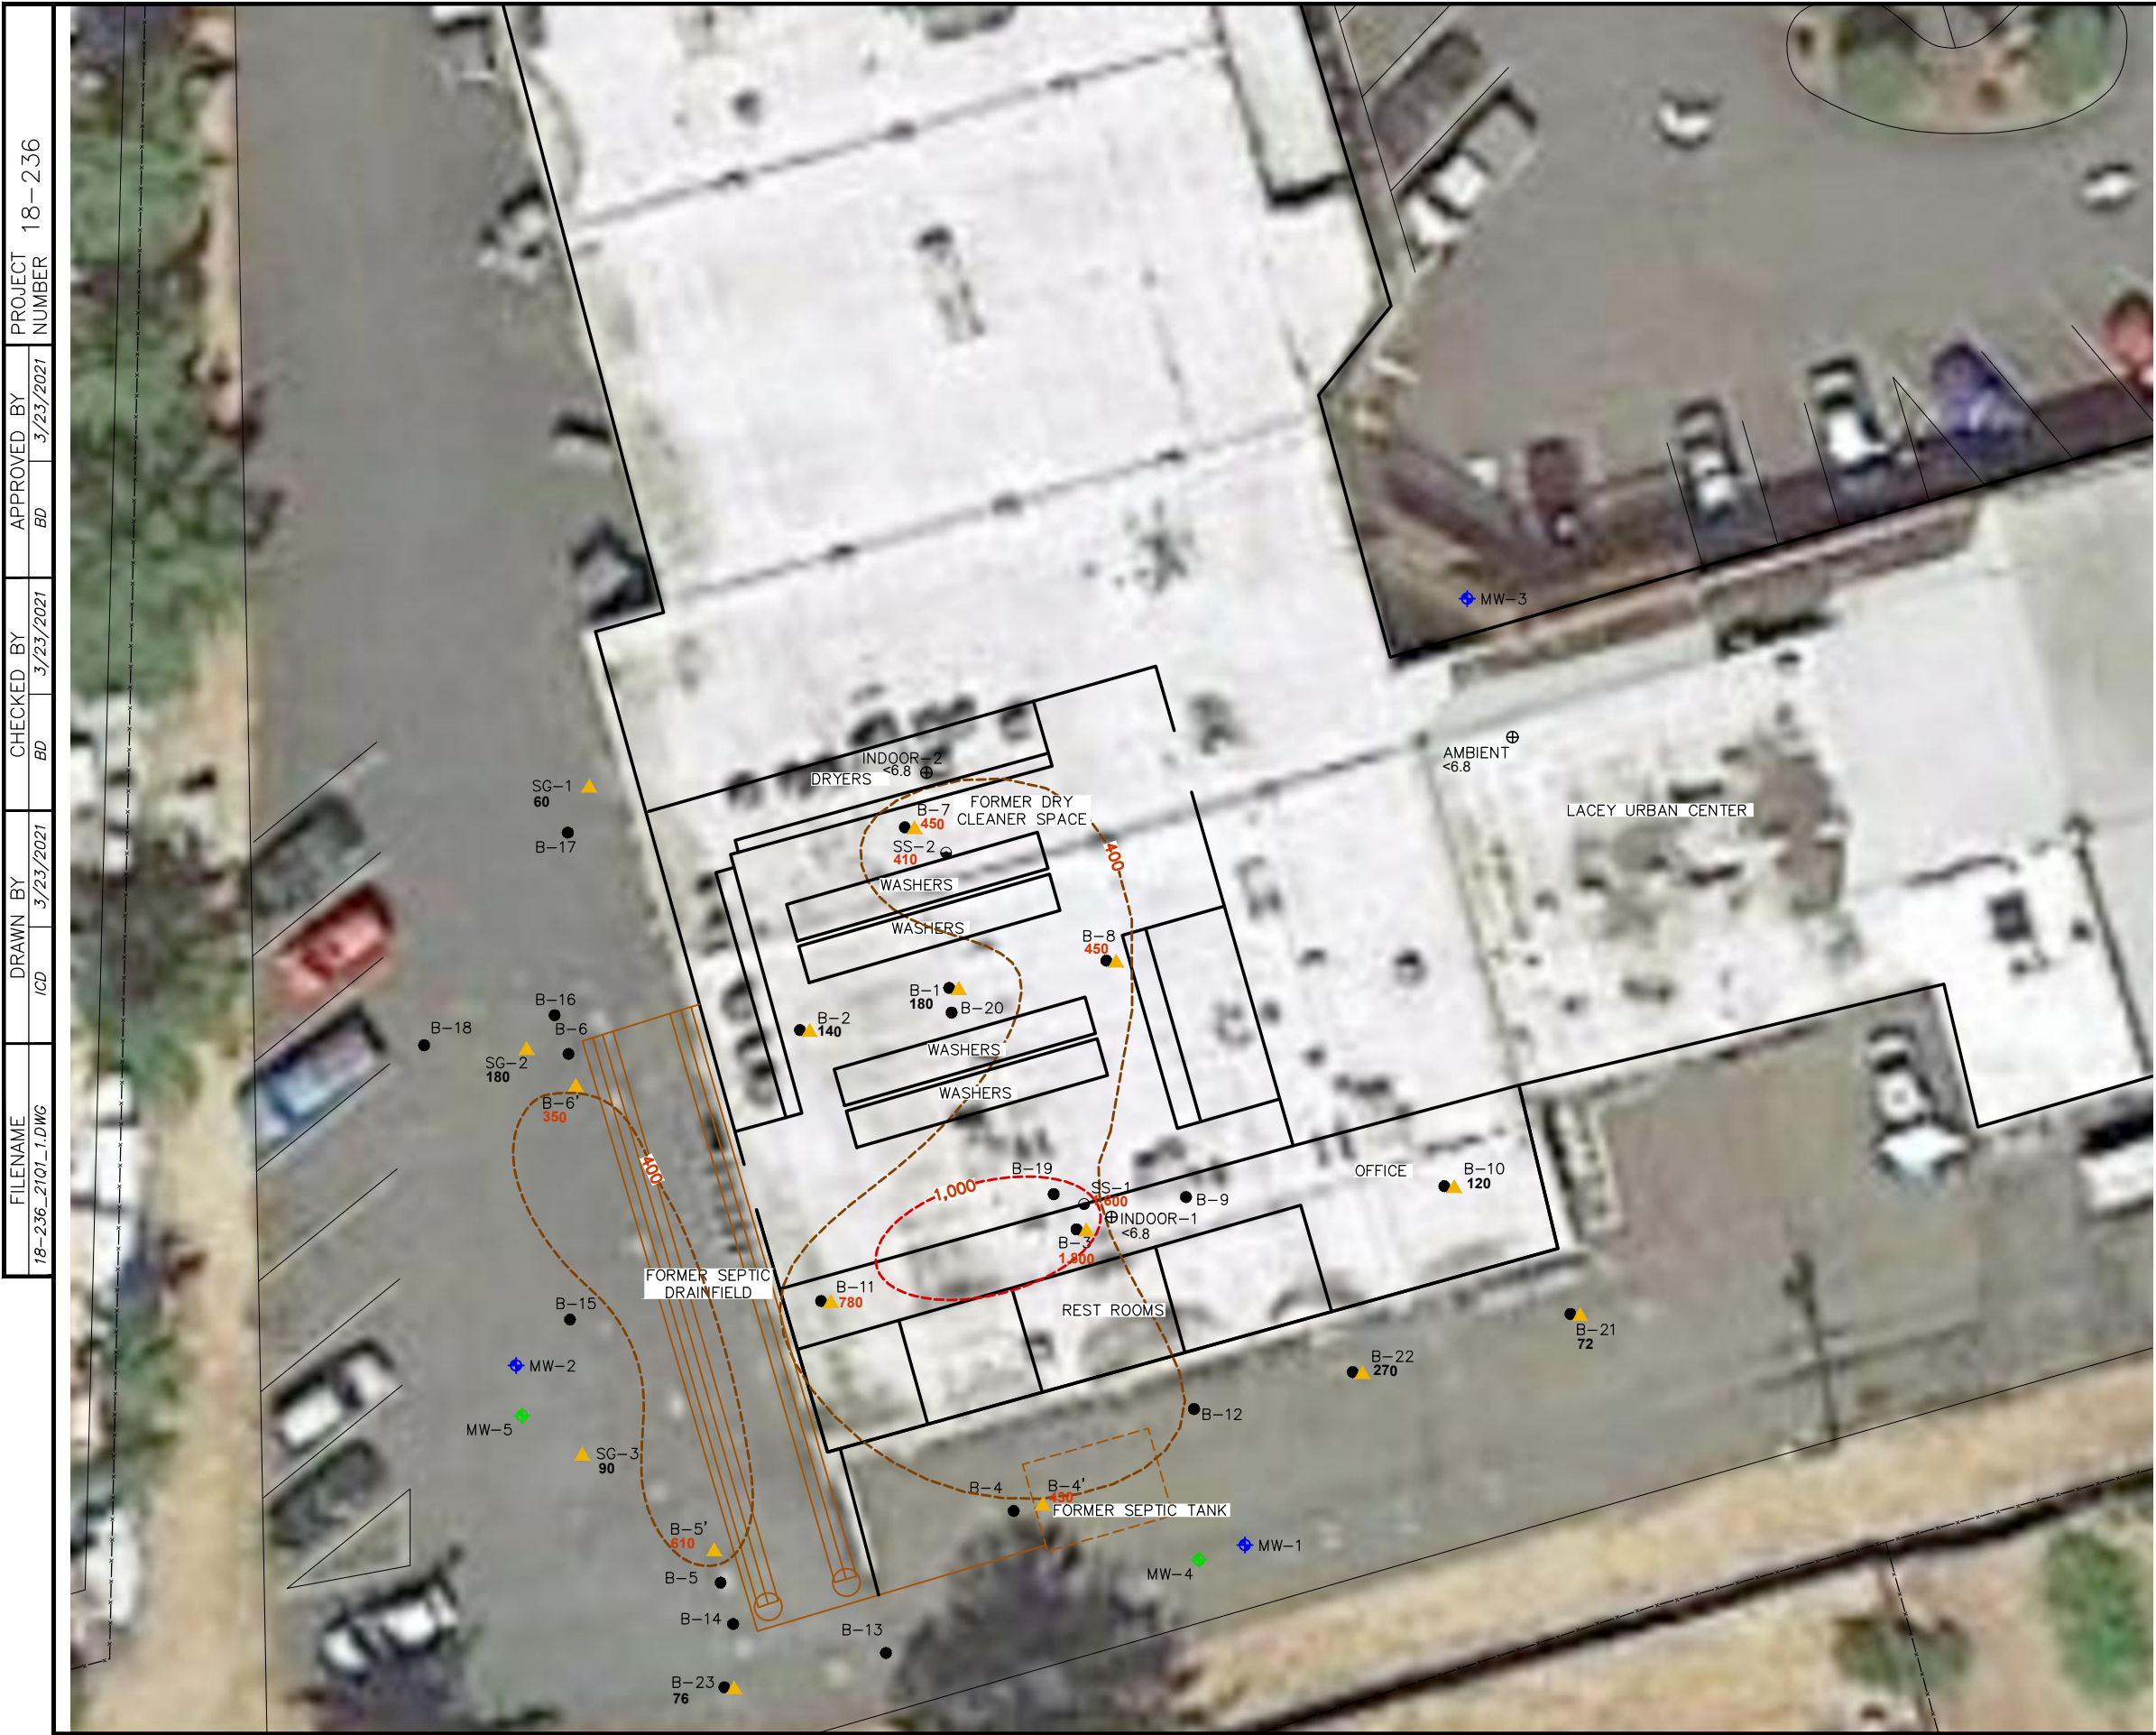
FIGURE 4  
PCE IN SOIL VAPOR PLUME MAP

Figure 4.....PCE in Soil Vapor Plume Map
