Re.: MTCA Cleanup of Former Evergreen Fuel Facility Site

Oakland Bay Marina

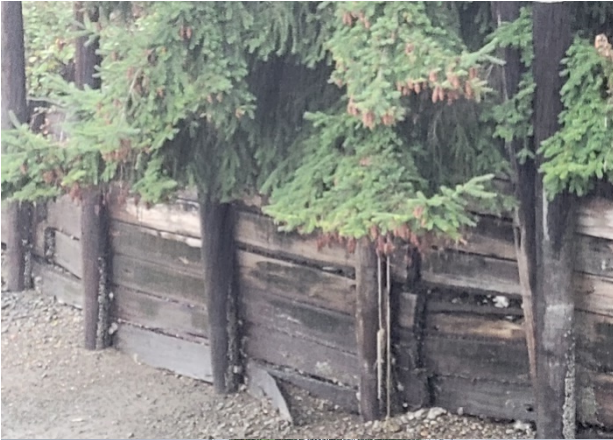
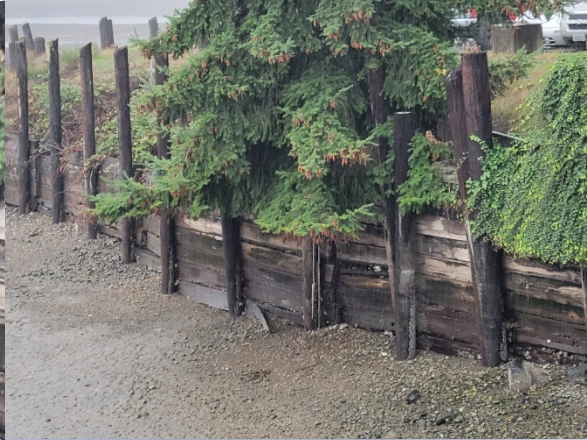
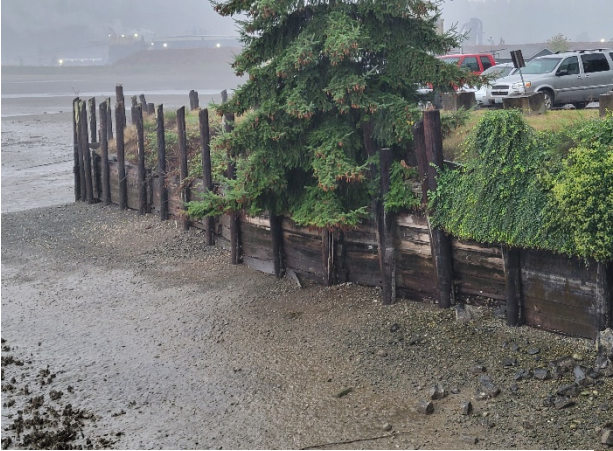
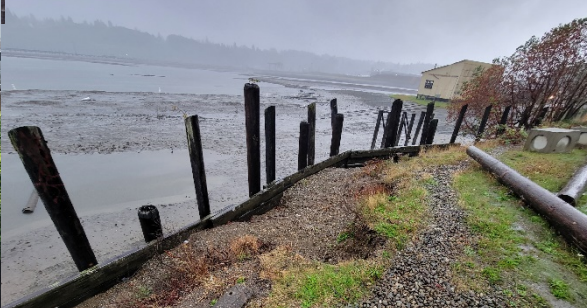
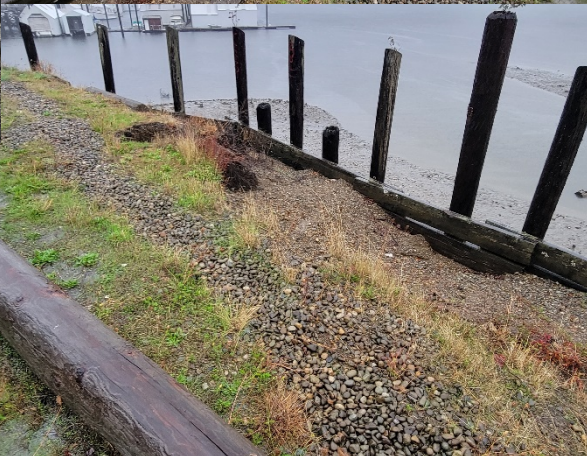
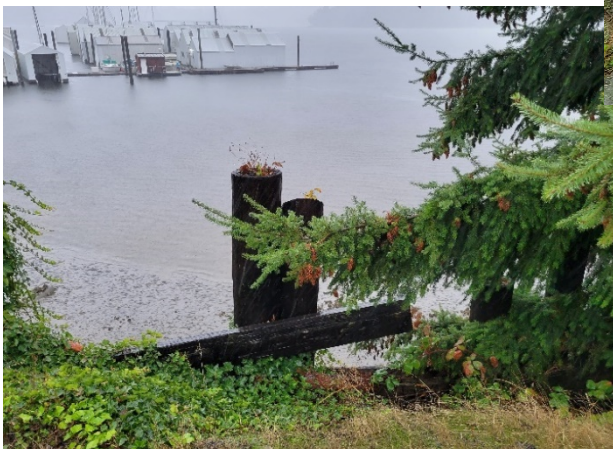
Since the MTCA cleanup of the Evergreen Fuel Facility, the wall remnants have continued to deteriorate, and the remnants left are now in a state of imminent failure. This is not surprising because the wall was well beyond its structural life when the Port lowered the wall height to address obvious failures then. However, the remedial work completed only lowered the height and did not address the failing structural components and the remnants left are now failing altogether. The creosote lagging continues to rot and deteriorate as tidal waters routinely penetrate under, through, and over top of the creosote lagging. Soils are being washed from behind the remnants of the existing wall into Oakland Bay. The soldier piles have continued to rotate forward due to mounting hydraulic pressures and increasing soil weights behind the wall. Imminent failure of the wall could result in large sections falling into Oakland Bay releasing contaminated soils behind in a large event. Other sections will continue to allow materials to wash through the wall over time until an eventual failure occurs. The contaminated soils are not currently being contained now and continue to migrate into Oakland Bay. This could be further accelerated by a failure.

The following are attached pictures of the current conditions. Figure 5 from the Farallon Consulting Group is attached along with a cross section of the proposed work for your review. We look forward to reviewing this with you and hope that you will see the need to complete the encapsulation of the material left by the Port of Shelton and the MTCA cleanup effort. We are also hopeful for your approval so that this work can commence quickly to prevent further impact to Oakland Bay and so that it can be best coordinated with the adjacent habitat restoration work.

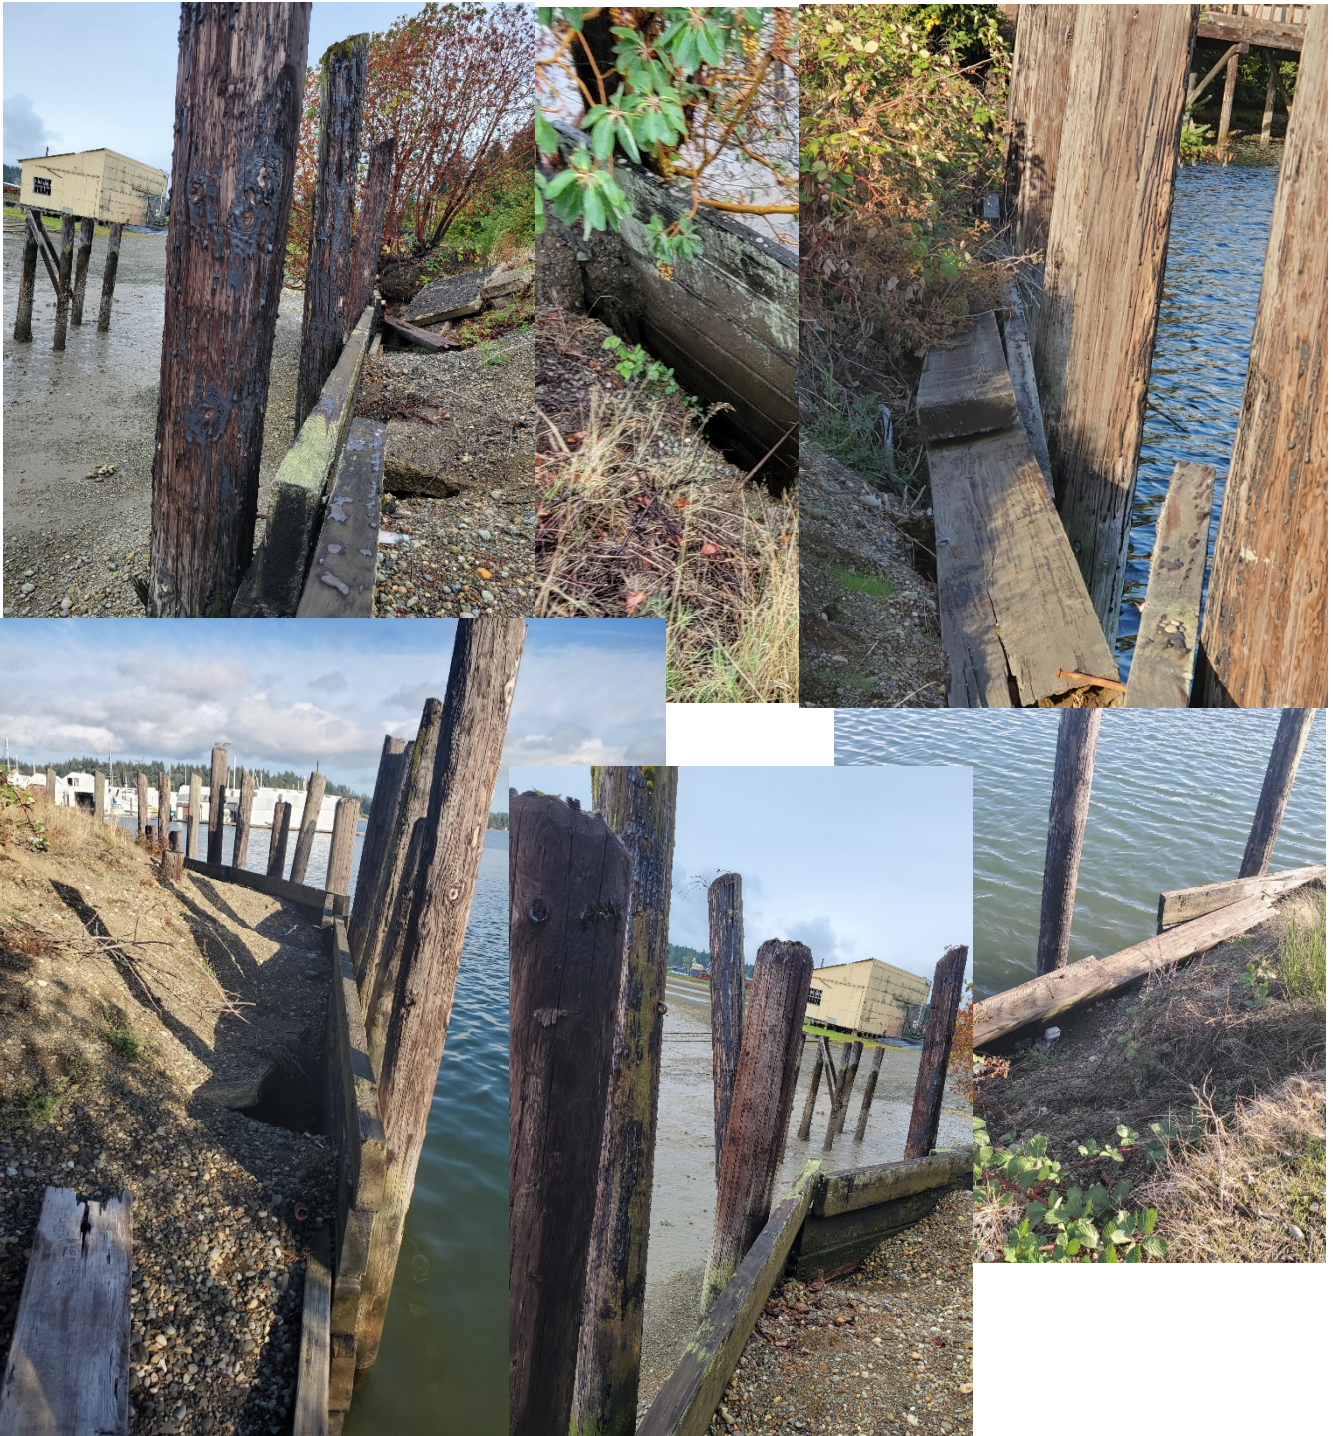
Figure 5 from Farallon Consulting shows an outline of the narrow ribbon of contaminated soils left. The exhibit also shows monitoring wells and recent results of site testing. While 4 of the 5 monitoring wells show conditions that have mitigated below MTCA limits, Monitoring Well No 10 remains above MTCA levels. This well is in an area of wall remnants showing signs of failure. Contaminated soils are currently migrating under and through the wall in this vicinity.

The improvements in the marina and the new boat launch being proposed by the project are very much needed to meet user demand within the community and to meet revenue needs for the project. However, despite the immediate need, the project is instead proposing to construct assigned mitigation improvements first. The adjacent habitat restoration work is proceeding towards completion. In coordination with the HR project, this proposal removes the last section of industrially damaged shoreline and completes the HR work by tying repairs completed by our partners into the adjacent natural shorelines of Oakland Bay. The entirety of the HR work is being completed on lands owned by the Shelton Yacht Club by our partners the Squaxin Tribe and the South Puget Sound Salmon Enhancement Group. We feel we have a responsibility to support the HR work and the efforts of our partners by competing the assigned mitigation work first. By repairing the damaged shorelines, the project proposes to contain the remaining contaminated soils by stabilizing the site and encapsulating them permanently until they have remediated over time.

We are also conscious of the risks during construction. The project proposes to cut off the exposed tops of the creosote soldier piles left by the Port. The tops of the existing creosote lagging are proposed to be removed a minimum of 2' below finished grade and disposed of. The areas in front of the wall remnant and behind the wall can then be constructed to desired grades with imported fill materials. Beach nourishment will be added to the top 2' of the shoreline repair to march the existing beach located to the north of the project. The uplands areas will be

constructed to grade leaving the ribbon of contaminated soils and creosote materials encapsulated in place. We suspect that WSDOE monitoring via the existing monitoring wells will continue until the ribbon of soil left behind has been shown to have remediated itself.
