RE: Final RI/FS report for the JELD-WEN/Former Nord Door Site, Everett, WA
FSID Number: 2757 and CSID Number: 4402

Final Remedial Investigation/Feasibility Study

Jeld Wen / Former Nord Door Facility
300 West Marine View Drive
Everett, Washington 98201

December 2021

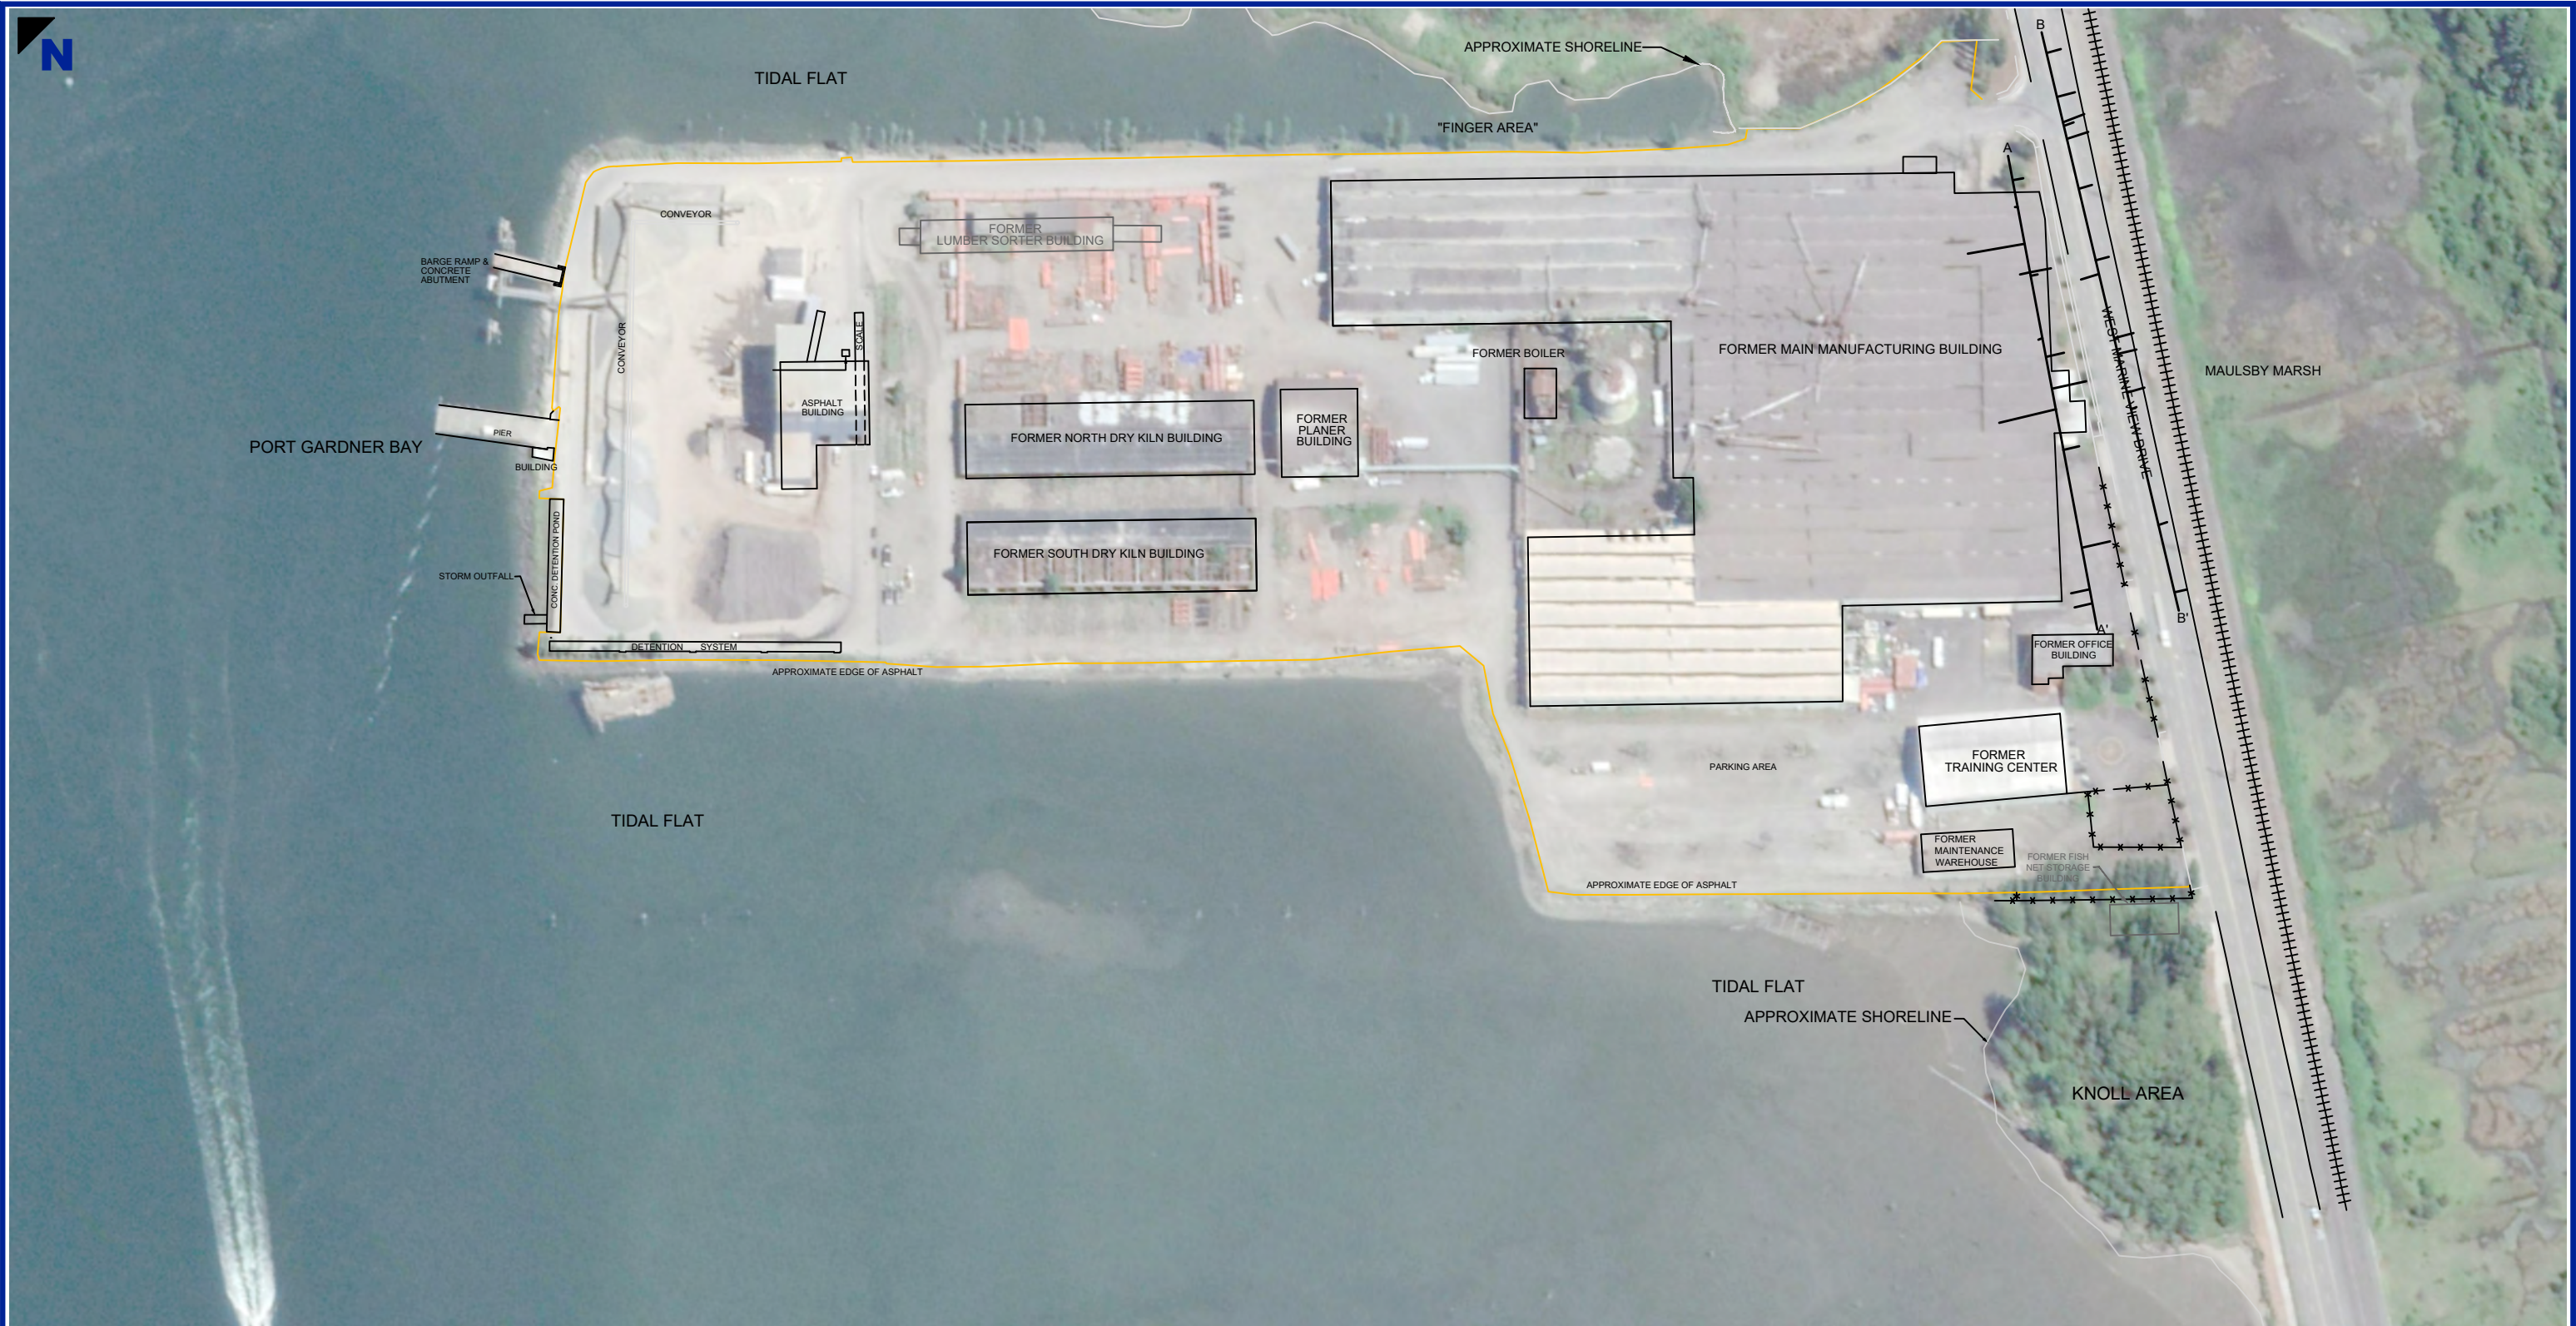
Date	MARCH 2021	Scale	AS SHOWN	Fig. No.	2.1-1
File Name	SITE_PLAN_NEW SYMBOLS	Project No.	108.00228.00061

The structures currently located on the former Nord Door portion of the Site include the following: the main manufacturing building, an office building, a training center building, a maintenance warehouse, a planer building, and two dry kiln buildings (Figure 2.1-1). These buildings have been subject to significant weathering and are not currently occupied. In addition, machinery including a hog fuel bin and other pieces of equipment (most seems to have reached design life) remain outside the northwest portion of the main manufacturing building.

The buildings and surrounding paved areas on the former Nord Door portion of the Site are currently leased to industrial tenants. The former main manufacturing building located on the eastern portion of the Site has remained primarily vacant, with intermittent use as a storage facility. The northeastern portion of the Site (approximately 6.1 acres) is currently leased to Cadman. The Cadman (leased) portion of the Site operates as an asphalt batch plant. The main structures on this portion of the Site include an approximately four-story asphalt building, feeder shed, and a conveyor system. Numerous aggregate piles are located around the perimeter of the Cadman portion of the Site. A conveyor system connects from the barge dock located at the north end of the Site to the aggregate piles. Aggregate is transferred via wheel-loader from the storage piles to feeders located on the north side of the plant. The feeders convey aggregate to the dryers and mixing towers. These features are shown on Figure 2.1-1.

Based on a review of historical aerial photographs and Sanborn maps (Appendix A), it appears that the original boiler for the Nord Door facility was an oil-fired boiler located near Norton Avenue (now West Marine View Drive). The 1955 aerial photograph and the 1957 Sanborn Map show that the former pole treating plant had been removed from the Site and the boiler for the Nord Door facility was a wood-fired boiler. Sometime prior to 1968, the wood-fired boiler was moved to its current location in the center of the Site adjacent to the main manufacturing building (Figure 2.1-1).

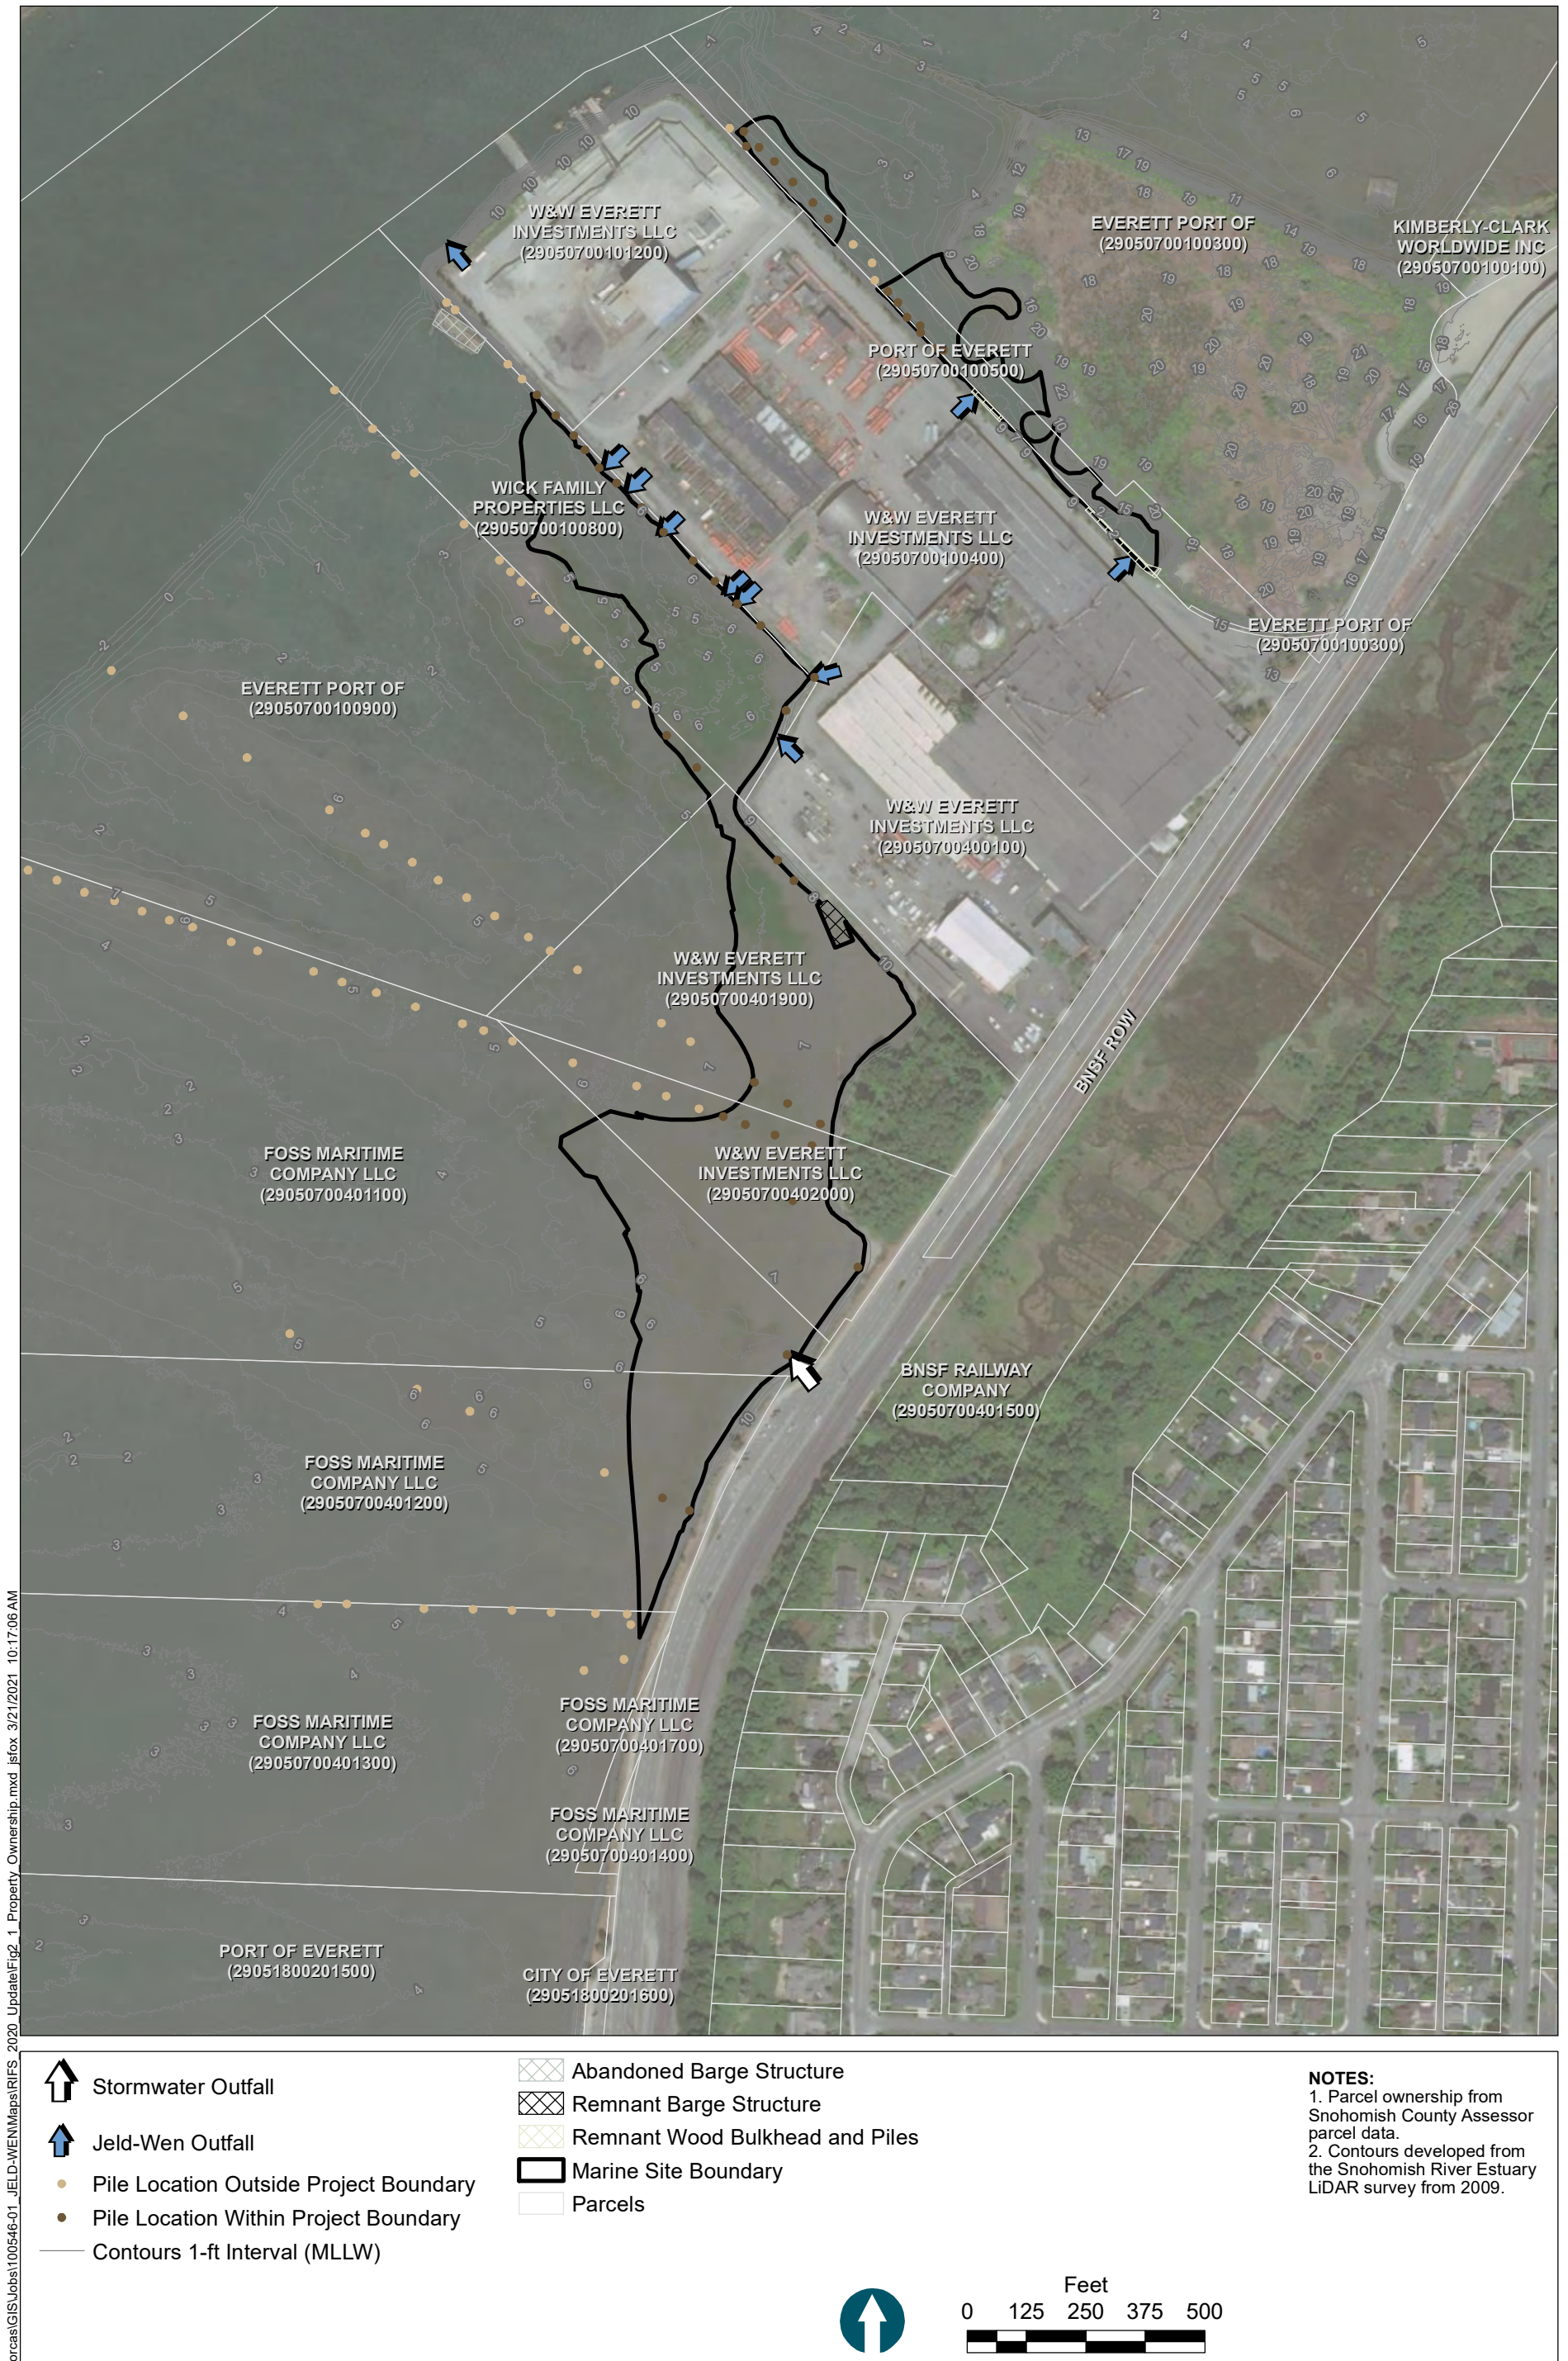
Door operations but nonetheless are considered part of the Site. Surrounding parcels and property owners are shown on Figure 2.1-2.

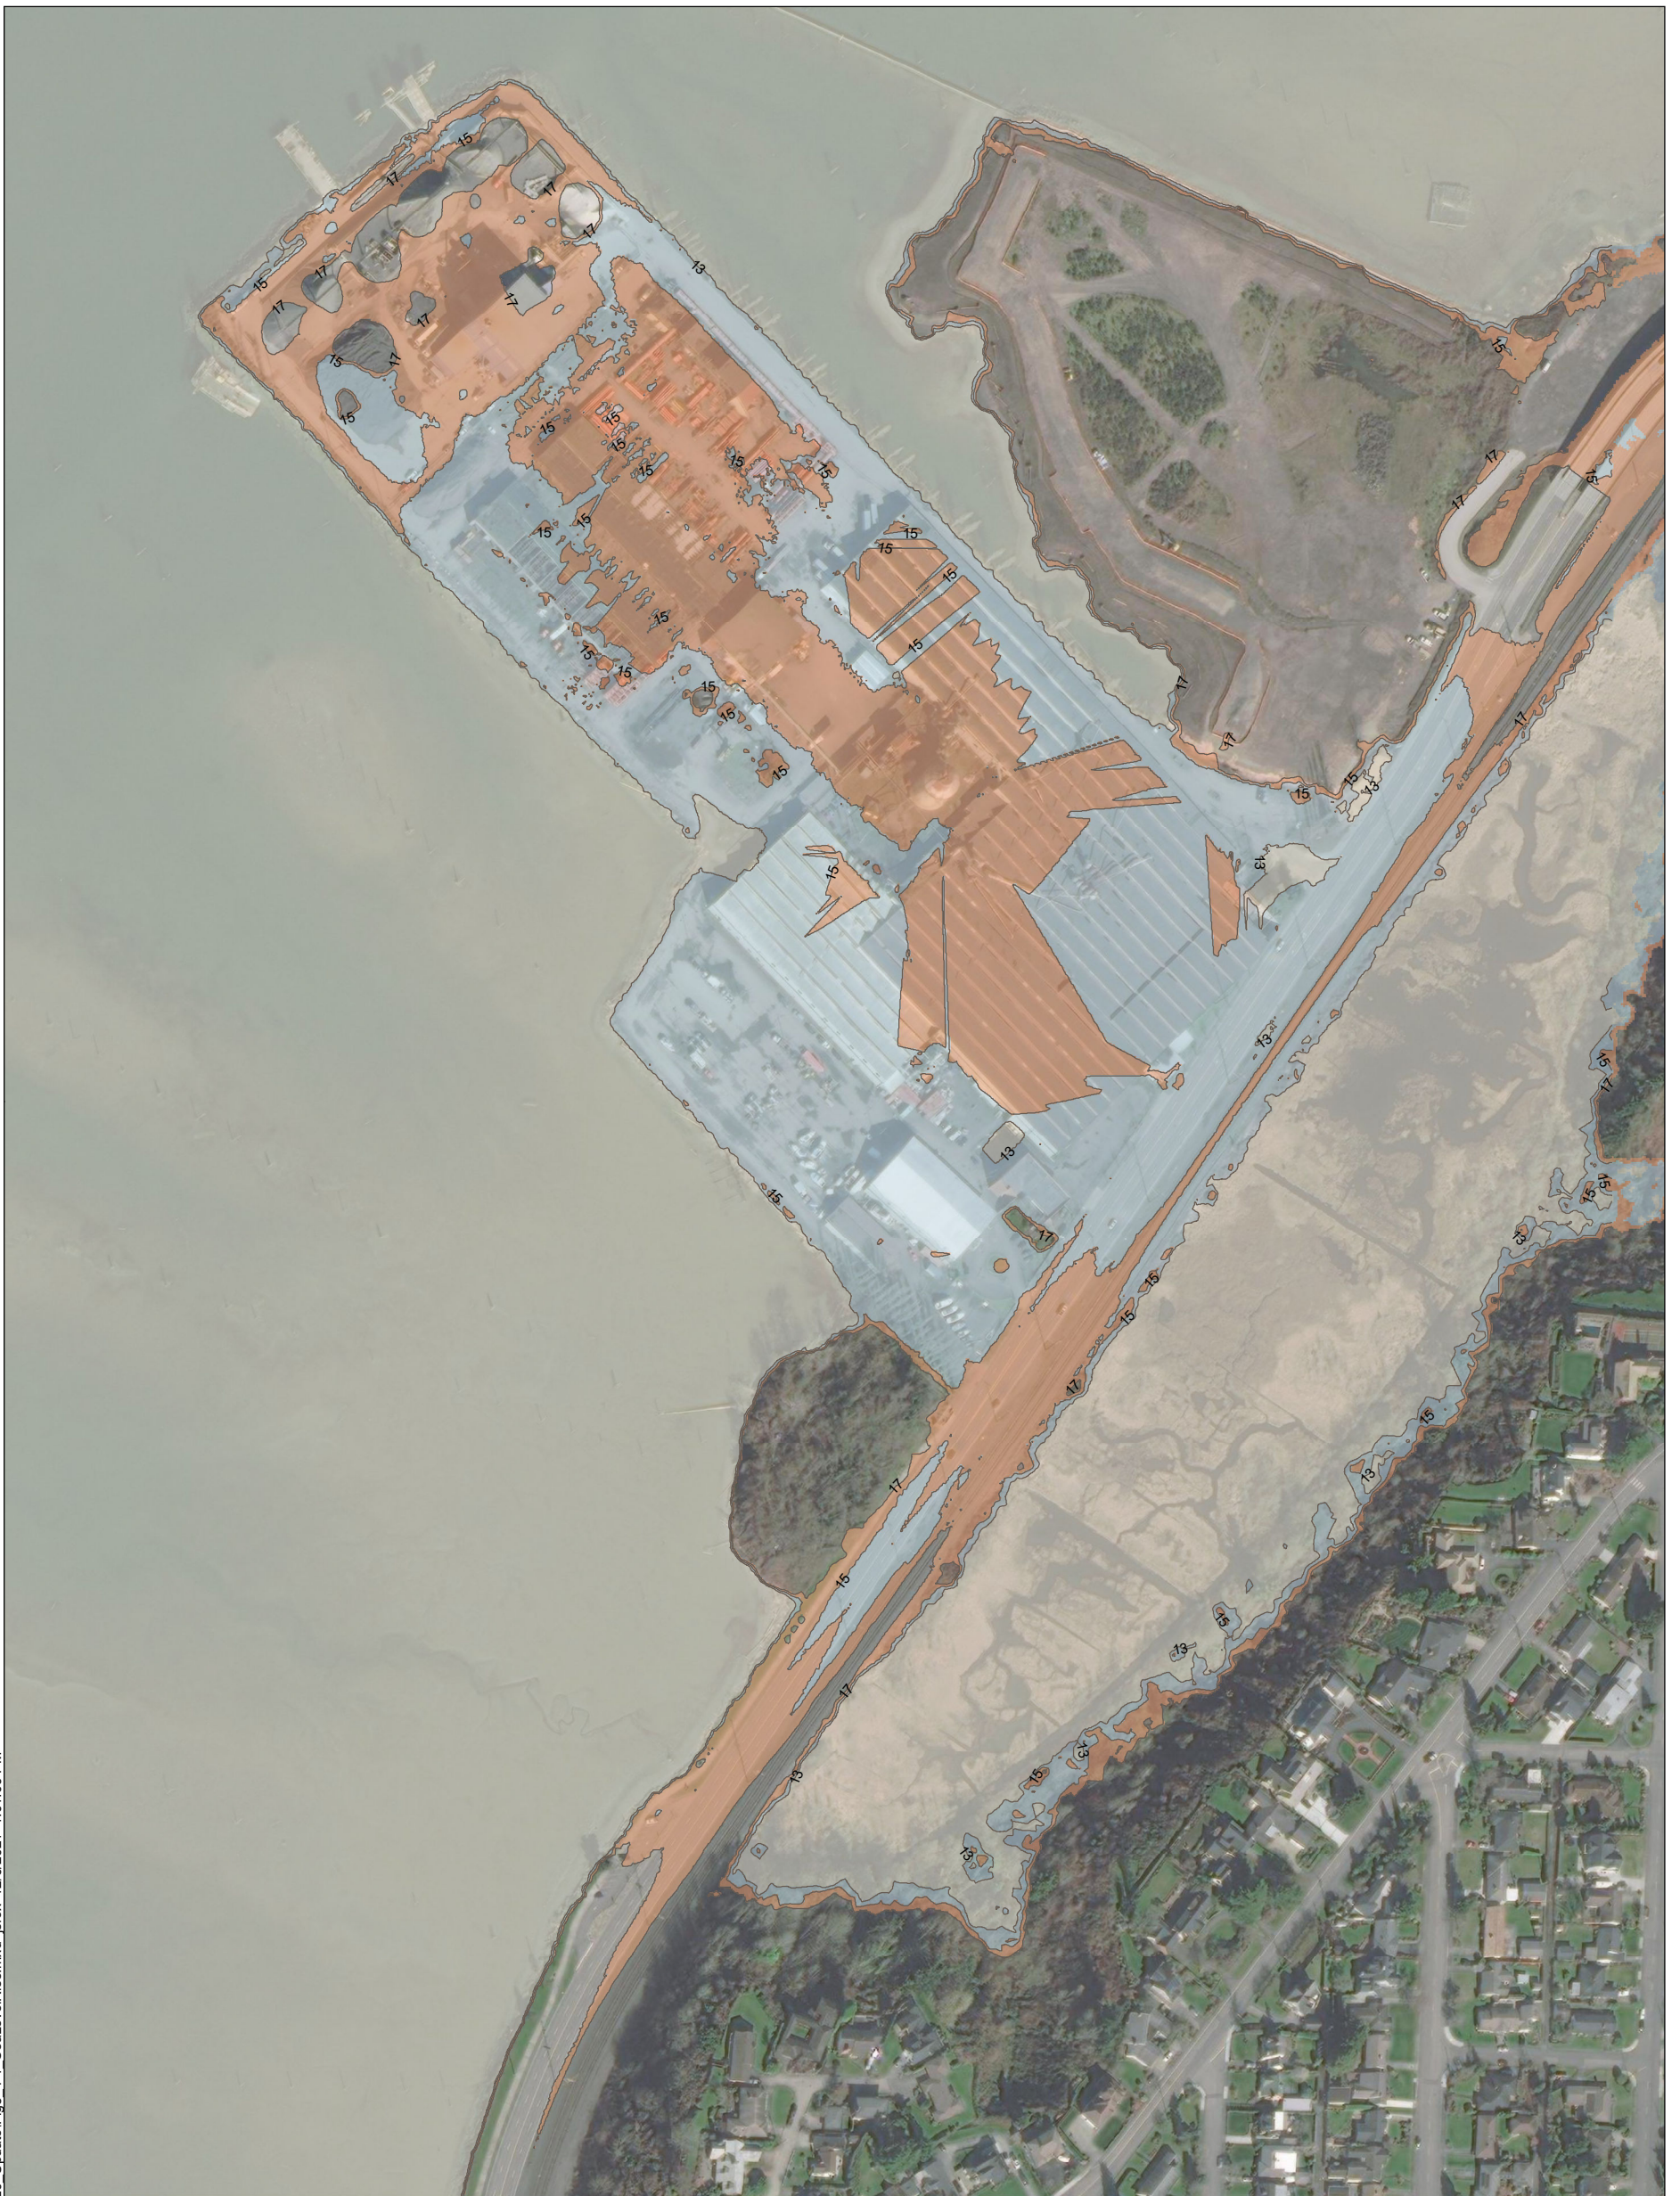
- Sea Level Rise Contours in feet (MLLW)
- Inundation Levels
 - < 13 ft MLLW (~2 ft of Sea Level Rise)
 - 13.1 - 15 ft MLLW (~4 ft of Sea Level Rise)
 - 15.1 - 17 ft MLLW (~6 ft of Sea Level Rise)

NOTES:
1. Contours developed from the Snohomish River Estuary LiDAR survey from 2009.

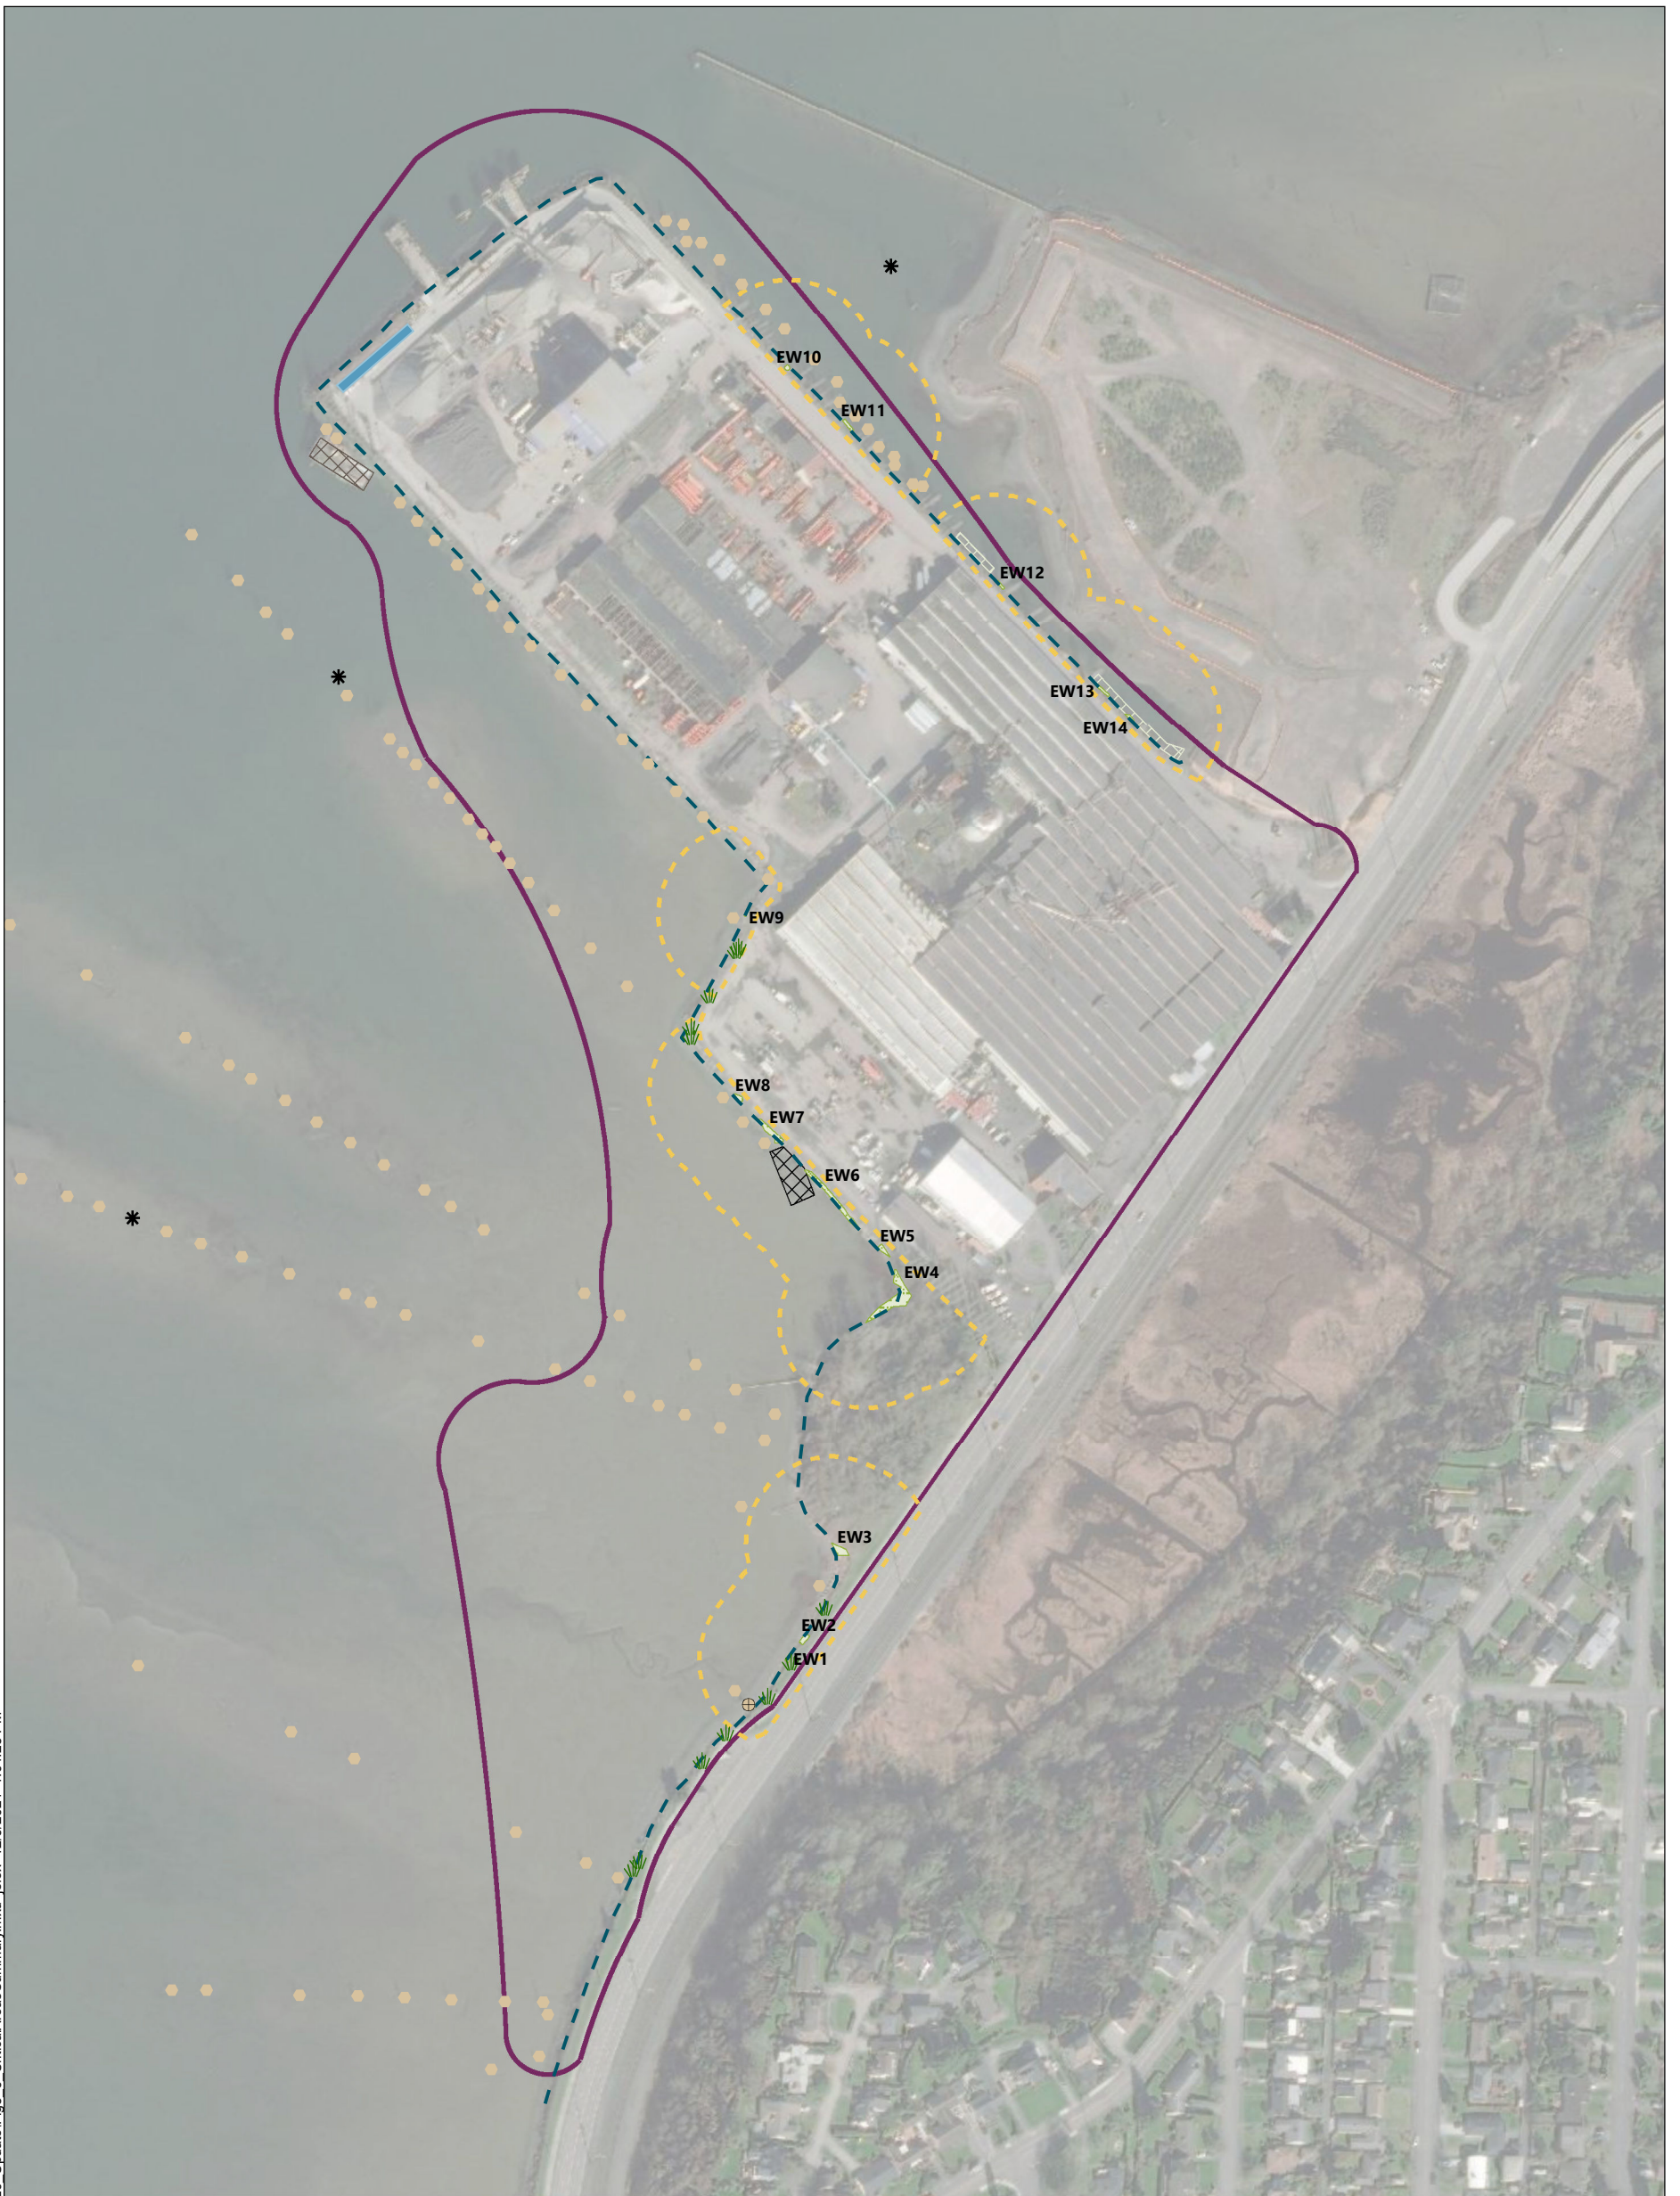
Figure 3.6
Critical Areas Summary
Final RI/FS
Jeld-Wen/Former Nord Door Facility

| Dune Grass | Estuarine Wetland and Designation (EW#) |

In the summer of 2019, a scope of work to conduct a critical areas evaluation was developed in consultation with Ecology. The field work was implemented in July and reported to Ecology in the August 2019 Critical Areas Report (CAR; Appendix D.2). The CAR characterized ecological conditions in the study area to allow for the avoidance, minimization, and mitigation of impacts related to future cleanup activities. Existing critical areas and associated regulated buffers identified in the CAR were addressed as defined in Chapter 19.37 of the Everett Municipal Code (EMC; City of Everett 2019a).

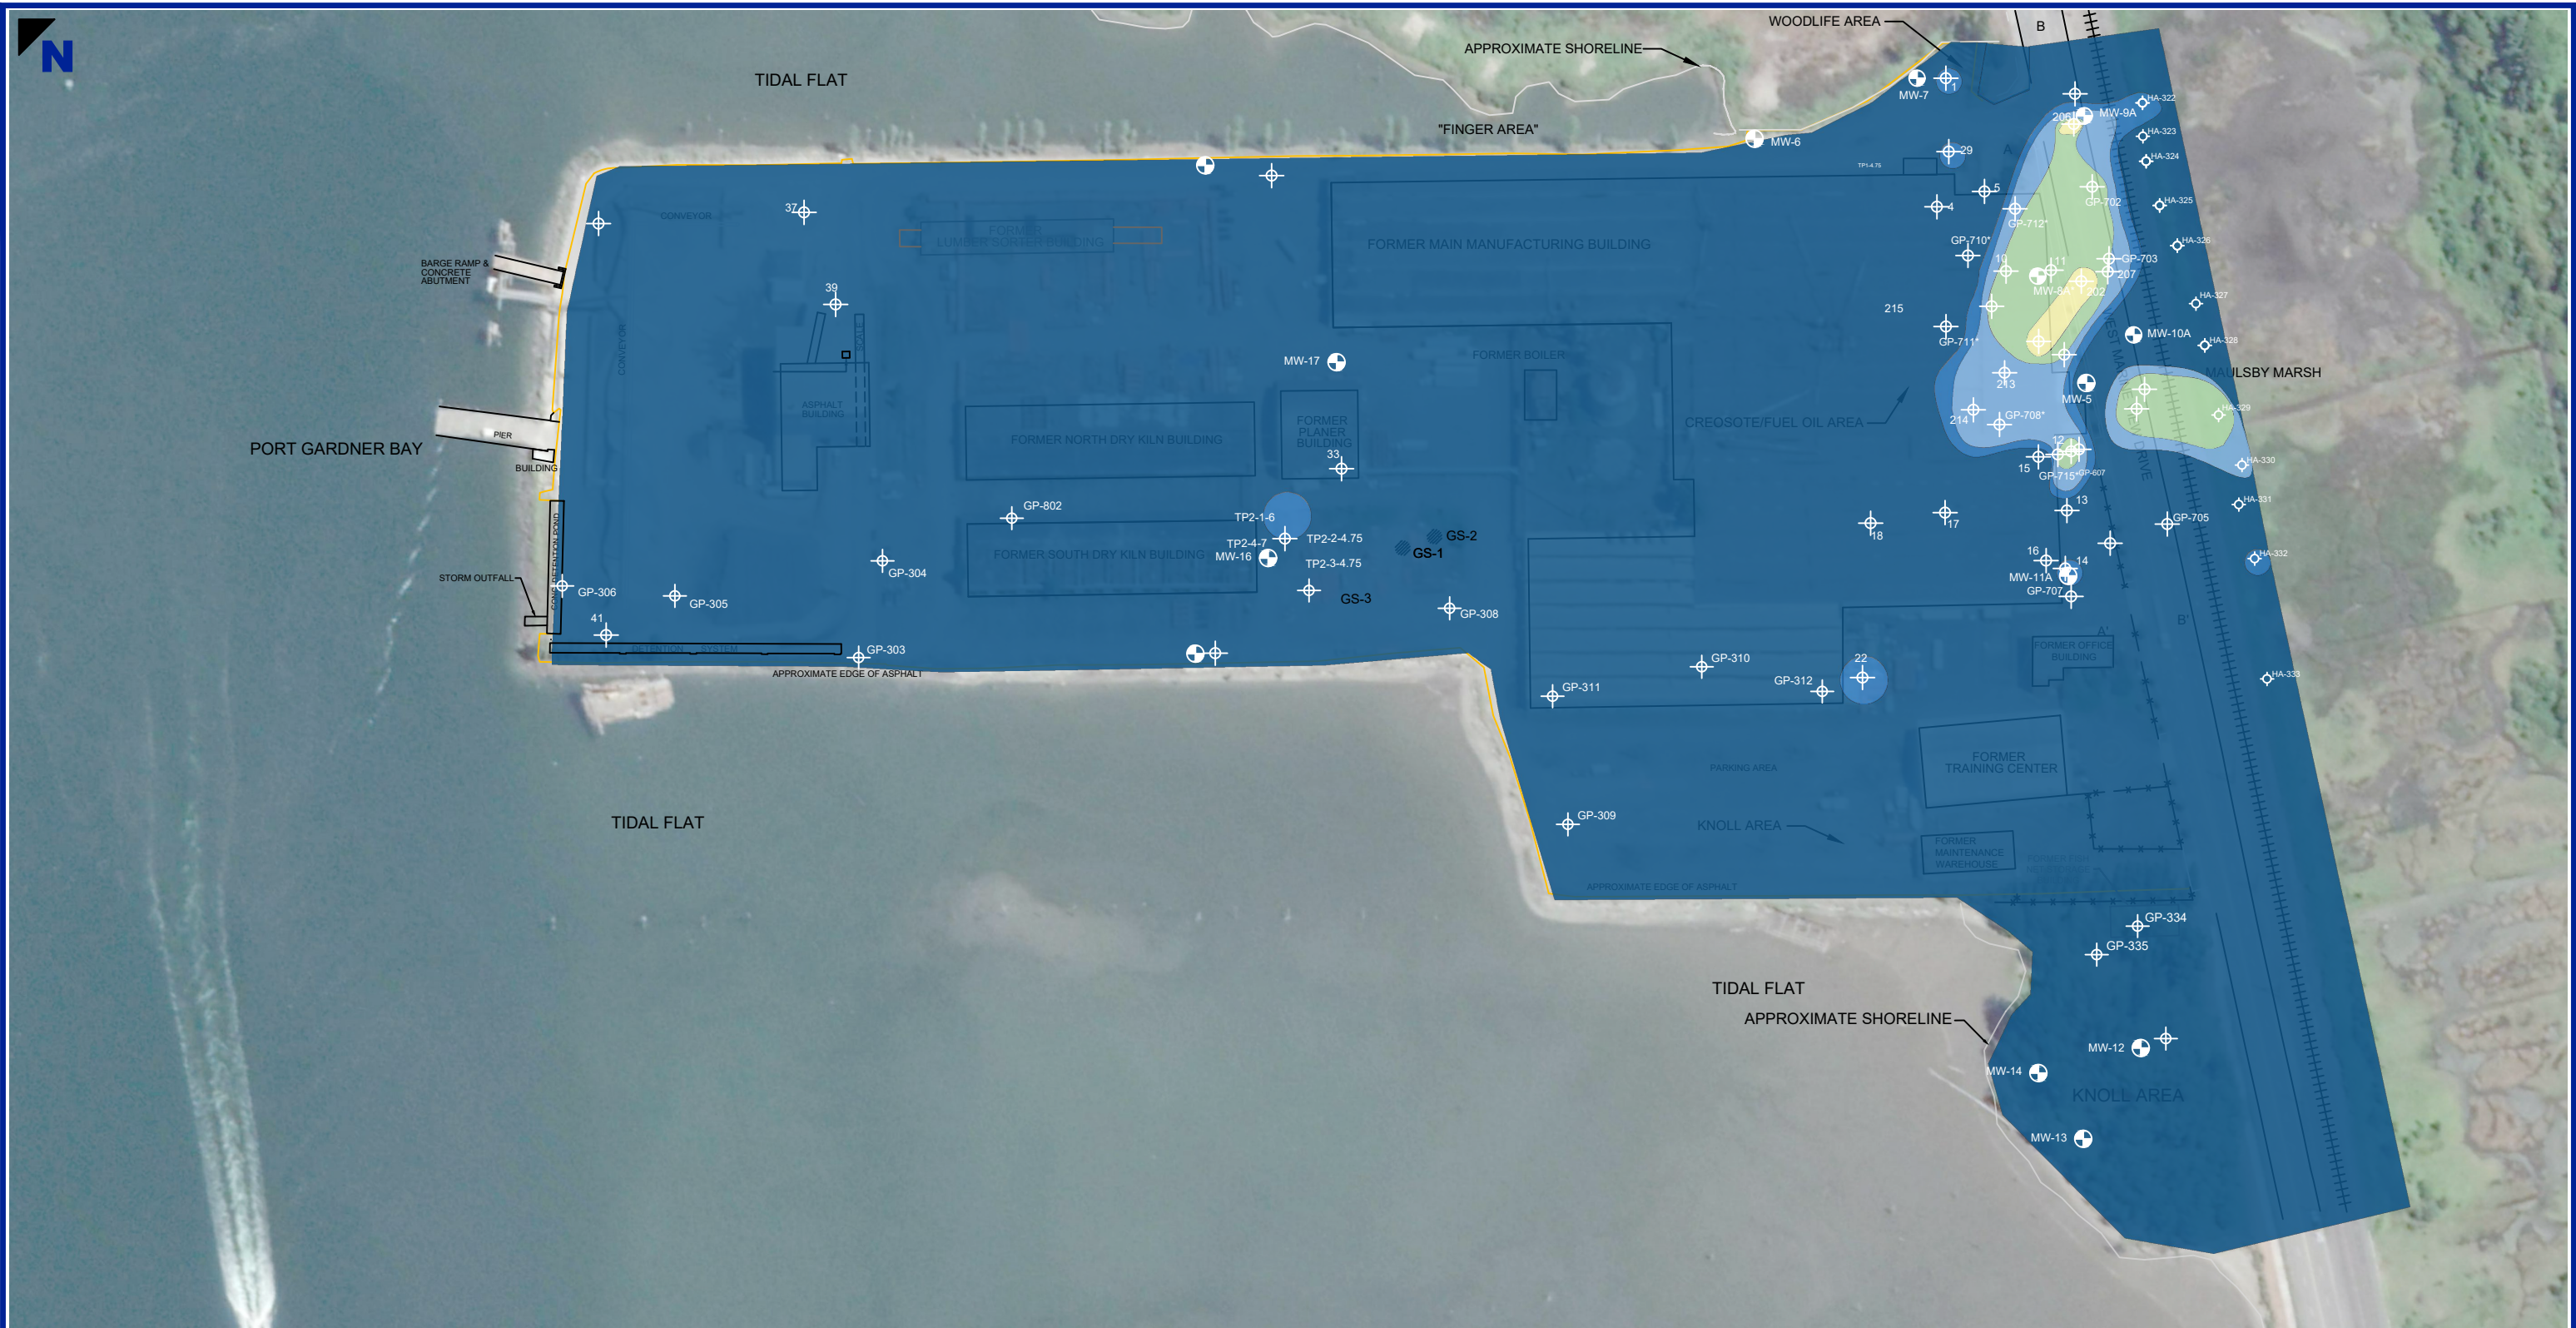
LEGEND		SOIL cPAHs (TEQ)	
GP	GEOPROBE	[Dark Blue]	<0.19 MG/KG (LESS THAN PCL)
MW-1	MONITORING WELL	[Medium Blue]	>0.19 MG/KG (GREATER THAN PCL)
		[Light Blue]	>1.9 MG/KG (10X PCL)
		[Green]	>19 MG/KG (100X PCL)
		[Yellow]	>190 MG/KG (1,000X PCL)

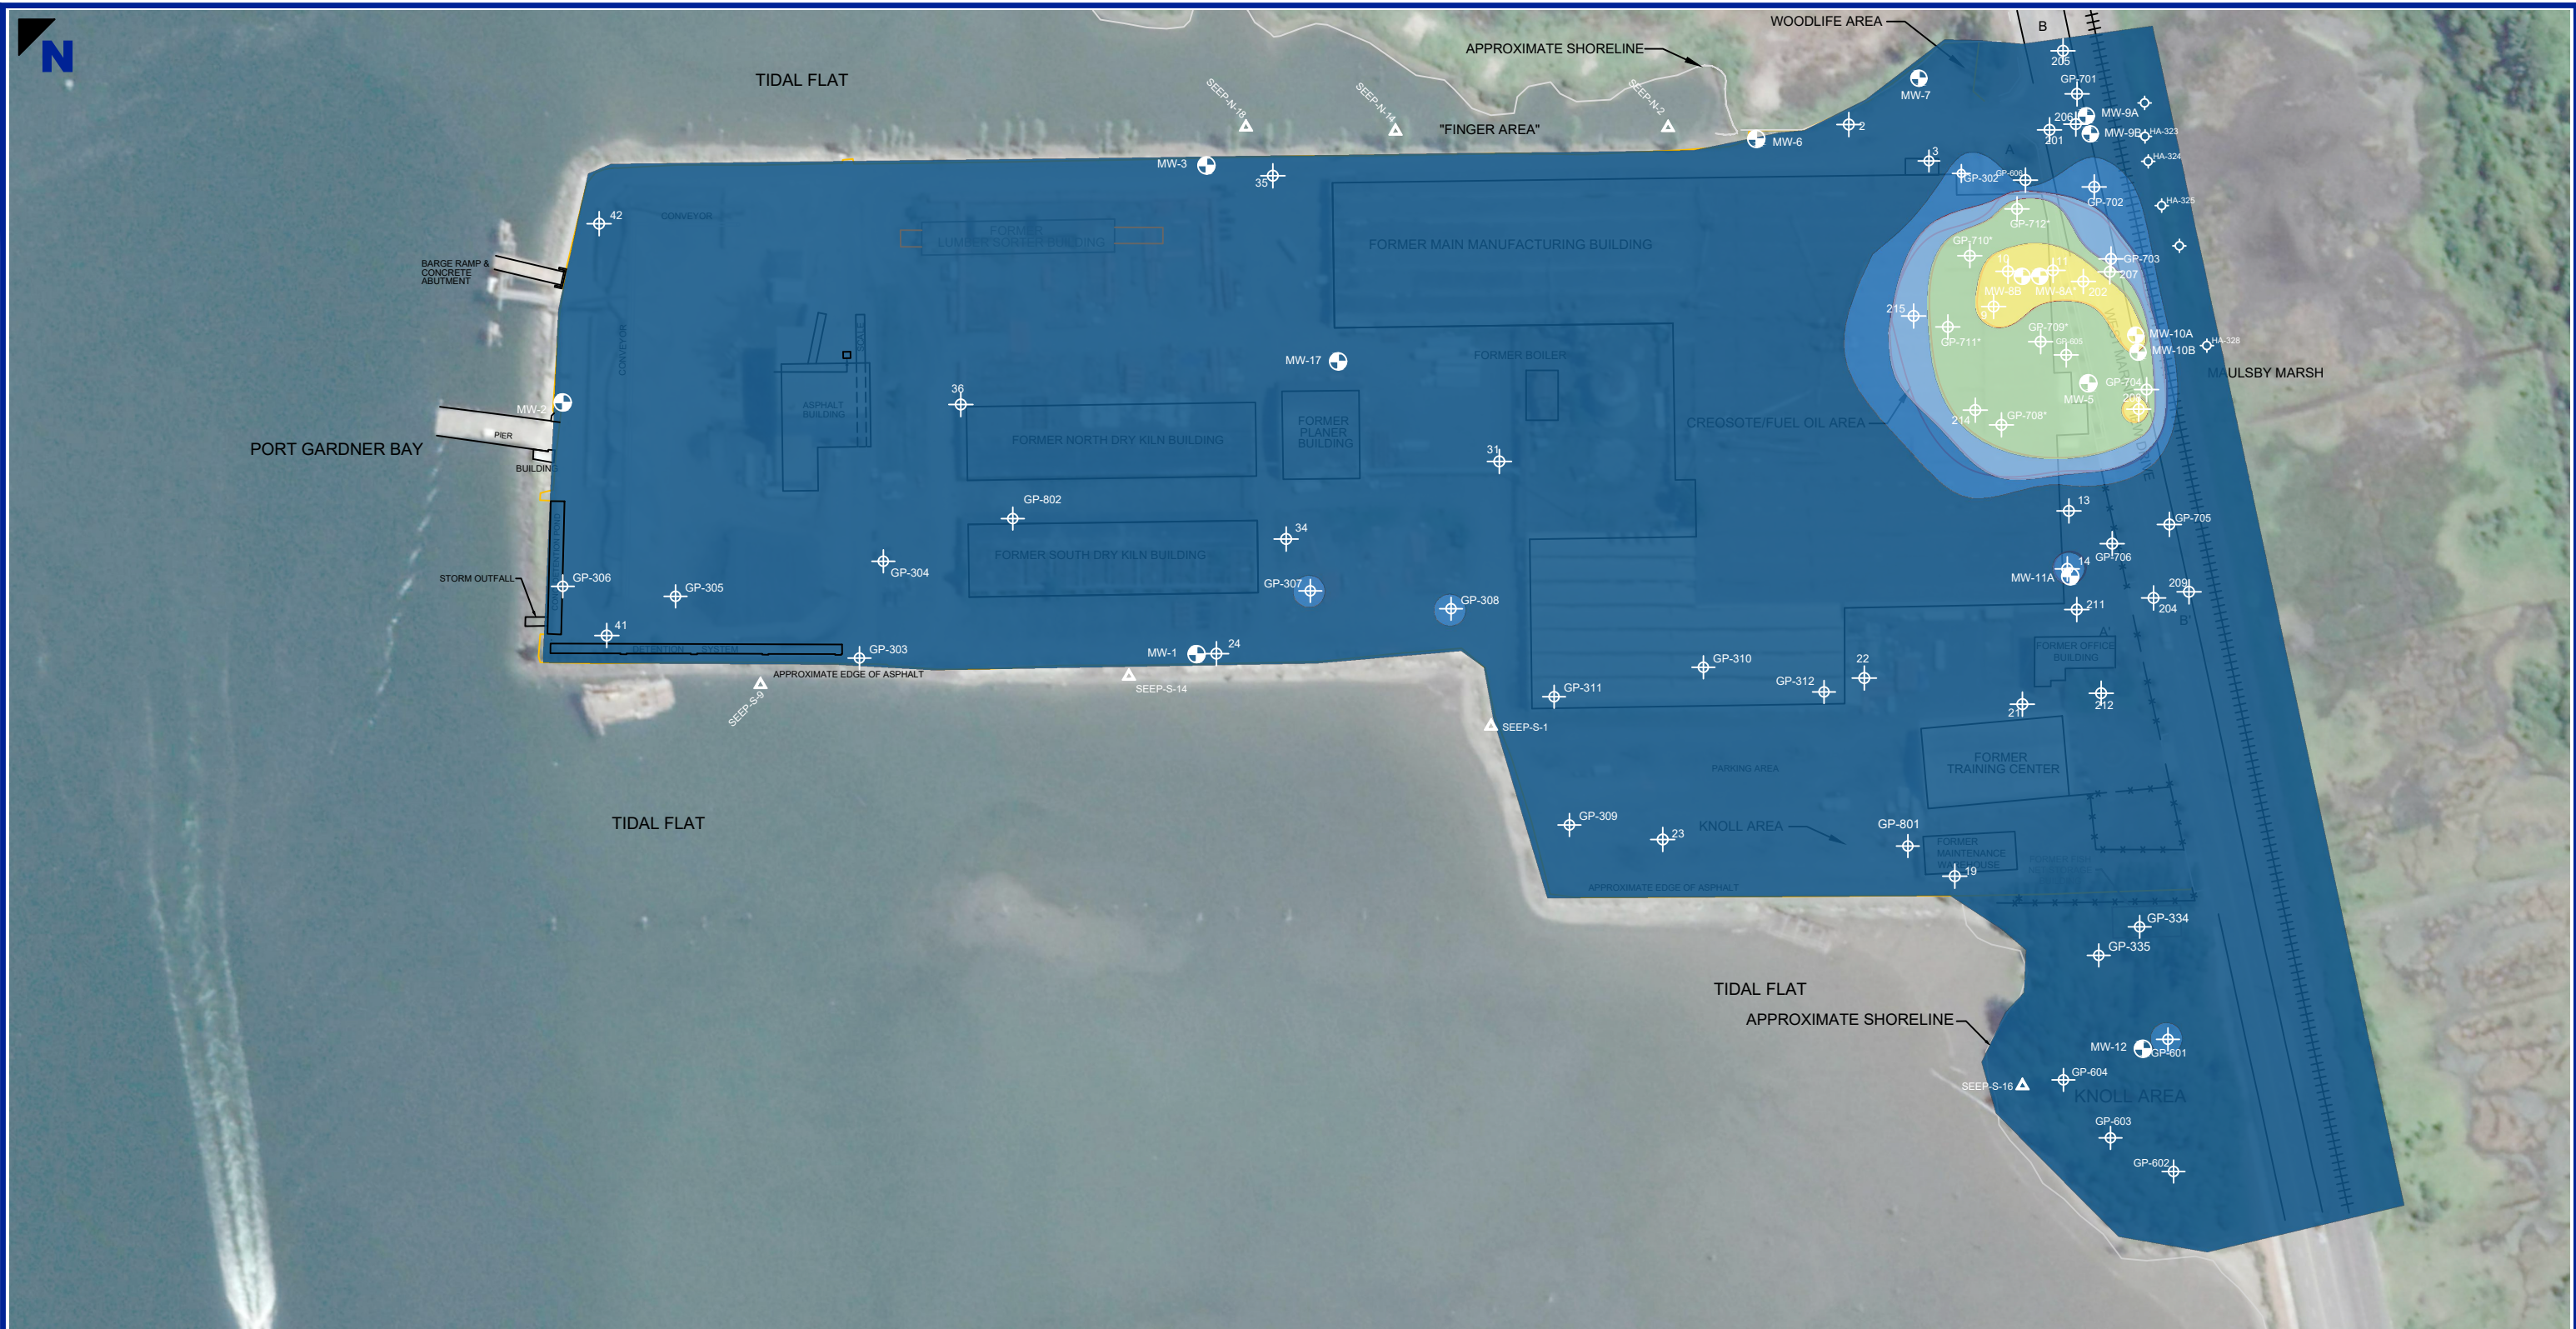
LEGEND		GROUNDWATER NAPHTHALENE	
GP	GEOPROBE		<math>< 8.9 \mu\text{g/L}</math> (LESS THAN PCL)
MW-1	MONITORING WELL		>8.9 $\mu\text{g/L}$ (GREATER THAN PCL)
			>89 $\mu\text{g/L}$ (10X PCL)
			>890 $\mu\text{g/L}$ (100X PCL)
			>8,900 $\mu\text{g/L}$ (1,000X PCL)
