RE: Final RI/FS report for the JELD-WEN/Former Nord Door Site, Everett, WA
FSID Number: 2757 and CSID Number: 4402

Final Remedial Investigation/Feasibility Study

Jeld Wen / Former Nord Door Facility
300 West Marine View Drive
Everett, Washington 98201

December 2021

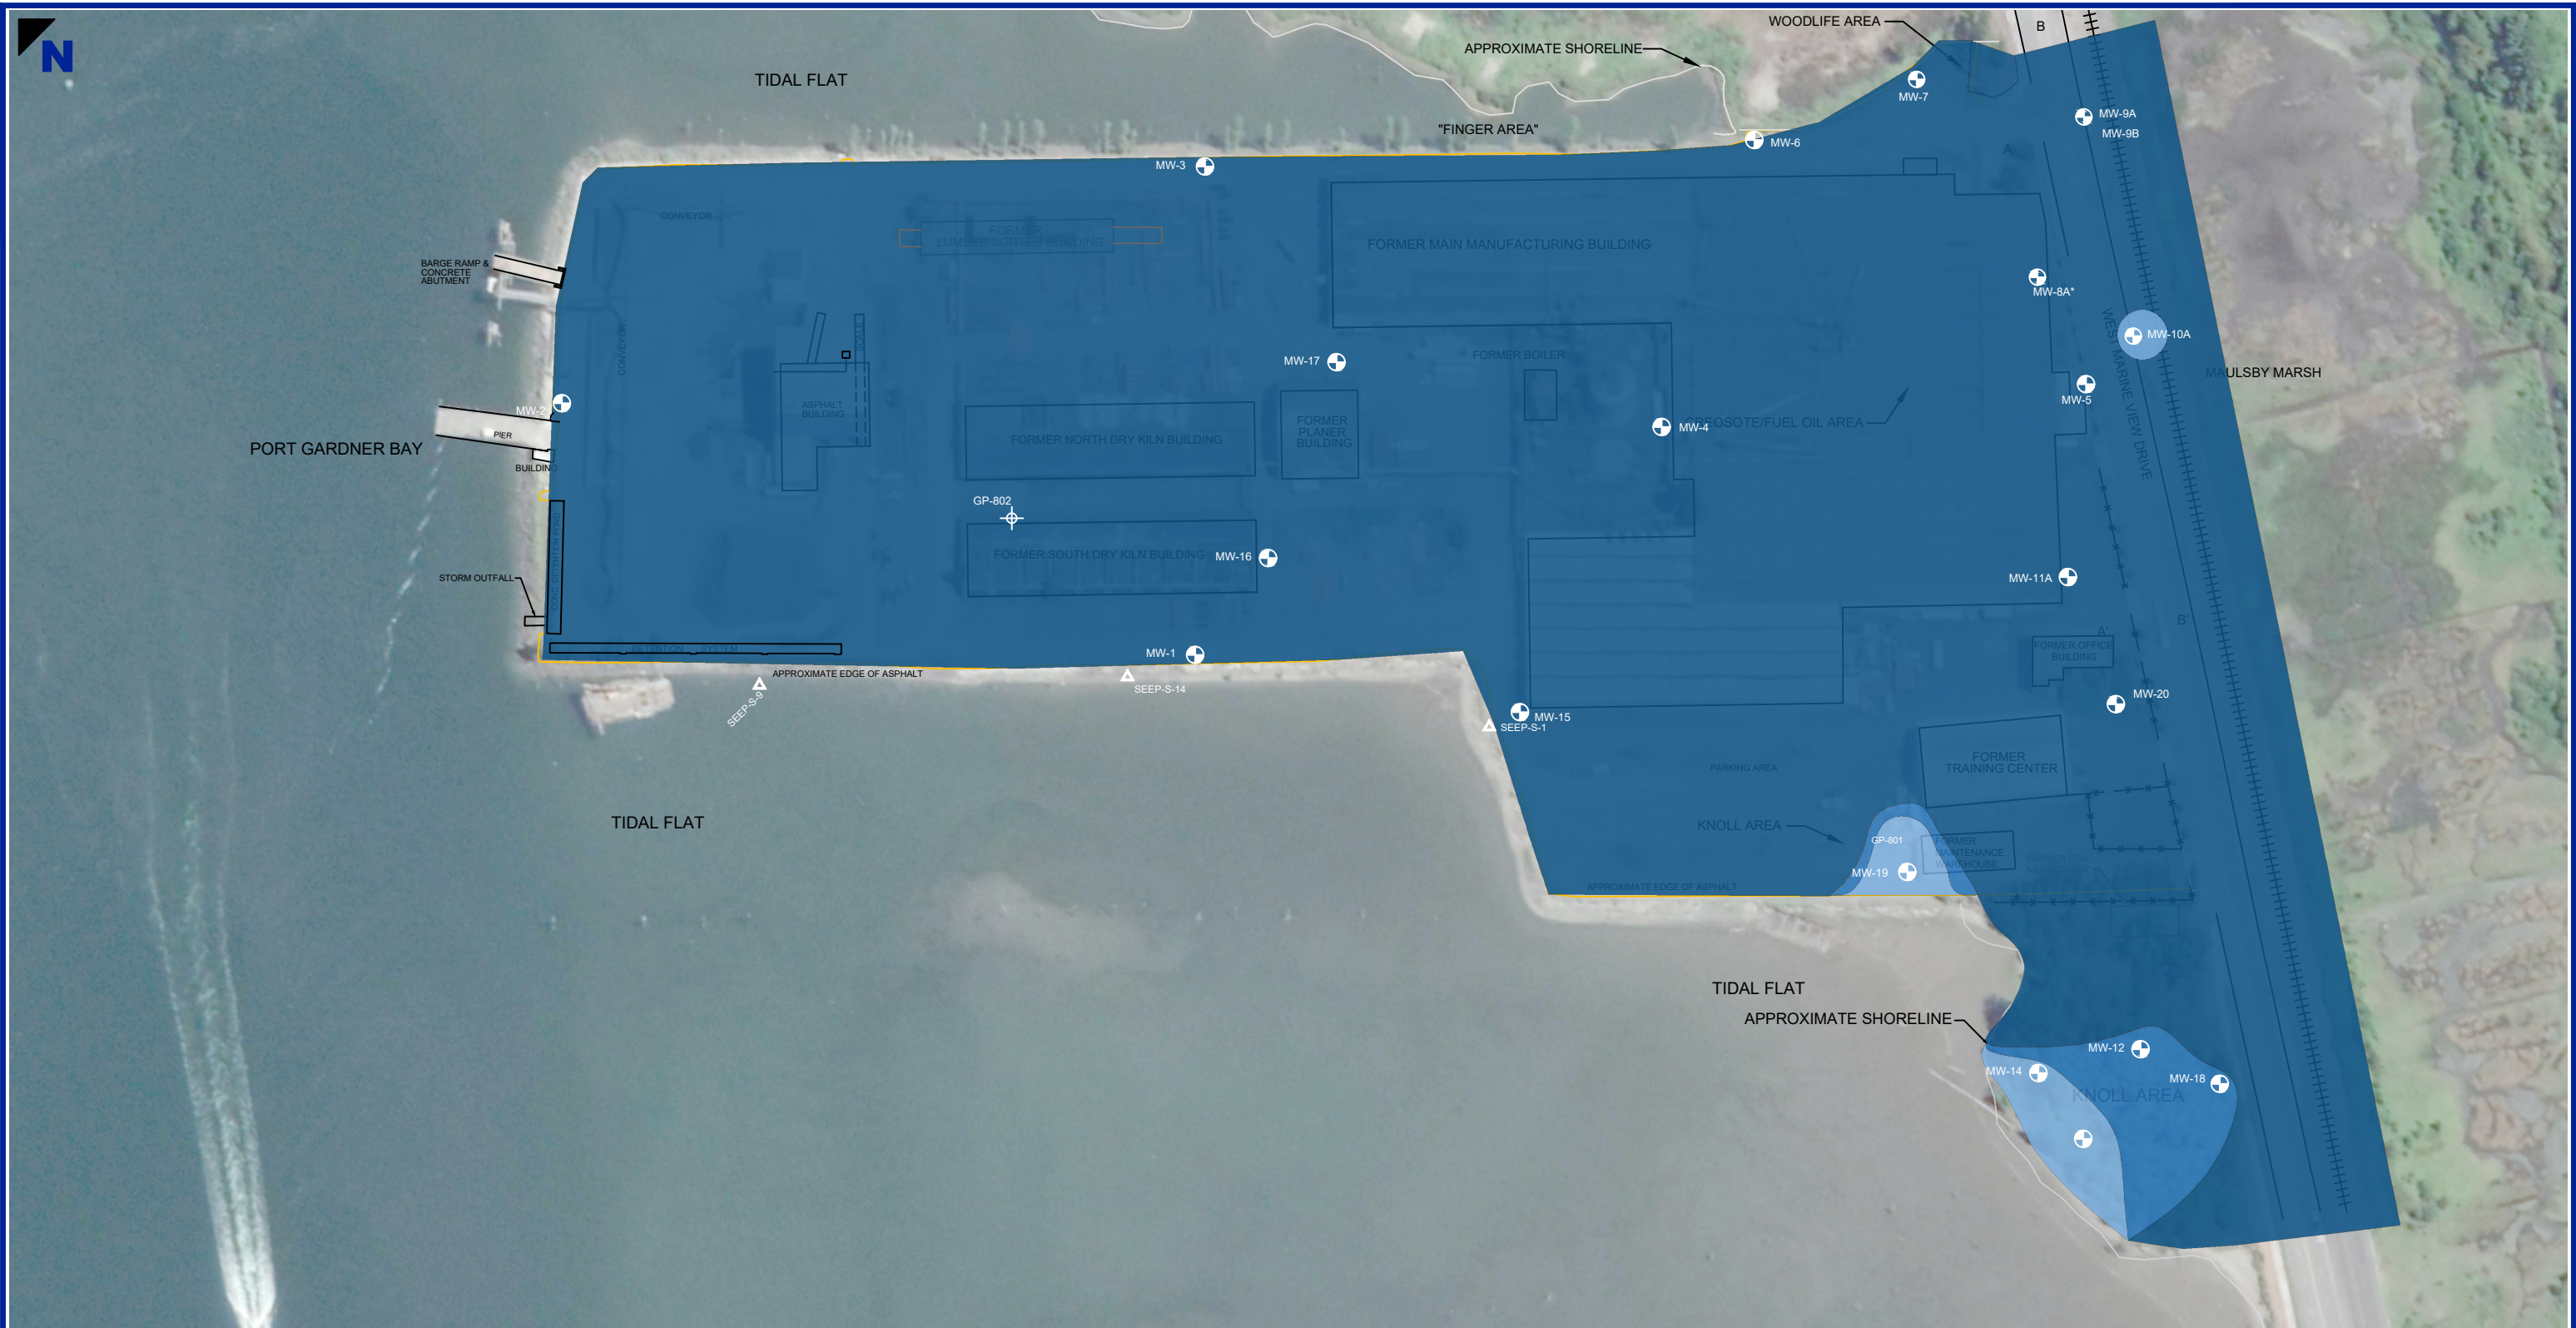
LEGEND		GROUNDWATER PCB COGENERS	
GP	GEOPROBE	[Light Blue Box]	<1,210 PG/L (LESS THAN PCL)
MW-1	MONITORING WELL	[Medium Blue Box]	>1,210 PG/L (GREATER THAN PCL)
		[Dark Blue Box]	>12,100 PG/L (10X PCL)

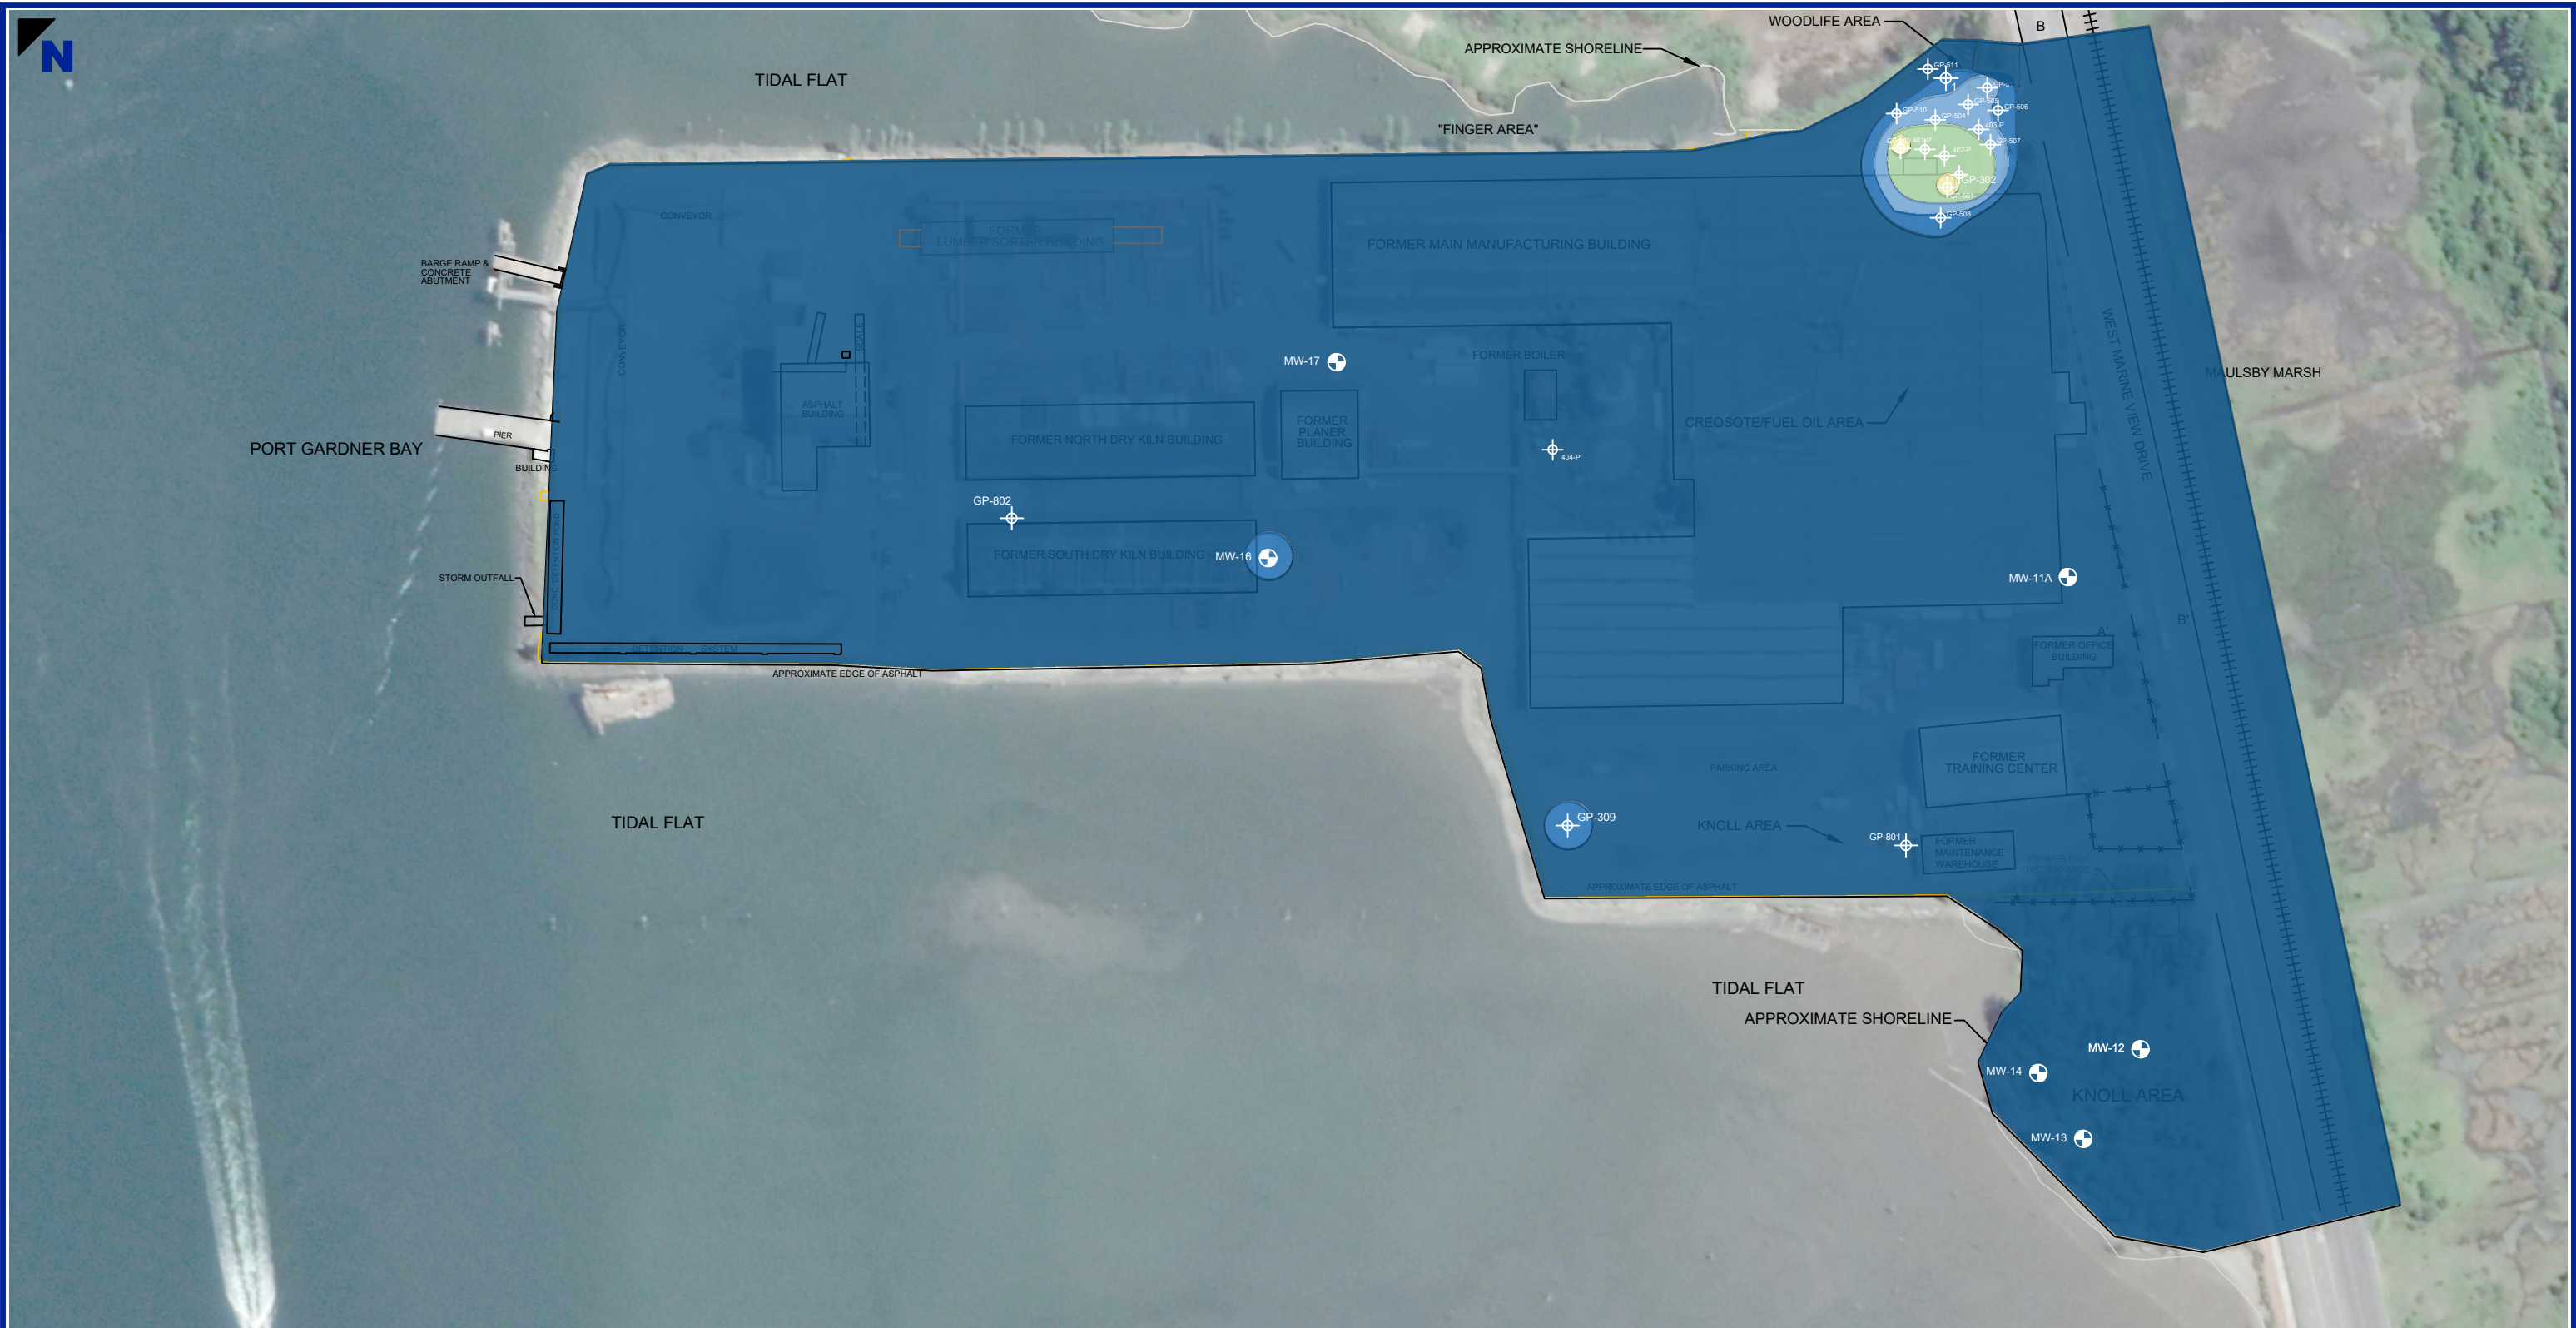
GP	GEOPROBE	SOIL DIOXINS (TEQ)
MW-1	MONITORING WELL	<5.2 PG/G (LESS THAN PCL)
		>5.2 PG/G (GREATER THAN PCL)
		>52.2 PG/G (10X PCL)
		>522 PG/G (100X PCL)
		>5,220 PG/G (1,000X PCL)

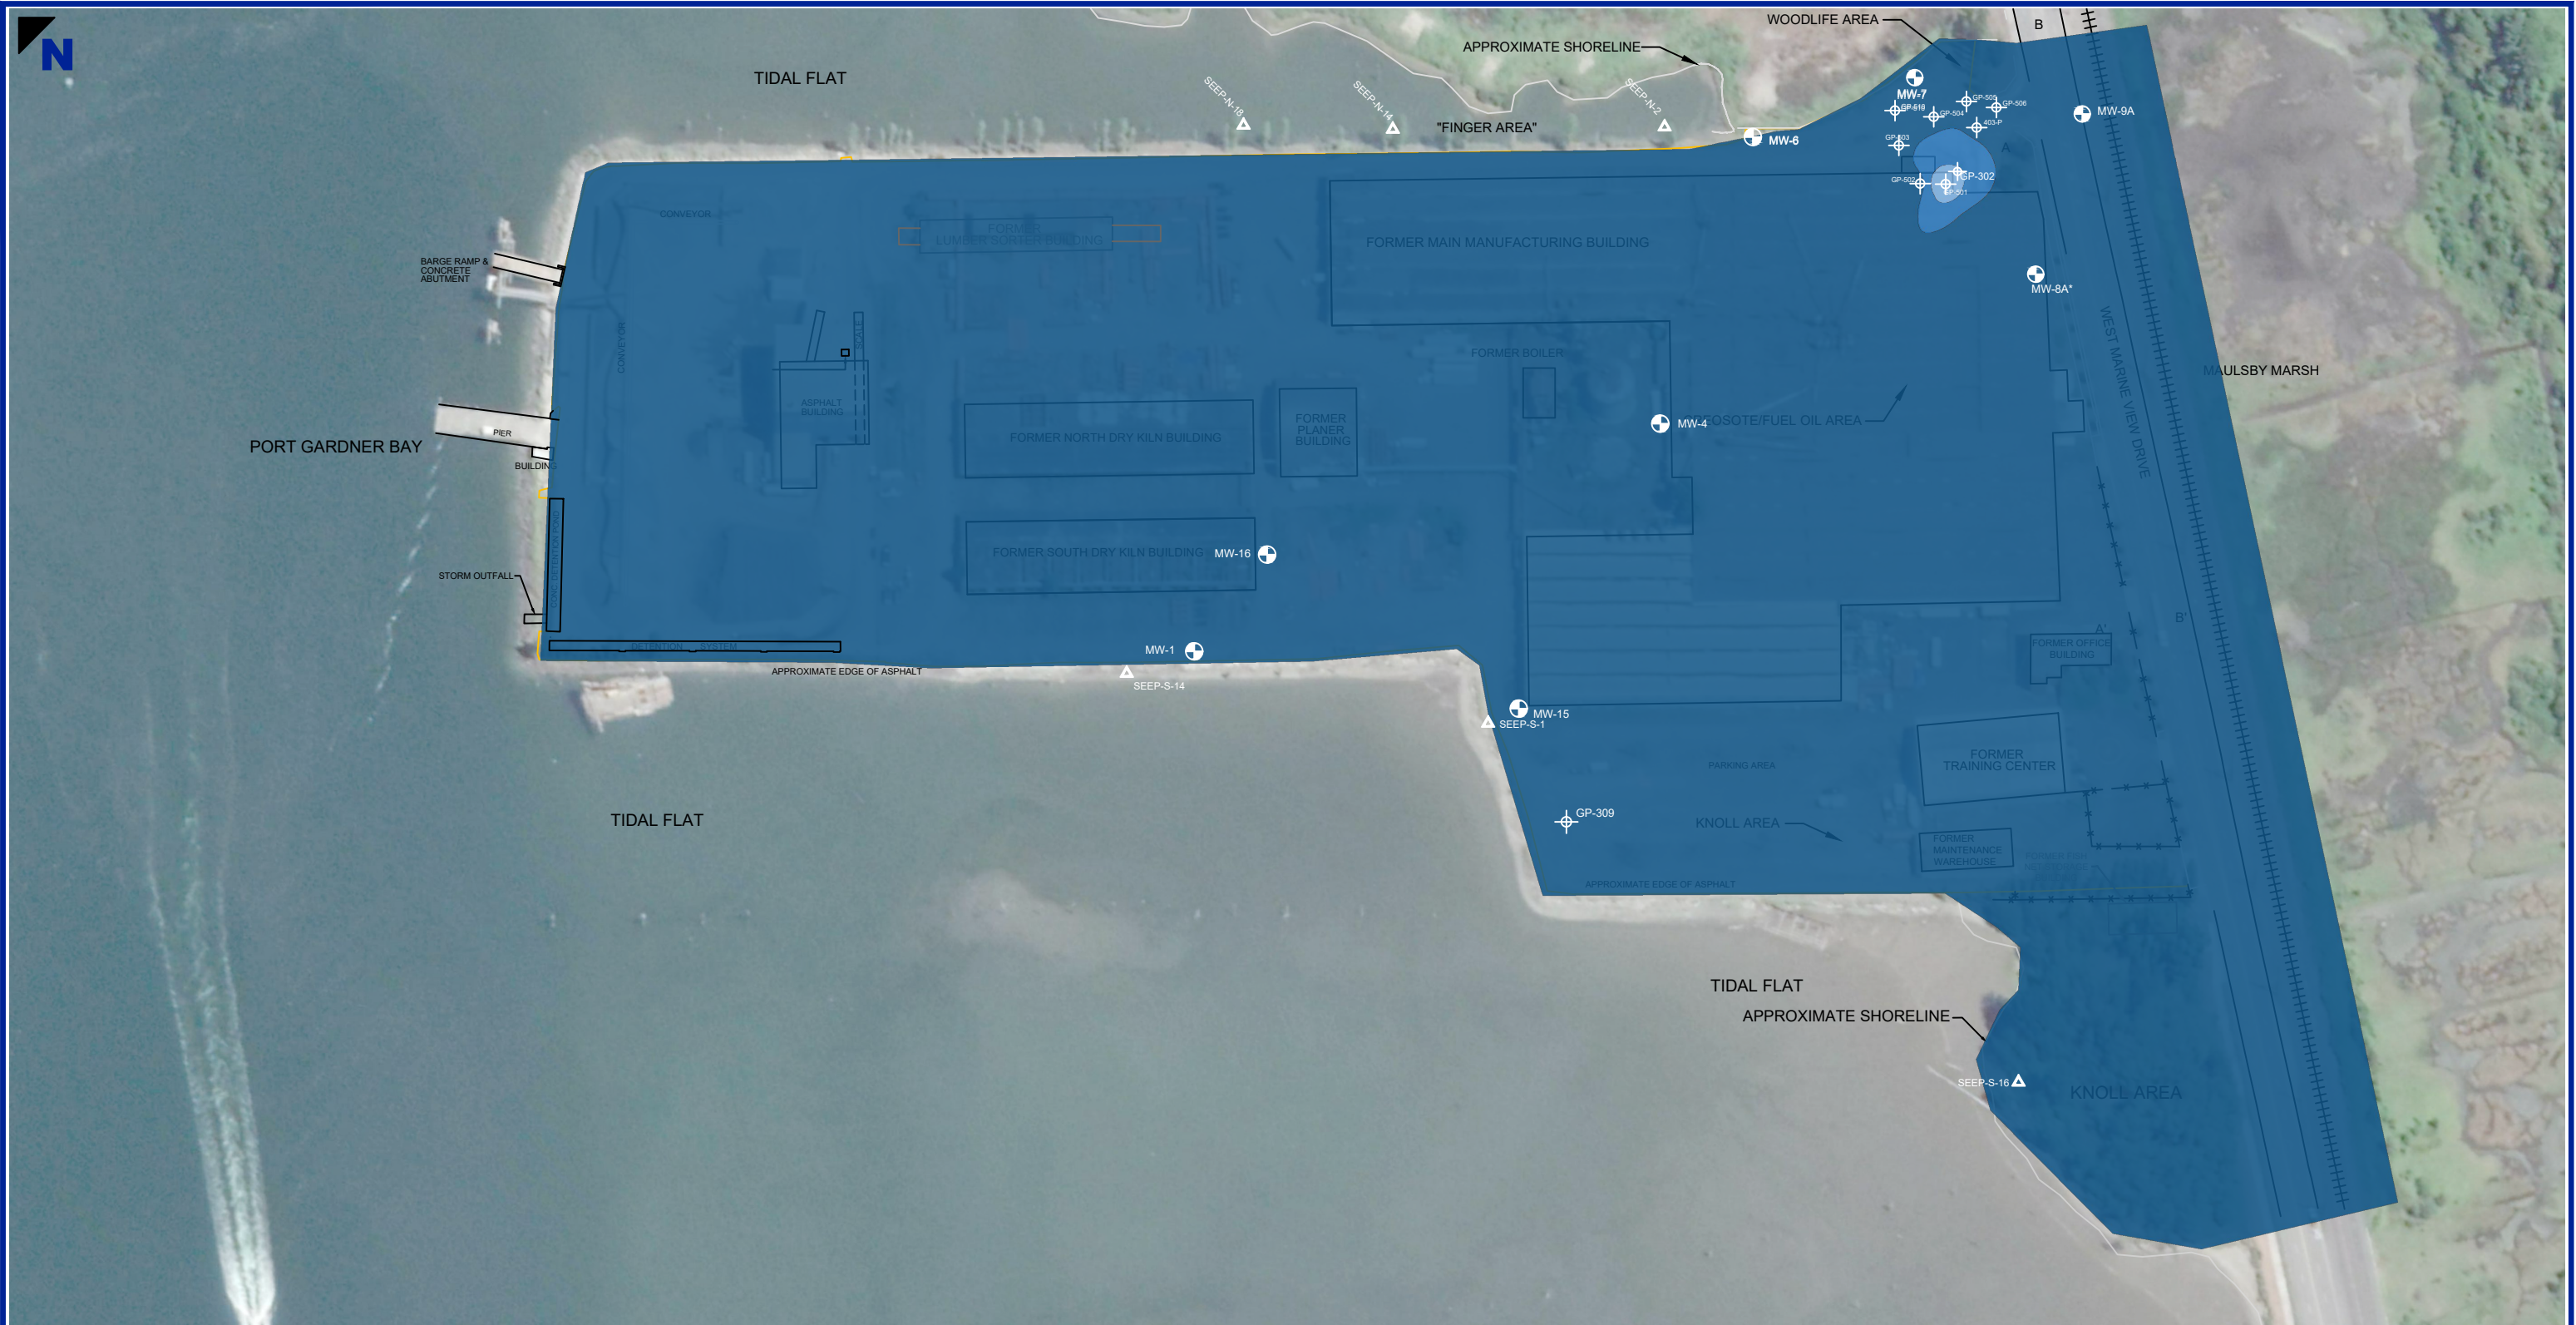
LEGEND		GROUNDWATER DIOXINS (TEQ)	
GP	GEOPROBE	[Light Blue Box]	<57 PG/L (LESS THAN PCL)
MW-1	MONITORING WELL	[Medium Blue Box]	>57 PG/L (GREATER THAN PCL)
		[Dark Blue Box]	>570 PG/L (10X PCL)

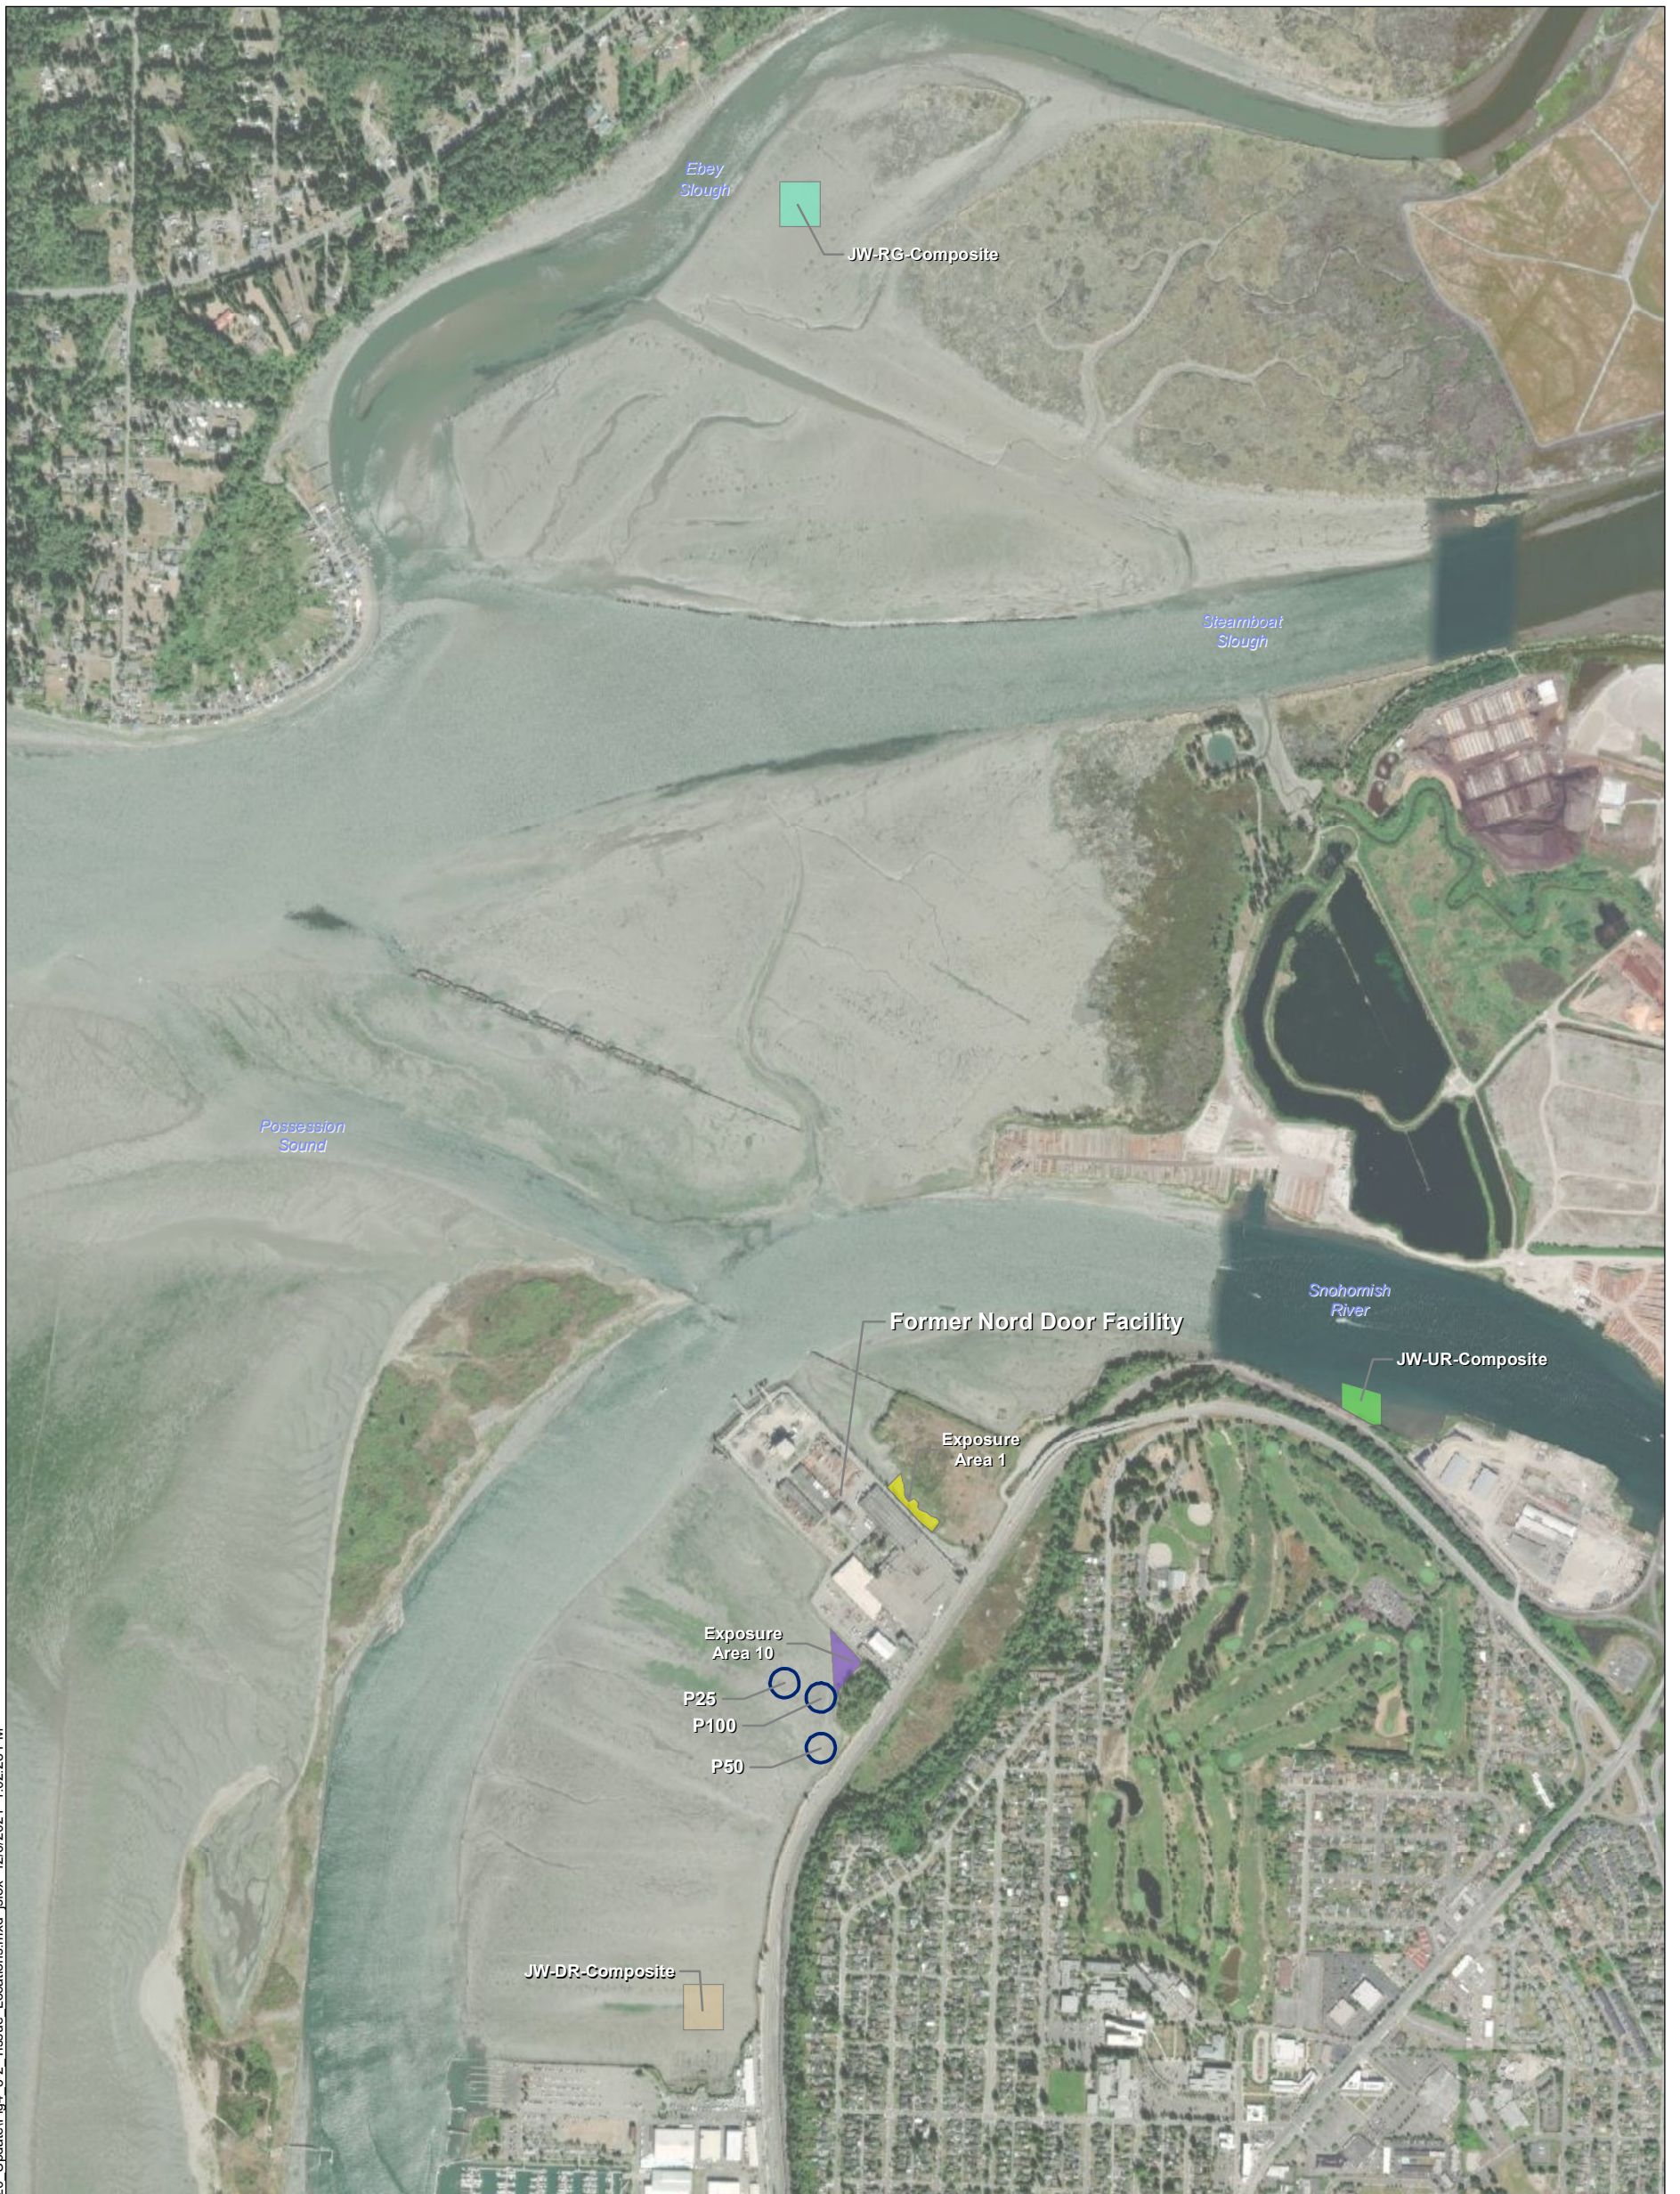
- ⊙ Surface Sediment Sample Location
- Downriver Tissue and Composite Surface Sediment
- Exposure Area 1 Tissue
- Exposure Area 10 Tissue
- Regional Tissue and Composite Surface Sediment
- Upriver Tissue and Composite Surface Sediment
- Tide-flat Tissue Collection Area (Ecology-defined Sediment Concentration)

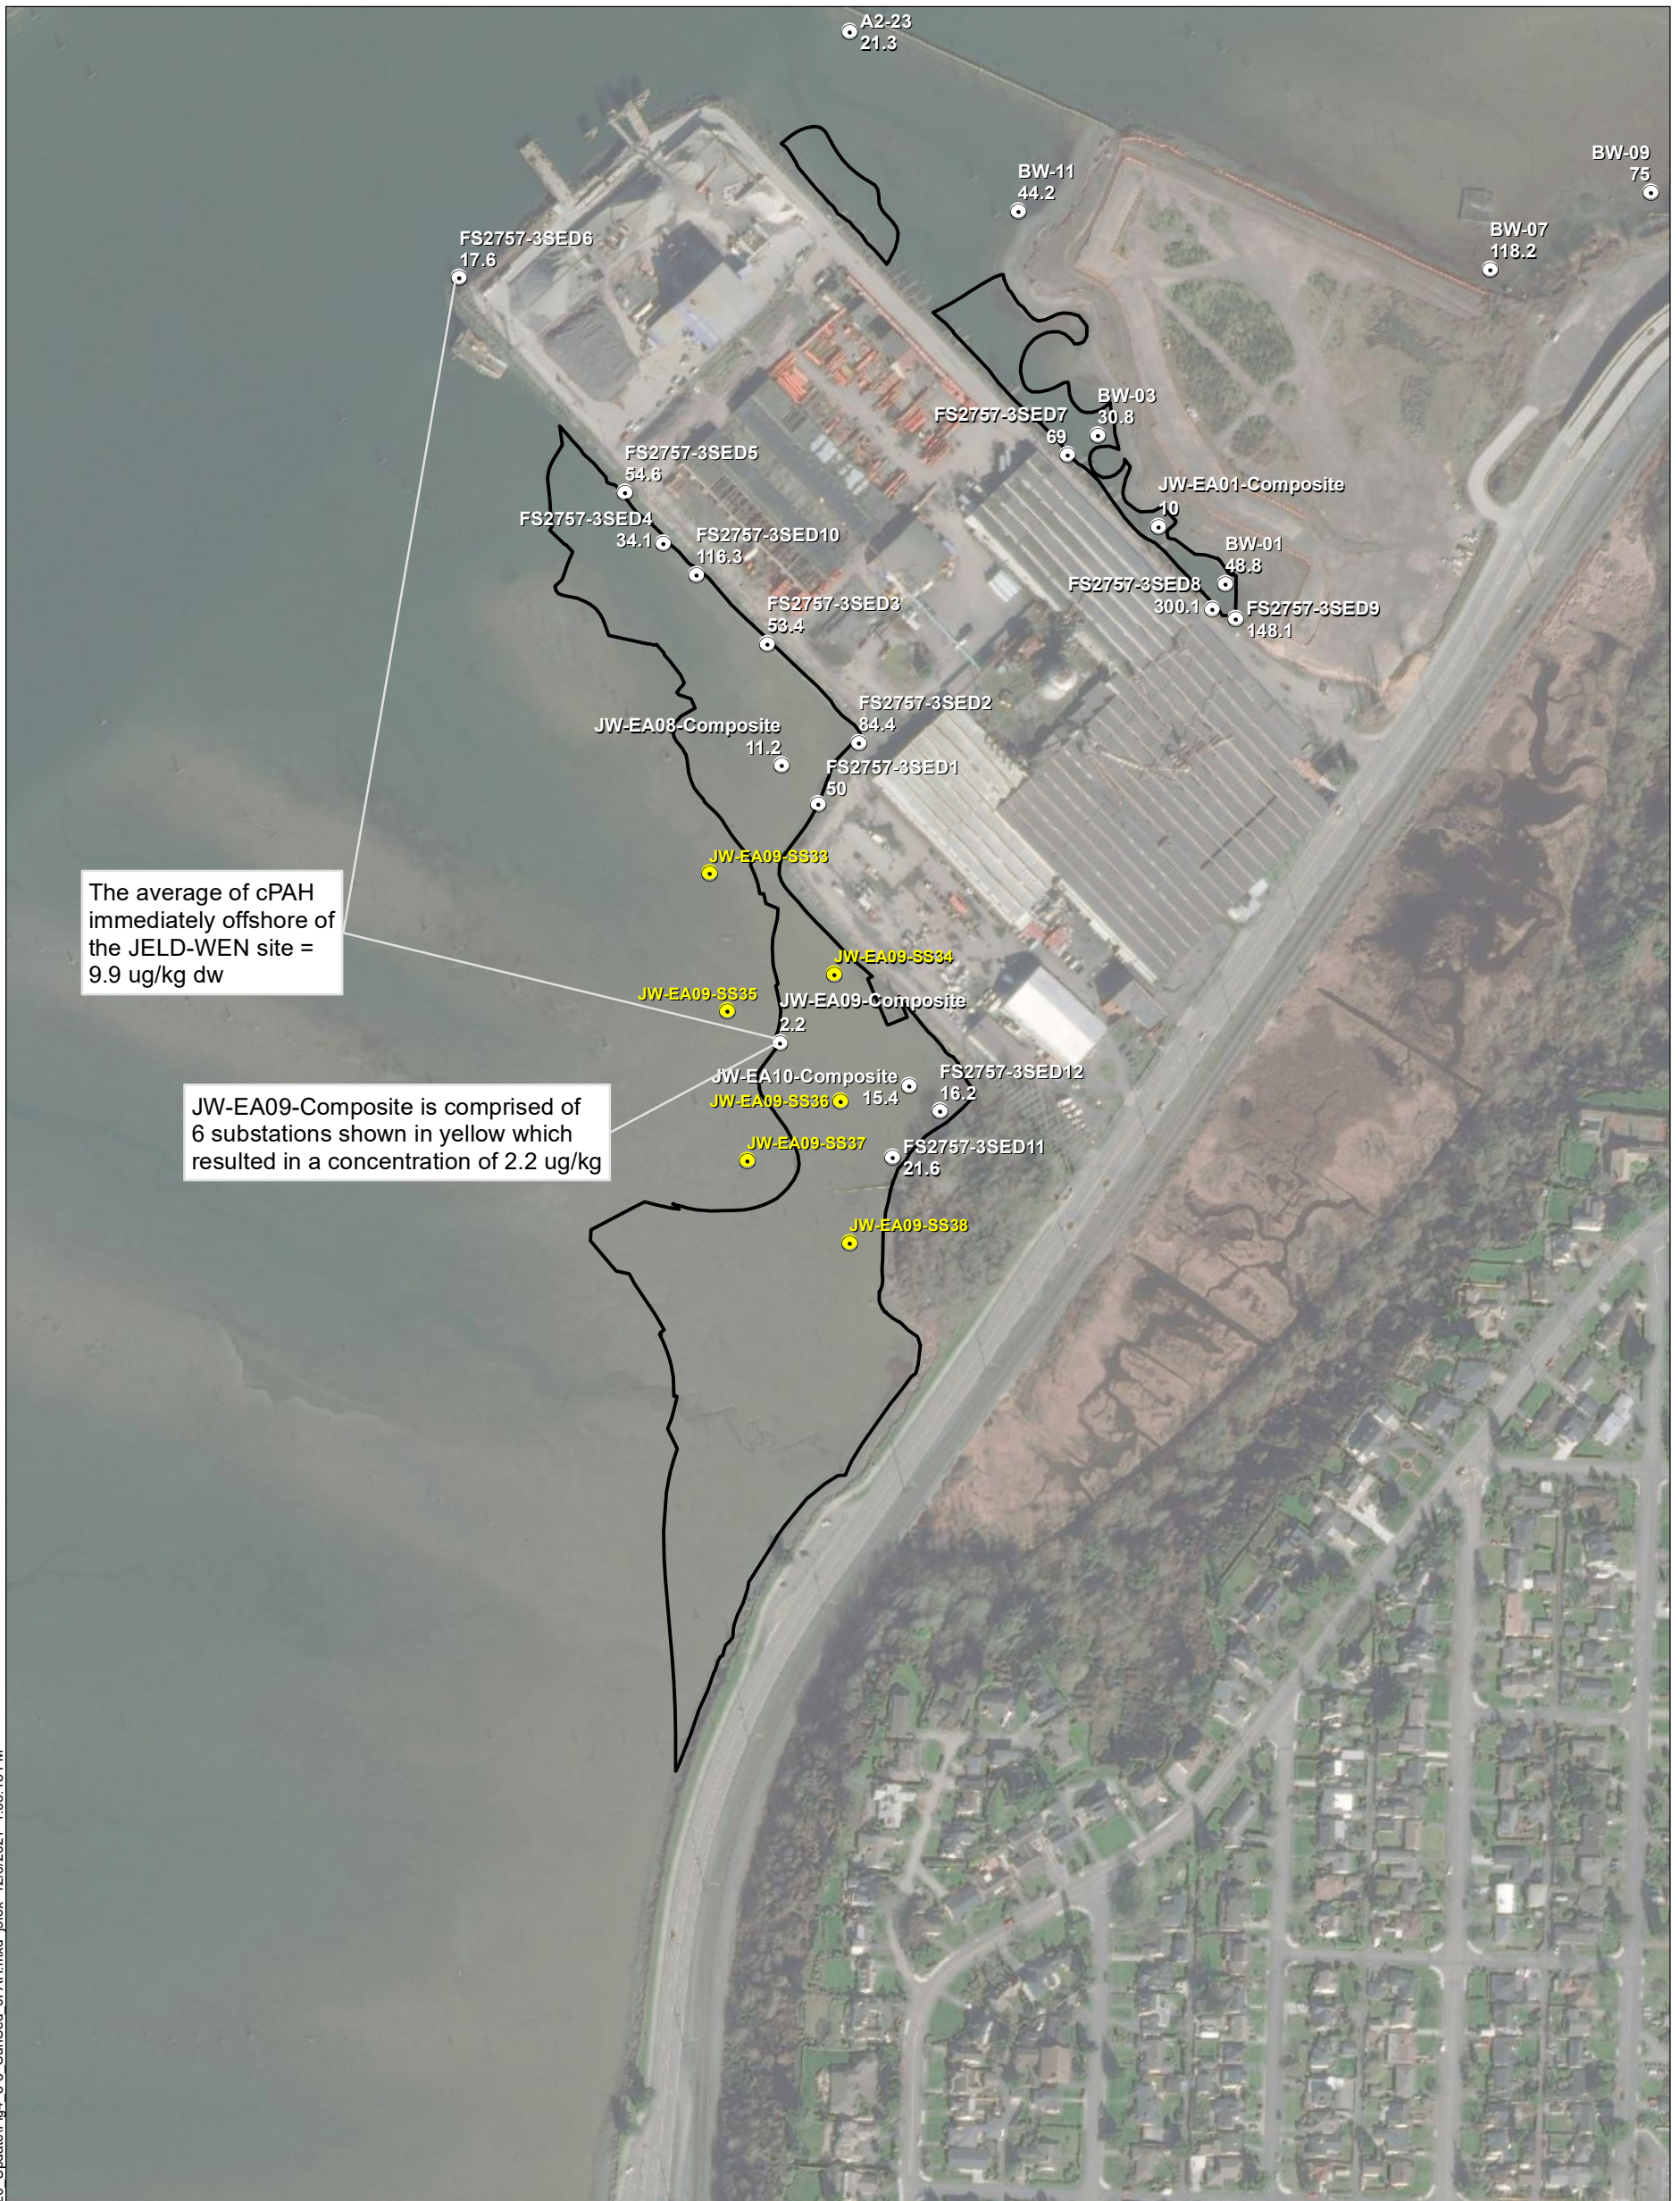
The average of cPAH immediately offshore of the JELD-WEN site = 9.9 ug/kg dw

JW-EA09-Composite is comprised of 6 substations shown in yellow which resulted in a concentration of 2.2 ug/kg

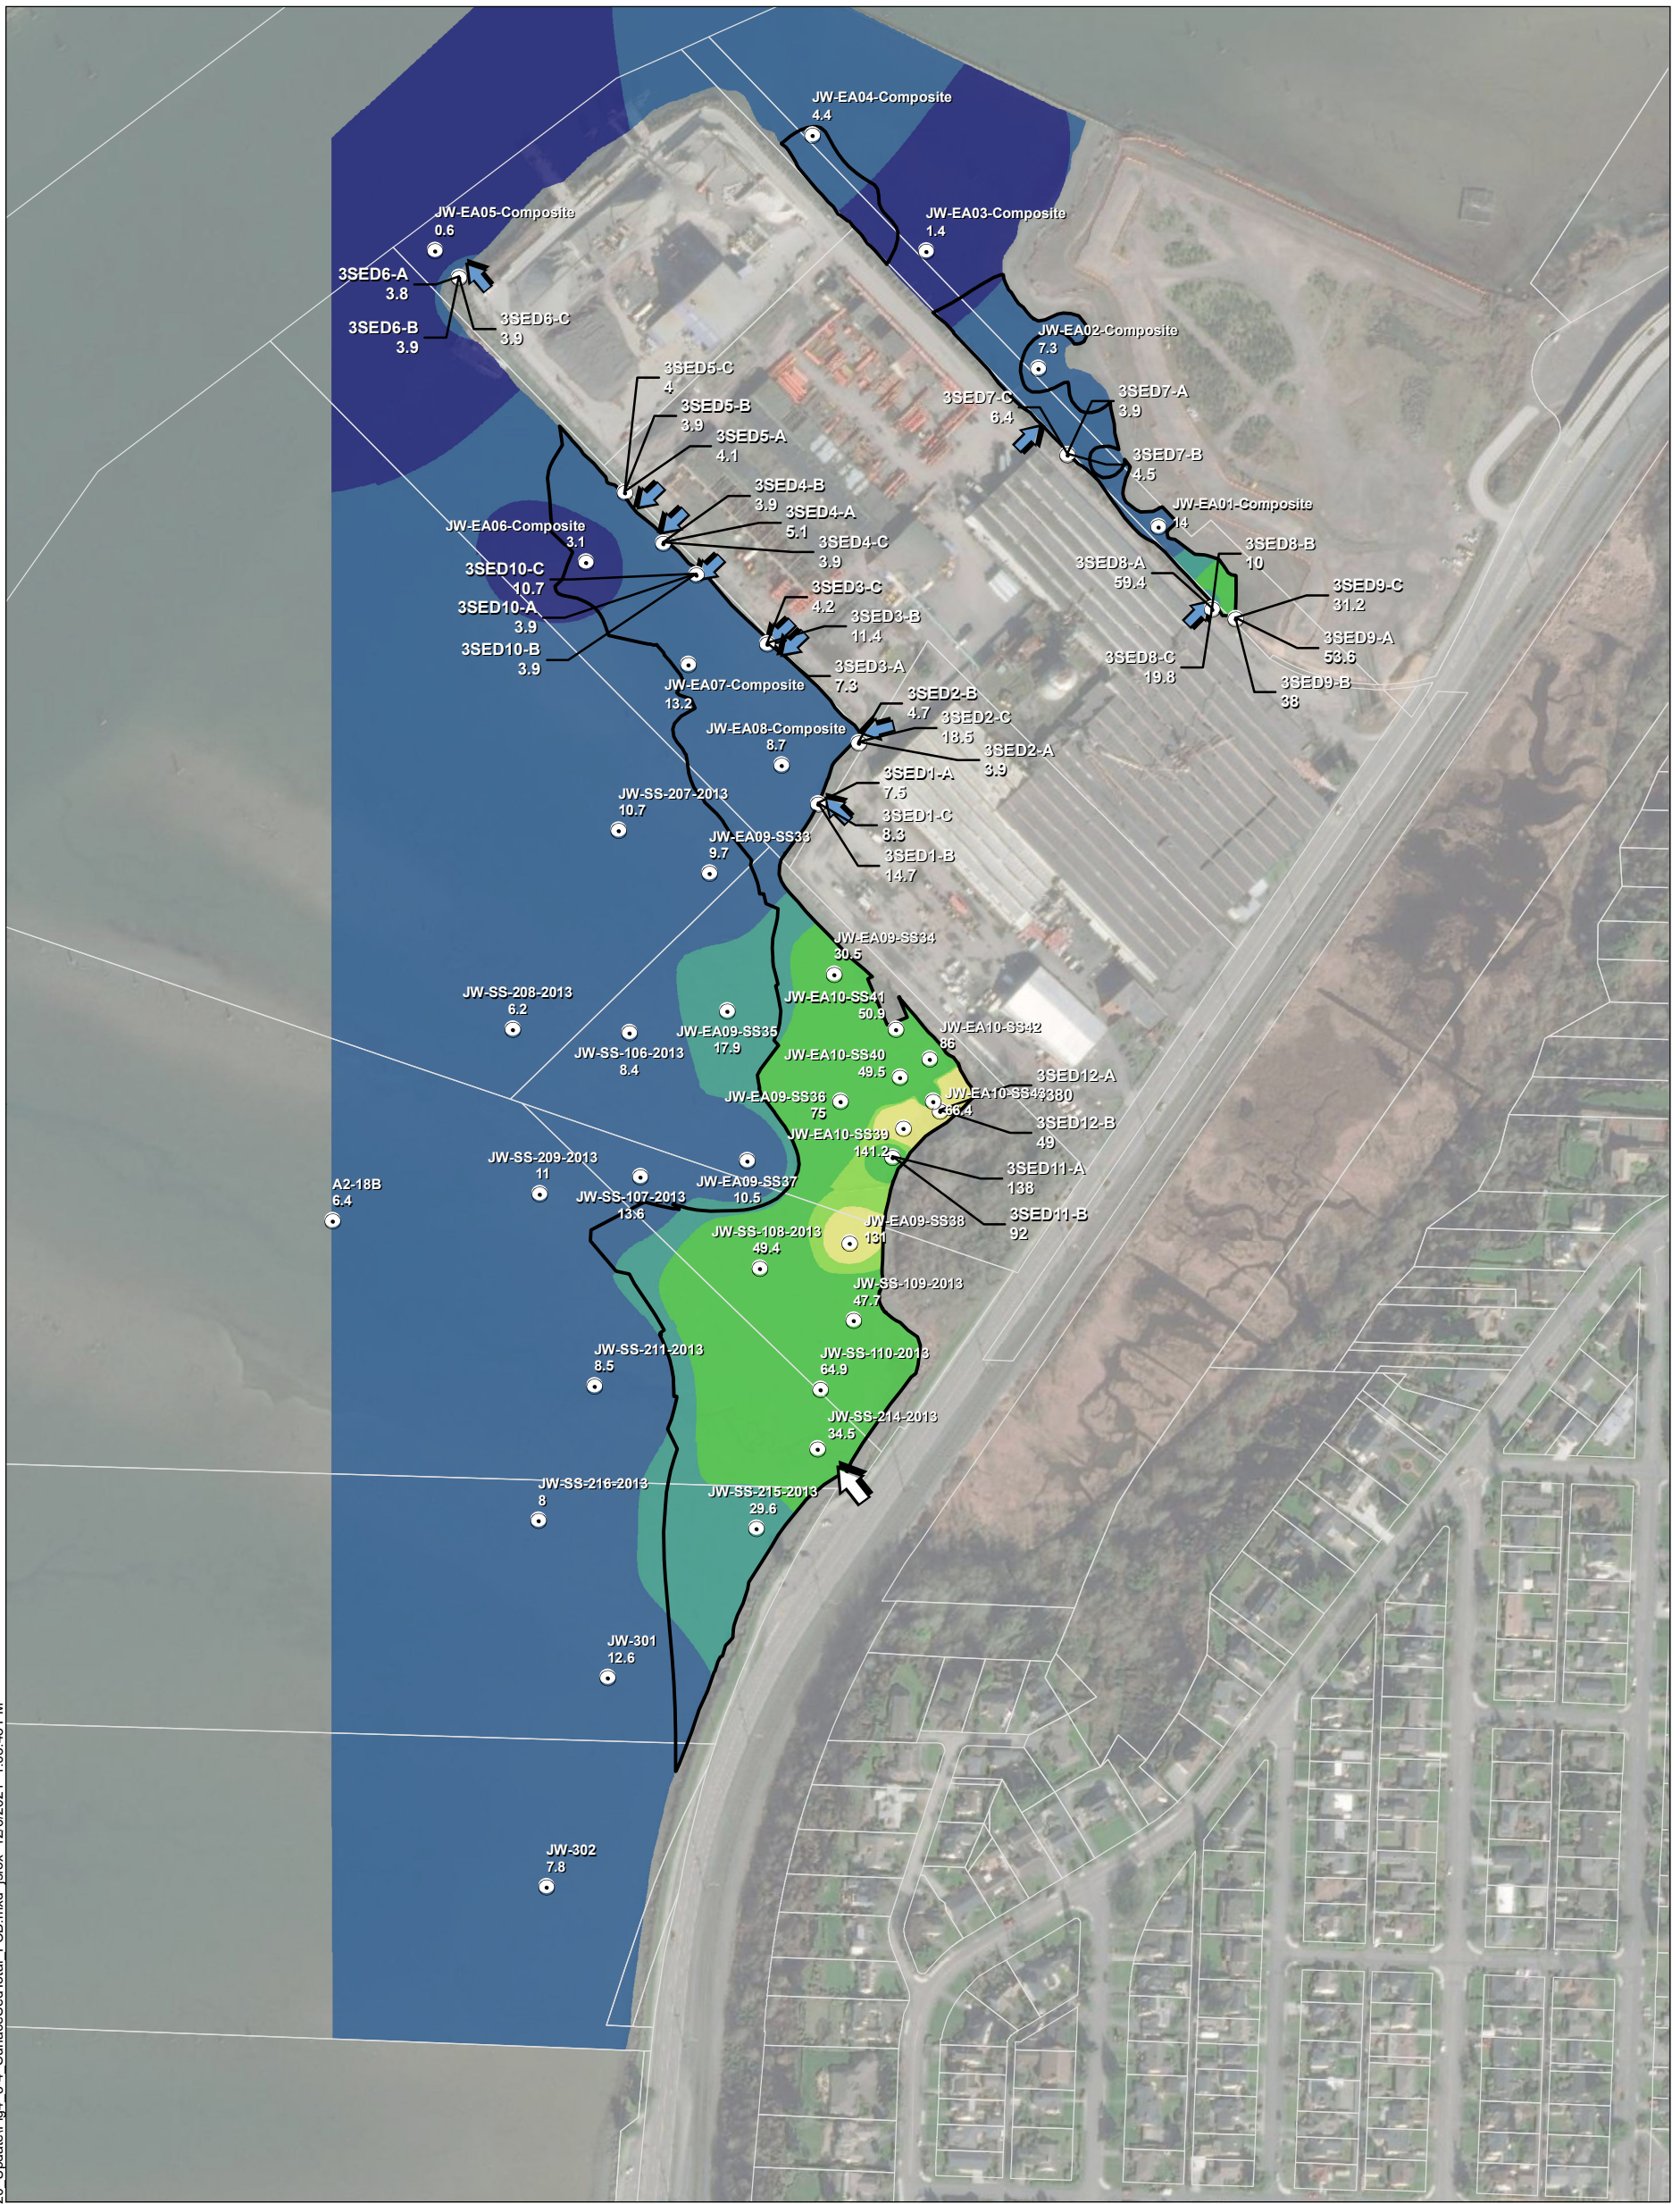
Figure 4.3-4
 Surface Sediment Total PCB Concentrations
 Final RI/FS
 Jeld-Wen/Former Nord Door Facility

PCB-dw Inverse Distance Weighting (IDW) Analysis µg/kg dw
