RE: Final RI/FS report for the JELD-WEN/Former Nord Door Site, Everett, WA
FSID Number: 2757 and CSID Number: 4402

Final Remedial Investigation/Feasibility Study

Jeld Wen / Former Nord Door Facility
300 West Marine View Drive
Everett, Washington 98201

December 2021

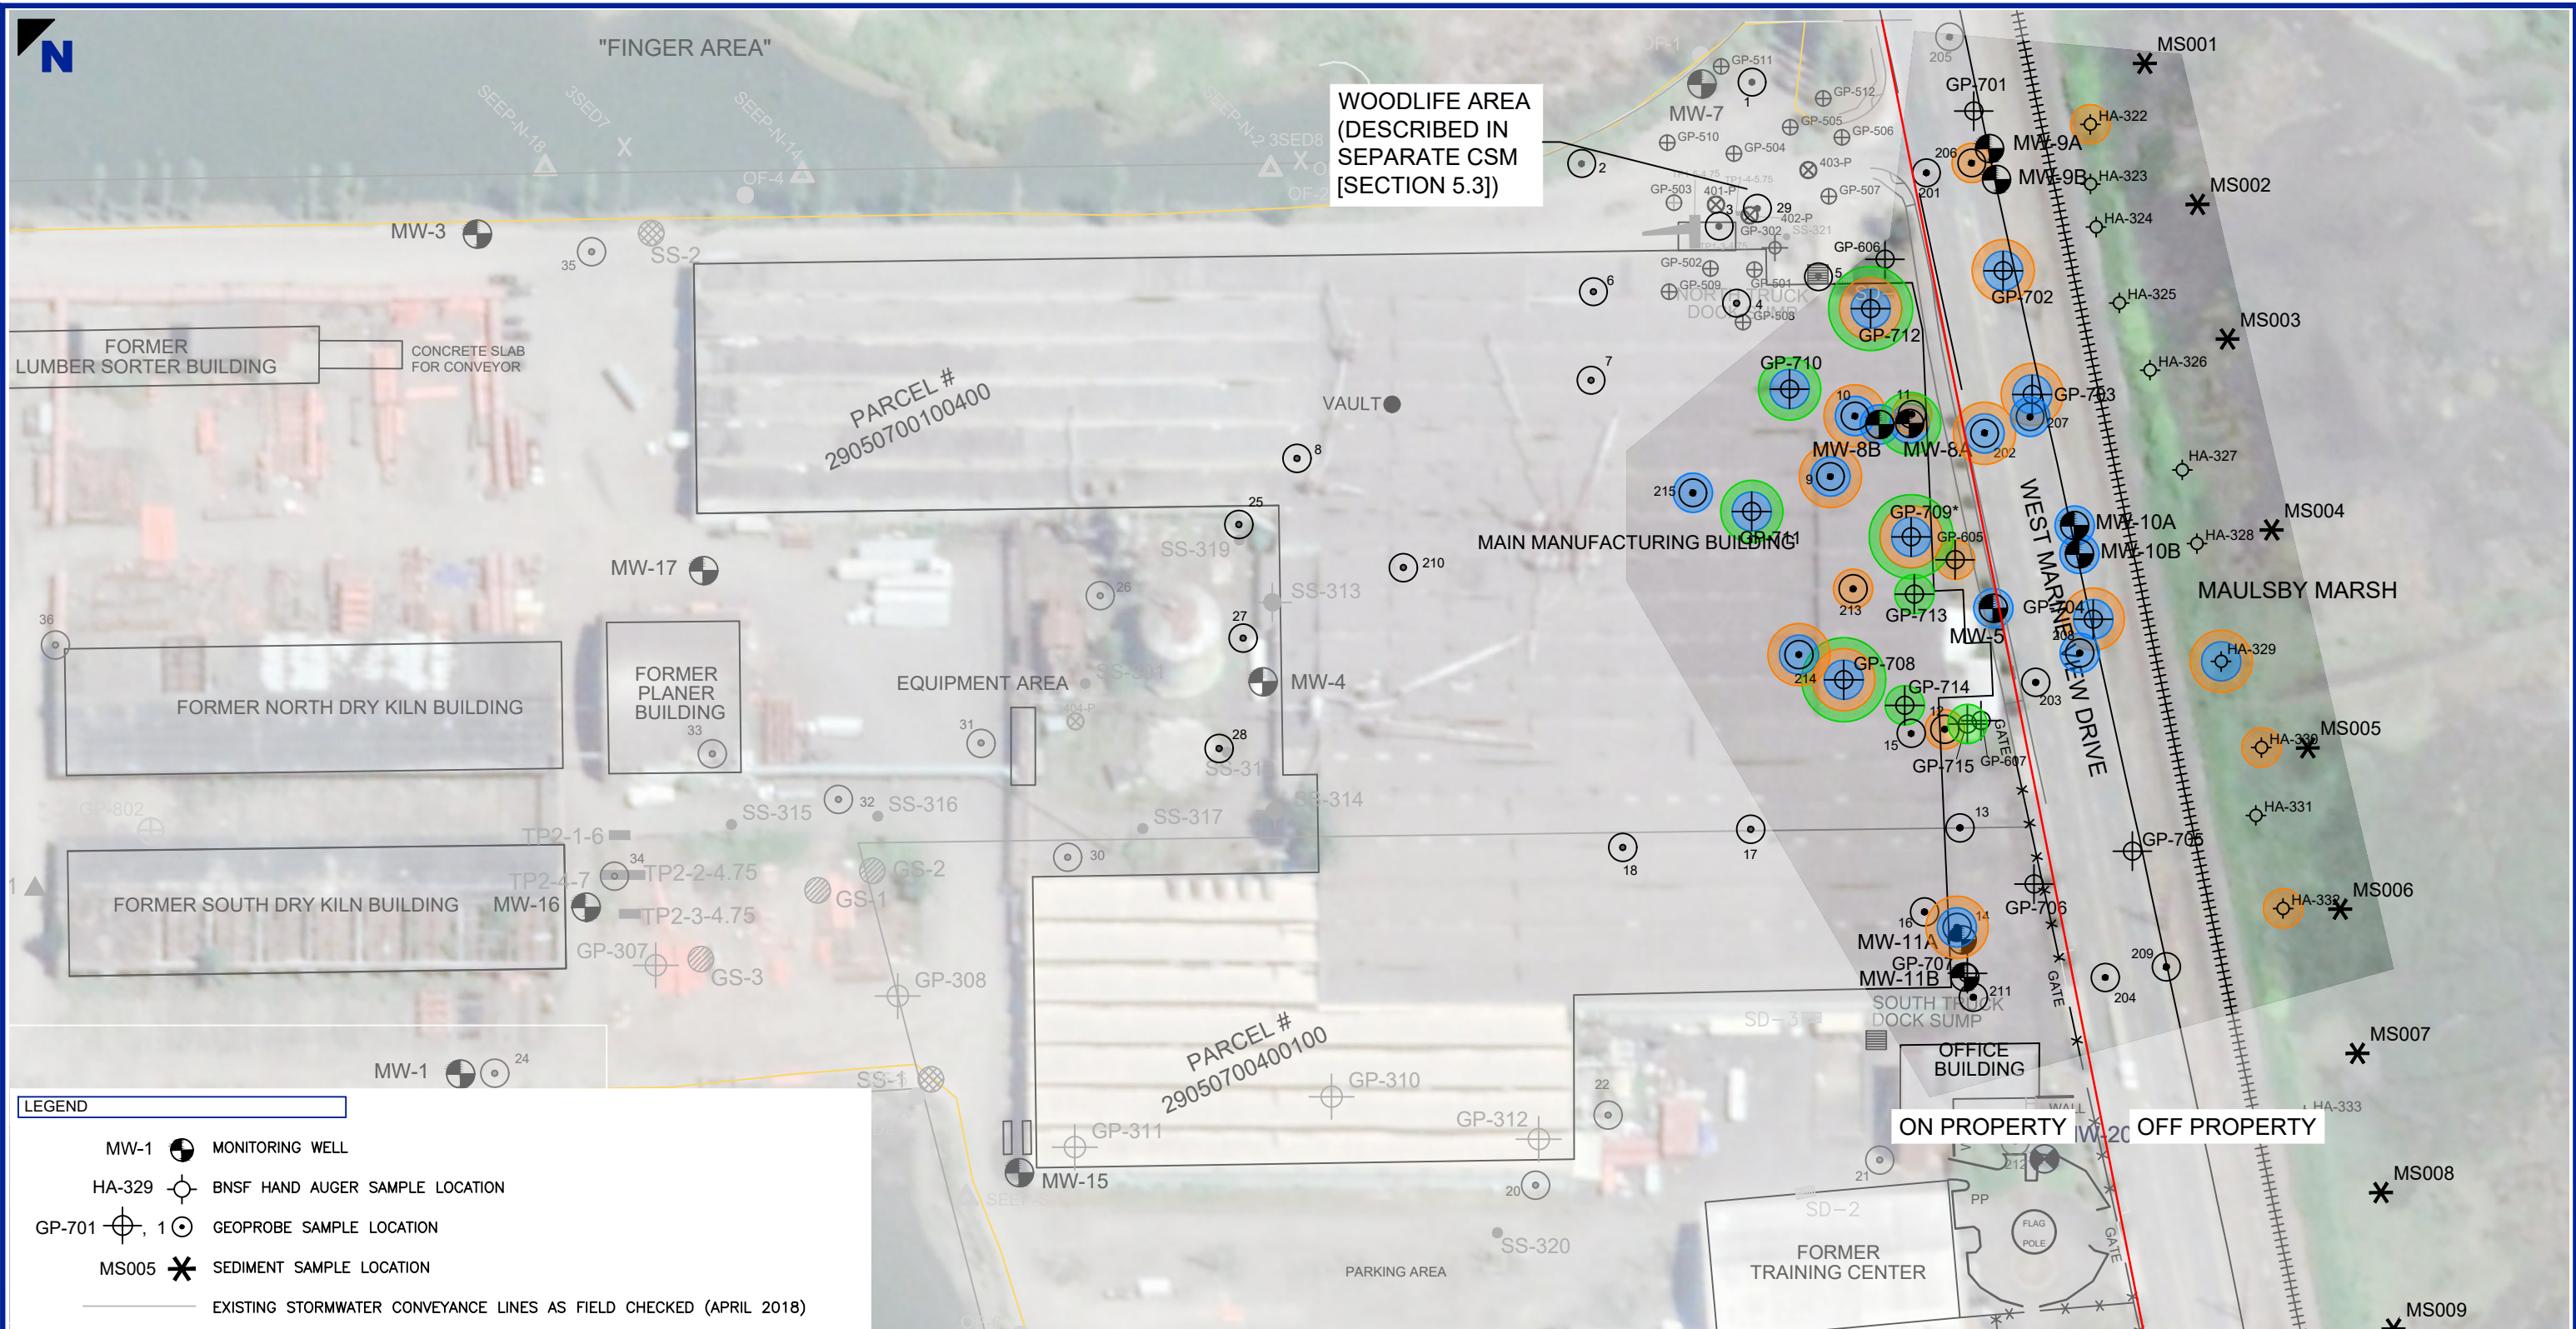
Date	MARCH 2021	Scale	AS SHOWN	Fig. No.
File Name	SW_NORD_NTL_POLE_EXCEEDANCE	Project No.	108.00228.00061	5.2-1

- MW-1 MONITORING WELL
- HA-329 BNSF HAND AUGER SAMPLE LOCATION
- GP-701 GEOPROBE SAMPLE LOCATION
- MS005 SEDIMENT SAMPLE LOCATION
- EXISTING STORMWATER CONVEYANCE LINES AS FIELD CHECKED (APRIL 2018)
- GROUNDWATER EXCEEDANCE OF NAPHTHALENE PCL (BASED ON VAPOR INTRUSION)
- SOIL EXCEEDANCE OF cPAH PCL (BASED ON DIRECT CONTACT)
- SOIL GAS EXCEEDANCE OF NAPHTHALENE PCL

Releases of petroleum hydrocarbons in the Creosote/Fuel Oil Area are likely associated with the historical fuel storage tanks that were located south of the identified pole treating activities (Appendix A). The highest concentrations of COPCs in soil and groundwater were reported during pre-RI investigations in the central portion of the Creosote/Fuel Oil Area including borings GP-9, -10, -11, -12, -214, -215, and several borings under the existing West Marine View Drive (see Figure 5.2-1). Grading and filling activities associated with construction of West Marine View Drive likely resulted in burial of surficial contamination east of the primary operations area. Additional assessments focused on the Creosote/Fuel Oil Area were performed under Ecology-approved work plans.

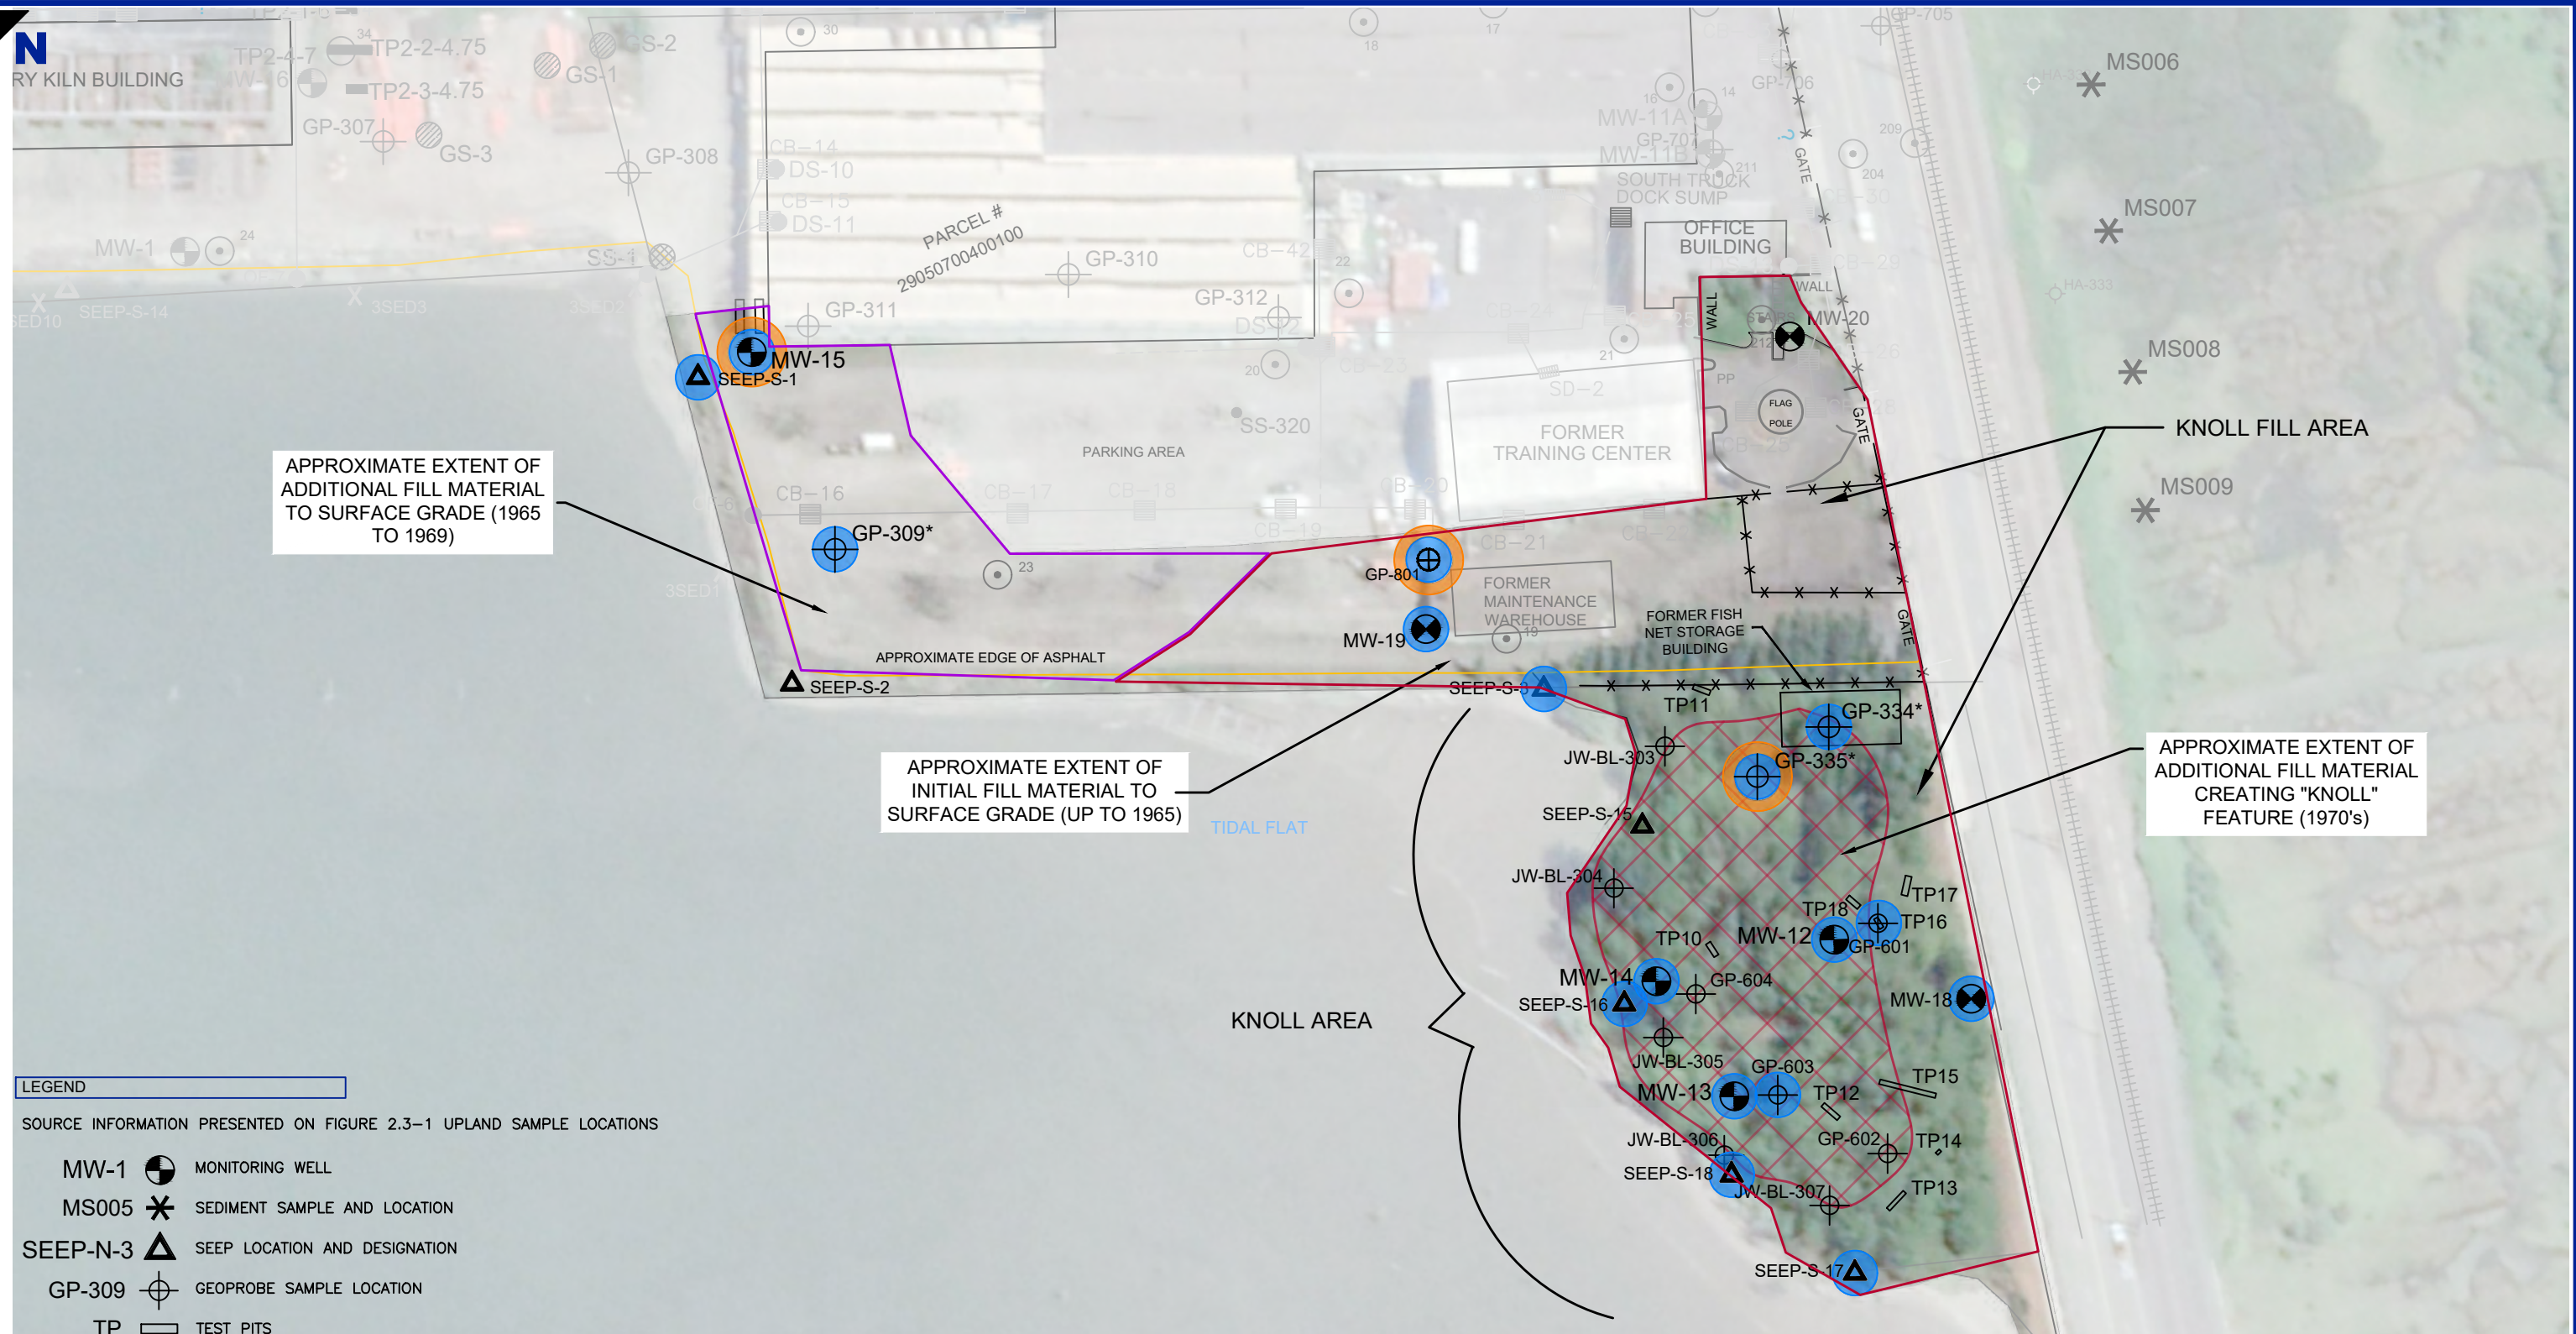
Date	MARCH 2021	Scale	AS SHOWN	Fig. No.
File Name	SW_NORD_KNOLL EXCEEDANCES	Project No.	108.00228.00061	5.4-1

APPROXIMATE EXTENT OF ADDITIONAL FILL MATERIAL TO SURFACE GRADE (1965 TO 1969)

APPROXIMATE EXTENT OF INITIAL FILL MATERIAL TO SURFACE GRADE (UP TO 1965)

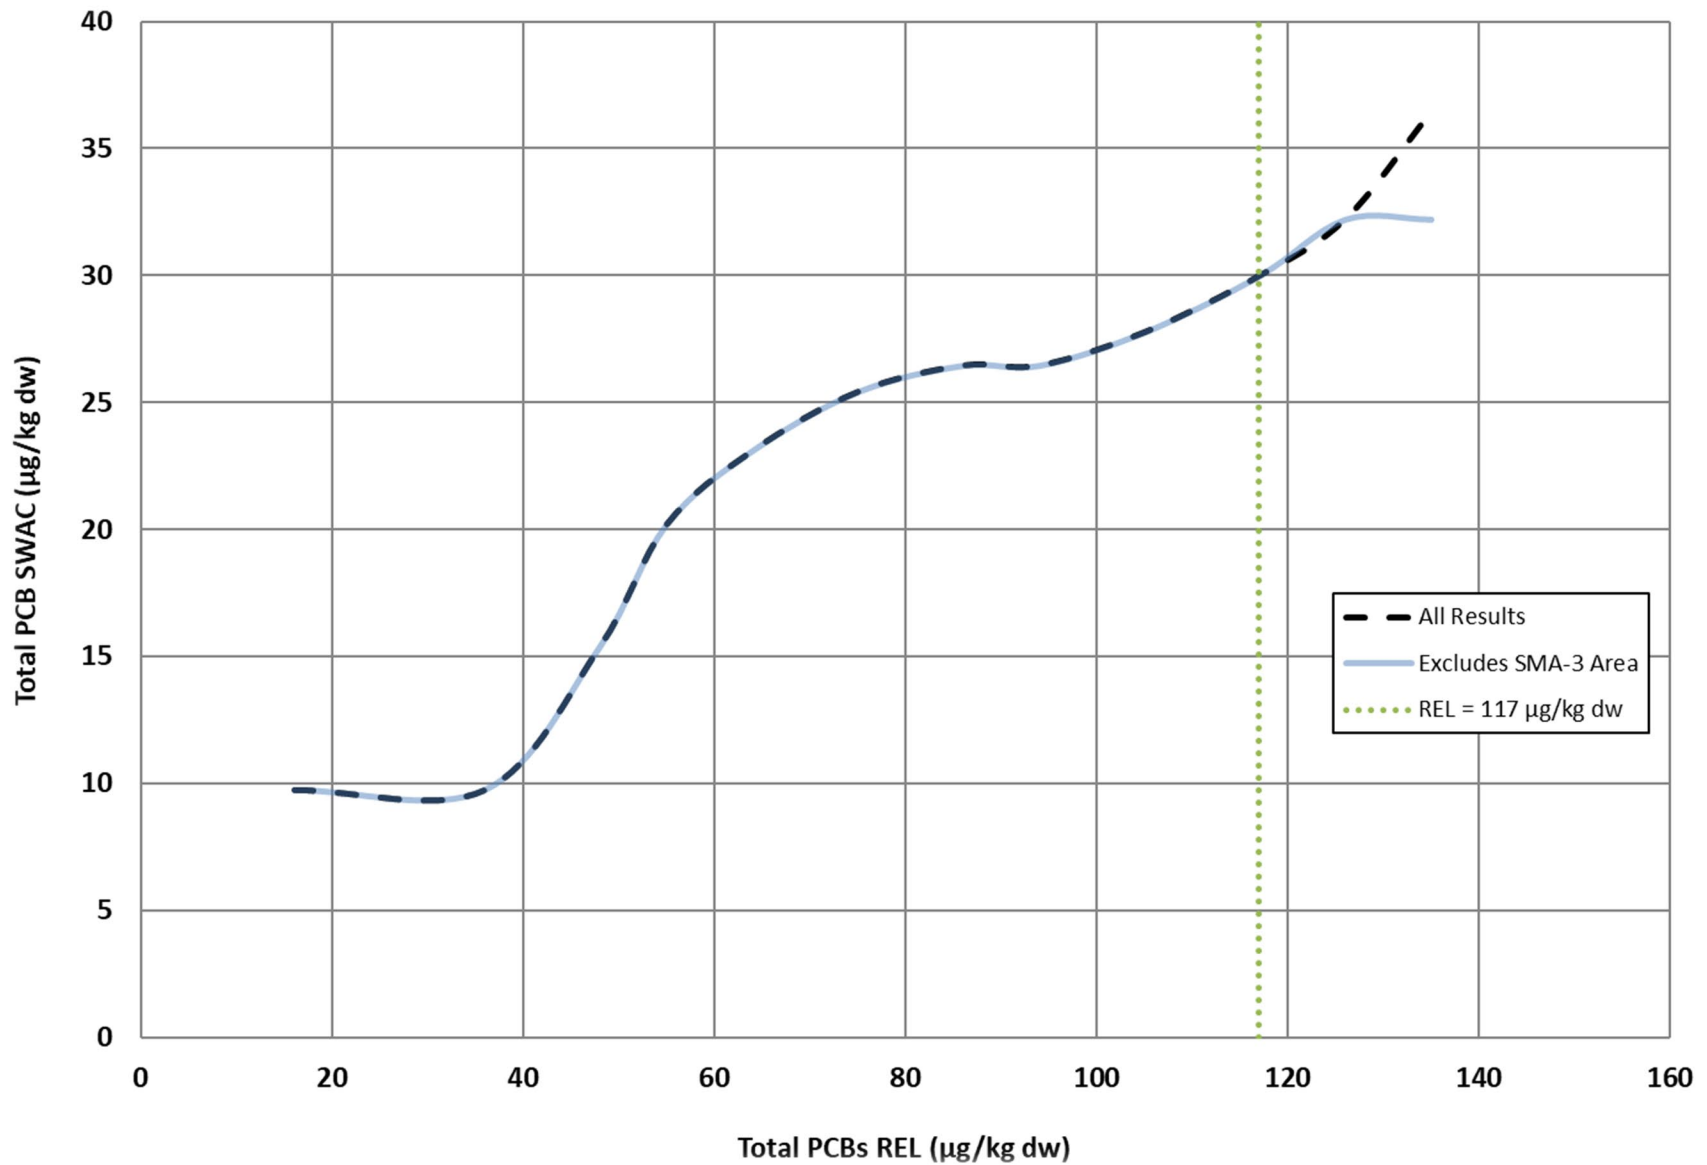
Figure 6.2-1
 Total PCB RAL Versus Acreage, JELD-WEN Marine Sediment Area
 Final RI/FS
 Jeld-Wen/Former Nord Door Facility

Note: REL = remediation level; SWAC = surface weighted average concentration

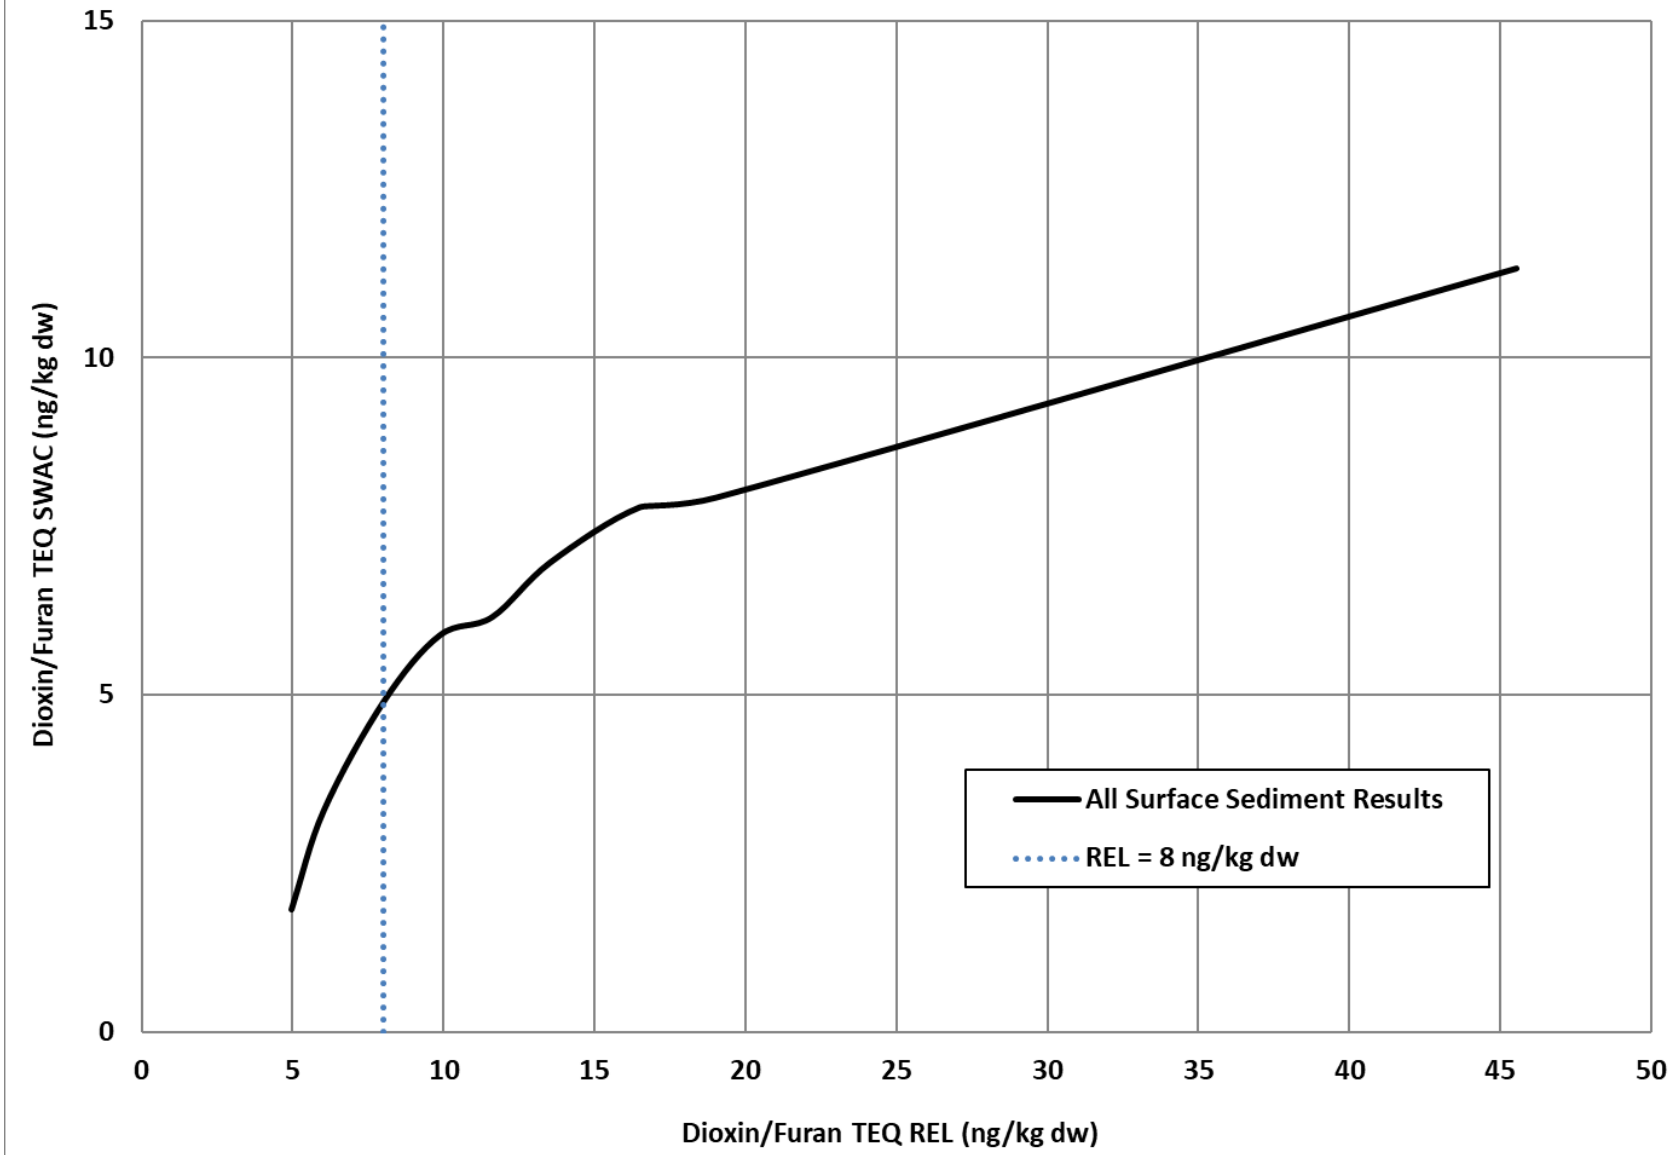
Figure 6.2-2

Note: REL = remediation level; SWAC = surface weighted average concentration

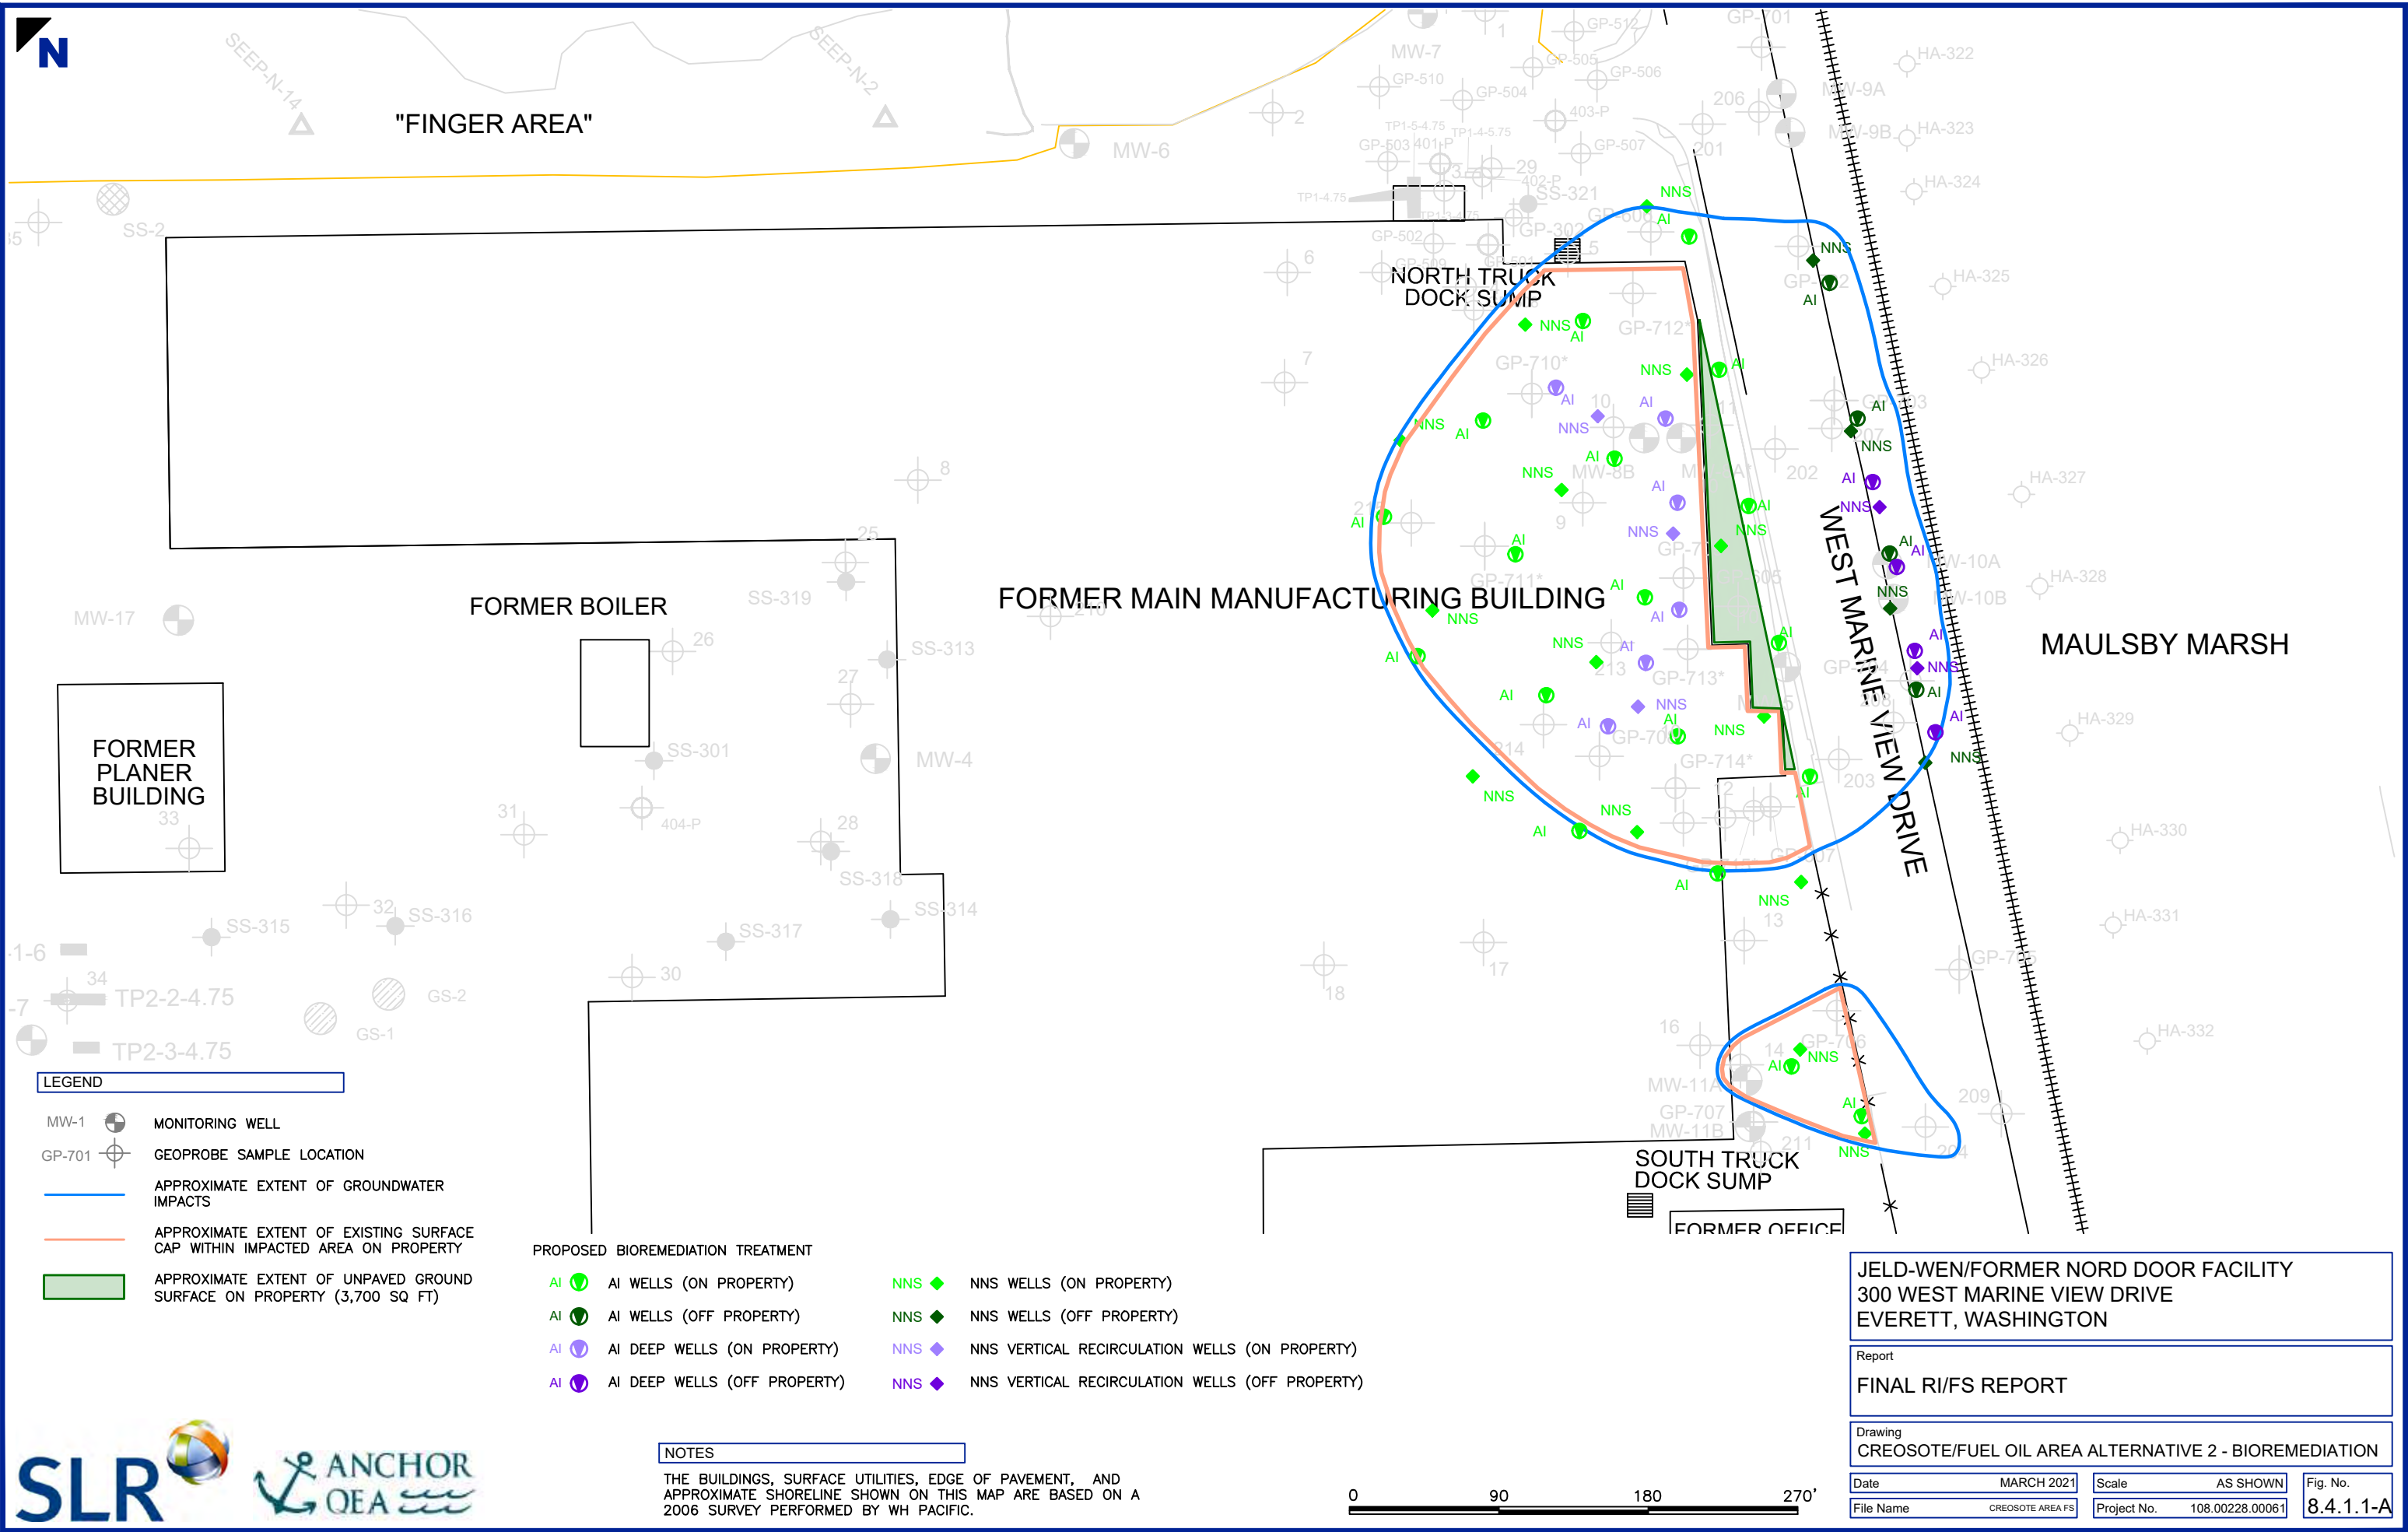
- MW-1 MONITORING WELL
- GP-701 GEOPROBE SAMPLE LOCATION
- APPROXIMATE EXTENT OF GROUNDWATER IMPACTS
- APPROXIMATE EXTENT OF EXISTING SURFACE CAP WITHIN IMPACTED AREA ON PROPERTY
- APPROXIMATE EXTENT OF UNPAVED GROUND SURFACE ON PROPERTY (3,700 SQ FT)

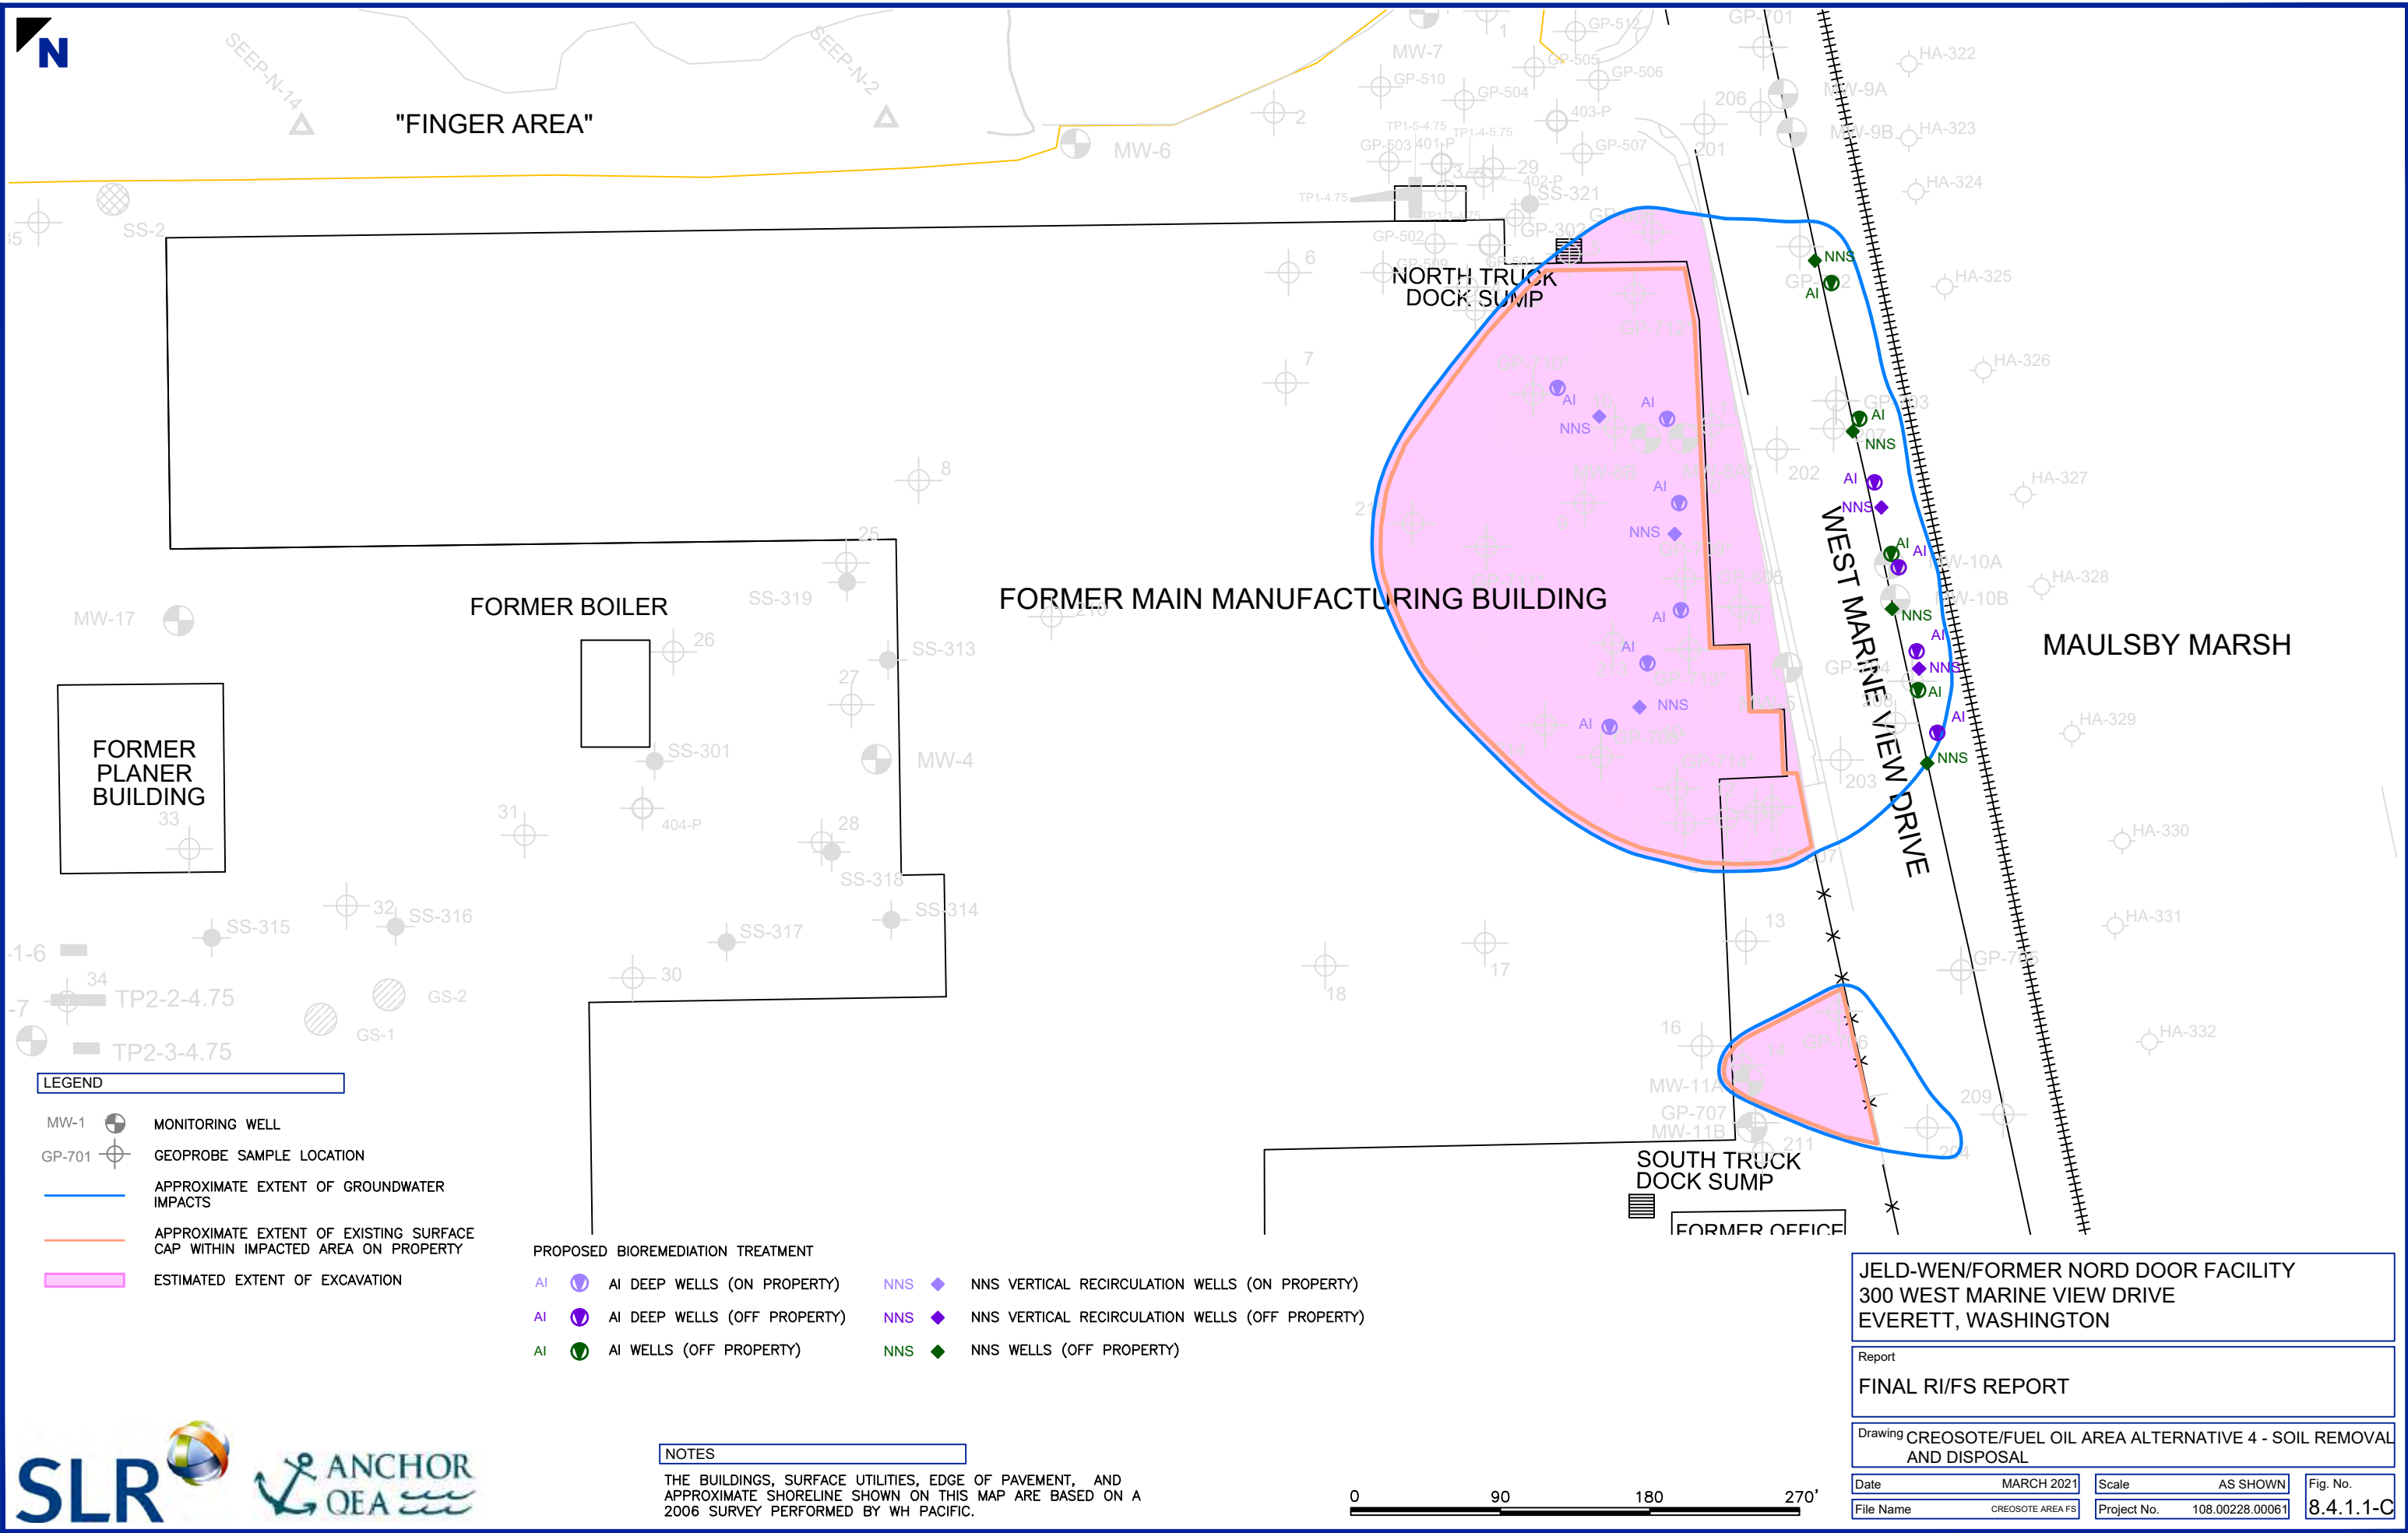
- MW-1 MONITORING WELL
- GP-701 GEOPROBE SAMPLE LOCATION
- APPROXIMATE EXTENT OF GROUNDWATER IMPACTS
- APPROXIMATE EXTENT OF EXISTING SURFACE CAP WITHIN IMPACTED AREA ON PROPERTY
- ESTIMATED EXTENT OF EXCAVATION

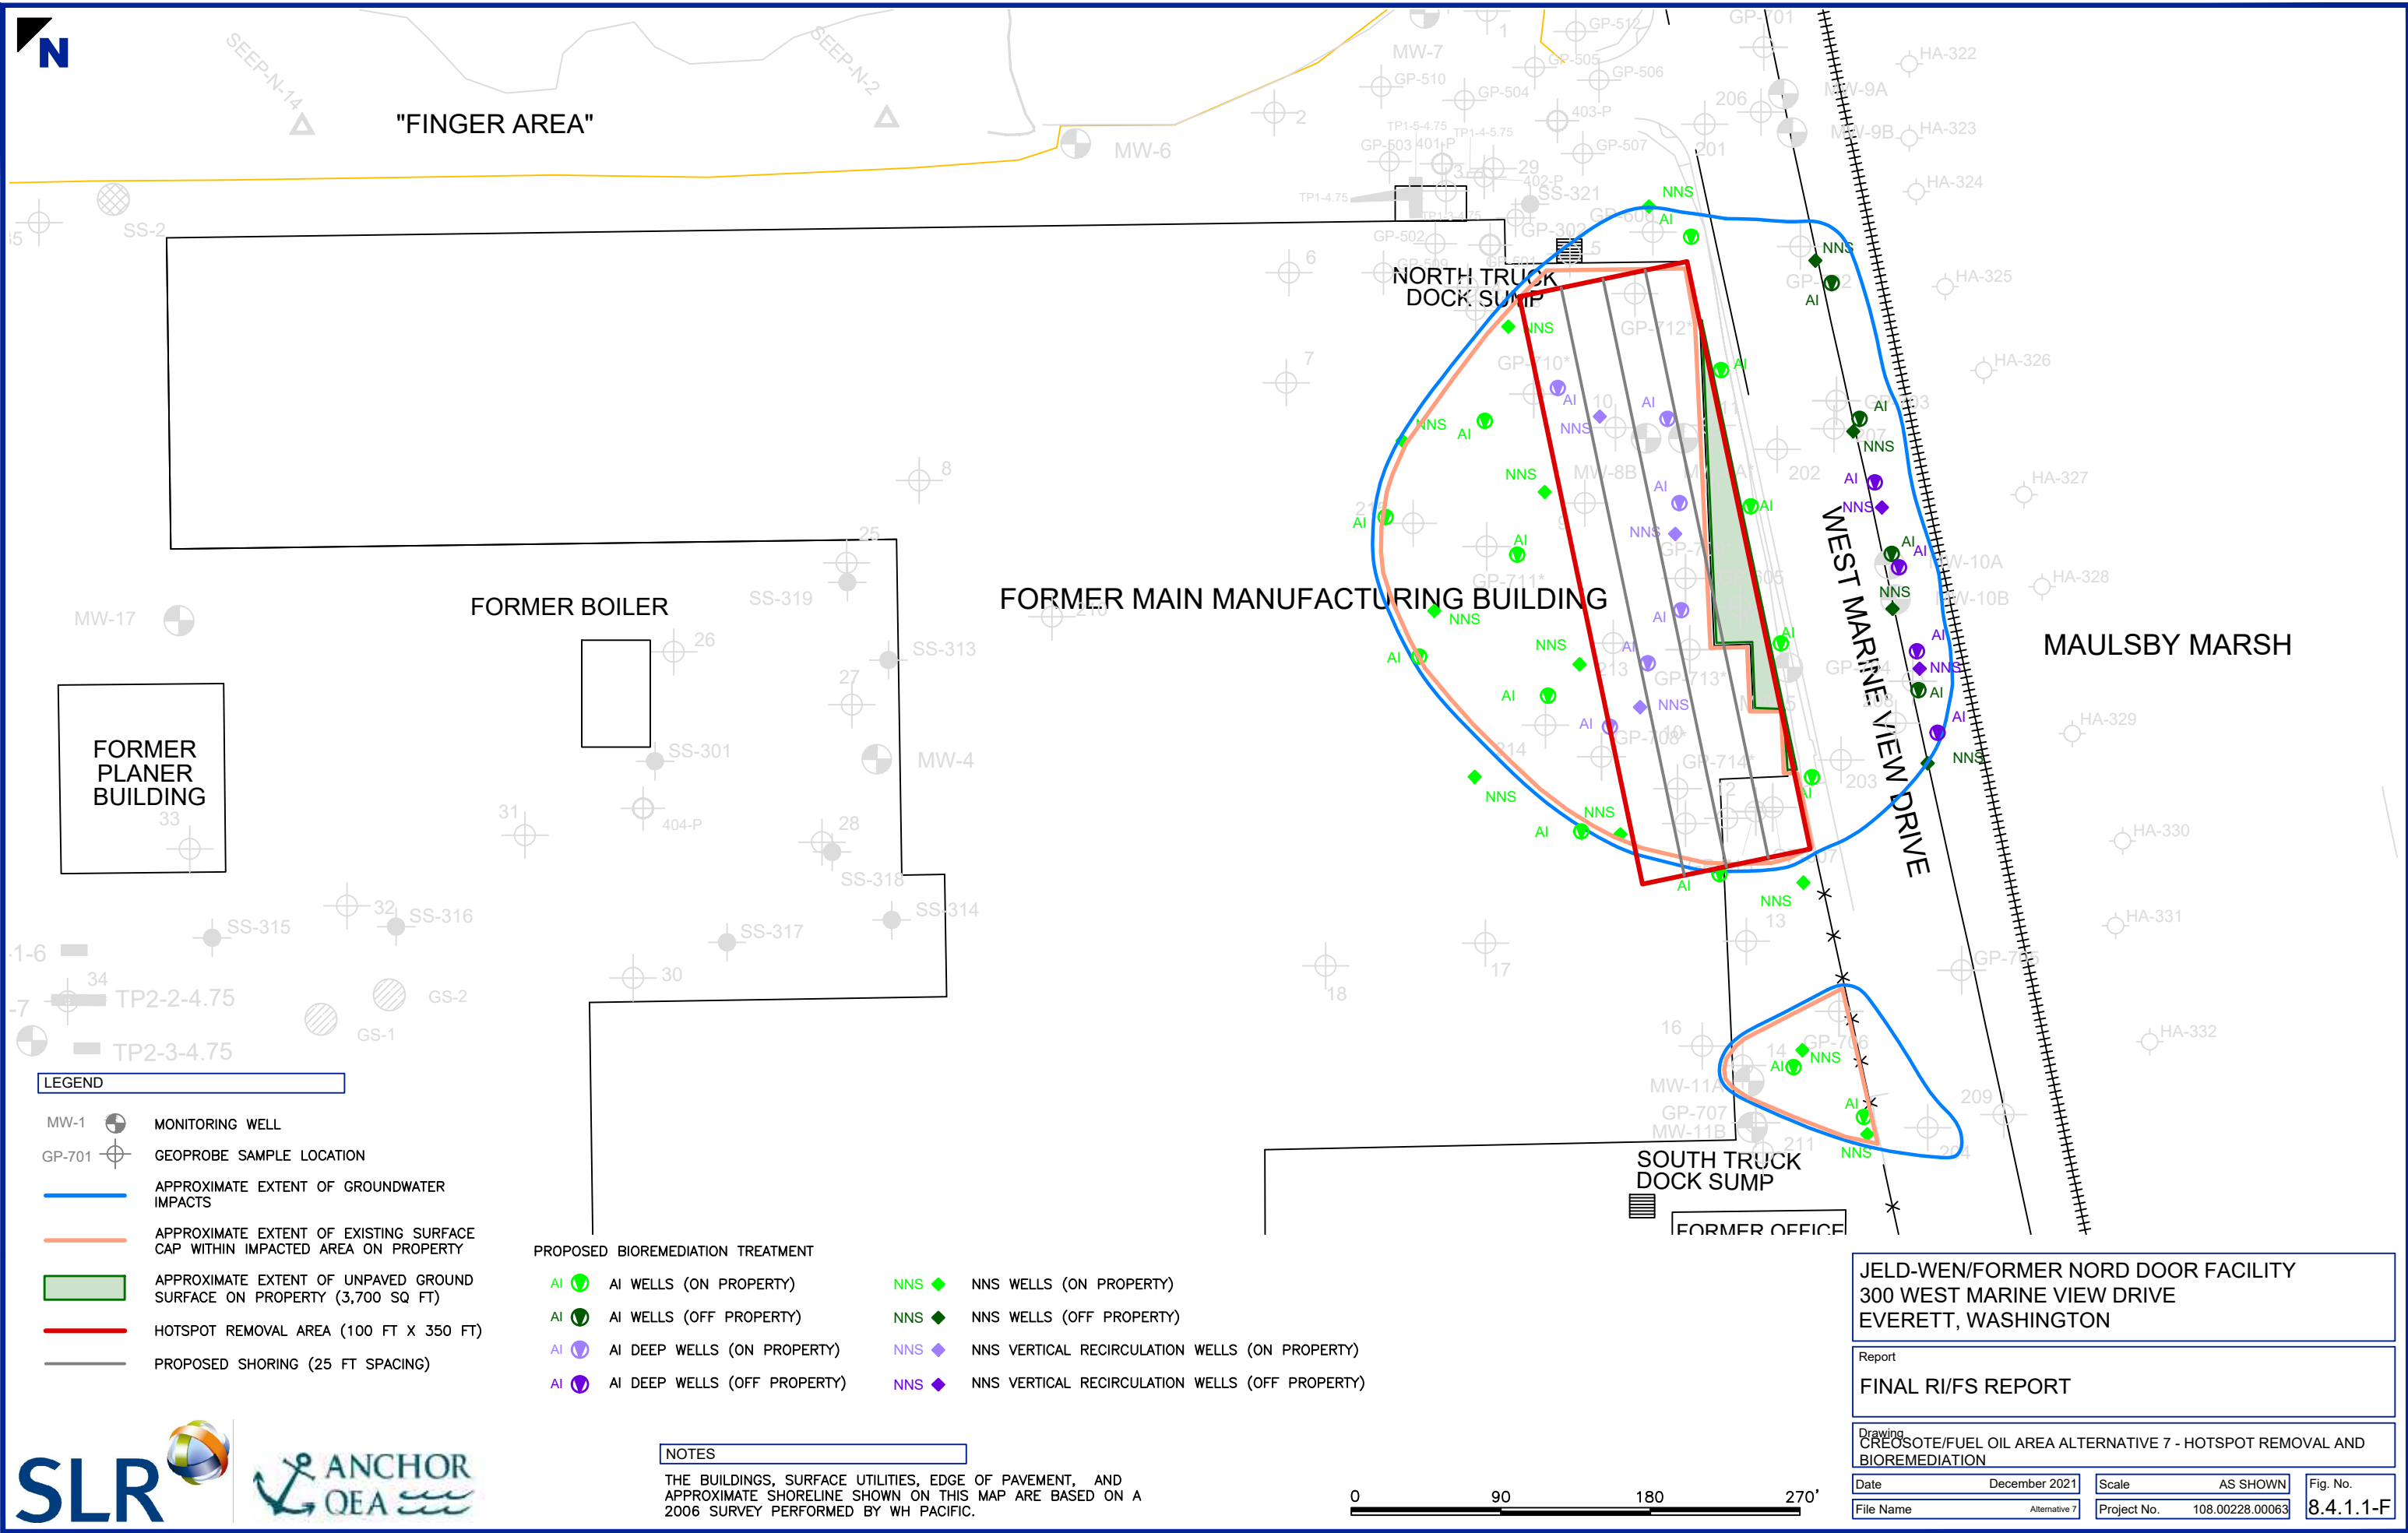
Date	December 2021	Scale	AS SHOWN	Fig. No.
File Name	Alternative 7	Project No.	108.00228.00063	8.4.1.1-F

- MW-1 MONITORING WELL
- GP-701 GEOPROBE SAMPLE LOCATION
- APPROXIMATE EXTENT OF GROUNDWATER IMPACTS
- APPROXIMATE EXTENT OF EXISTING SURFACE CAP WITHIN IMPACTED AREA ON PROPERTY
- APPROXIMATE EXTENT OF UNPAVED GROUND SURFACE ON PROPERTY (3,700 SQ FT)
- HOTSPOT REMOVAL AREA (100 FT X 350 FT)
- PROPOSED SHORING (25 FT SPACING)
