RE: Final RI/FS report for the JELD-WEN/Former Nord Door Site, Everett, WA
FSID Number: 2757 and CSID Number: 4402

Final Remedial Investigation/Feasibility Study

Jeld Wen / Former Nord Door Facility
300 West Marine View Drive
Everett, Washington 98201

December 2021

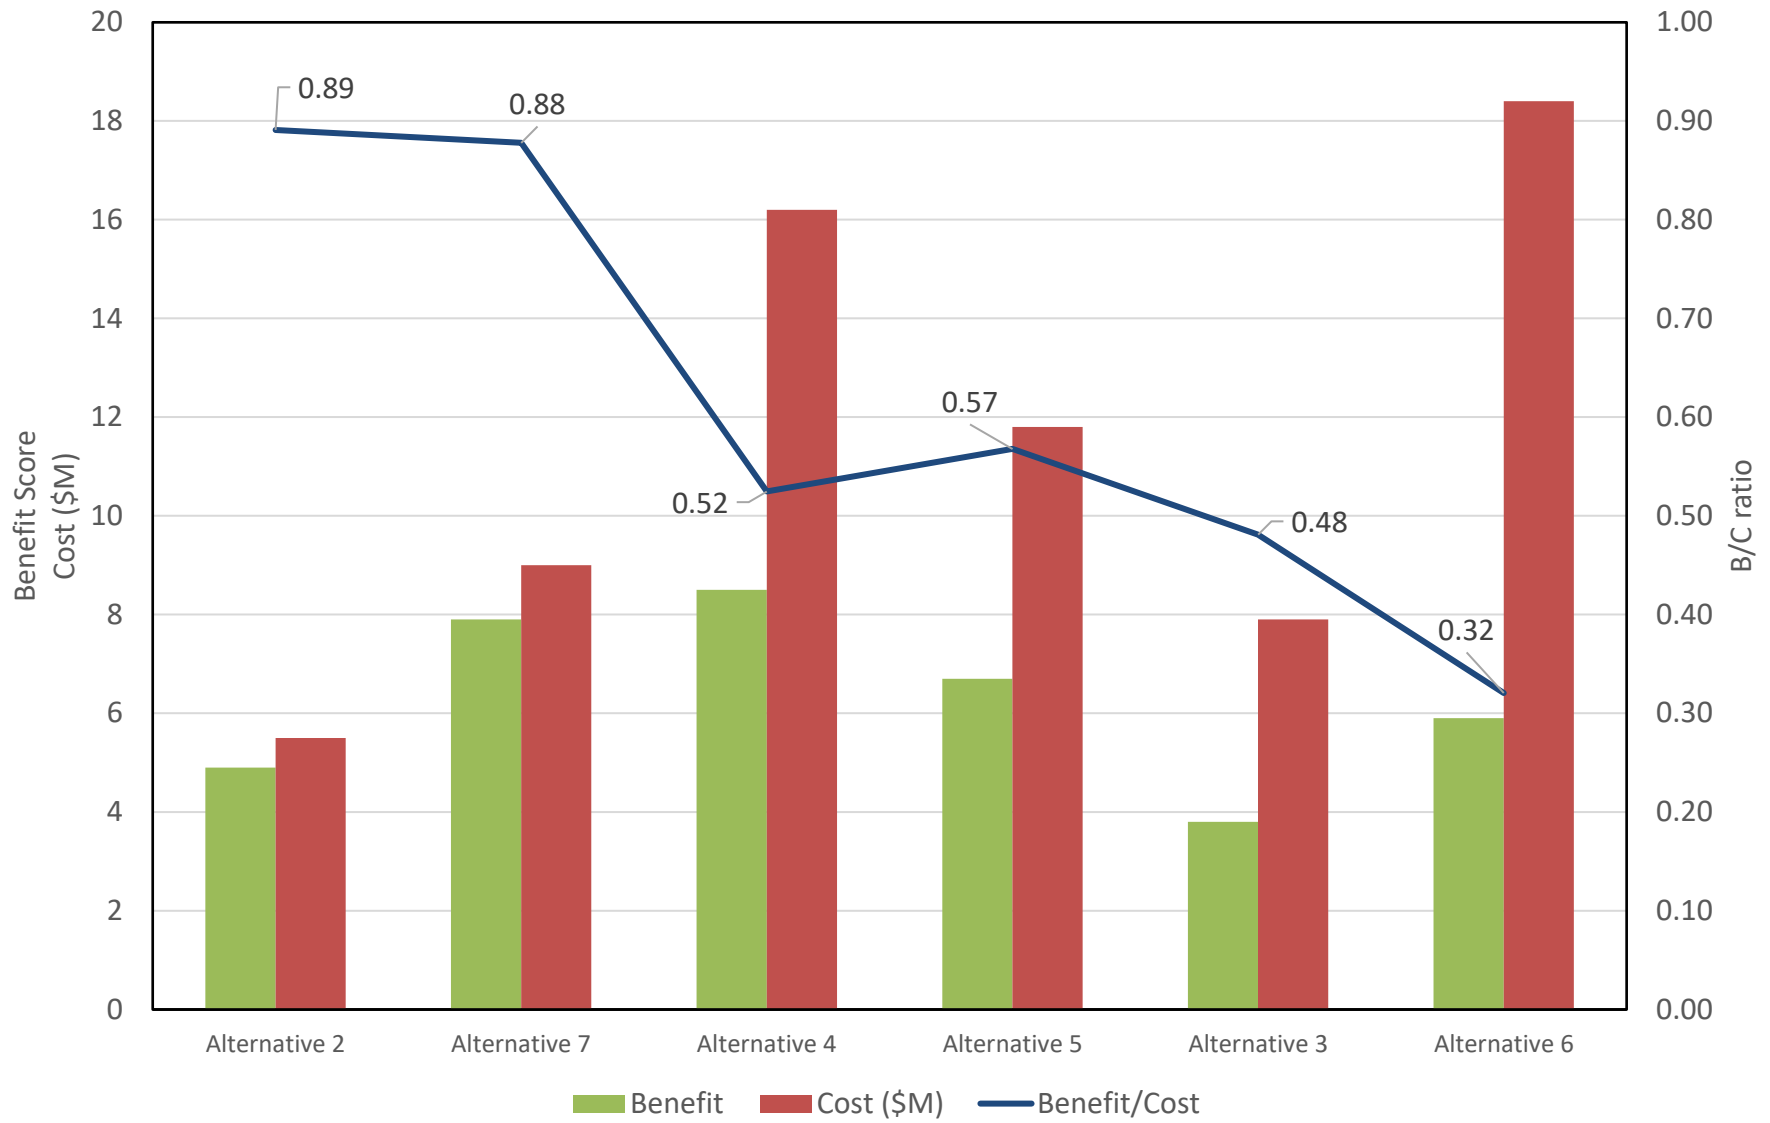
Figure 10.1-1
Creosote/Fuel Oil Area DCA
(Excludes Alternative 1)

Based on the analysis presented in Section 10.1.4 and the DCA, Creosote/Fuel Oil Area - Figure 10.1-1 presents the weighted score for each alternative along with the estimated cost. Table 10.1-1 presents the total Composite Benefit Score, estimated cost, and unit cost (dollars per composite benefit score increment). Ecology provided Alternative 7, consisting of hot spot soil removal and BIO, is Ecology's preferred Alternative and Ecology has instructed JELD-WEN to use Alternative 7 as the preferred alternative for the Creosote/Fuel Oil Area (see correspondence included in Appendix O). Below is a summary of the DCA process. Details can be found in Section 10.1.4.

The results of the evaluation are summarized below by area and presented as a numeric scoring system in Table 10.1-1 (Creosote/Fuel Oil Area) and Table 10.1-2 (Woodlife Area). Figure 10.1-1 (Creosote/Fuel Oil Area) and Figure 10.1-2 graphically depict the costs and benefits based on the discussion and scoring described in this section. For reference, a summary of the treatment technologies by area (on-property vs off-property, shallow vs deep, etc.) for each alternative are presented in Table 8.4.1-1.

Detailed costs for each alternative are provided in Appendix M. Figure 10.1-1 provides a summary of the estimated total cost for each alternative, including construction as well as non-construction costs. This Cost Benefit Chart was provided by Ecology via email on June 19, 2020 with the Ecology-derived revised cost estimate for Alternative 7 (correspondence included in Appendix O). Alternative 1 was the lowest cost alternative, estimated to cost \$1.2 million to implement; however, as previously noted Alternative 1 does not MTCA requirement for permanent solution to maximum extent practicable and reasonable restoration timeframe for cleanup actions. Alternative 2 was the least cost alternative that met threshold requirements, costing \$5.5 million to implement. Costs for Alternatives 3, 5, and 7 were similar, but increased considerably from Alternative 2, ranging from \$7.9 to \$12 million dollars to implement. Alternatives 4 and 6 were the most expensive alternatives, costing between \$166 and \$18 million dollars to implement.
