INITIAL INVESTIGATION FIELD REPORT

INCIDENT#: 115931

Case Name Penske Rental Truck Gasoline Spill to Asphalt and Soil, Lacey - 3/25/21
Incident Date: 03/25/2021
Inc. Category: Oil Spill
Inc. Type#: 5
Status: Open
Incident#: 115931
ERTS#: 705700
ANT#:
Potential Vessel Emerg? N
SIC/MIC#:
Tug Deployment? N
ECY Hired Contractor? N

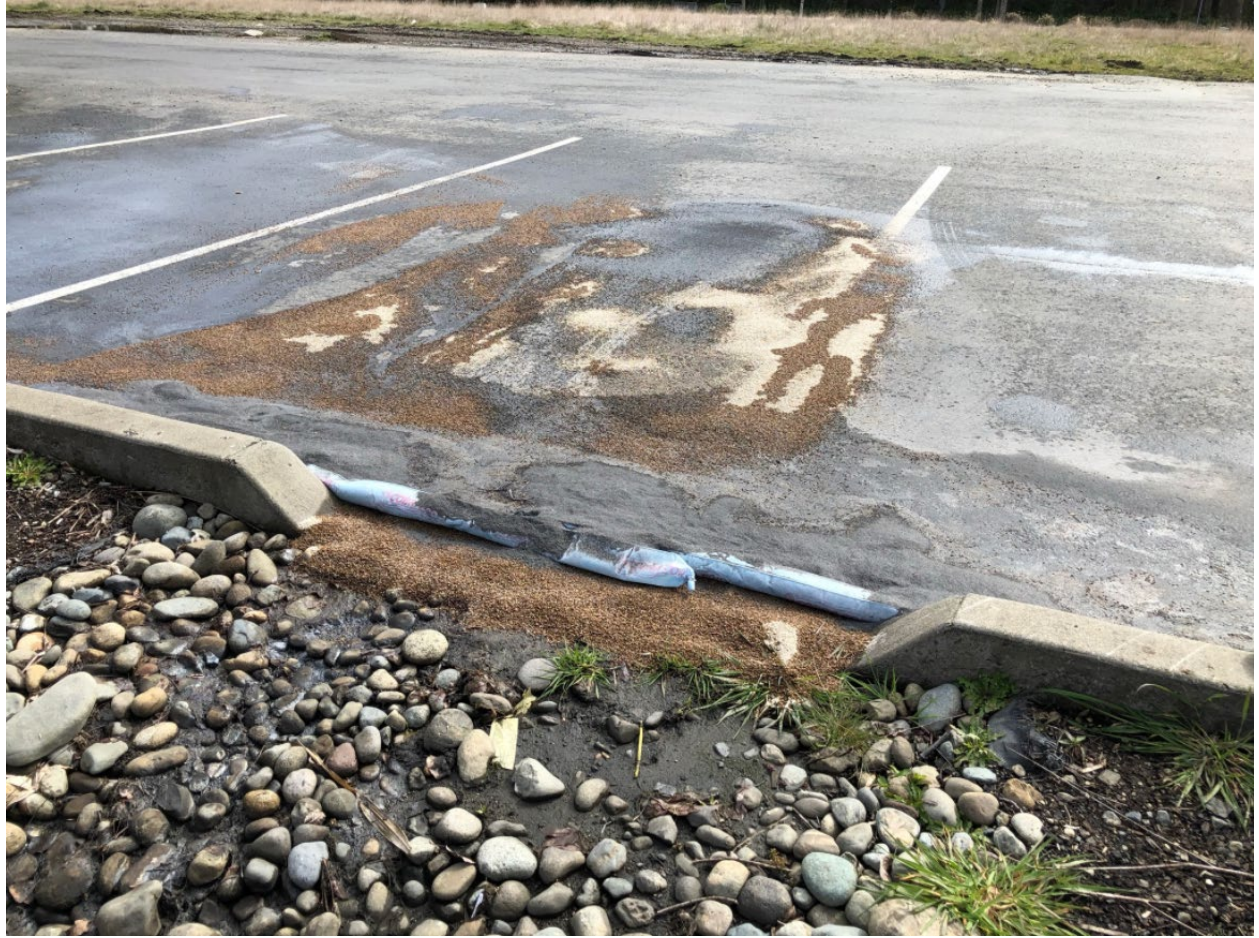
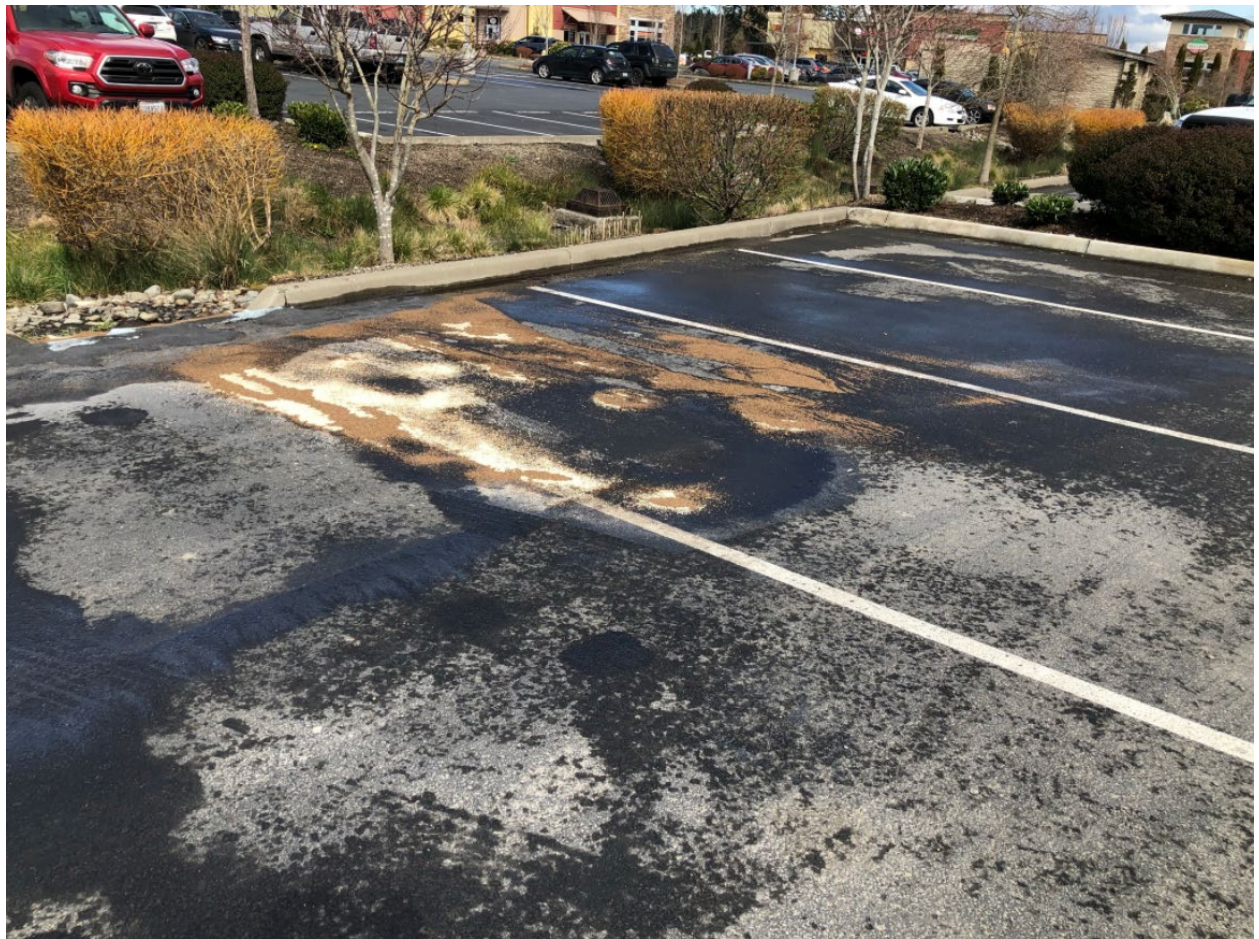
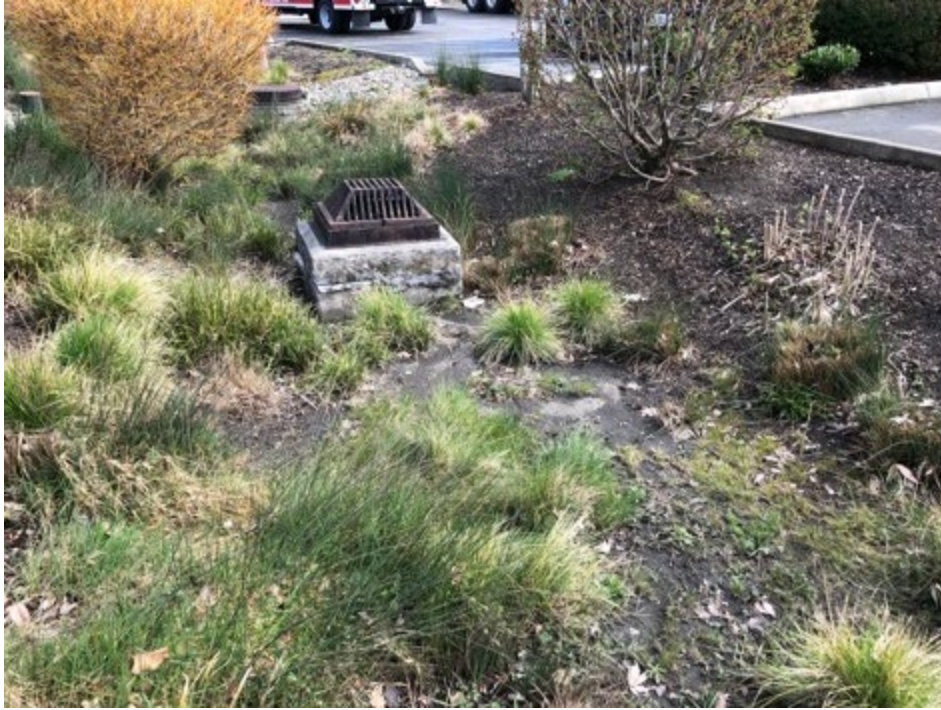
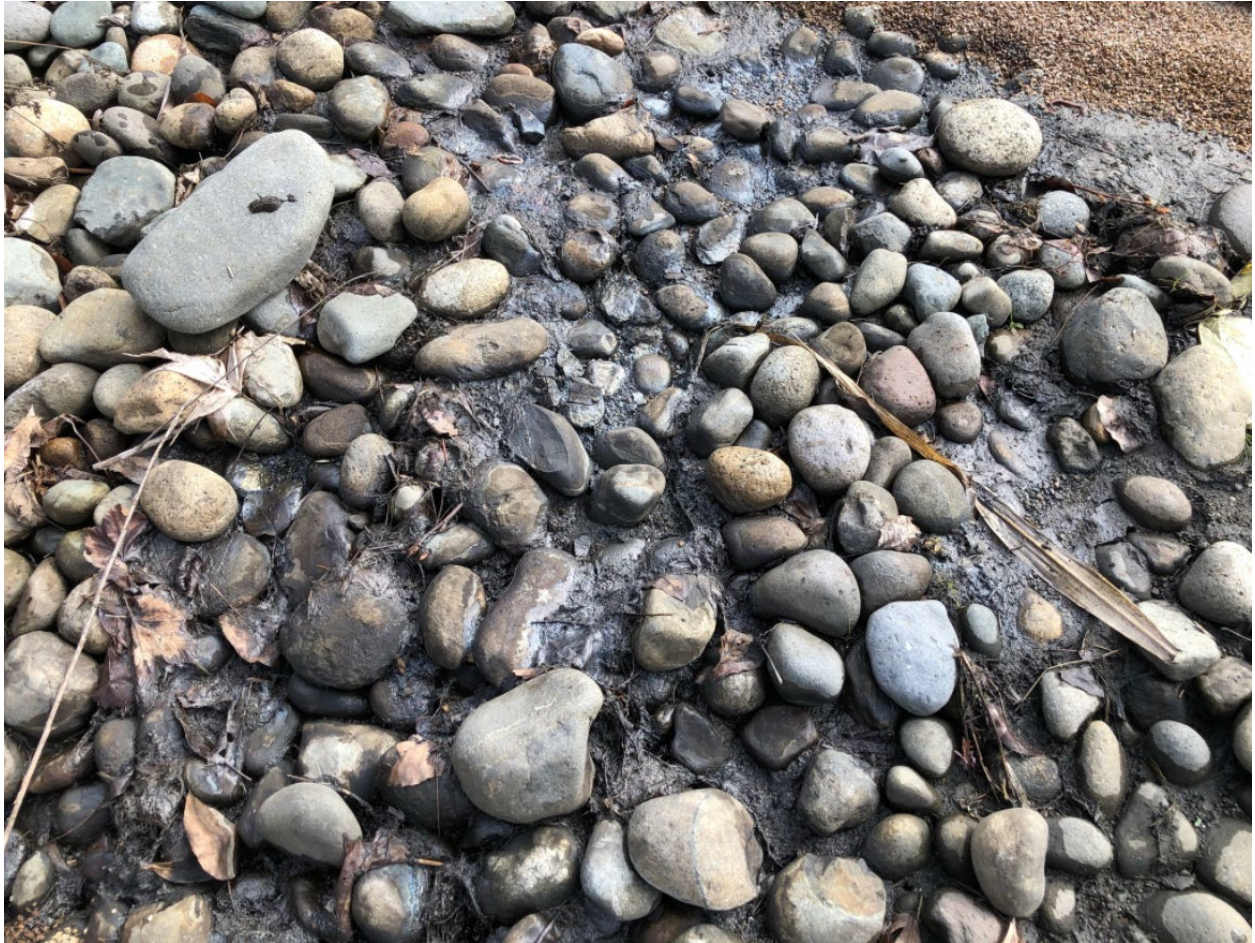
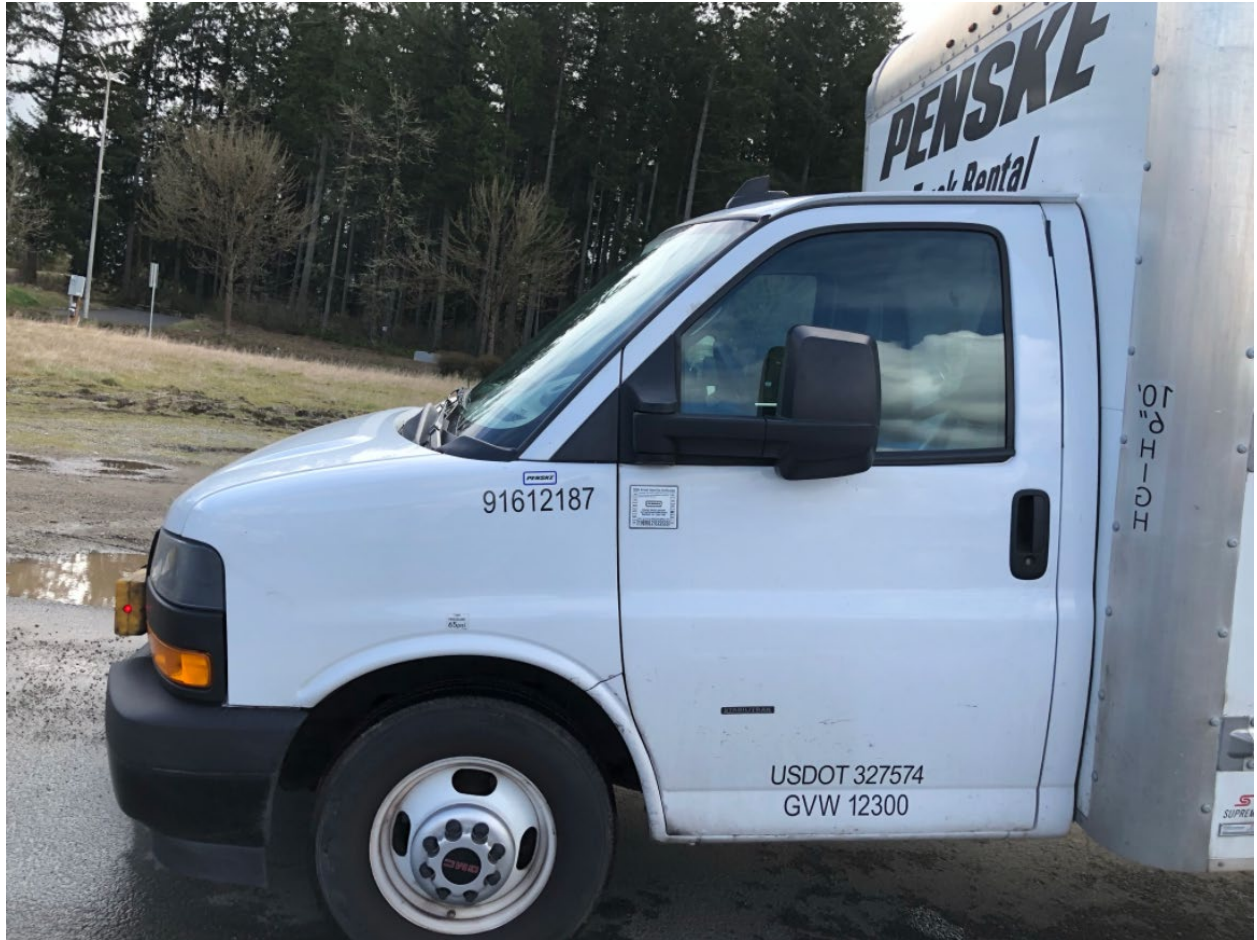
I arrived at Britton Plaza as Gene's Towing was preparing to lift and tow the truck to the nearby Penske Truck rental at 7647 Betti Ln NE. I confirmed that the putty on the tank was successfully preventing any further spill and that the tank was still about 1/4 full. I took photos (uploaded to file) and at 1448 updated Regional Supervisor, Alison Meyers, that the bioswale will require some remediation. FloorDry and absorbent socks had been applied to block impact to the river rocks and soil of the bioswale, gasoline odor also present. There was no sign of gasoline in the gravel area except a small amount of unrecoverable sheen in a puddle.

The release was a result of a ruptured gas tank on a Penske rental truck which had been refueled at a nearby 7-Eleven on Marvin Rd NE before being returned to the Home Depot at 1450 Marvin Rd NE. After leaving the 7-Eleven and being alerted that the truck was leaking, the driver pulled into the Britton Plaza parking lot, where the Lacey Fire Department and Lacey Public Works were both notified and responded. We currently estimate that approximately 15 gallons of gasoline spilled from the tank before the hole was sealed. It is likely that around 10 gallons flowed through a gap in the parking lot curb and into a drainage bio-swale, impacting a small area of rocks and soil.

I visited the site with William and discussed plan to excavate contaminated soil in bioswale.

- CCS excavated 18 yds of impacted soil
- Evidence that gasoline infiltrated perforated drainage pipe (meter readings)
- Plan to have PRC visit site on 4/2 to take water samples from pipe to determine possible extent of infiltration into drainage system
- I forwarded this new info to Nannette Brooks with TCP.
