**SUBJECT**      **ExxonMobil ADC Site – Port of Everett Property Interim Action Work Plan**  
ExxonMobil ADC  
2717/2731 Federal Avenue  
Everett, Washington

Cardno's *ExxonMobil ADC Site – Port of Everett Property Interim Action Work Plan*, dated **DRAFT**

ExxonMobil ADC  
2717/2731 Federal Avenue  
Everett, Washington

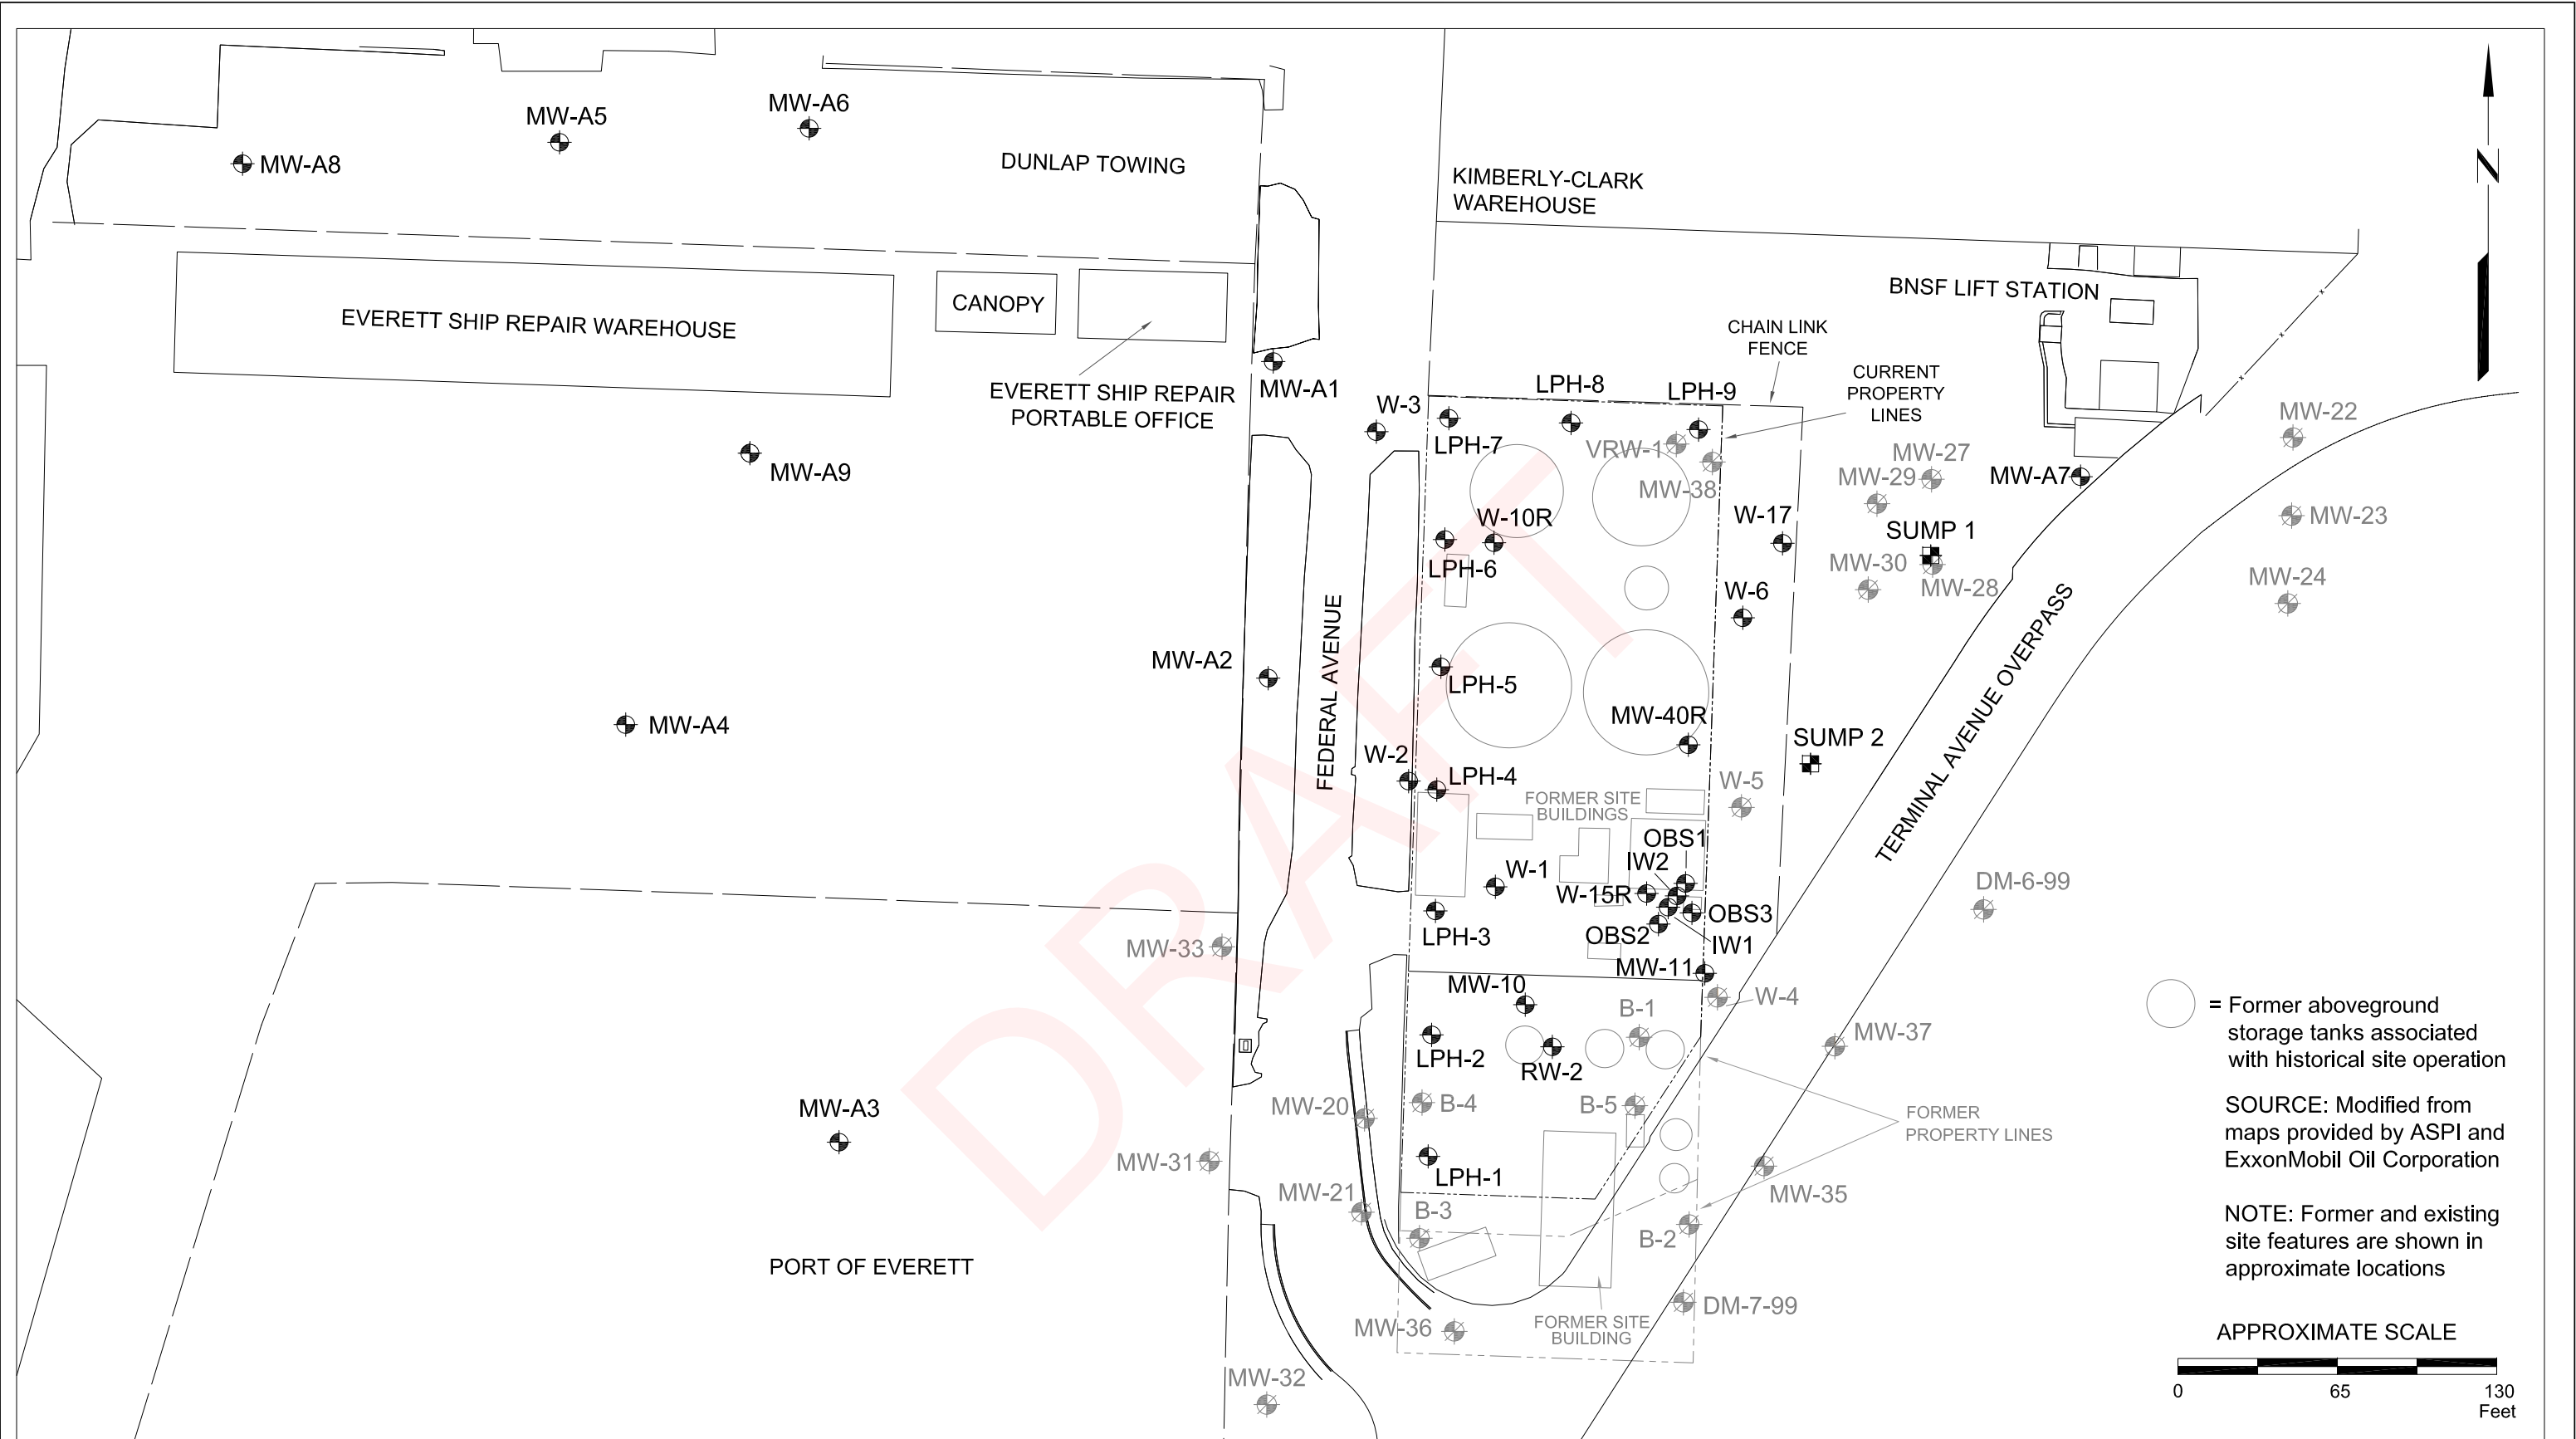
1

○ = Former aboveground storage tanks associated with historical site operation

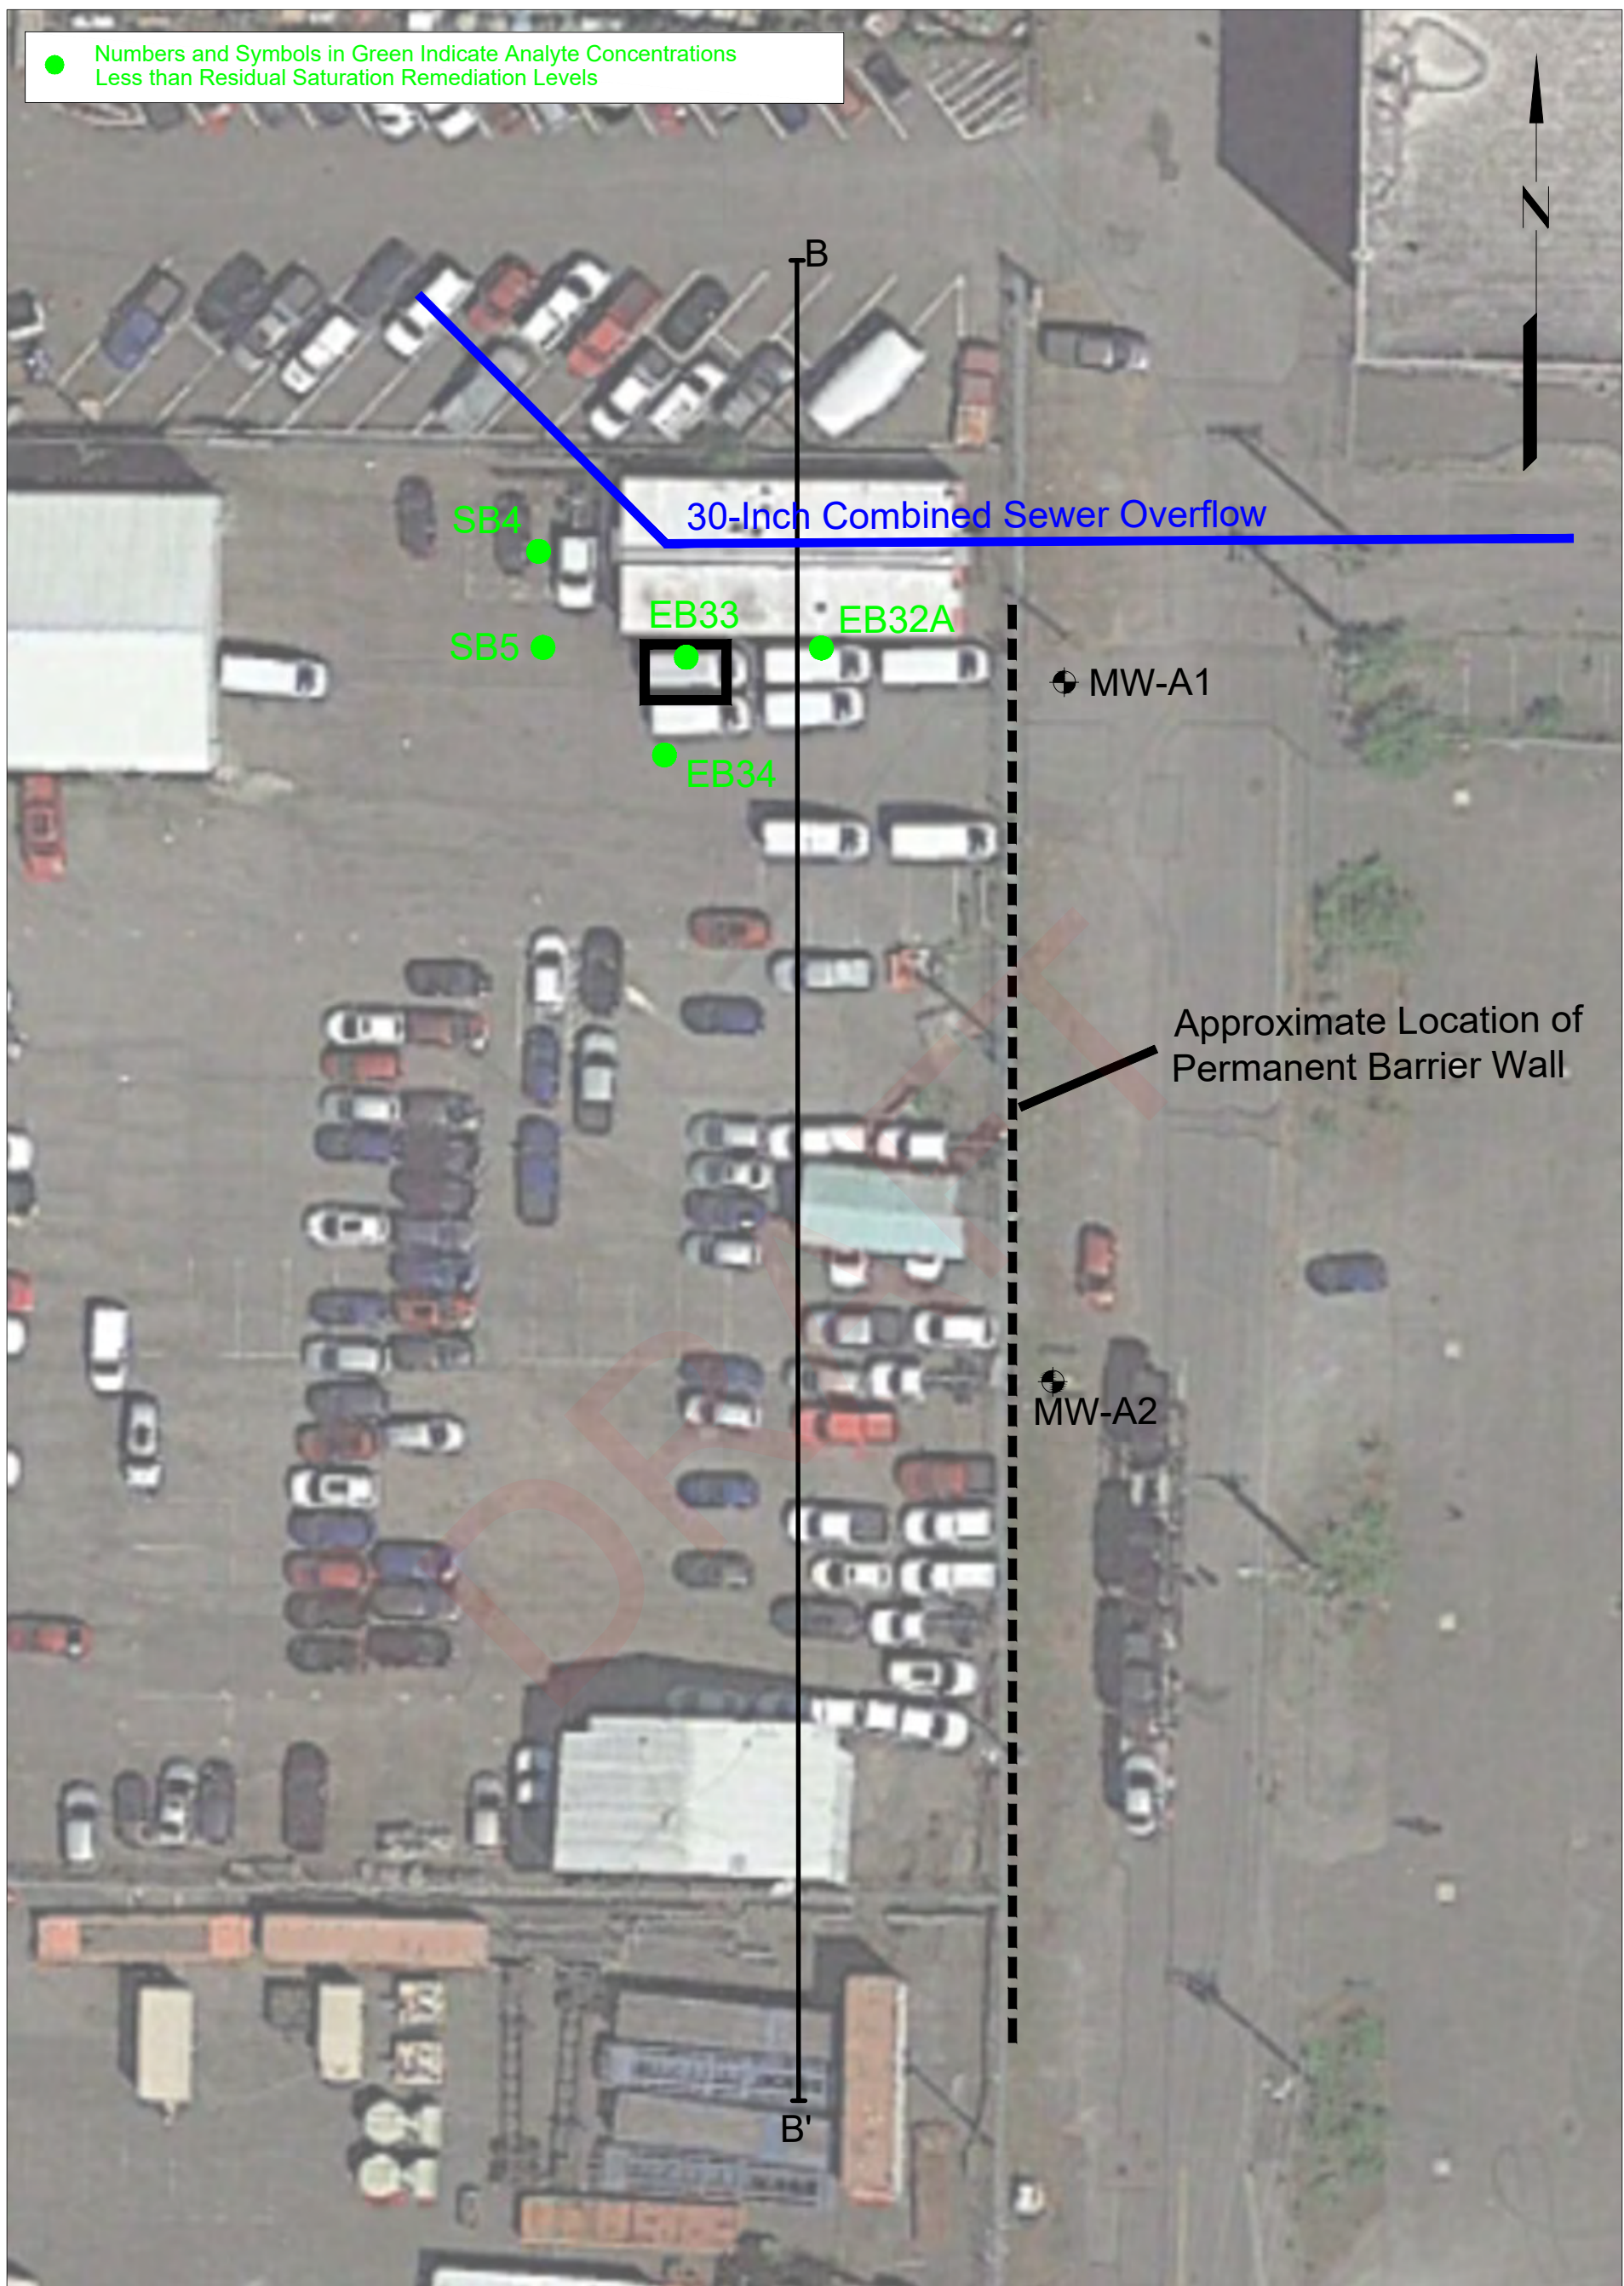
**PROJECT NO.**  
031447  
**PLATE**  
10  
CPA: 03/28/22

● Numbers and Symbols in Green Indicate Analyte Concentrations Less than Residual Saturation Remediation Levels

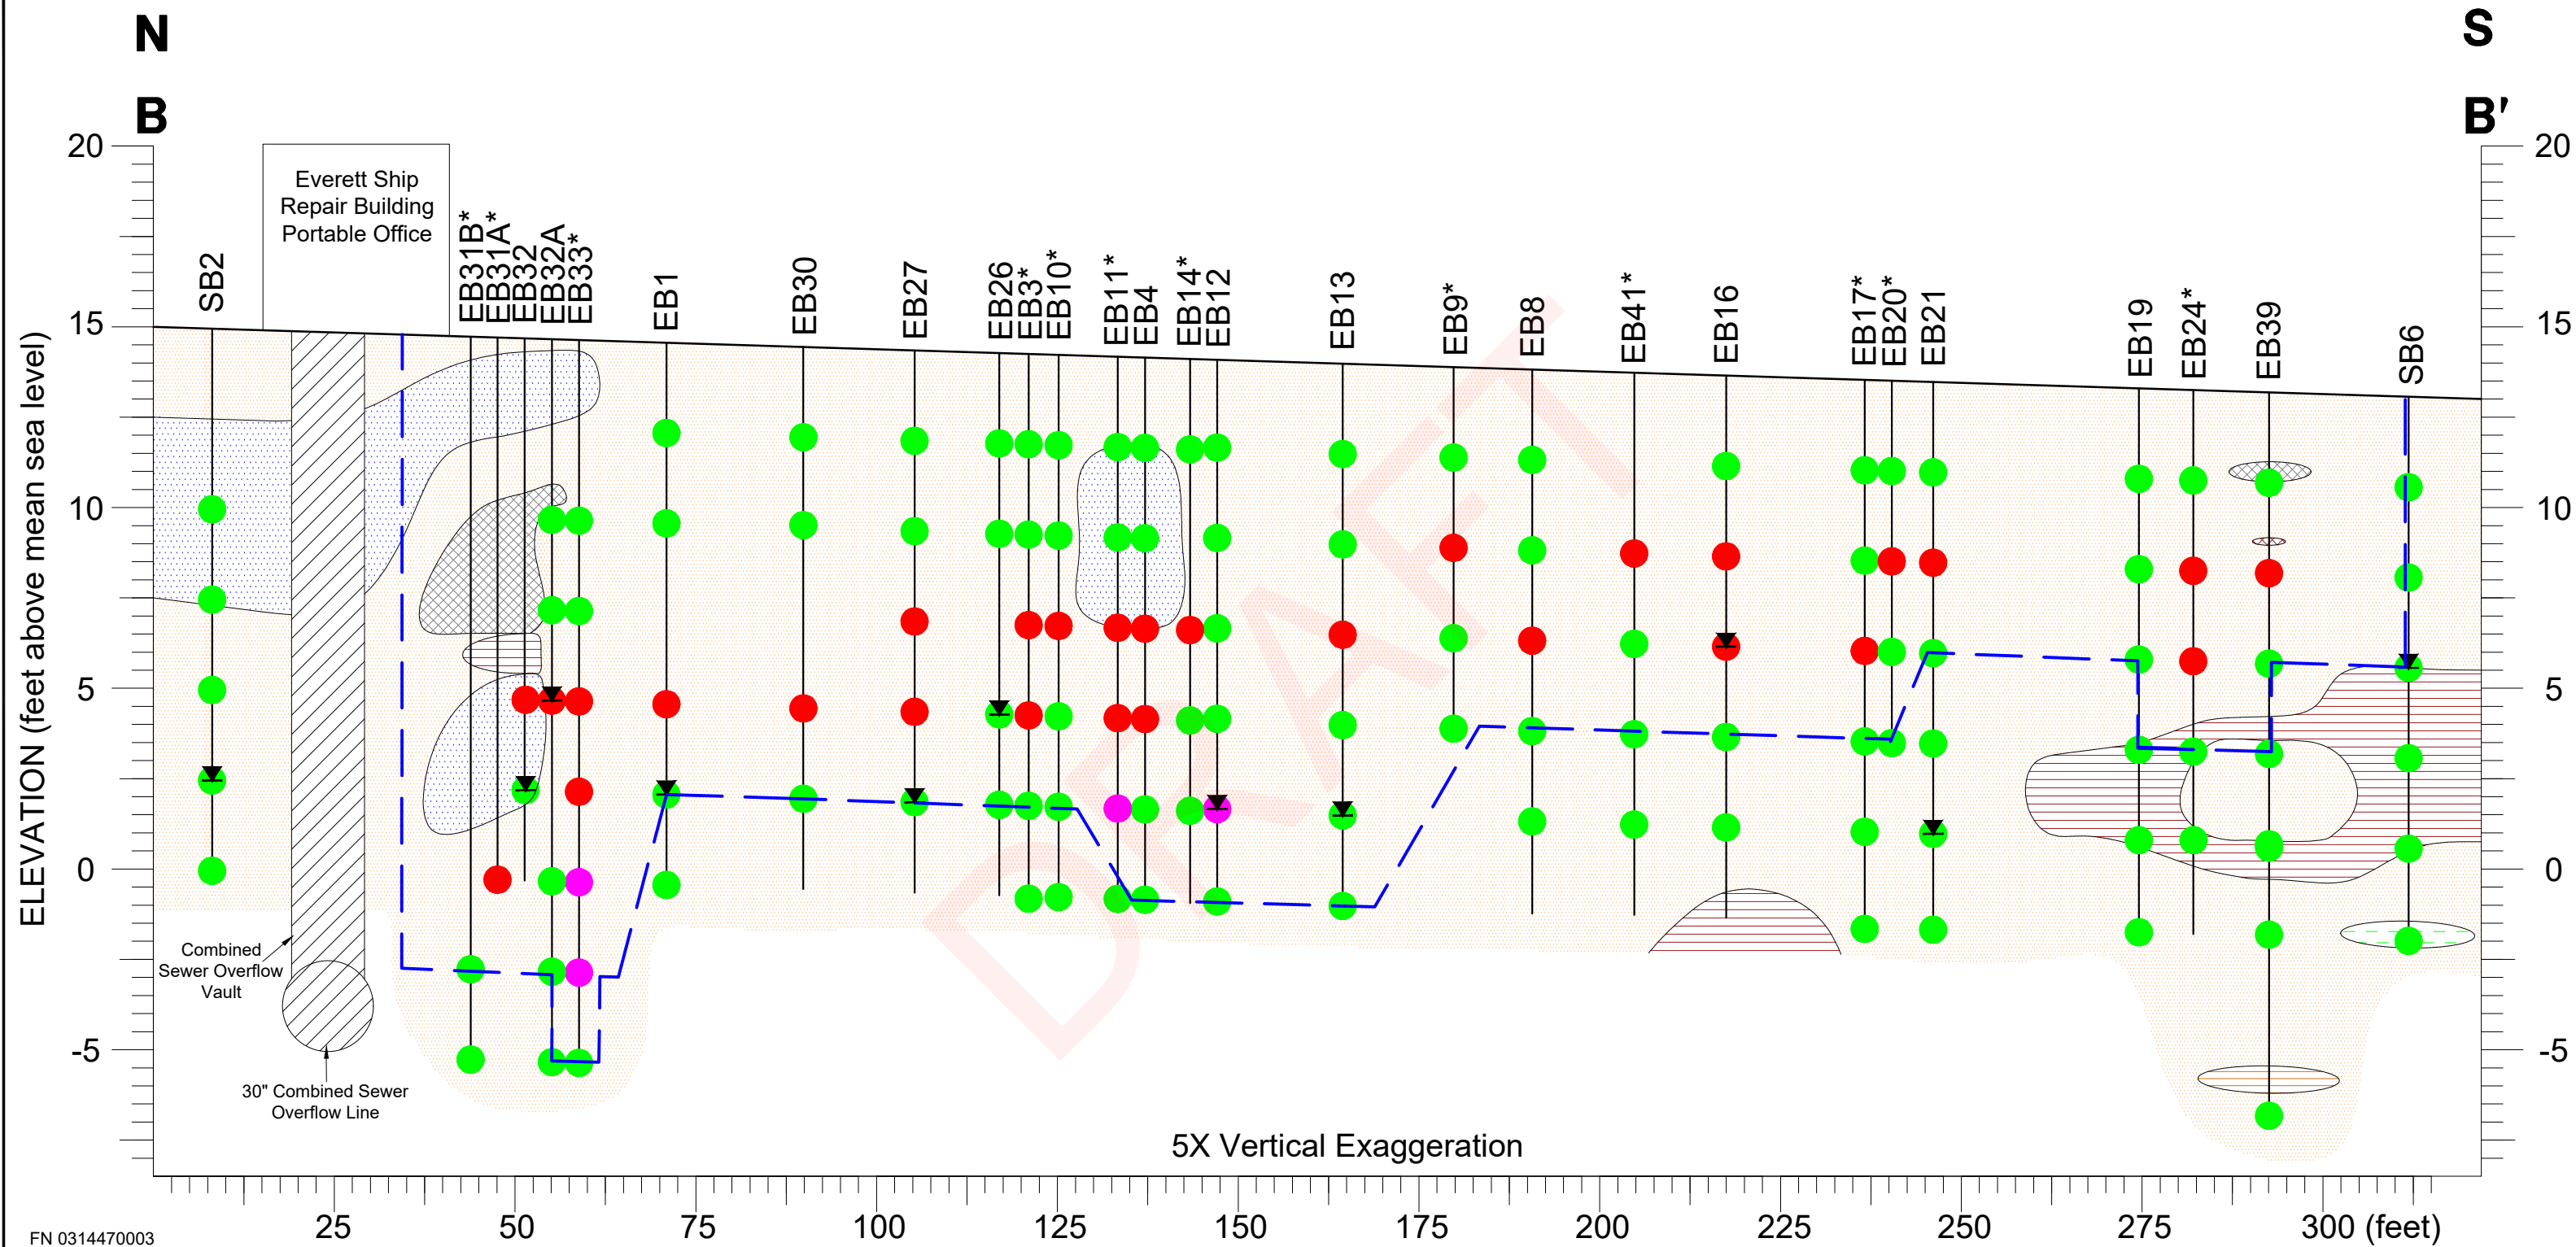
\* = Borings EB1, EB3, EB9, EB10, EB11, EB14, EB17, EB20, EB24, EB31A, EB31B, EB33, and EB41 are projected onto the cross section for hydrocarbon concentration distribution purposes; projected borings were not used to construct lithology illustration

- ▼ Water Level Encountered During Drilling
- Hydrocarbon Concentrations In Soil Less Than Site-Specific Residual Saturation Remediation Levels
- Hydrocarbon Concentrations In Soil Greater Than Site-Specific Residual Saturation Remediation Levels
- LNAPL Observed During Drilling
- Proposed Excavation Extents
- Coarse-grained Gravelly Sediments (GW, GC)
- Coarse-grained Sandy Sediments (SW, SP, SM, SC)
- Fine-grained Sediments (CL, CH, ML)
- Organic Sediments (OH, PT, Wood Debris)
- Concrete Debris

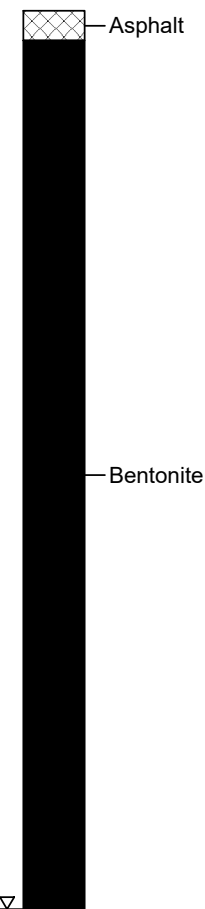
Boring: EB31A

Depth (ft)	Blow Count	OVM/PID (ppmv)	Sample	Column	USCS	Sample Condition	Water Levels	DESCRIPTION (%clay/silt/sand/gravel)
						<input type="checkbox"/> No Recovery <input type="checkbox"/> Sampled Interval <input type="checkbox"/> Described Sample <input type="checkbox"/> Preserved Sample	<input type="checkbox"/> After Completion <input type="checkbox"/> During Drilling	
0								6" Asphalt Borehole was not logged from 6 inches bgs to 10 feet bgs.
5								
10								
15		13.1			SP			SAND: medium- to coarse-grained, gray, wet, poorly to moderately graded; fine gravel, angular to subangular; 40% recovery (0/5/90/5)
20

Backfill Materials:  
 0.2 50-lb. bag of Asphalt  
 0.5 50-lb. bag of Bentonite Chips

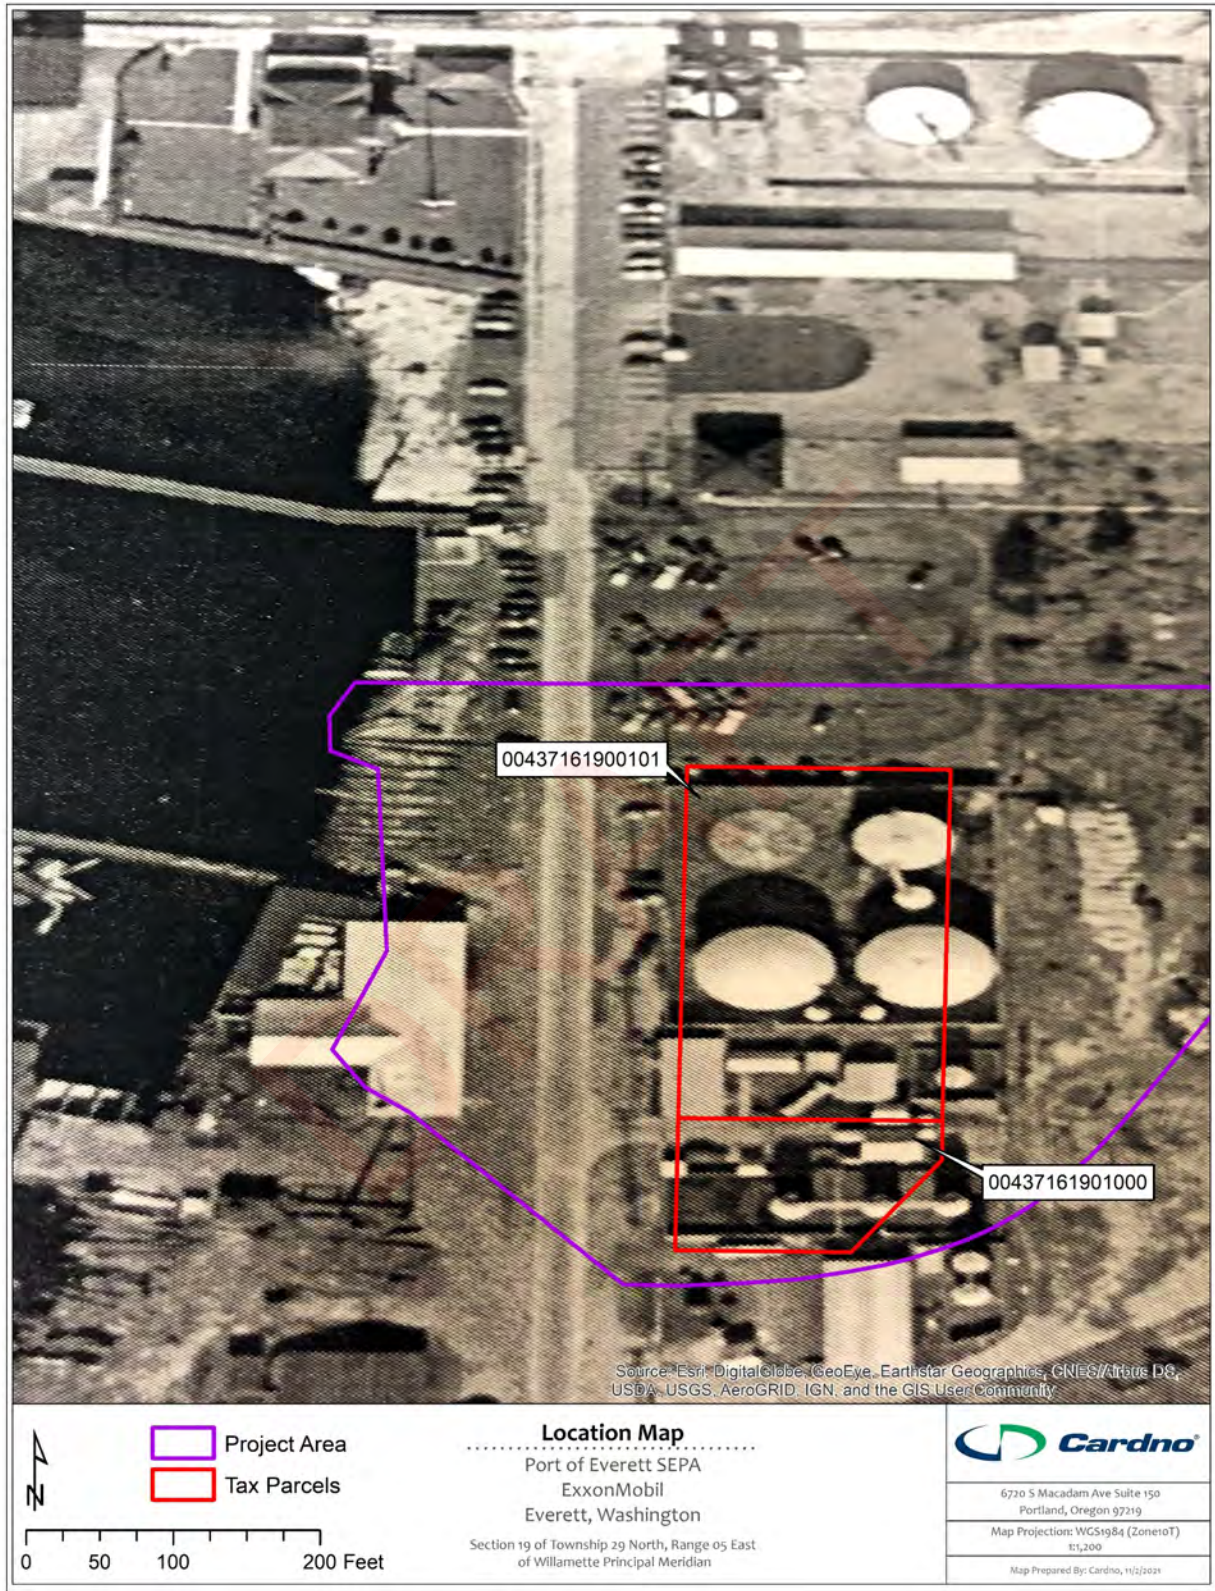
Figure 6. Project Area depicted on aerial imagery from 1947 (Image courtesy of ExxonMobil 2021).

The warehouse complex contained automobile truck storage, an oil and grease warehouse, a wash rack room, a boiler room, and an oil in steel drum staging yard adjacent to a wooden bulkhead (Figure 5; Sanborn Map Co. 1939 [Revised through June 1955]). By 1947 development within the project area had been expanded significantly to the south (Figure 6). Additional infrastructure constructed included several cylindrical petroleum tanks each containing 25,000 gallons of gasoline, eight outbuildings including a wooden office building, pump room, and warehouses, and a steel filling rack (Figures 5, 7, and 8; Sanborn Map Co. 1939 [Revised through June 1955]). The shoreline has not been modified with fill since approximately 1950 (Figure 9). An Everett USGS map from 1953 shows the area developed with gasoline tanks and a pier directly adjacent to the company warehouse complex (Figure 10). It does not appear the eastern portion of the project area was ever significantly developed.

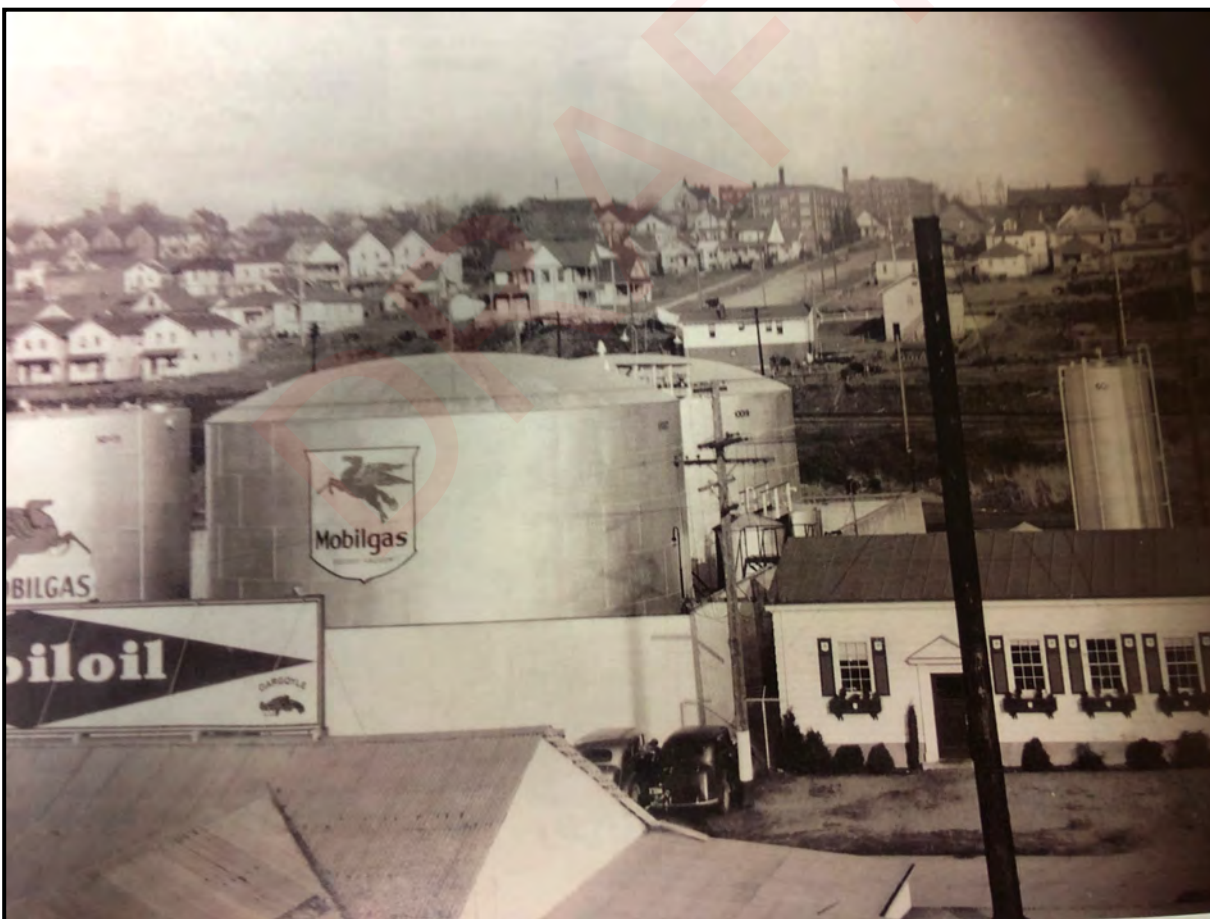
**Figure 8. Undated photograph showing gasoline infrastructure after General Petroleum Corporation was rebranded to Mobilgas. The office building on the site is at the right. (Washington Department of Ecology 2014:65)**

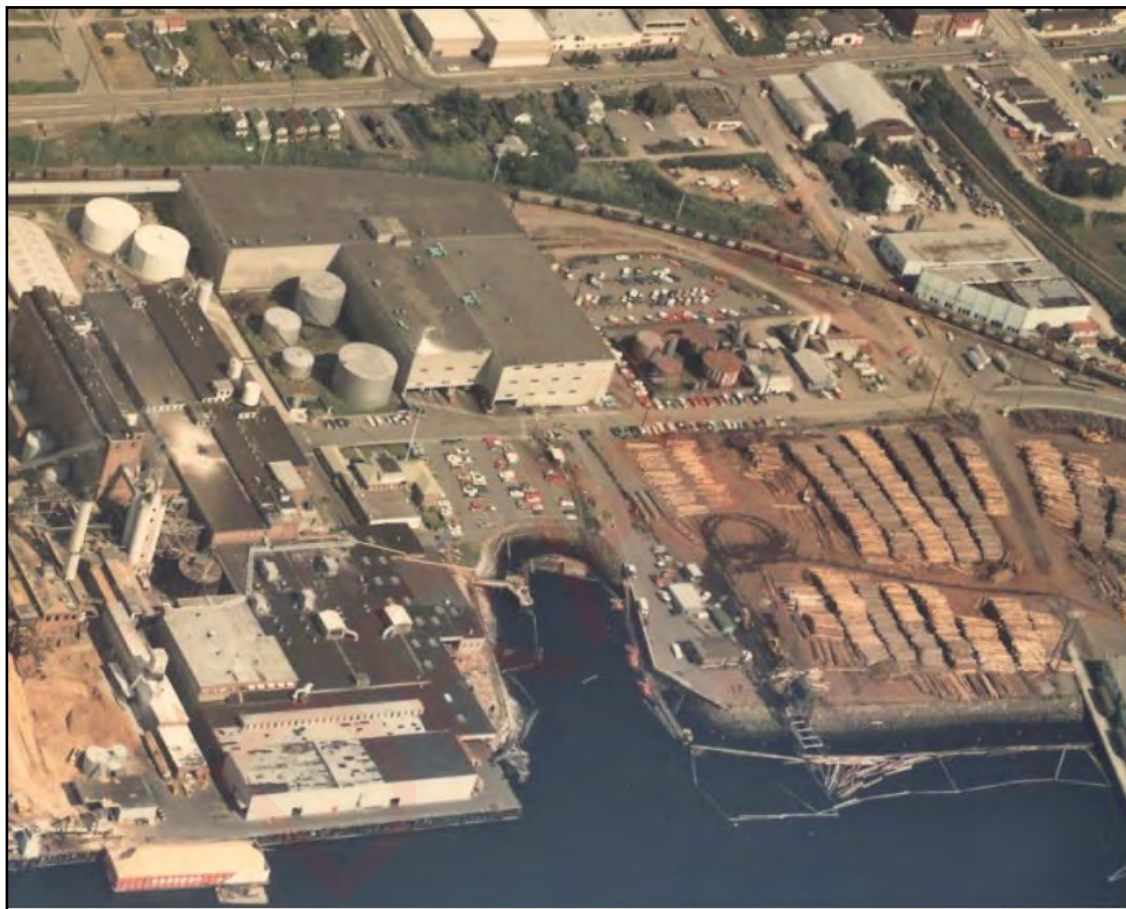
**Figure 11. A 1977 aerial photograph of the project area (Washington Department of Ecology 2021).**

In 1974, Mobil Oil sold the northern part of the project area to A.P. Miller for use by the American Distributing Company (ADC) who continued petroleum operations until 1990 (Washington Department of Ecology 2021). By 1977 the warehouse complex across Federal Avenue and the office building had been demolished (Figure 11). Mobil Oil ceased petroleum operations on the project area in 1987. All remaining infrastructure at the site was demolished between 1998 and 2002, and the project area was used as a parking lot (Washington Department of Ecology 2021). In late 2003 Terminal Avenue was developed adjacent to the site. The project area experienced continued development and change over several years precluding the identification of a particular year or period of importance of the petroleum infrastructure which was once extant.
