# INITIAL INVESTIGATION FIELD REPORT

| <u>Site Name (Name over door):</u><br>Skagit County Transfer Station Spill | <u>Site Address (including City, State and Zip):</u><br>14158 Ovenell Rd<br>Mt Vernon, WA 98273 | <u>Phone</u><br><u>Email</u> |

During the transfer of waste oil from the facility to an Emerald Service truck on June 2, 2020, about 20 gallons of used motor oil released to concrete (primarily) and soil beyond a concrete berm. Heavy rains allowed some waste oil to escape the containment area.

Impacted soil was successfully cleaned up. Confirmation samples show contaminant levels are below MTCA cleanup standards. Recommendation: no further action required.

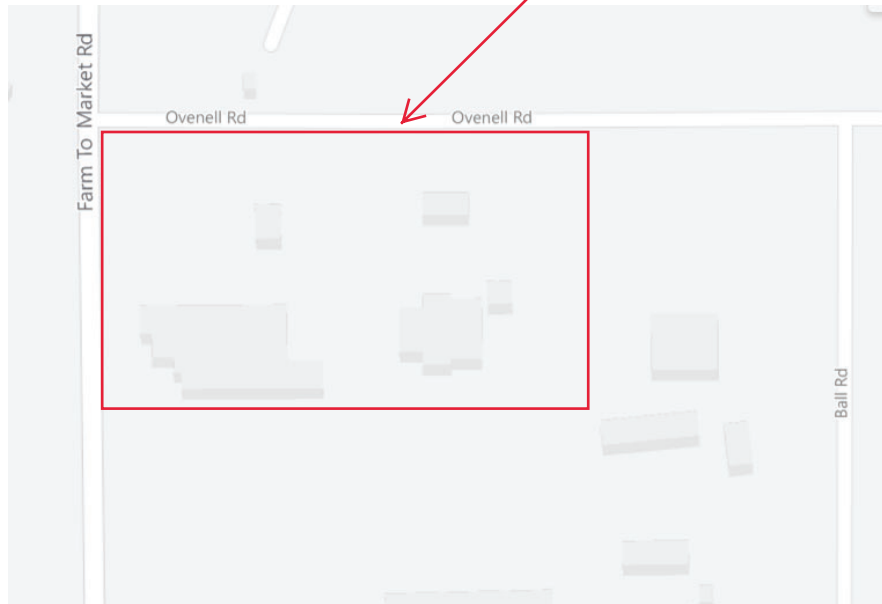
Figure 1: Aerial photo of Skagit County facility with spill location identified

Following Ecology's recommendations to remove obviously impacted soil and collect samples, Skagit County excavated about 1.5 cubic feet of visibly impacted soil along the north side of the paved loading dock in February 2021. A Skagit County employee (licensed as a hydrogeologist) collected three soil samples (Soil-1-020321, Soil-2-020321, and Soil-3-020321) from six inches below ground surface along a 15-feet long stretch to evaluate if contaminated soils were successfully removed. Edge Analytical analyzed the samples for lead; BTEX (benzene, toluene, ethylbenzene, and xylenes); and petroleum hydrocarbons. The lab reported results of 6,920 mg/kg heavy oil for sample Soil-1-020321, which Skagit County collected from the most visibly impacted area.

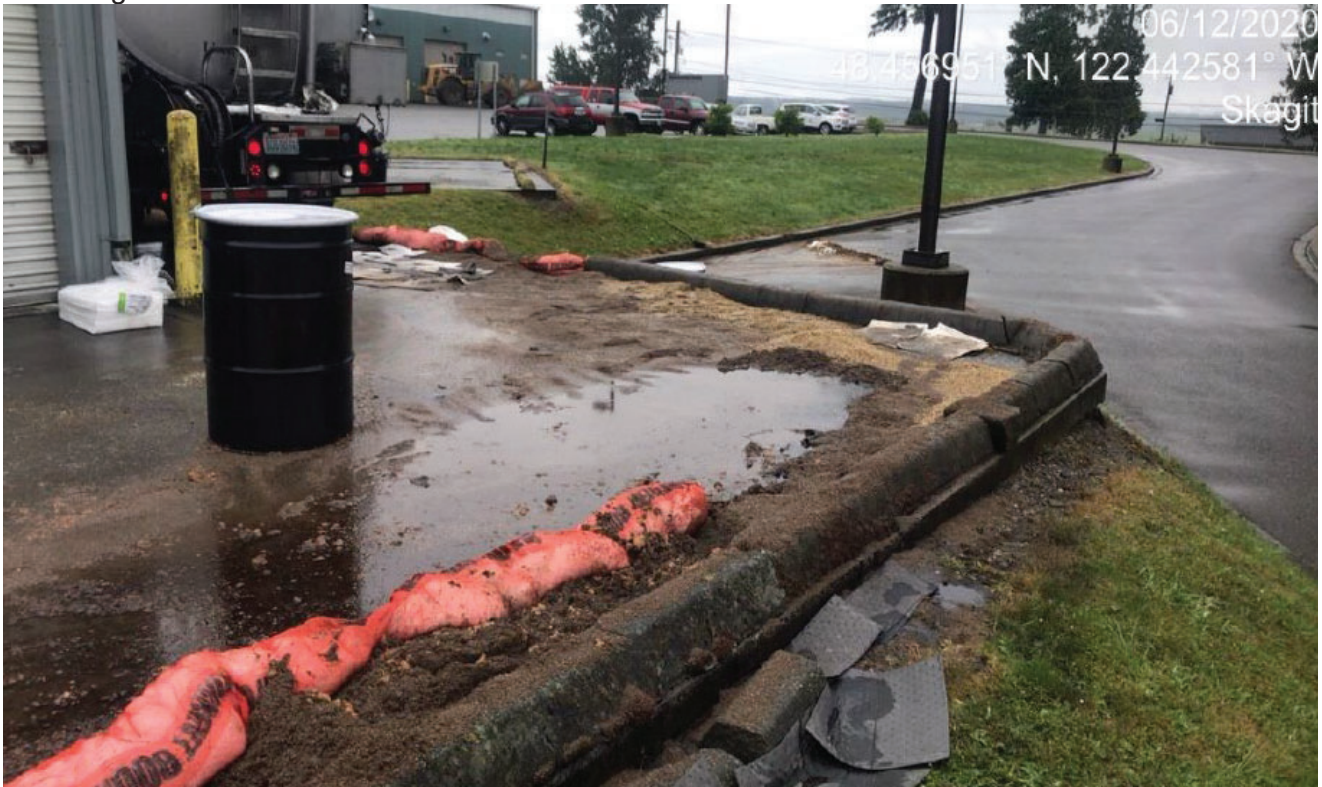
According to Skagit County's report documenting cleanup efforts, about 30-50 gallons of waste oil spilled to a paved driveway and loading dock at the Household Hazardous Waste facility. Due to heavy rains at the time, some waste oil released to soil along a concrete berm and to a storm drain. The drain goes to a 30 feet wide by 90 feet long vault.

Image 1: Release to soil observed along the concrete berm on the northeast corner of Household Hazardous Waste loading dock

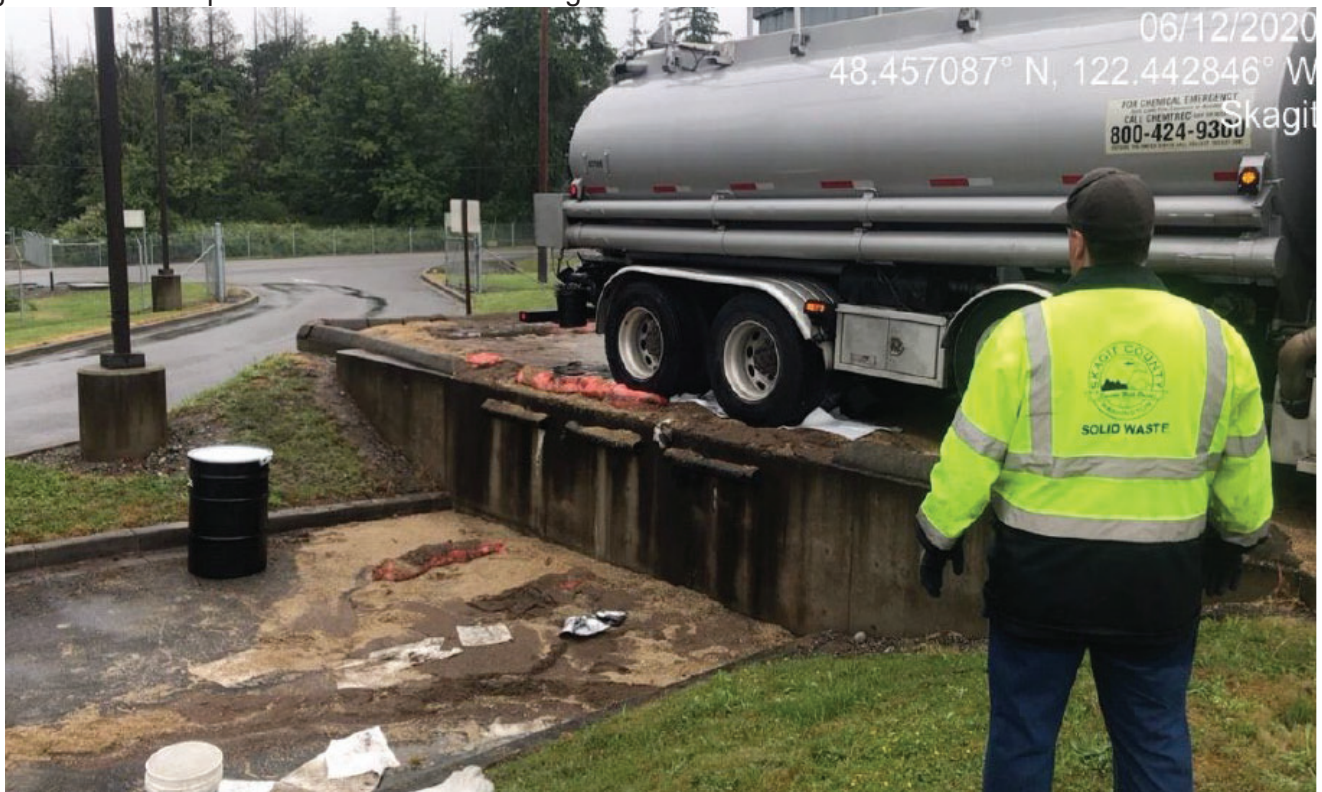
Image 2: Waste oil spilled on west side of loading dock

Following the spill, Emerald Services pressure washed at least one storm drain next to the vault and didn't find oil in smaller catch basins. They also used absorbent material to collect waste oil from the paved area. They placed used absorbent material and impacted surface soil in 55-gallon drums, which Emerald Services removed from the facility.

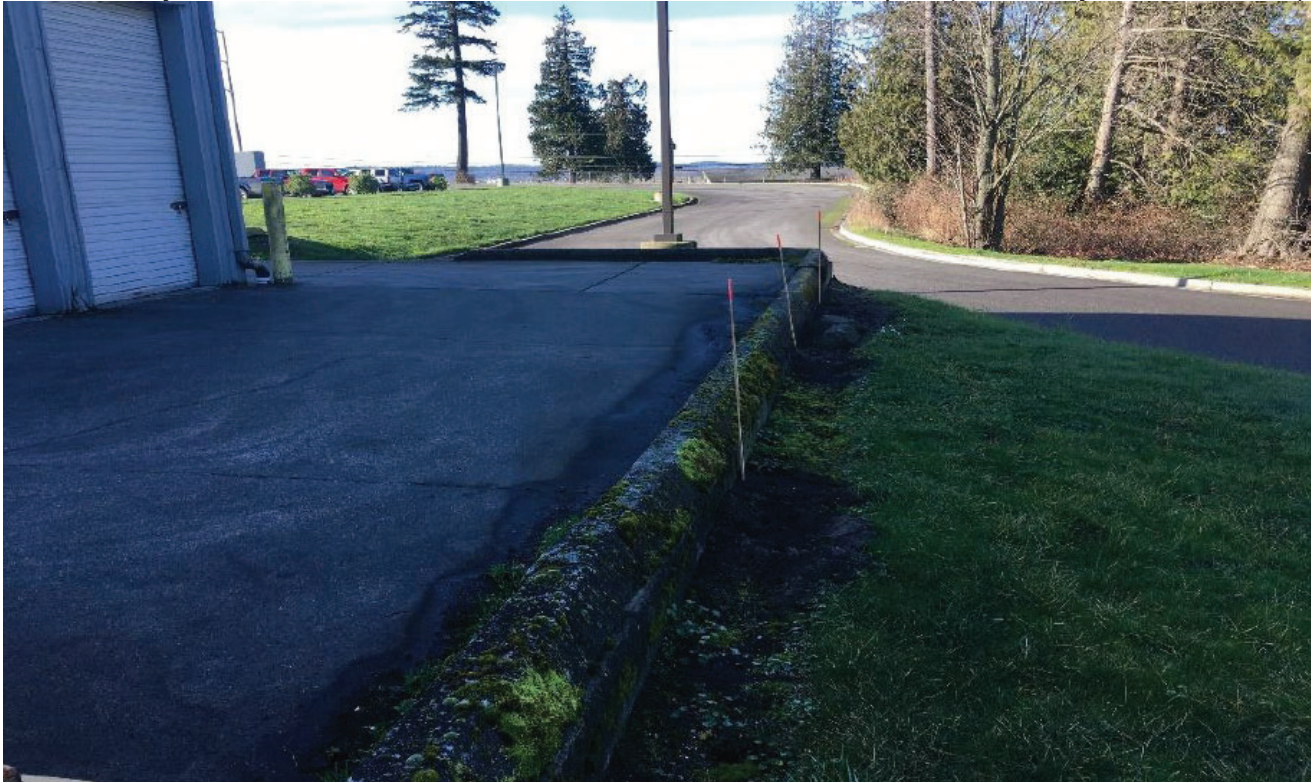
Image 3: February 2021 excavation areas and locations of three soil samples (marked by wooden stakes)

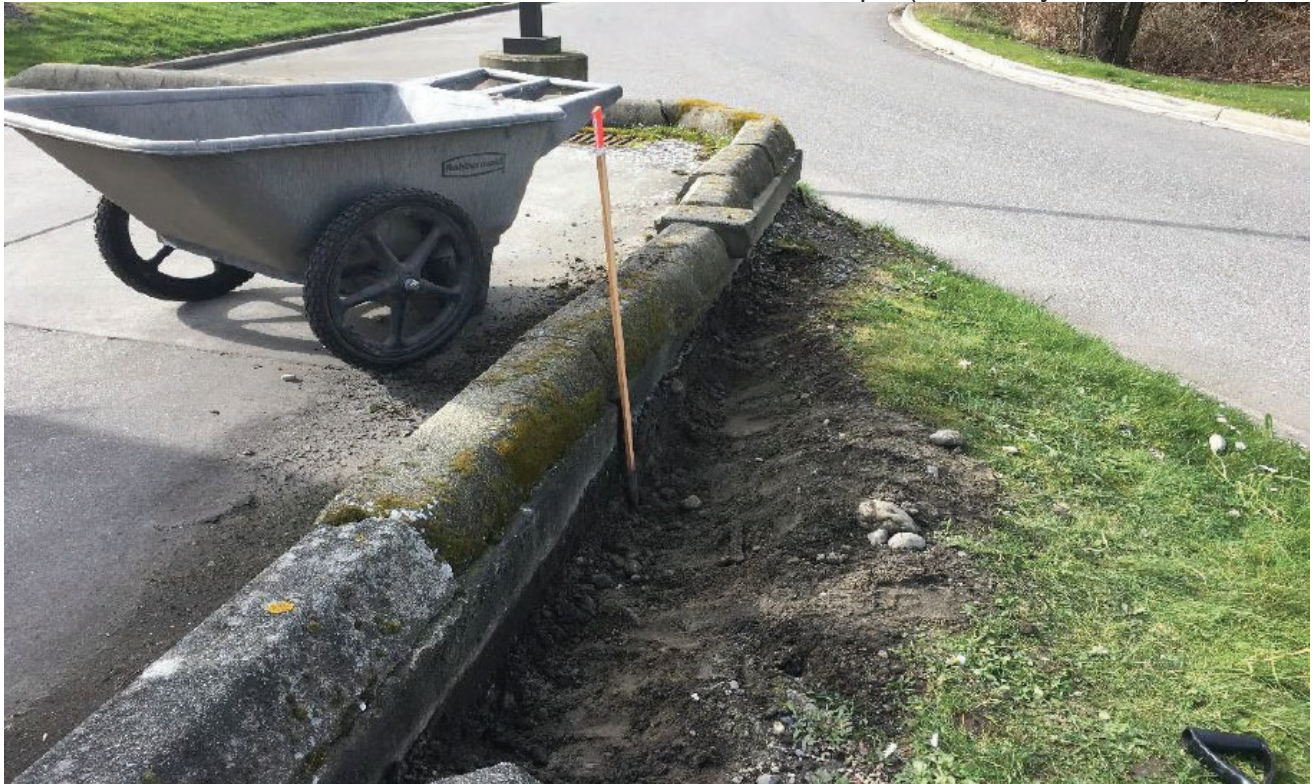
Image 4: March 2021 excavation area and location of confirmation sample (marked by wooden stake)

In response to the high heavy oil concentration reported by the lab, Skagit County removed an additional two cubic feet of soil from that area on March 2, 2021. Soil sample TS-Soil-030221 was collected from a depth of 12 inches and submitted to the lab for diesel- and heavy-oil range petroleum hydrocarbons. With a reported concentration of 151 mg/kg, the lab confirmed the contaminated soil was removed to below MTCA Method A cleanup levels.

Skagit County disposed of the 3.5 cubic feet of contaminated soil at the transfer station. Solid waste from the transfer station is transported to Roosevelt Regional Landfill.
