Periodic Review

Cape Disappointment Lighthouse
Fort Canby State Park
Ilwaco, WA 98624

Prepared by:
Headquarters Cleanup Section
Toxics Cleanup Program

July 2022

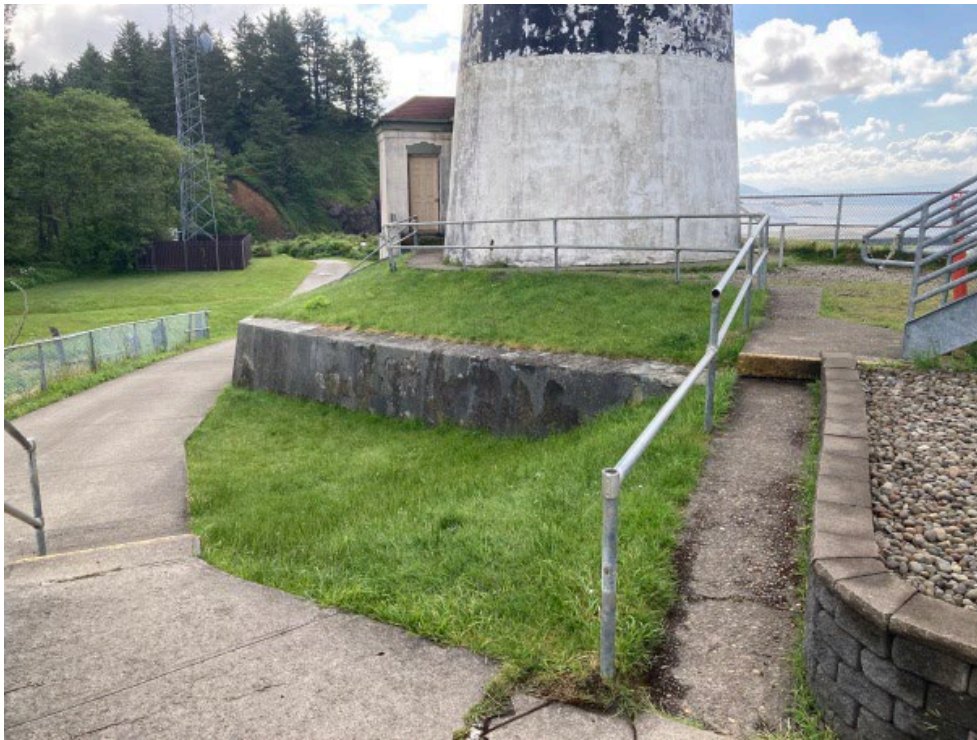
Photo 3: View of the “Northern Grassy Area”

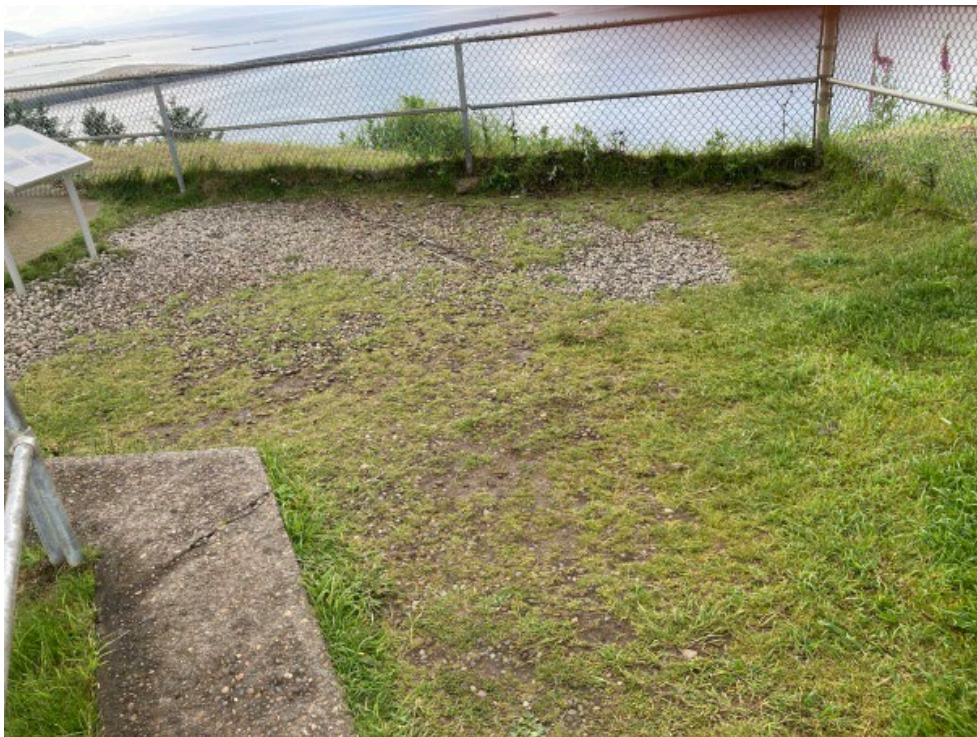
“The Site looks good with one exception. The area between the lighthouse and the watch tower referenced as “western grassy area” (image 150) has been trampled by foot traffic and the turf is in poor condition. The “southern strip” (image 143) has recently been trimmed but the turf is in good condition.”

Photo 4: View of Trampled Turf in the “Southern Grassy Area” (image 150)

However, based on the above observations and photographs, Ecology recommends that appropriate actions be taken by the U.S. Coast Guard to address the trampled turf grass in the “western grassy area”. The one foot of clean fill soil does not appear to be at immediate risk; however, it is important to ensure that erosion of this material does not take place.

The institutional controls implemented for soil at the Site continue to prevent exposure to lead contaminated soil by ingestion and direct contact. However, based on the above observations made during a Site inspection and photographs, Ecology recommends that appropriate actions be taken by the U.S. Coast Guard to address the trampled turf grass in the “western grassy area”. The one foot of clean fill soil does not appear to be at immediate risk; however, it is important to ensure that erosion of this material does not take place.

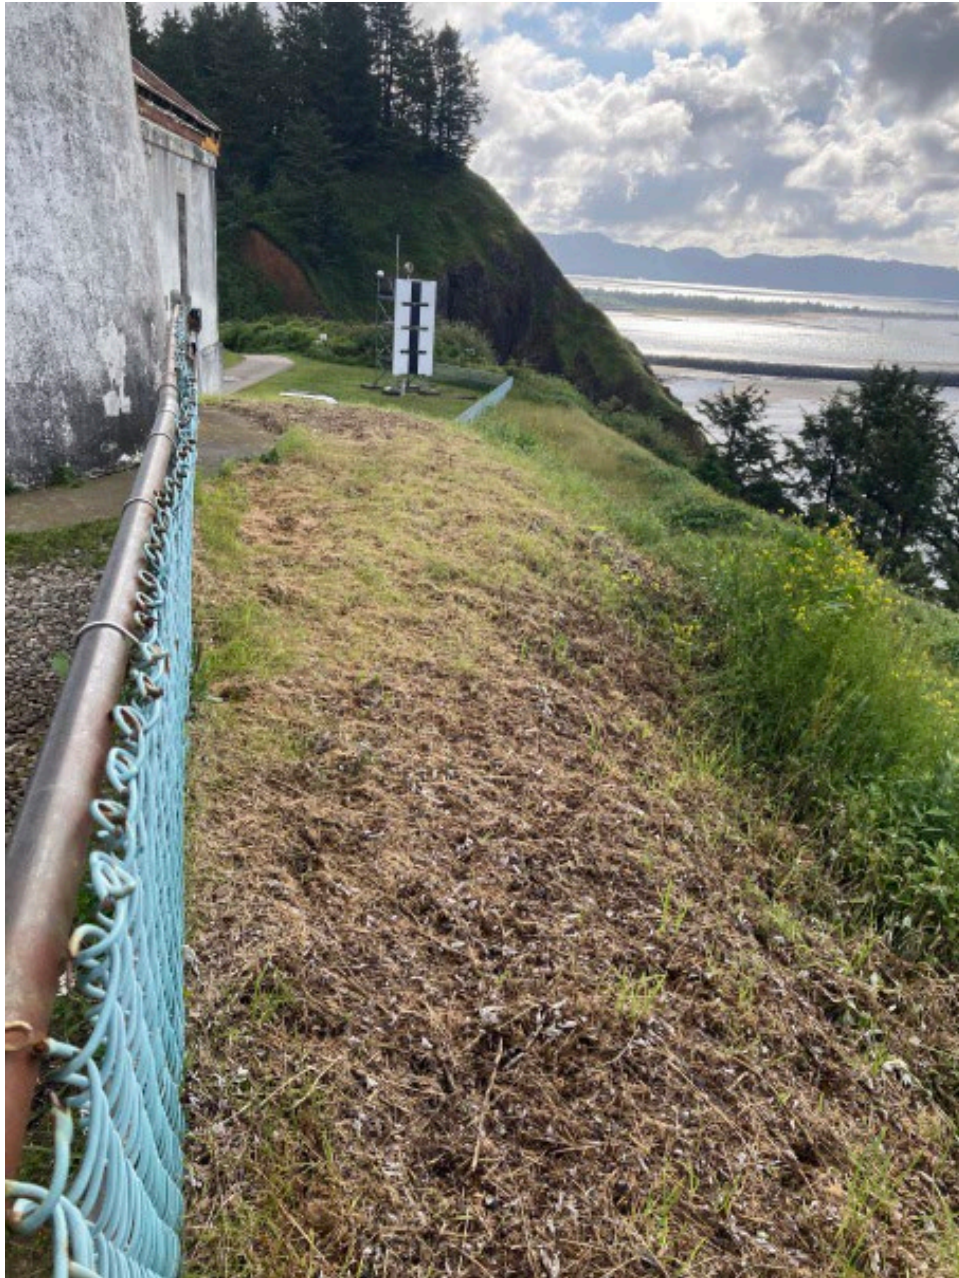
Photo 5: View if the “Southern Strip” of the Lighthouse (image 143)
