# STATE OF WASHINGTON DEPARTMENT OF ECOLOGY

### Re: Comments on Indoor Air Sampling and Analysis Plan, Former Potter Property

• **Site Name:** Taylor Way and Alexander Avenue Fill Area (TWAAFA)

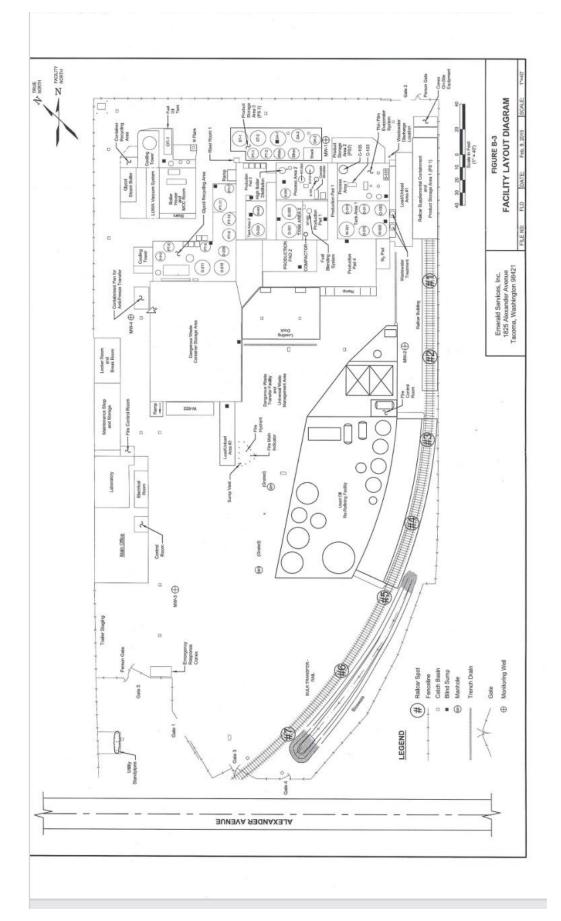
Figure – Emerald Services Facility Layout Diagram

<sup>&</sup>lt;sup>3</sup> Figure from: Facility Layout Diagram, Emerald Services Inc., February 9, 2015.

- 1. As recommended by the New Jersey Vapor Intrusion Technical Guidance, please place subslab sampling locations no closer than 5 feet to an outer wall.<sup>2</sup>
- 2. Please move sampling location TWA-SV-45, 15-20 feet southwest, so it is closer to the portion of the Emerald Services Building that contains the Break Room. See attached Figure for a facility map that shows the layout of this building.<sup>3</sup>
- 3. Ecology recommends that the data-logging manometers be installed at vapor pins TWA-SV-36 and -42 instead of TWA-SV-37 and -43 because these locations are near the center of the building slab and will likely provide more representative differential pressure data.
