Lower Duwamish Waterway

Cement Kiln Dust: Summary of Existing Information

April 2015

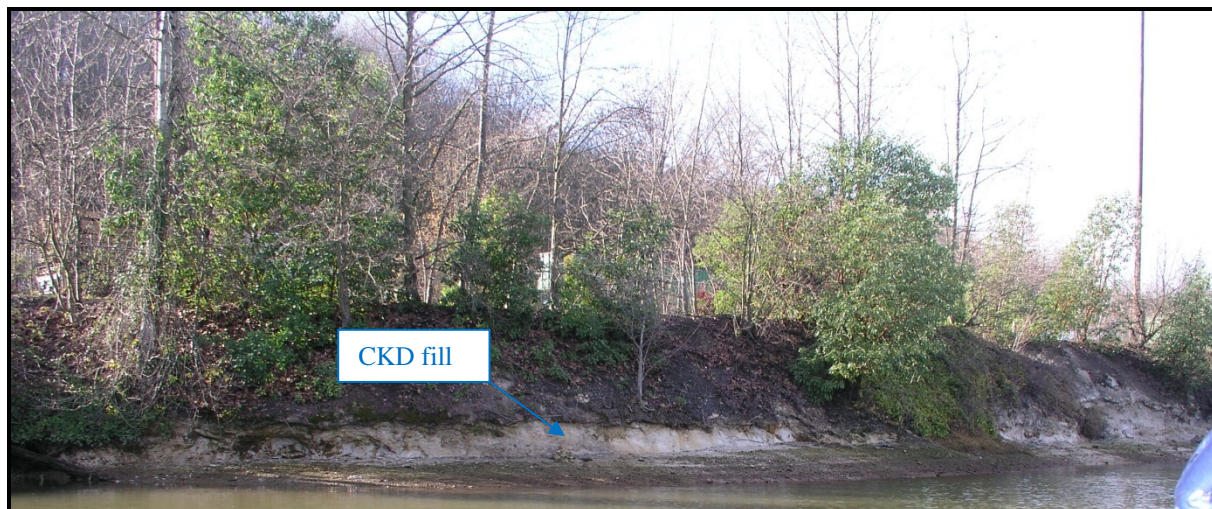
Western Shoreline at Upland Terminal 107 (2005)

Extensive fill material is present at Terminal 107. Fill activities were performed from the 1880s through the 1920s and from the 1950s through 1976. The maximum thickness of fill encountered at the terminal is 50 feet. Fill material on Kellogg Island consists of fine to medium sand. Fill materials on the upland portion of the terminal consist of sand, gravel, clay, brick fragments, and CKD. The CKD is present on the southern, upland portion of the terminal (parcel 9103), near Lafarge Cement (SoundEarth 2011a) (Figure 2). Johnson (1971) and anecdotal accounts from sediment investigations in the area indicate that CKD is present along the upland bank from the southern portion of the terminal to the northern tip of Kellogg Island. The shoreline of Terminal 107 is over 8,500 linear feet and consists of exposed soil and vegetated slopes. The photograph below illustrates bank soil conditions at Terminal 107.

Bank soil samples collected in 2011 from the CKD fill contained arsenic, lead, and zinc at concentrations exceeding the Washington State Sediment Quality Standard (SQS) and Cleanup Screening Level (CSL) (Washington Administrative Code [WAC] 173-204); however, metals concentrations in sediment samples collected adjacent to the fill area did not exceed the SQS/CSL (Table 10). Metals concentrations in the bank soil samples exceed Puget Sound, Washington State and U.S. background concentrations. No other areas of the shoreline have been investigated.

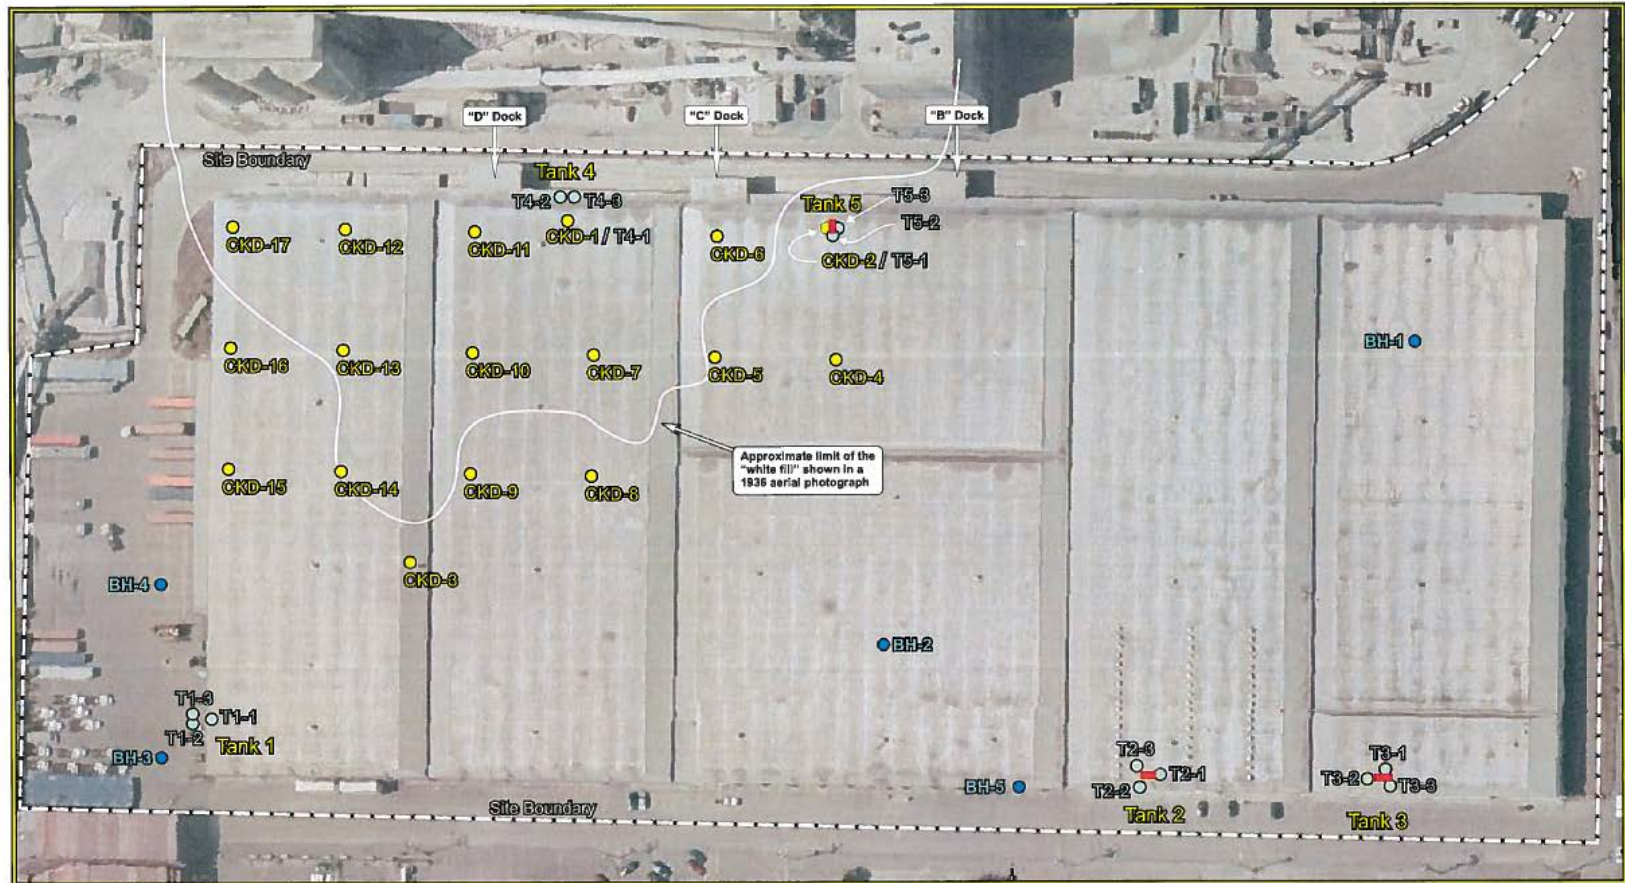
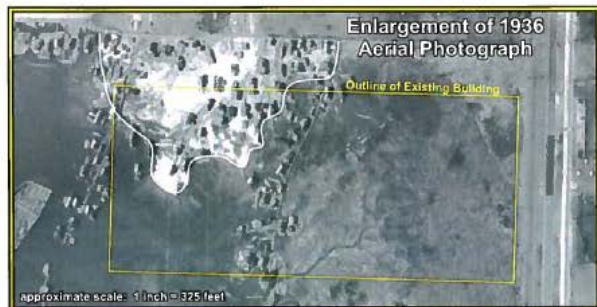
Figure 18. Extent of Cement Kiln Dust: Port of Seattle Terminal 106 W

- BH-1** ● Geotechnical exploration by PanGeo in 2005.
- CKD-1** ● Exploration to evaluate CKD conditions.
- T1-1** ○ Exploration to evaluate underground storage tank conditions.
- Tank 3** ■ Underground storage tank size and location and surrounding patch (typical).
