REMEDIAL INVESTIGATION REPORT

Industrial Container Services, WA, LLC [Former NW Cooperage Site)
Seattle, Washington

Public Review Draft: February 2020

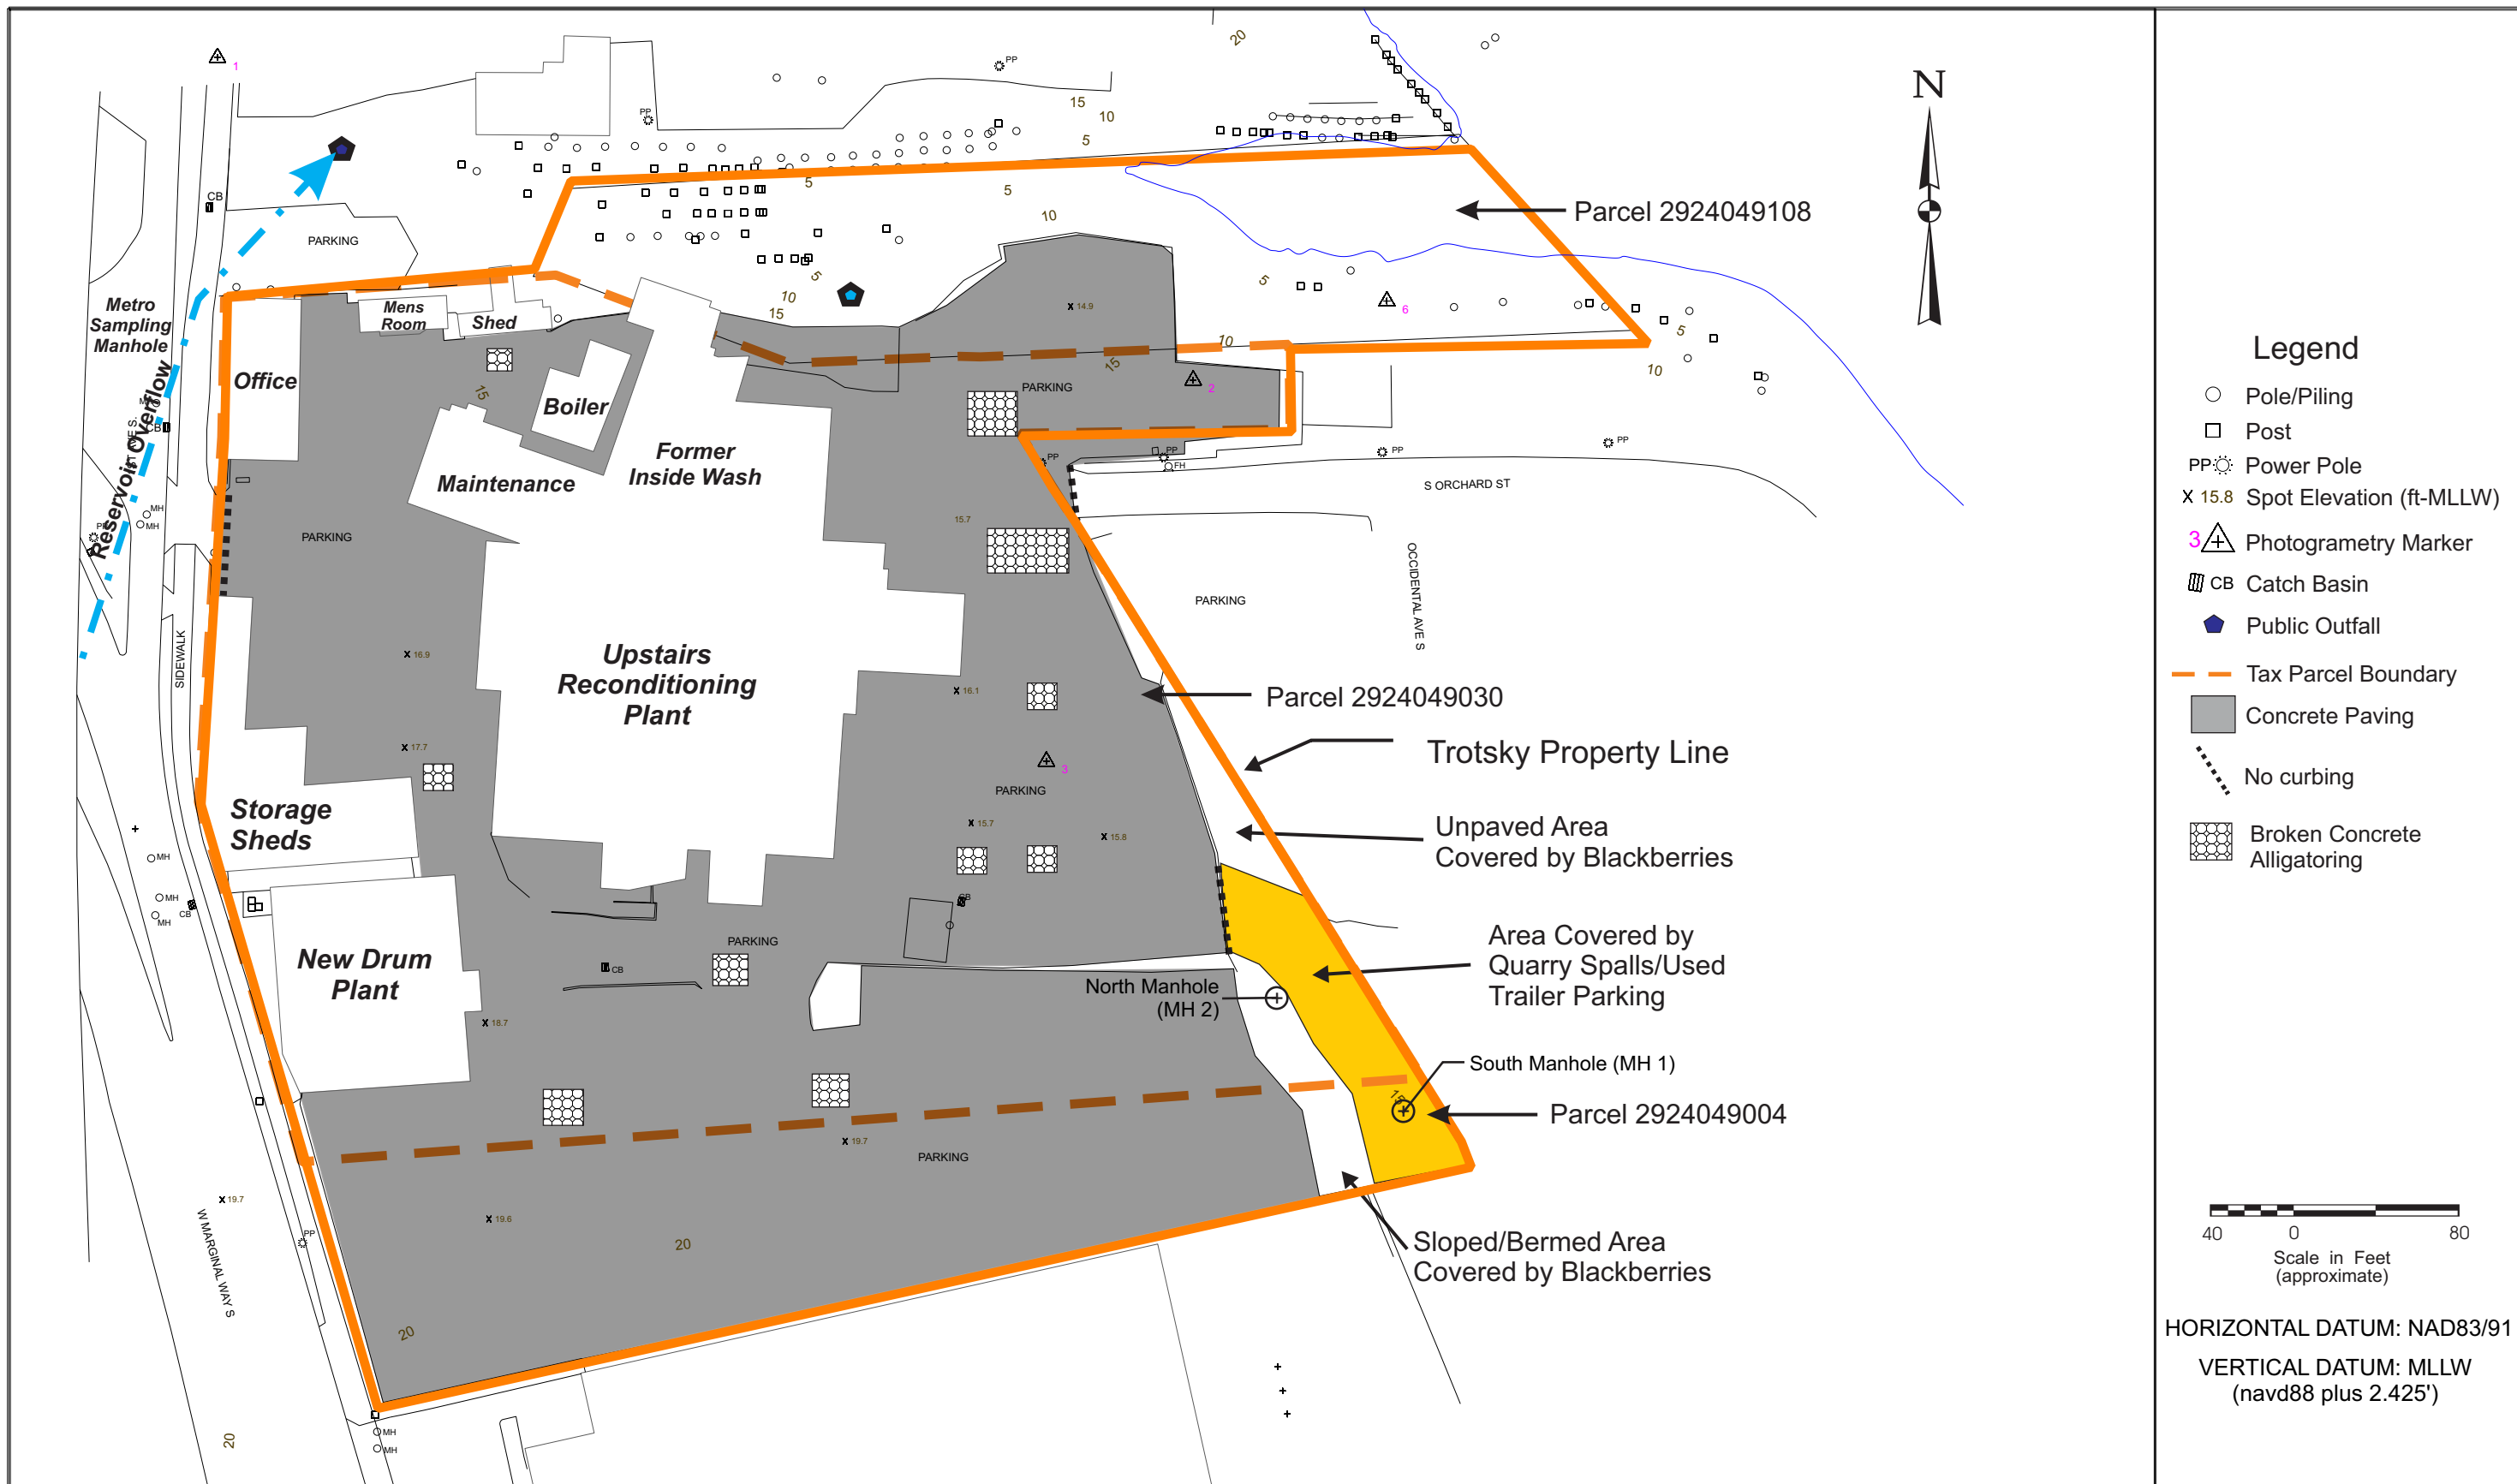
FIGURE 2-6

- 1) All site paving consists of concrete, with many joints, hairline fractures, overlays and patches.
- 2) Perimeter of paved area is surrounded by 6-inch concrete curbing, except as noted in driveway areas.
- 3) Areas of pavement damage with multiple fractures/alligating shown.
