**Indoor Air and Soil Vapor Sampling Plan, Rev. 2**

**Fox Ave Building Site**

**Seattle, Washington**

**February 15, 2023**

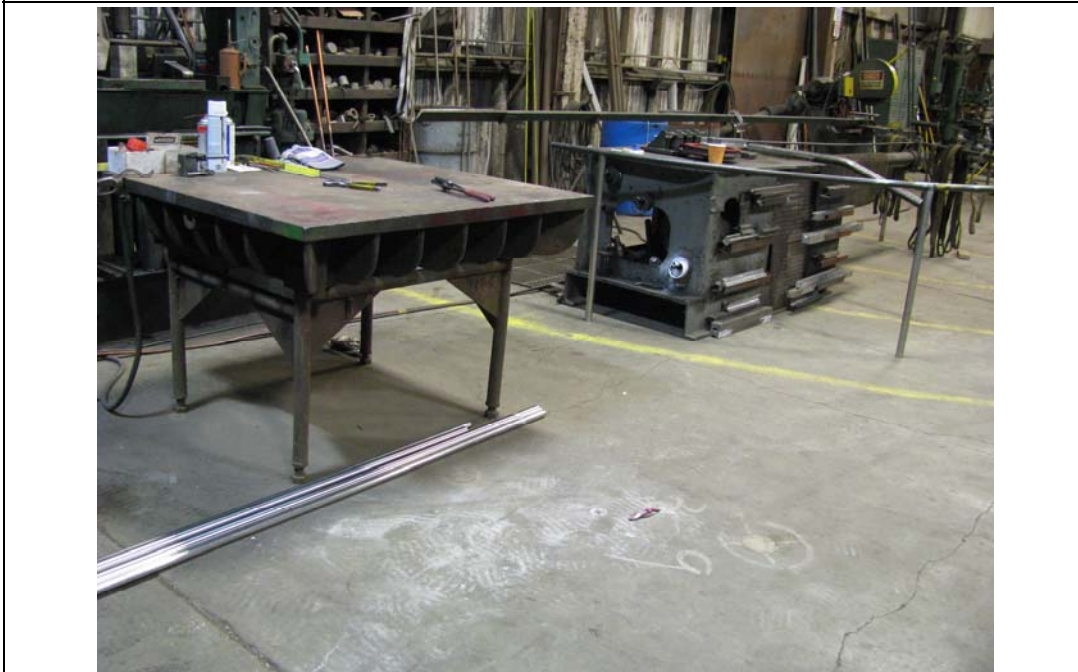
Photograph No: 1 Sub-slab soil vapor sampling location SSV-B, near former borehole 3-9 inside SBW tube shop building

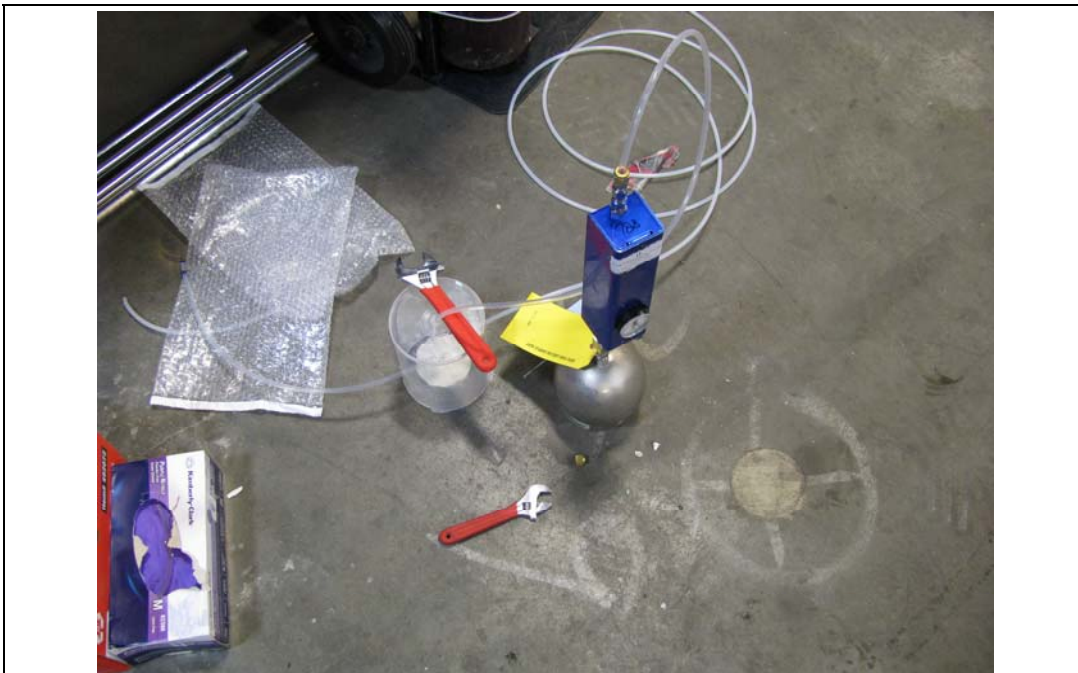
Photograph No: 2 Sub-slab soil vapor sampling train set up at SSV-B

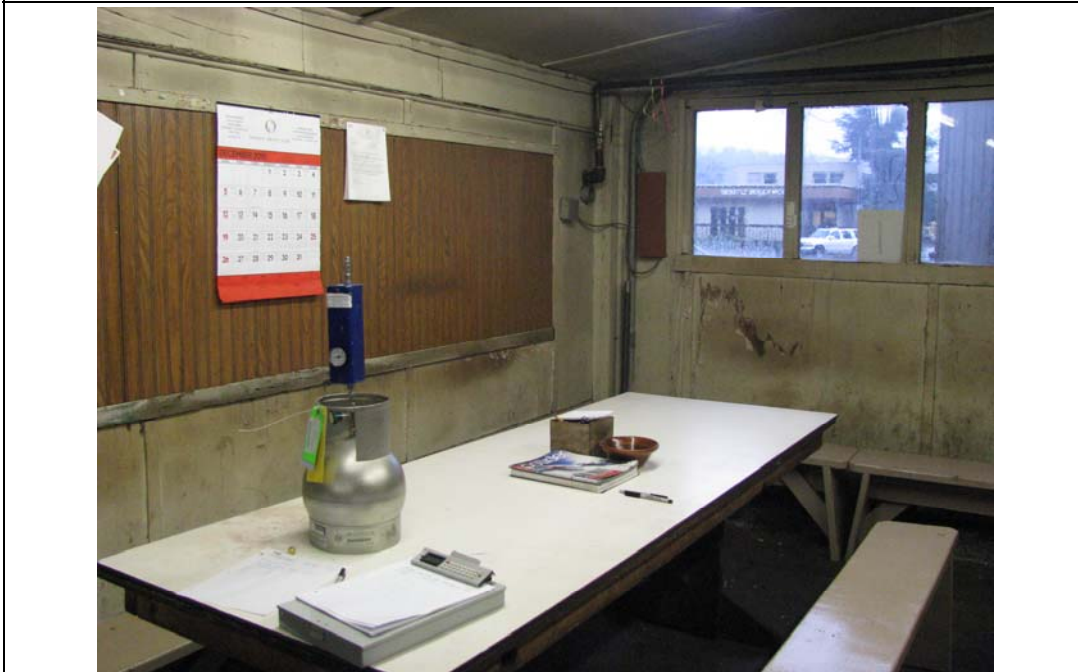
Photograph No: 3 Indoor air sampling location SBW-IA-LUNCH in lunchroom located in southwest corner of tube shop building

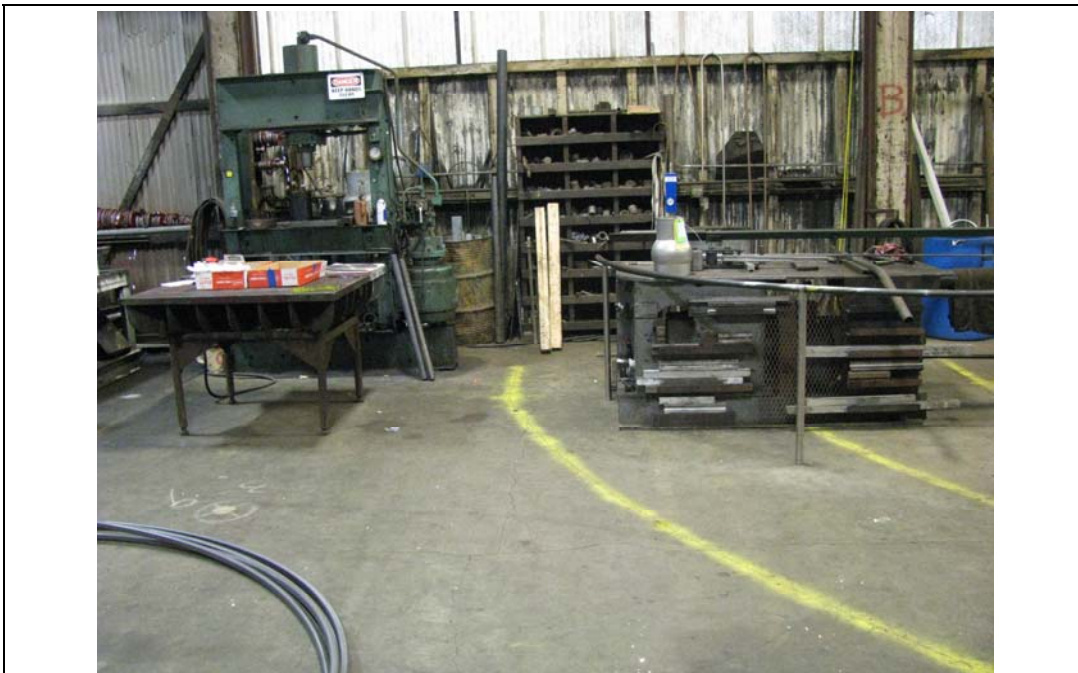
Photograph No: 4 Indoor air sampling location SBW-IA-SSVB in the main portion of the tube shop

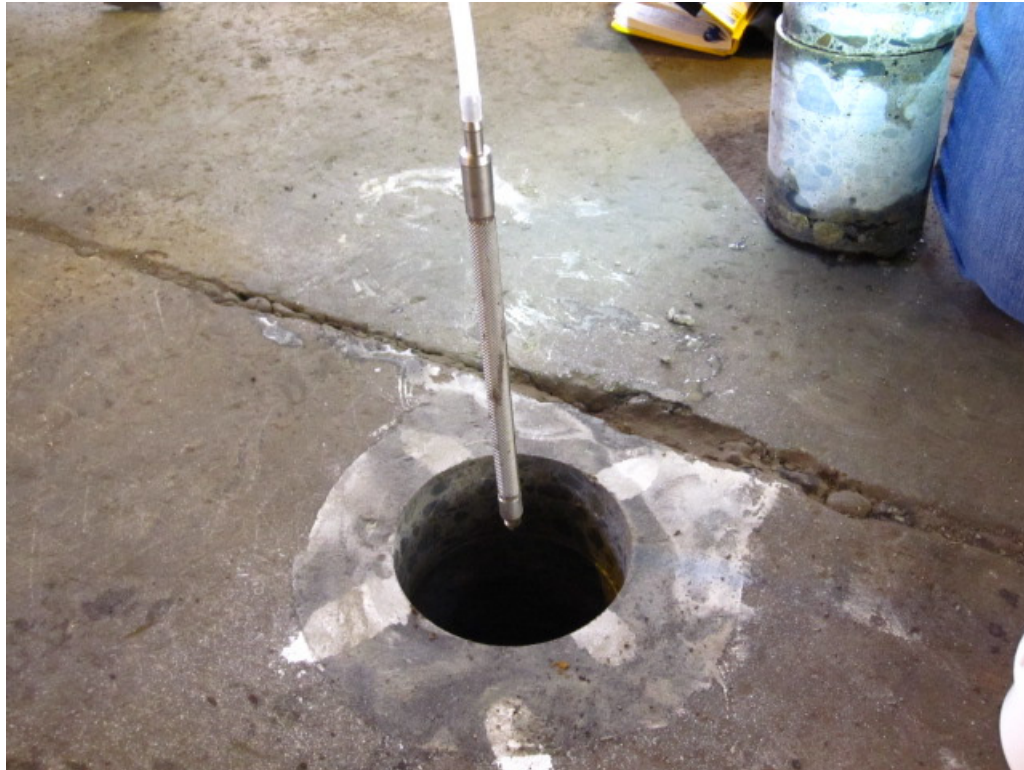
Photograph 1. Soil Vapor Implant.

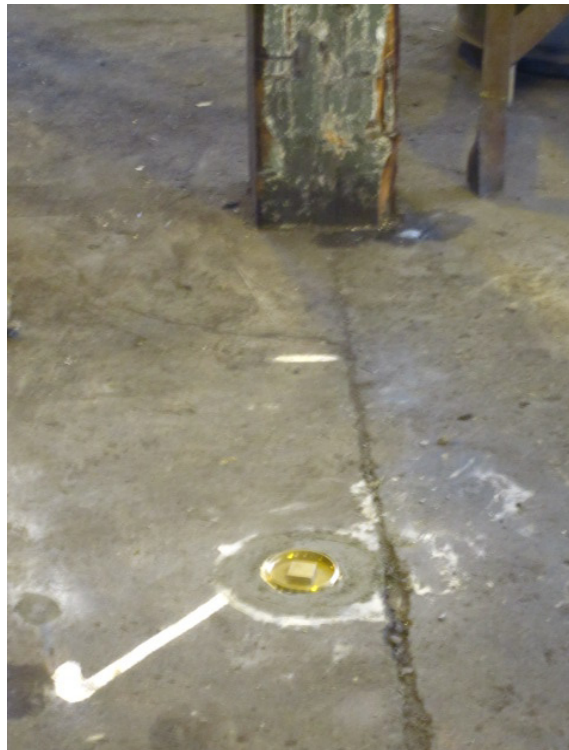
Photograph 2. Completed Vapor Point with Protective Brass Cover.

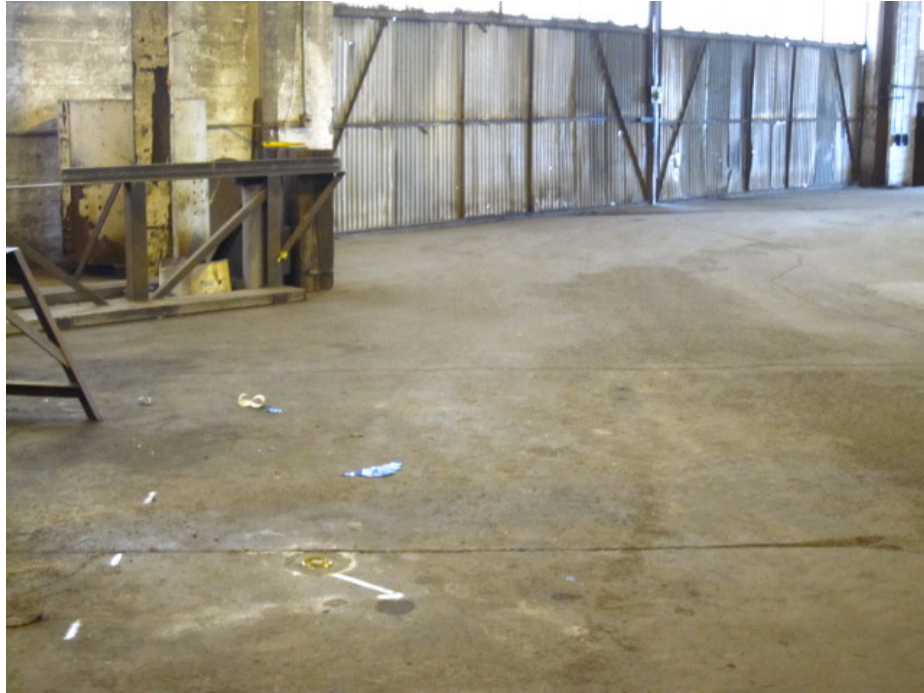
Photograph 3. Alternative View of Completed Soil Vapor Point.
