STATE OF WASHINGTON
DEPARTMENT OF ECOLOGY

Re: Technical Assistance for the following contaminated Site:

Site Name: Pend Oreille Mine - Historic Debris Field
Site Address: 1382 Pend Oreille Mine Road, Metaline Falls
Cleanup Site ID: 16669
Facility/Site ID: 15428546
VCP Project ID: EA0369

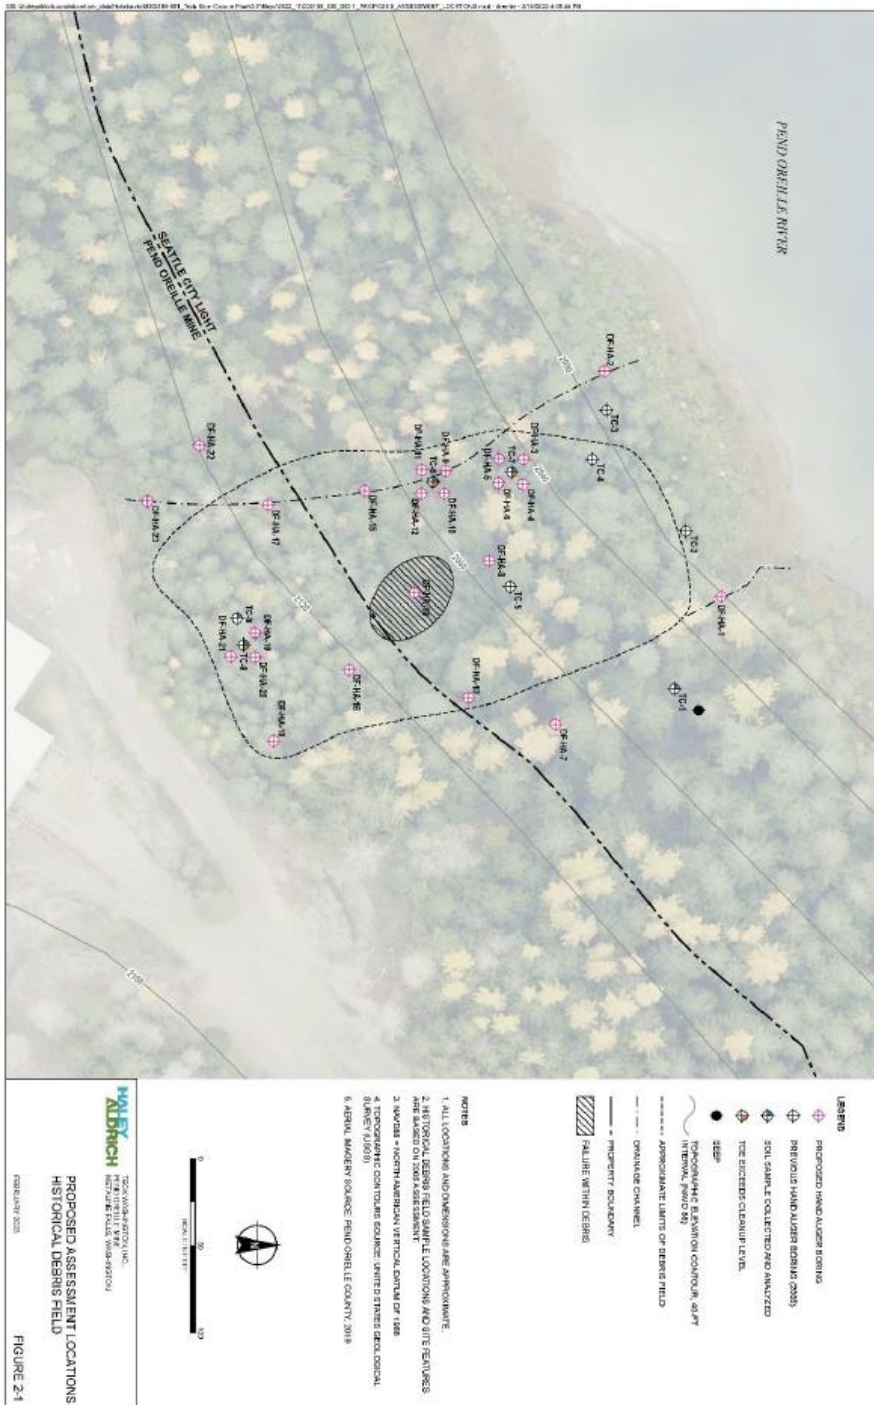
Site Diagram

The HDF consists of metal drums, vehicle parts, machine parts, cables, hoses, sheet metal, and wood debris disposed between the early 1950s up to 1977 allegedly using a launder chute system meant to discharge mine tailings from the mill to the river. The approximate extent of contaminated soil and waste materials within the HDF is 1.5 acres (200 x 300 feet) and 5.5-20 feet thick. The approximate volume of the waste materials within the HDF is 6,500 cubic yards assuming a uniform 5.5 foot thickness, which increases if the true thickness is closer to 20 feet. The HDF extends downslope (NW-SE) with an elevation range of approximately 115 feet.

Enclosure A includes a detailed description and diagram of the Site, as currently known to Ecology.
