21-2-00194-29  
DC 6  
Decree  
9984306

**STATE OF WASHINGTON  
SKAGIT COUNTY SUPERIOR COURT**

CONSENT DECREE

# EXHIBIT A

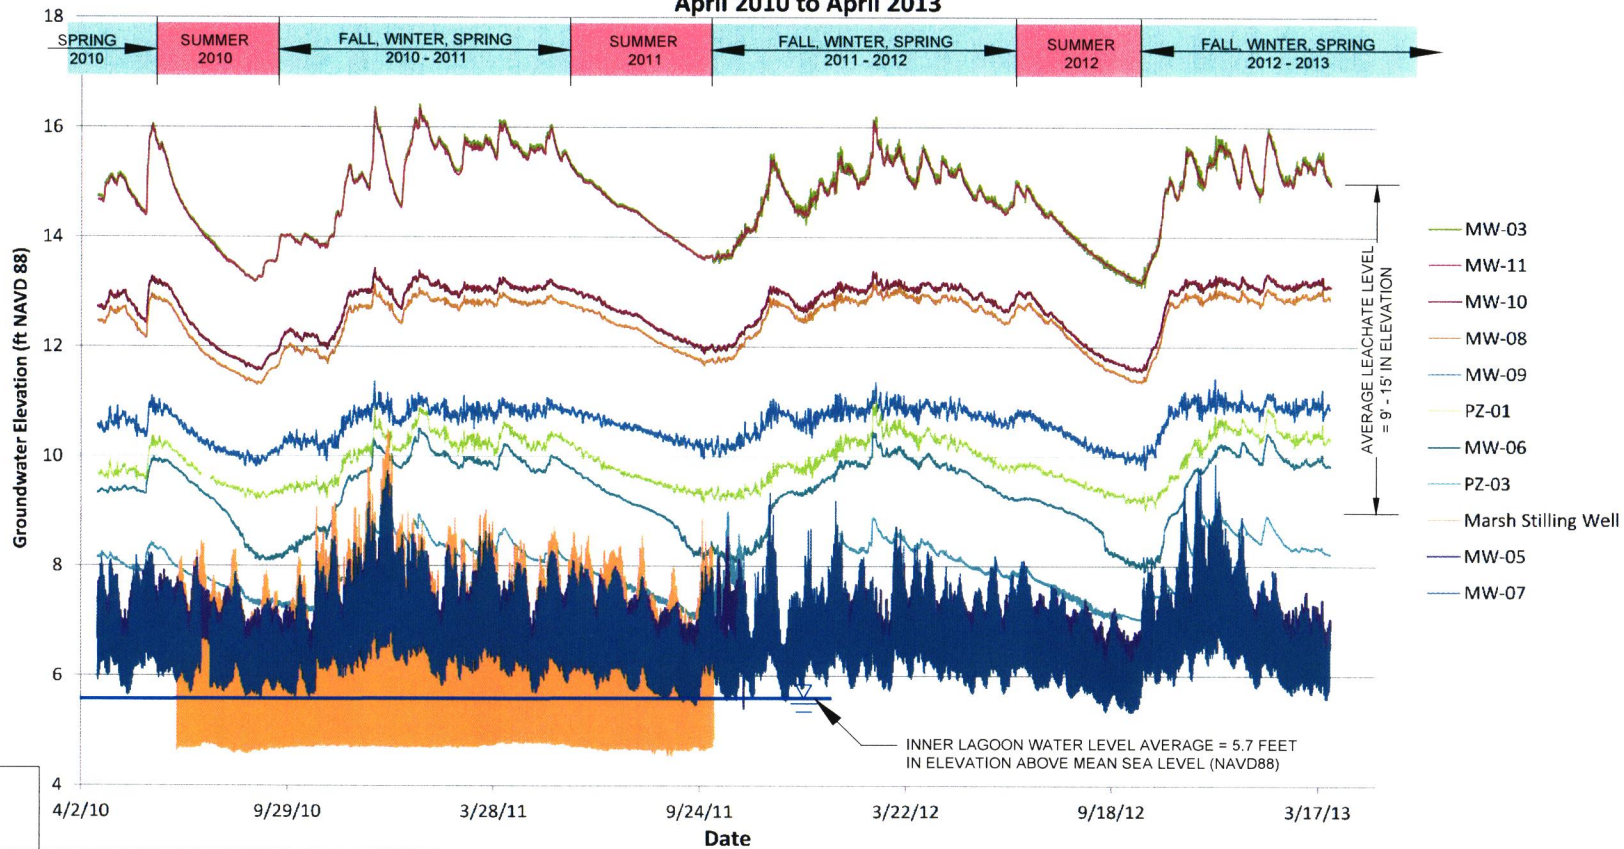
### Whitmarsh Landfill April 2010 to April 2013

1. PIEZOMETER 2 (PZ-02) IS DRY, AND NOT SHOWN.
2. MARSH STILLING WELL TRANSDUCER MALFUNCTIONED STARTING ON OCT. 7, 2011.
3. READINGS COLLECTED EVERY 15 MINUTES.

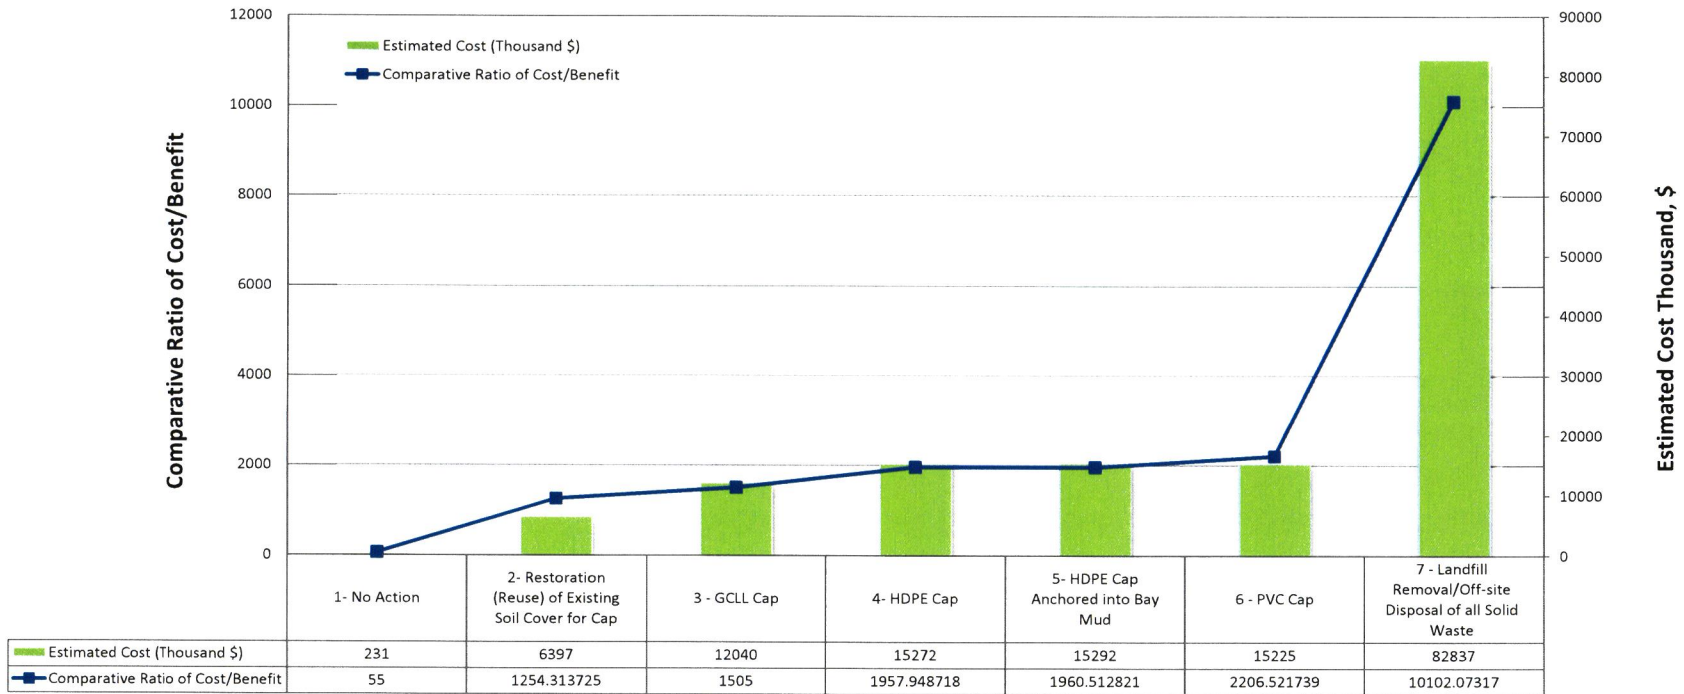
Figure 15

DISPROPORTIONATE COST ANALYSIS SUMMARY: COST & COST BENEFIT RATIO  
Former Whitmarsh Landfill  
Anacortes, Washington

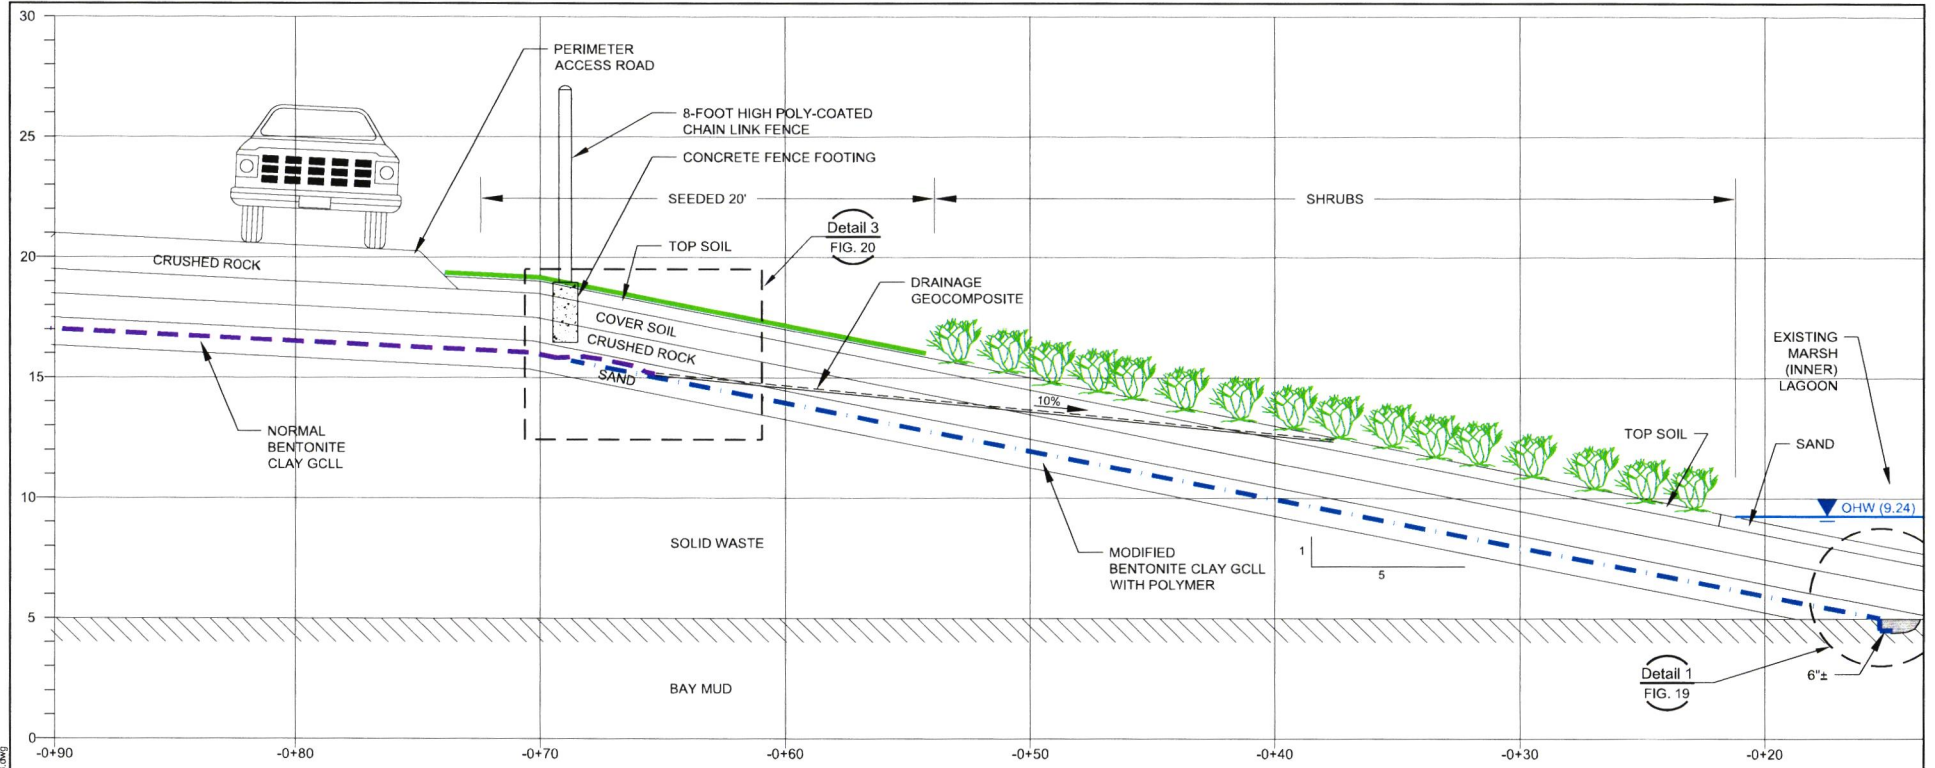
<b>SHORELINE CROSS SECTION</b> March Point (Whitmarsh) Landfill Skagit County, Washington			
By: APS	Date: 06/15/18	Project No. 14159	
Amec Foster Wheeler Environment & Infrastructure, Inc.			Figure <b>3</b>

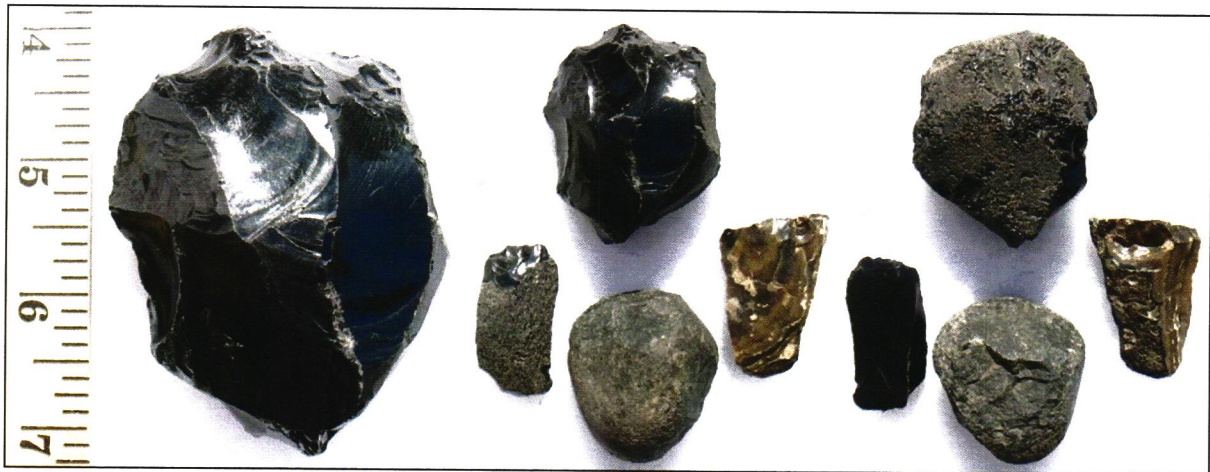
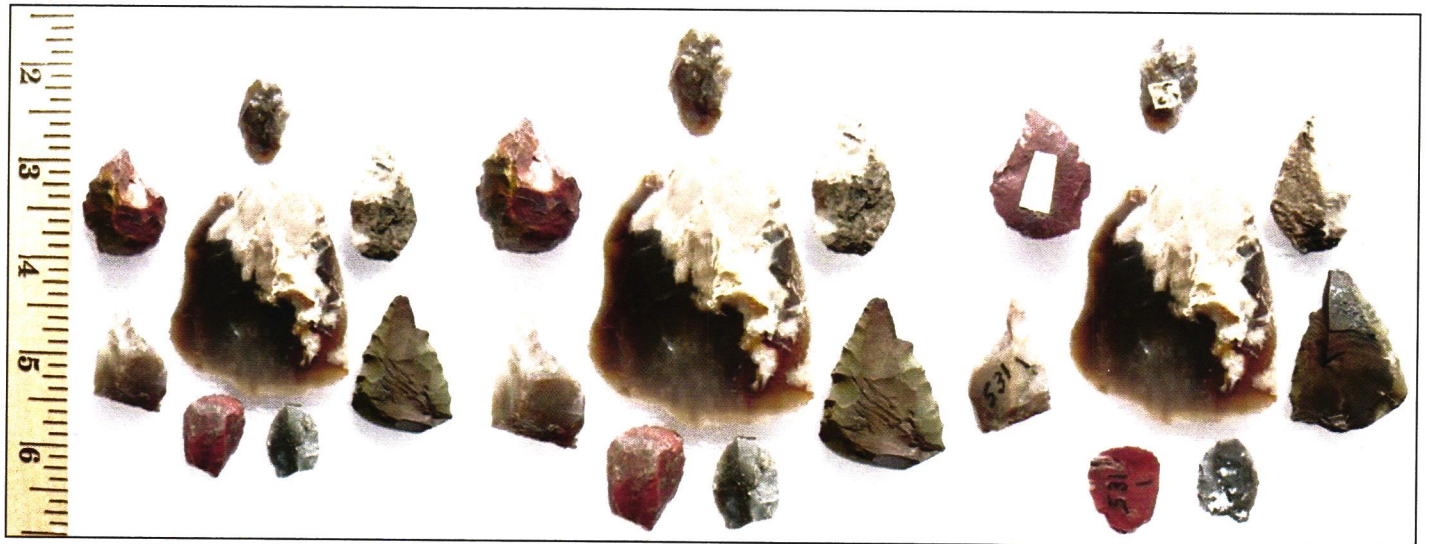
You see chipped stone artifacts.

- Glass-like material
- Angular
- "Unusual" material for area
- "Unusual" shape
- Regularity of flaking
- Variability of size

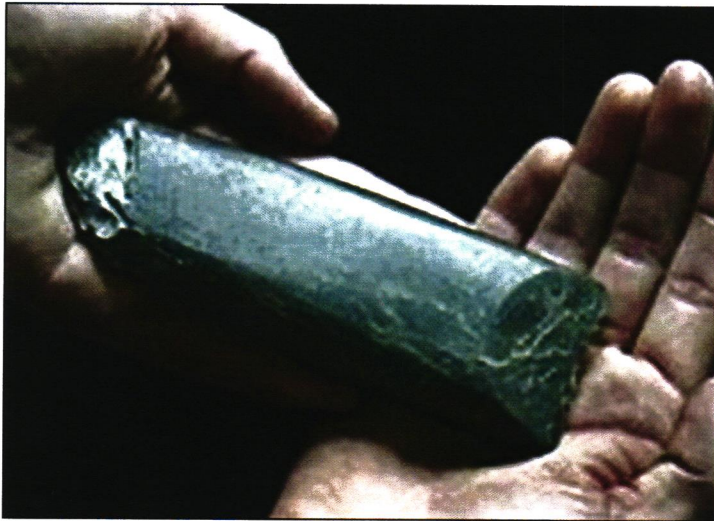
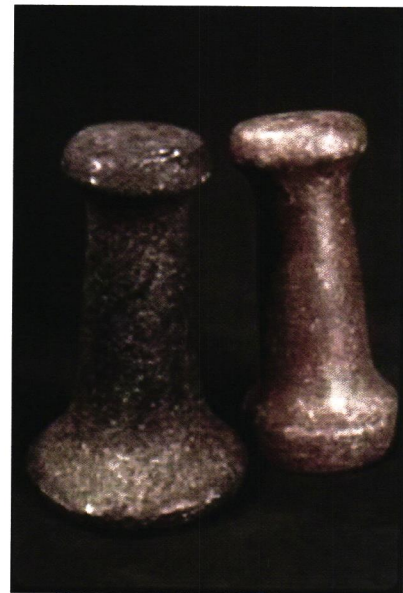
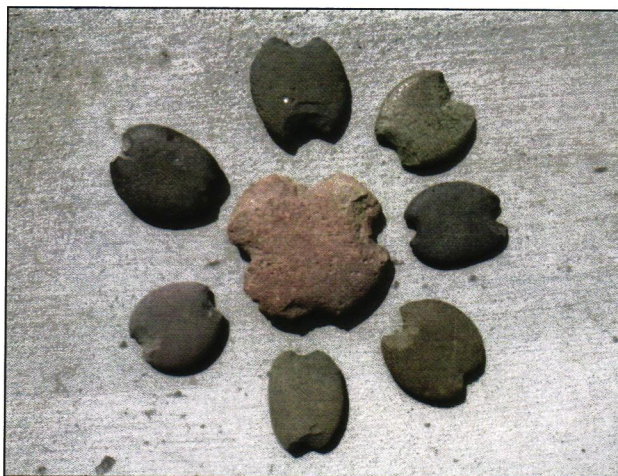
You see ground or pecked stone artifacts.

- Striations or scratching
- Unusual or unnatural shapes
- Unusual stone
- Etching
- Perforations
- Pecking
- Regularity in modifications
- Variability of size, function, and complexity

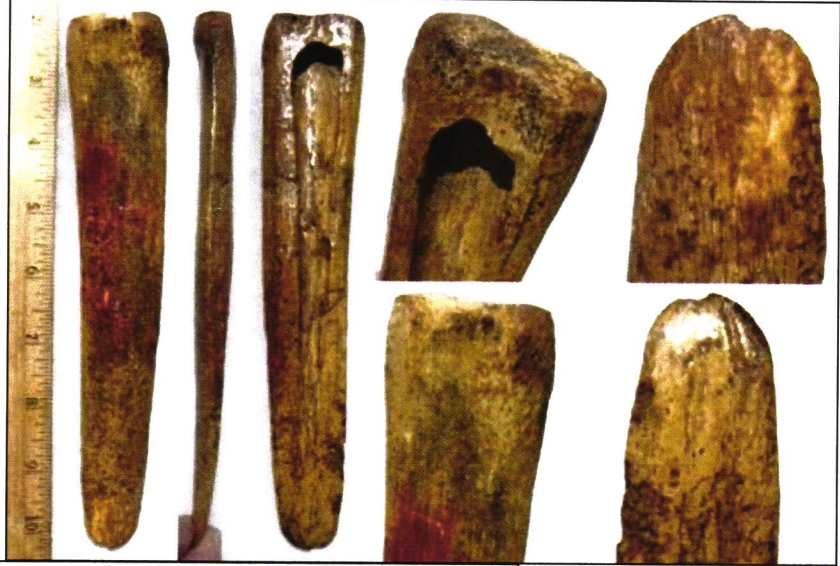
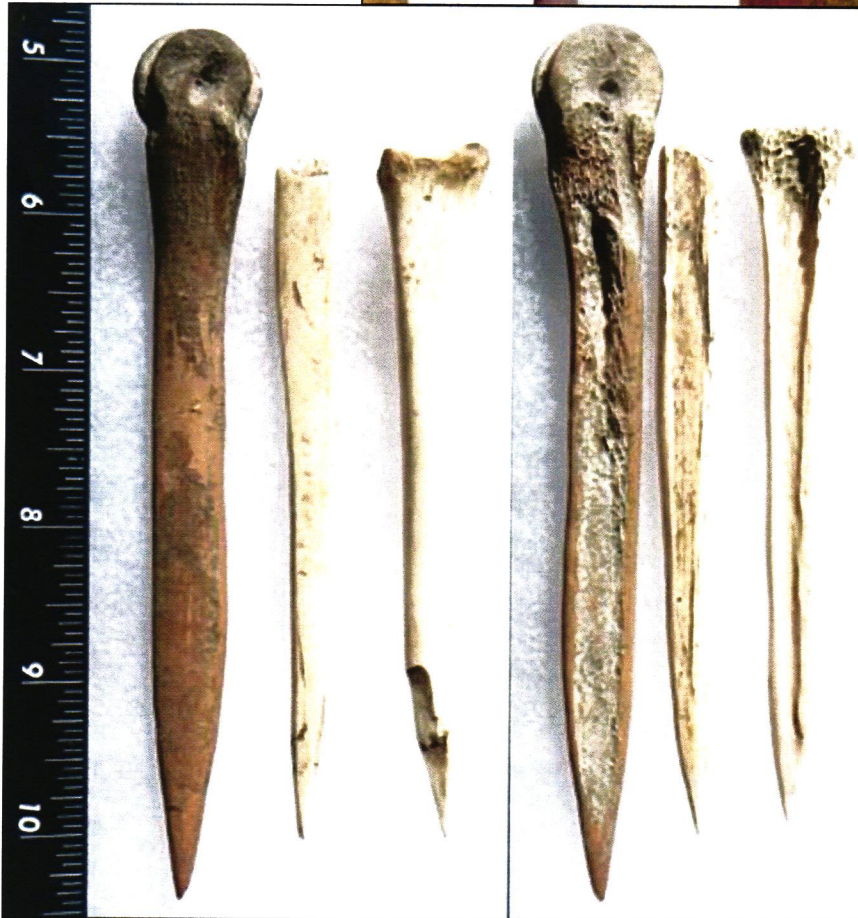
You see bone or shell artifacts.

- Often pointed if used as a tool
- Often wedge shaped like a “shoe horn”
- Often smooth
- Unusual shape
- Carved

*Bone Awls from Oregon and Bone Wedge from California*

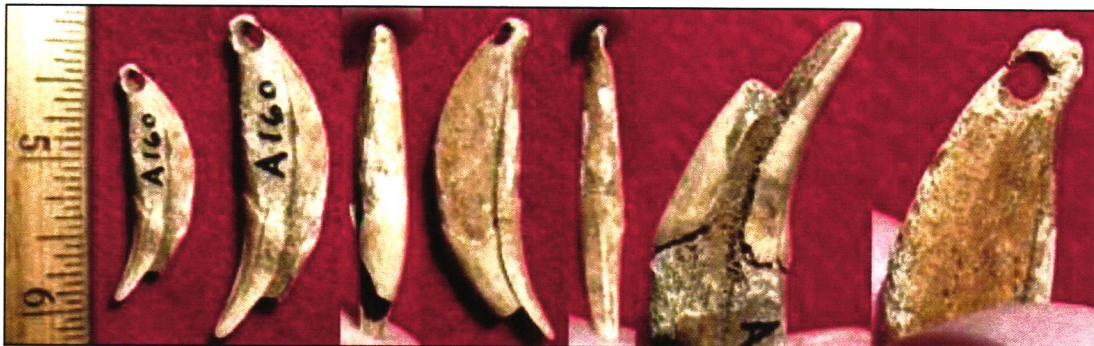
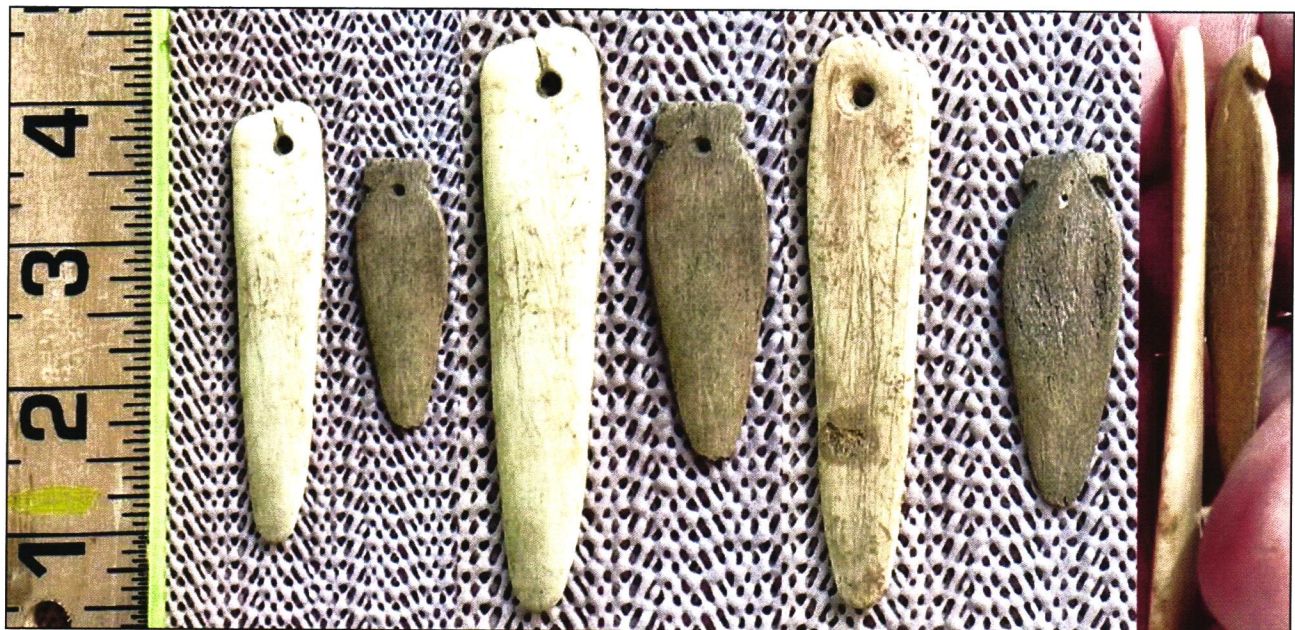
You see bone or shell artifacts.

- Often smooth
- Unusual shape
- Perforated
- Variability of size

*Tooth Pendant and Bone Pendants from Oregon and Washington*

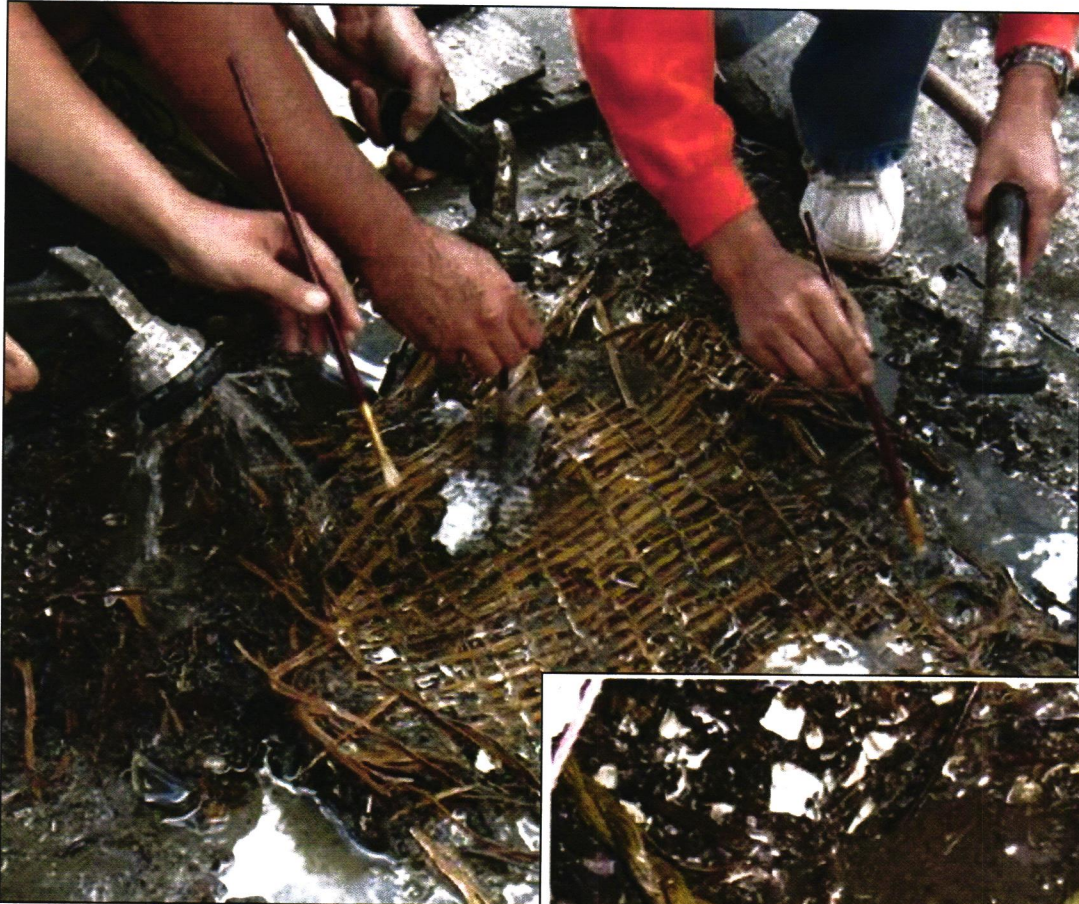
You see fiber or wood artifacts.

- Wet environments needed for preservation
- Variability of size, function, and complexity
- Rare

*Artifacts from Mud Bay, Olympia, Washington*

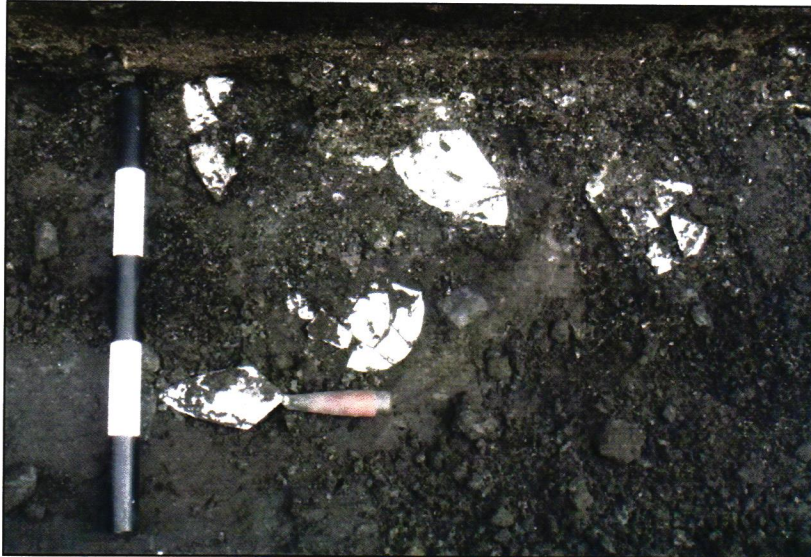
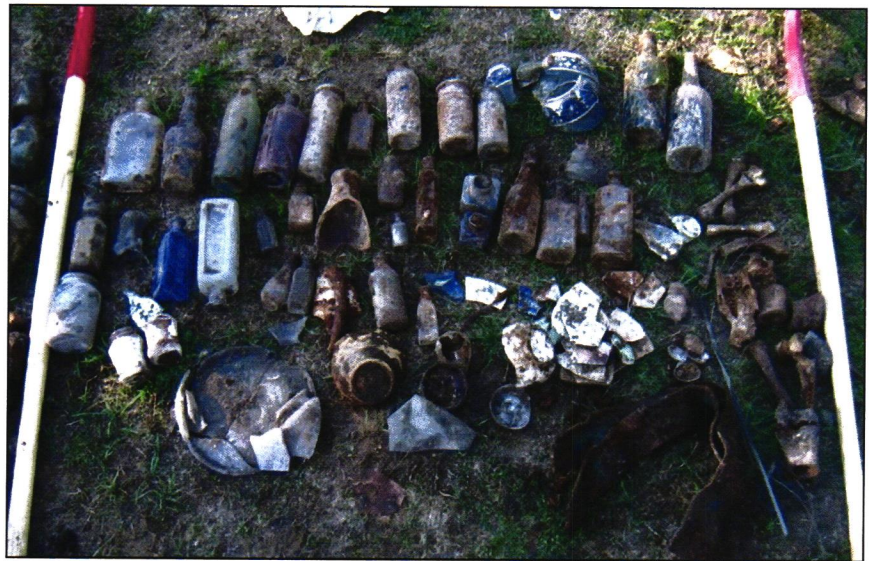
**Implement the IDP if...**  
**You see historic period artifacts.**

*Artifacts from Downtown Seattle, Alaskan Way Viaduct (Upper Left and Lower) and Unknown Site (Upper Right)*

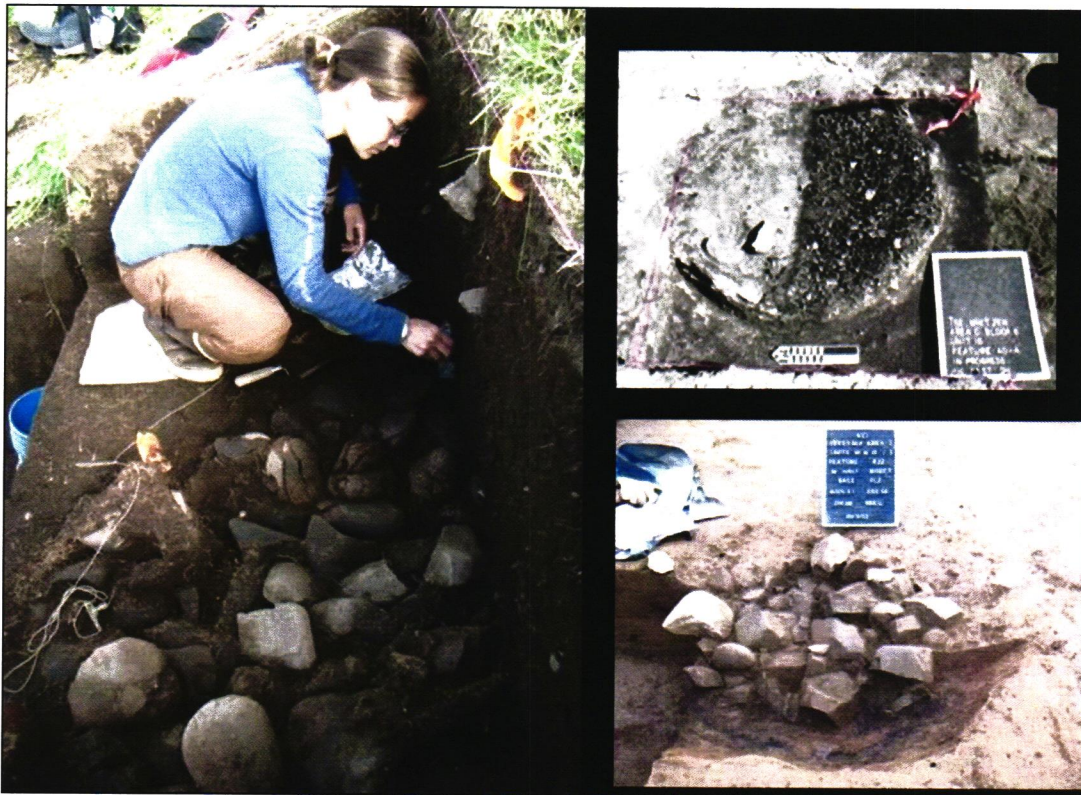
Unknown Sites

You see strange, different or interesting looking dirt, rocks, or

- Human activities leave traces in the ground that may or may not have artifacts associated with them
- “Unusual” accumulations of rock (especially fire-cracked rock)
- “Unusual” shaped accumulations of rock (e.g., similar to a fire ring)
- Charcoal or charcoal-stained soils
- Oxidized or burnt-looking soils
- Accumulations of shell
- Accumulations of bones or artifacts
- Look for the “unusual” or out of place (e.g., rock piles or accumulations in areas with few rock)

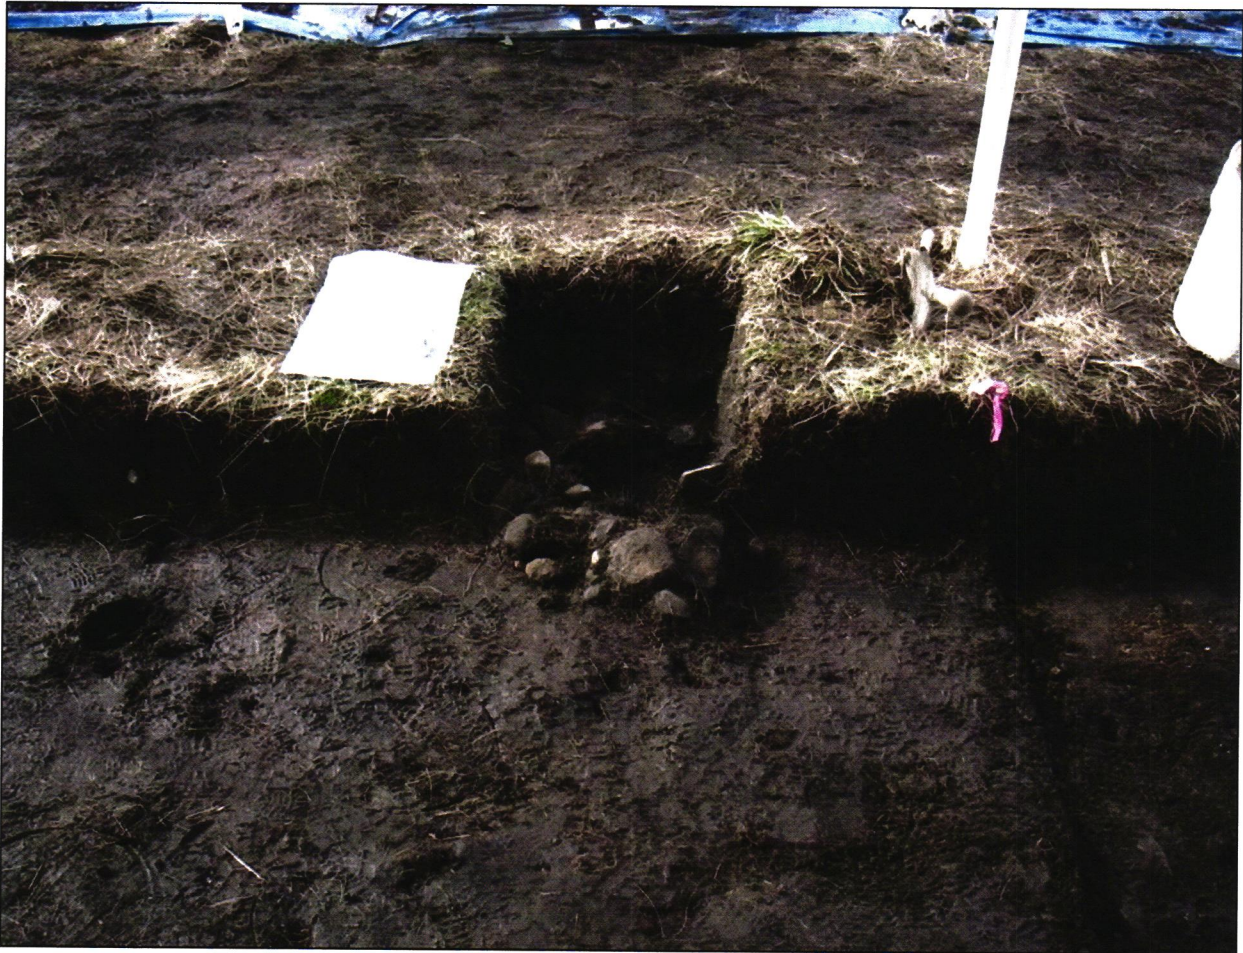
You see strange, different or interesting looking dirt, rocks, or

- “Unusual” accumulations of rock (especially fire-cracked rock)
- “Unusual” shaped accumulations of rock (e.g., similar to a fire ring)
- Look for the “unusual” or out of place (e.g., rock piles or accumulations in areas with few rock)

*Site on Muckleshoot Indian Reservation, near WSDOT ROW along SR 164*

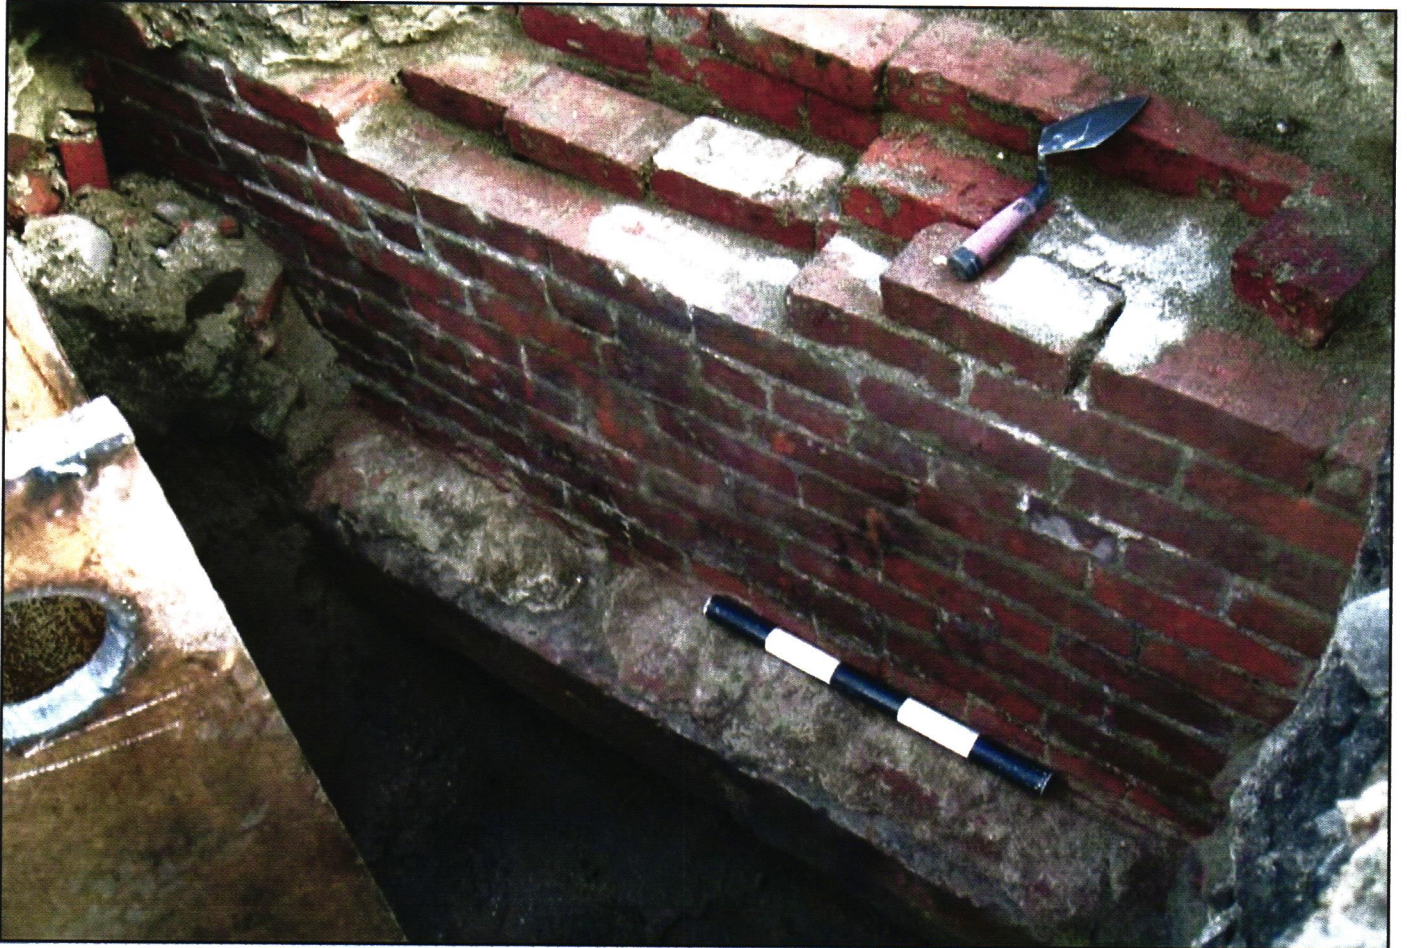
You see historic foundations or buried structure
