REPORT GROUND WATER MONITORING QUARTERLY REPORT (1QTR09) HALCO PROPERTIES, LLC SEATTLE, WASHINGTON

March 24, 2009

5232 SHILSHOLE AVE NW, SEATTLE

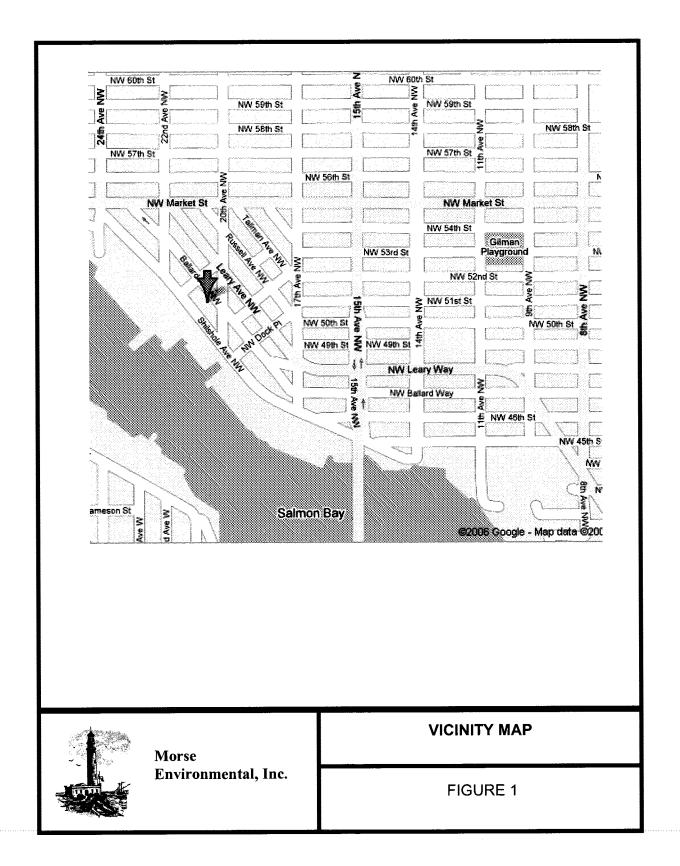
This report presents the results of our Fourth Quarter (2008) Ground Water Monitoring of the property located at 5221 Ballard Avenue NW, Seattle, Washington. The subject site currently is owned by the HALCO PROPERTIES LLC. The property is currently operated by the Salmon Bay Sand & Gravel Company. The location of the subject site relative to surrounding physical features is shown in Figure 1. The general layout of the site is shown in Figure 2.

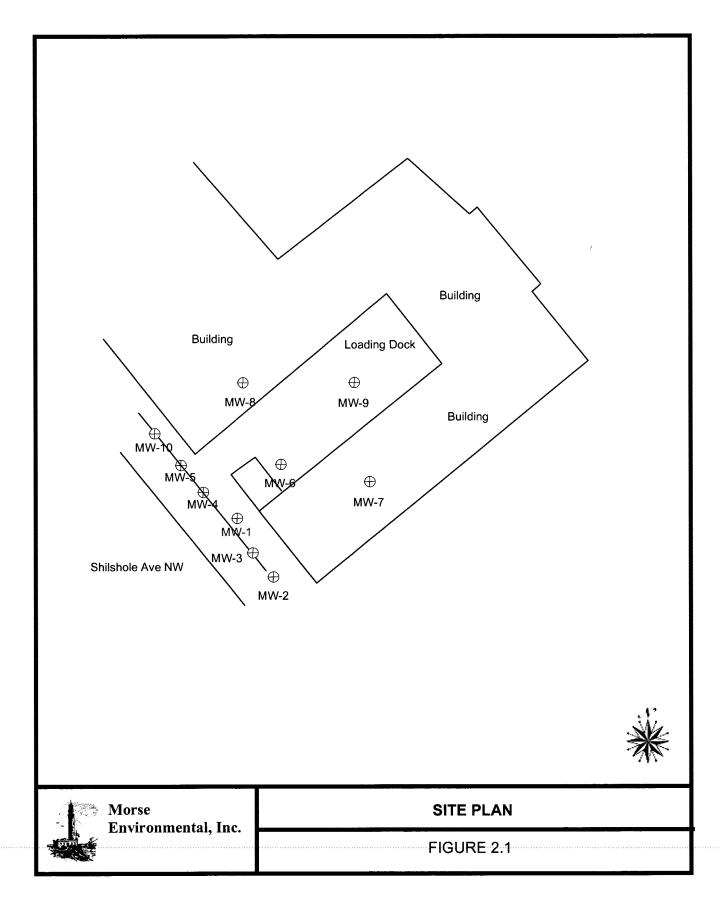
The site is occupied by the Salmon Bay Sand & Gravel Company. The site is comprised of three parcels that encompass 0.51 acres; the approximate location of the on-site building is shown in Figure 2.
