From: [Winslow, Frank \(ECY\)](#)
To: [John Funderburk](#)
Cc: [Roy Kuroiwa \(rkkpe@comcast.net\)](mailto:Roy.Kuroiwa@comcast.net)
Subject: RE: Request for Change Order - Change Order Number 3
Date: Thursday, September 21, 2023 2:28:56 PM

Frank: Hi! This email has a lot of attachments - sorry, and it is intended to provide new soil data collected in areas where the 3 new CMP borings (B113, B14, and B115) were completed in August. We did find some deeper contamination in the northwest area on the Property, so these CMP borings were very useful.

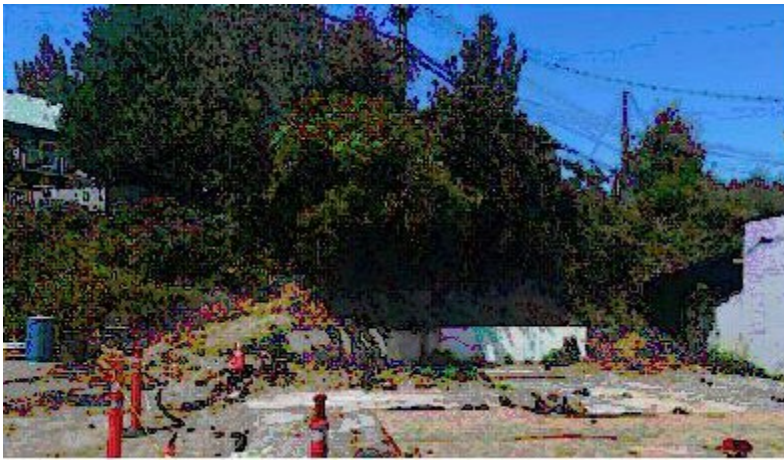
An additional condition for a change in approach is shown below in the photo. Once the building was demolished and blackberries and shrubbery were removed, the driller decided that he cannot put the planned vertical borings in on the steep slope behind the white retaining wall, as shown on the Figure. Consequently, 4 of the ERH electrodes (E05, F04, G03, and H02) will require angle drilling and longer lengths to achieve the deeper depths along the NW side, in the 2 treatment areas, as shown on TRS Figure Y-1 above.

Steep Slope on North Side – Behind Retaining Wall
Drill Rig Cannot Get Access to drill Electrodes
