**DECEMBER 2023
GROUNDWATER SAMPLING EVENT REPORT**

**HAHN MOTOR COMPANY
1201 SOUTH 1ST STREET
YAKIMA, WASHINGTON 98901**

**Facility Site ID No. 502
Cleanup Site ID No. 4927
VCP Project No. CE0529**

January 29, 2024

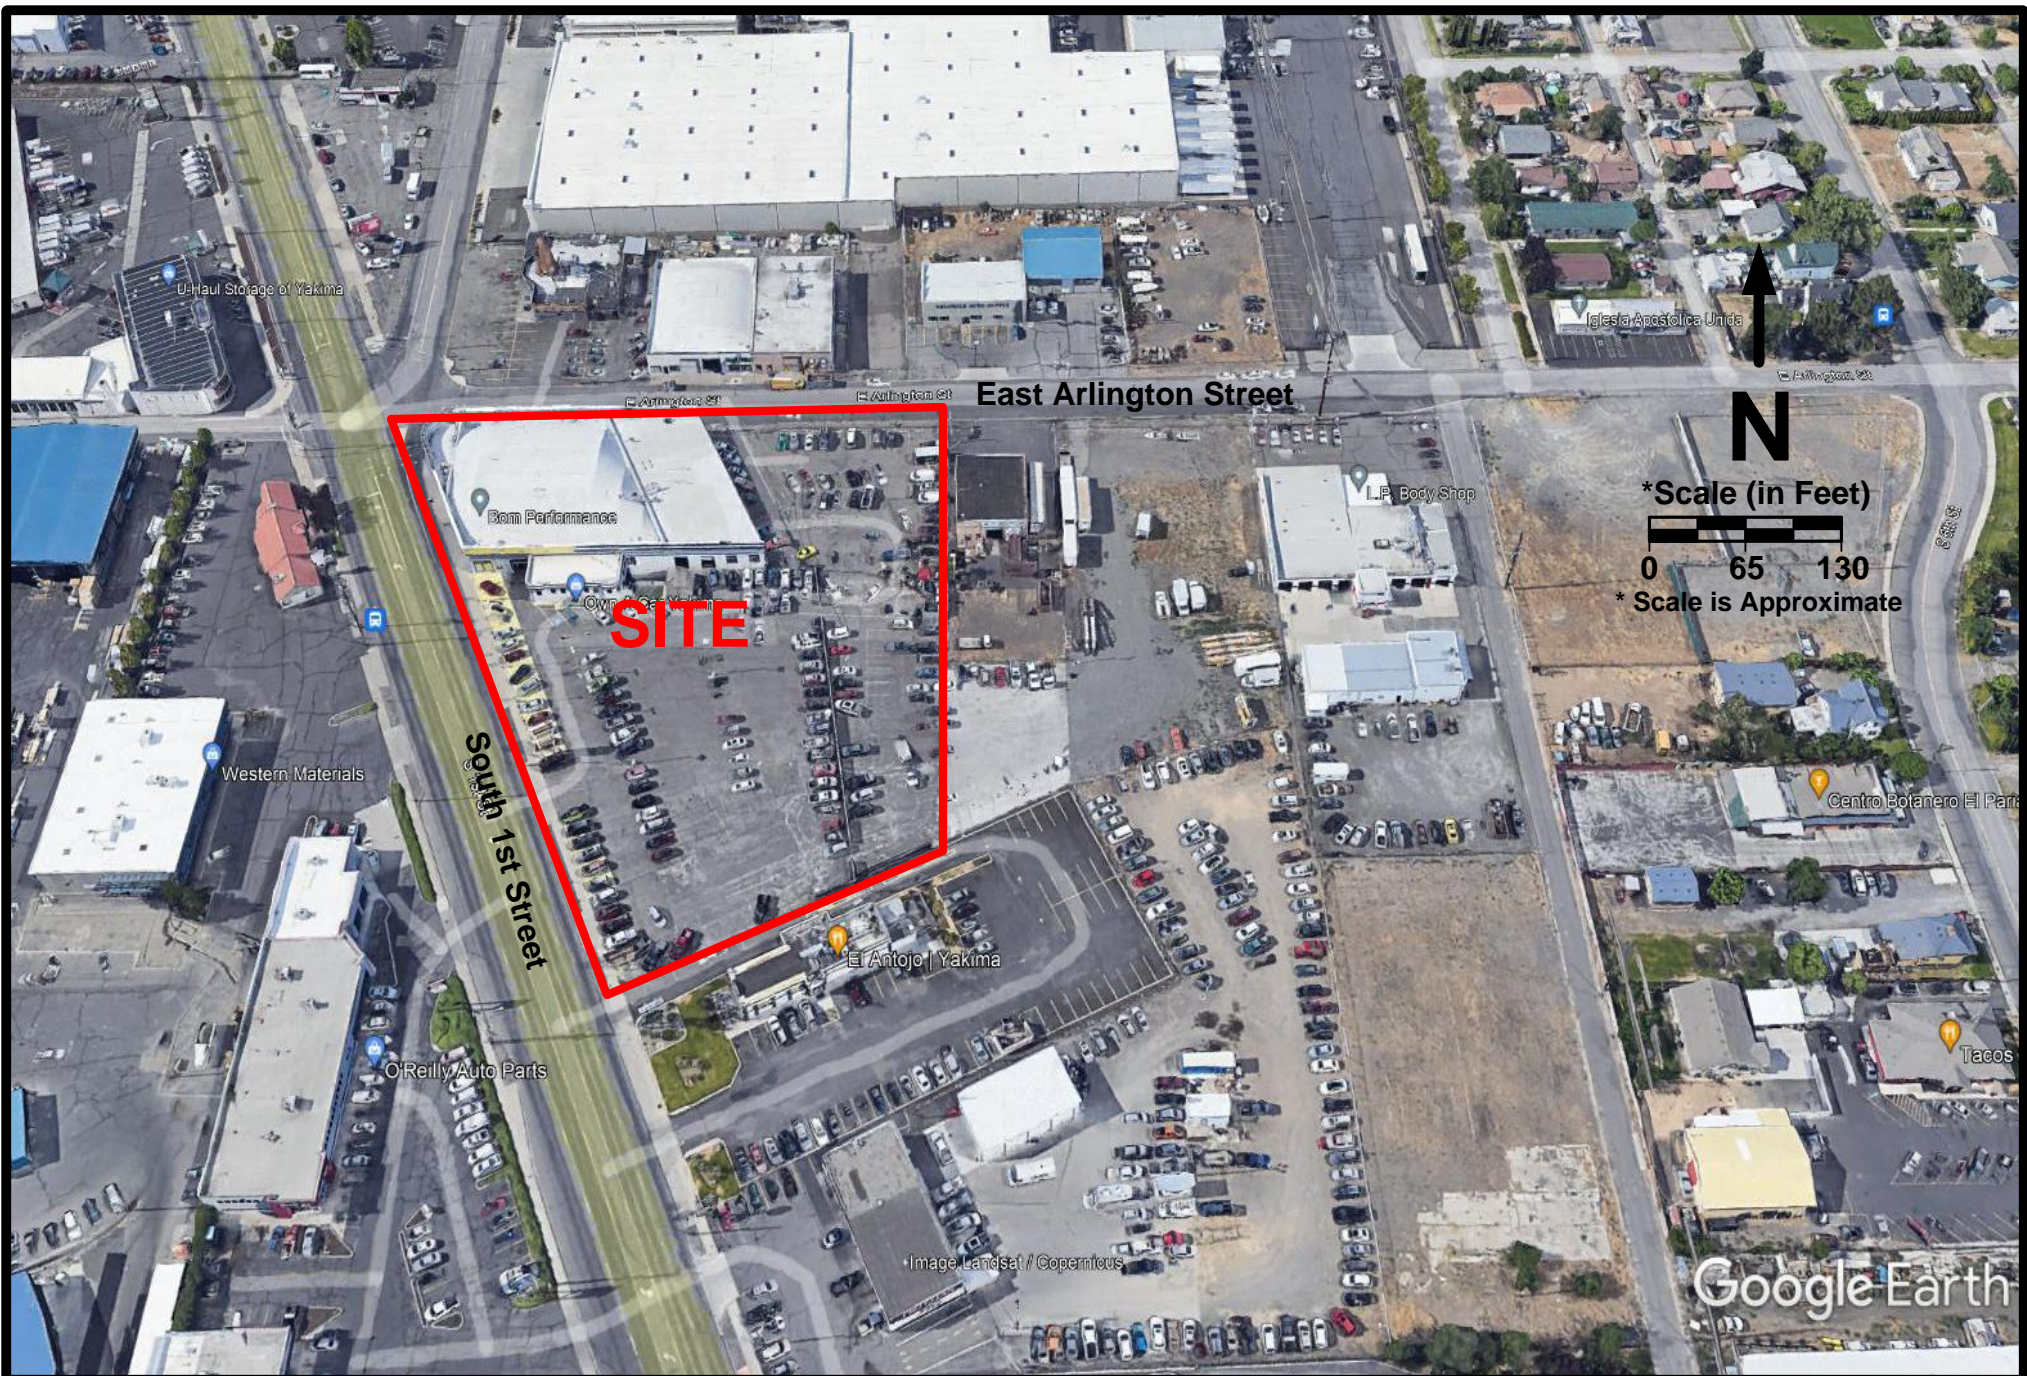
FIGURE 2 – SITE LOCATION MAP

One building is located on the Site (**Figures 2 – 5**). The rectangular building located on the northwest corner of the property consists of an automobile showroom with offices on the western half, bathrooms and break room near the center of the building, and an automobile repair and automobile wash bay in the eastern half of the building. During the visit to the Site on February 1, 2022, a minimum of one sump was noticed on the interior of the eastern half of the building. The sump appeared to drain to the south toward the drywells which BMEC investigated via soil and groundwater sampling on February 1, 2022. The drywells and all associated petroleum and metals impacted soils were removed on July 12 and 13, 2022, and replaced by a single dry well on July 14, 2022.

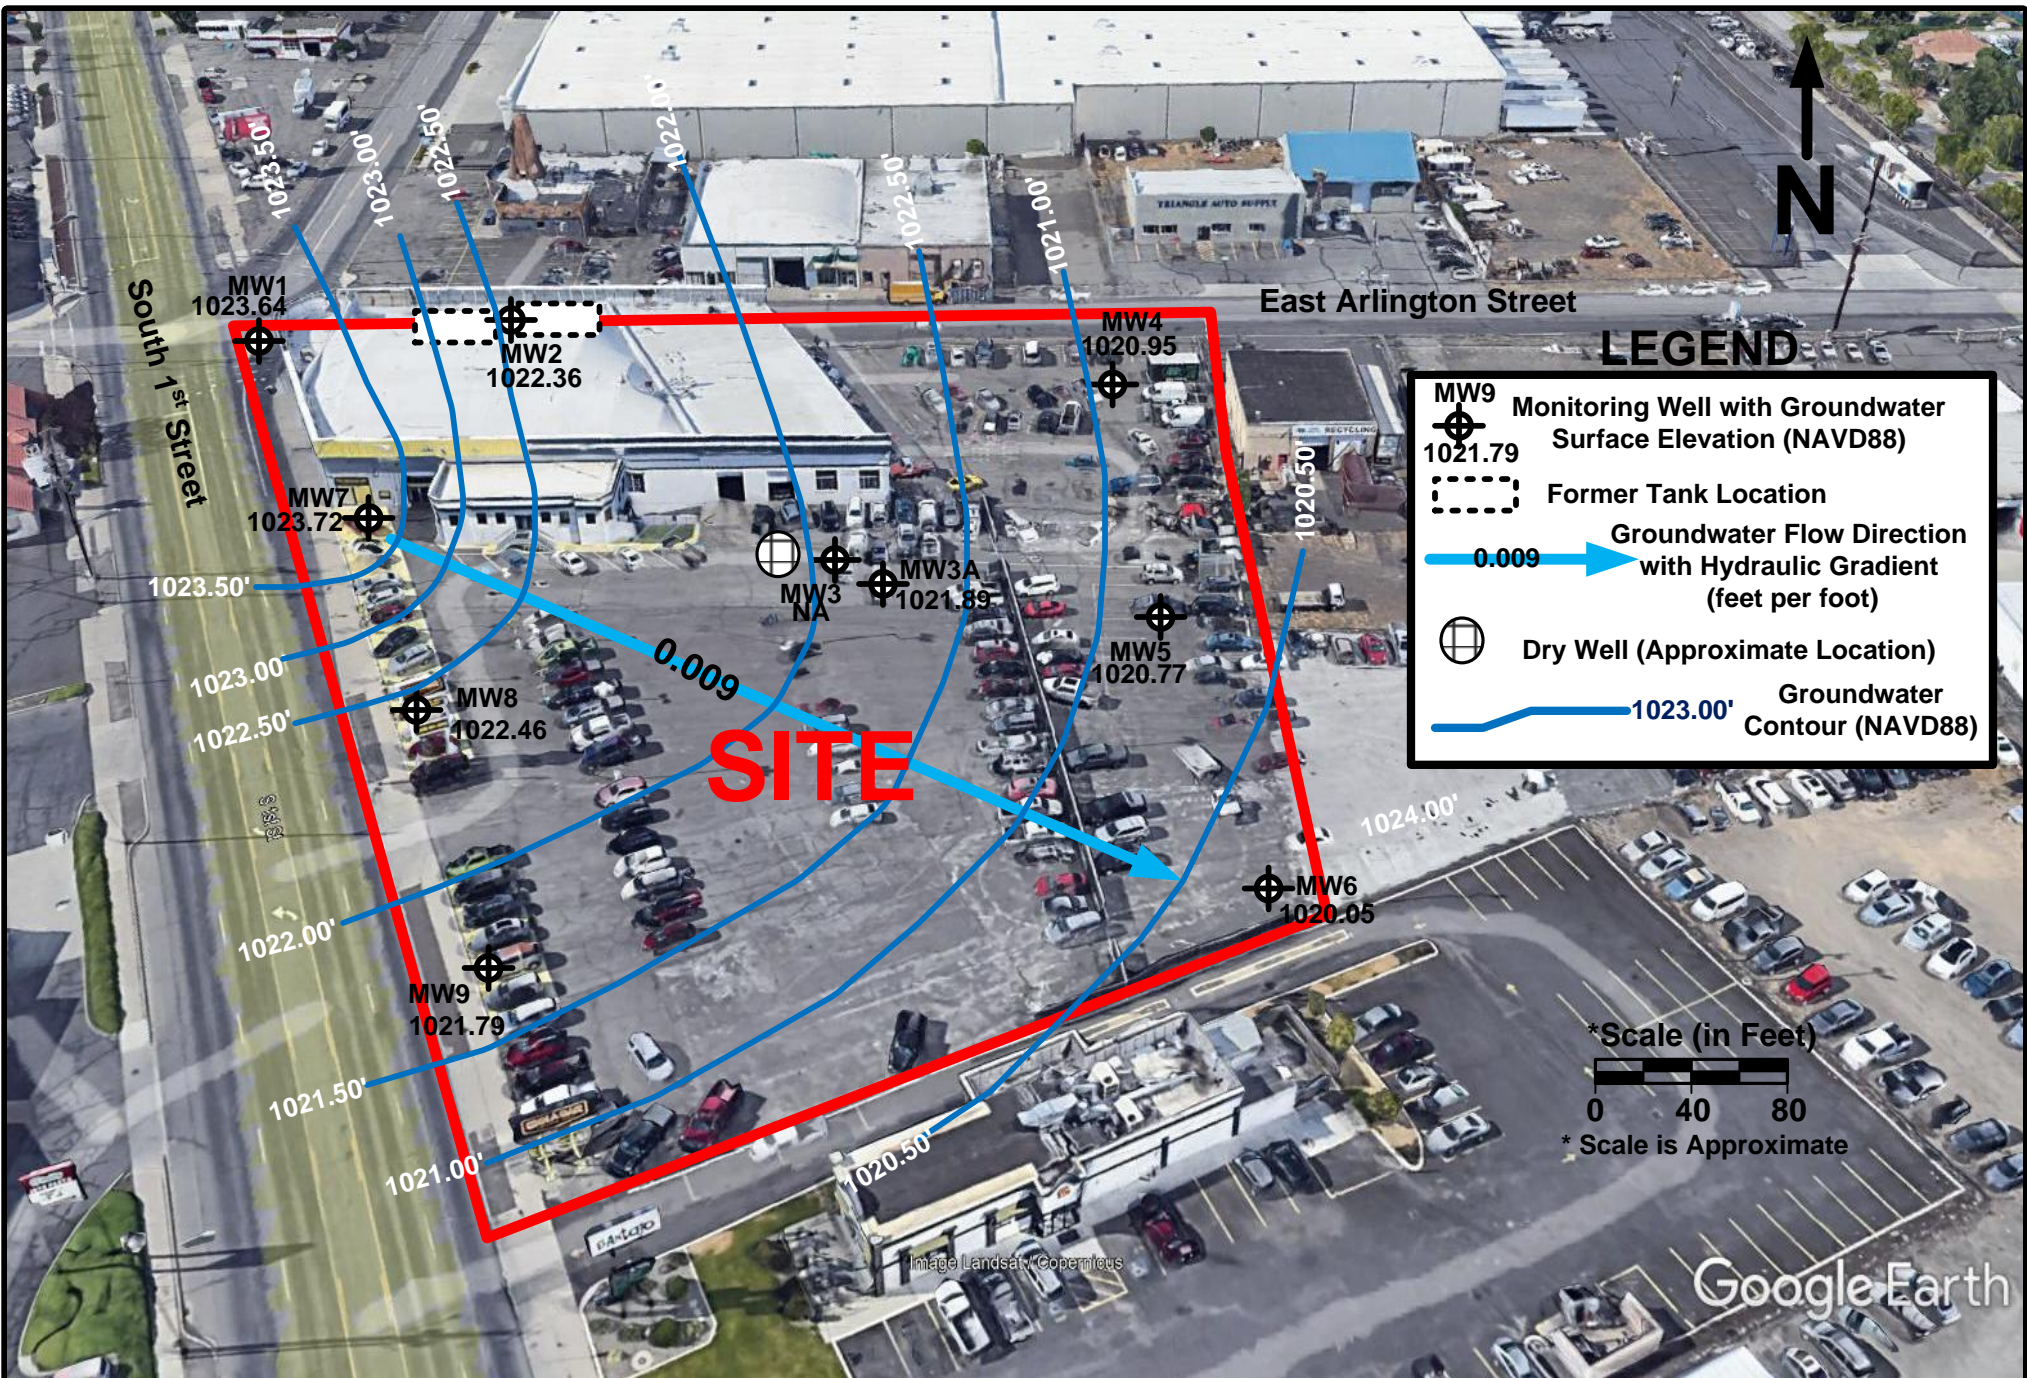
**FIGURE 3 – GROUNDWATER
 FLOW DIRECTION
 DECEMBER 27, 2023**

During the May 19, 2023, monitoring well installation activities, soil lithology in wells MW3A and MW7 through MW9 was similar to the afore-mentioned soil with predominantly brown to gray-brown sandy, rounded, coarse GRAVELS (GW) from 2.5 to 30 feet below ground surface (bgs) and groundwater saturation noted from 18 - 22 feet bgs. During the June 13, 2023, GWSE, depth to groundwater was measured around 18 - 20 feet below top of casing (btoc) in all nine wells. Groundwater flow direction was to the southeast at 0.004 feet per foot on June 13, 2023. During the September 26, 2023 GWSE, depth to groundwater was measured around 16 – 18 feet btoc in all nine wells. Groundwater flow direction was to the southeast at 0.005 – 0.006 feet per foot. During the most recent December 27, 2023 GWSE, depth to groundwater was measured around 19 – 20.5 feet btoc in all nine wells. Groundwater flow direction was to the southeast at 0.009 feet per foot (**Figure 3**).

Over the past six GWSEs conducted at the Site by BMEC personnel, the groundwater flow direction of the shallow aquifer has been determined to be to the southeast toward the Yakima River which is approximately 1.5 miles east of the Site. The hydraulic gradient of the shallow aquifer has been calculated to range between 0.004 and 0.009 feet per foot. Per information obtained from Ecology regarding the overall regional hydrogeology, the estimated flow direction in the deeper aquifer beneath the Site is also to the southeast with an approximate hydraulic gradient of 0.004 feet per foot.
