**Anchor QEA Memorandum
“Response to U.S. Army Corp of Engineers’ Request
for Additional Information”**

To: Erin Legge, U.S. Army Corps of Engineers **Date:** March 28, 2013
From: Heather Griffin, City of Everett
Heather Page, Anchor QEA, LLC
Re: Kimberly Clark DWO Project (NWS-2000-34)
Response to U.S. Army Corps of Engineers' Request for Additional Information

FIGURES OF ORIGINAL BEACH RESTORATION, PHASE 1, AND PHASE 2

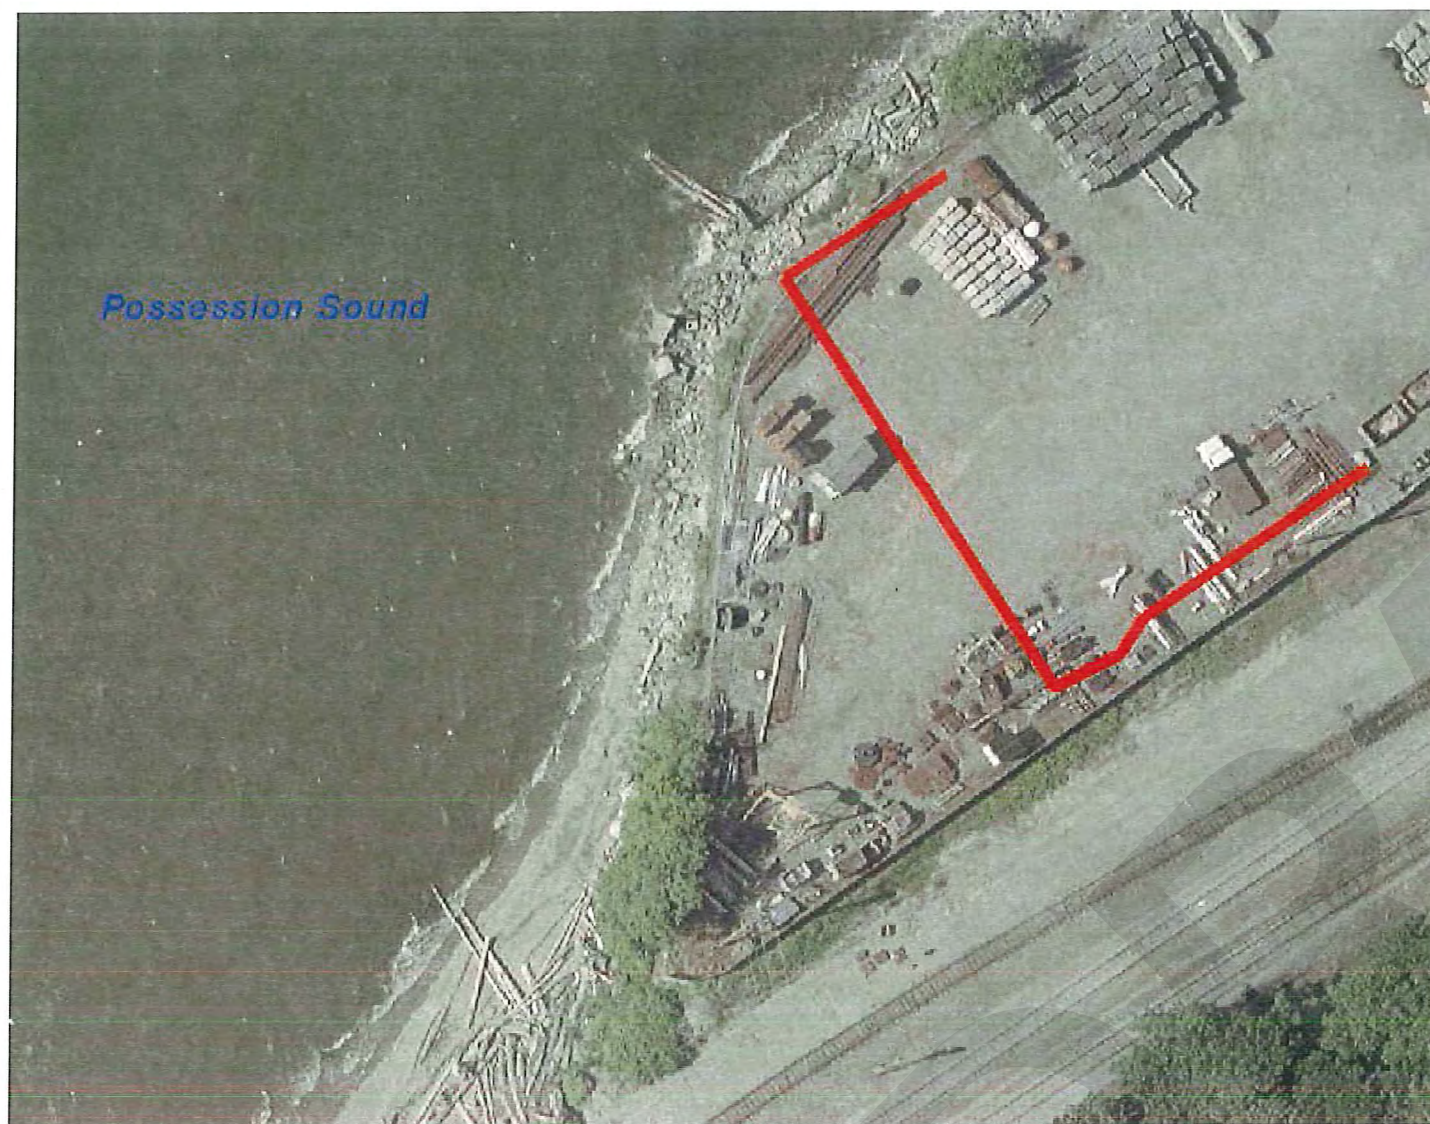
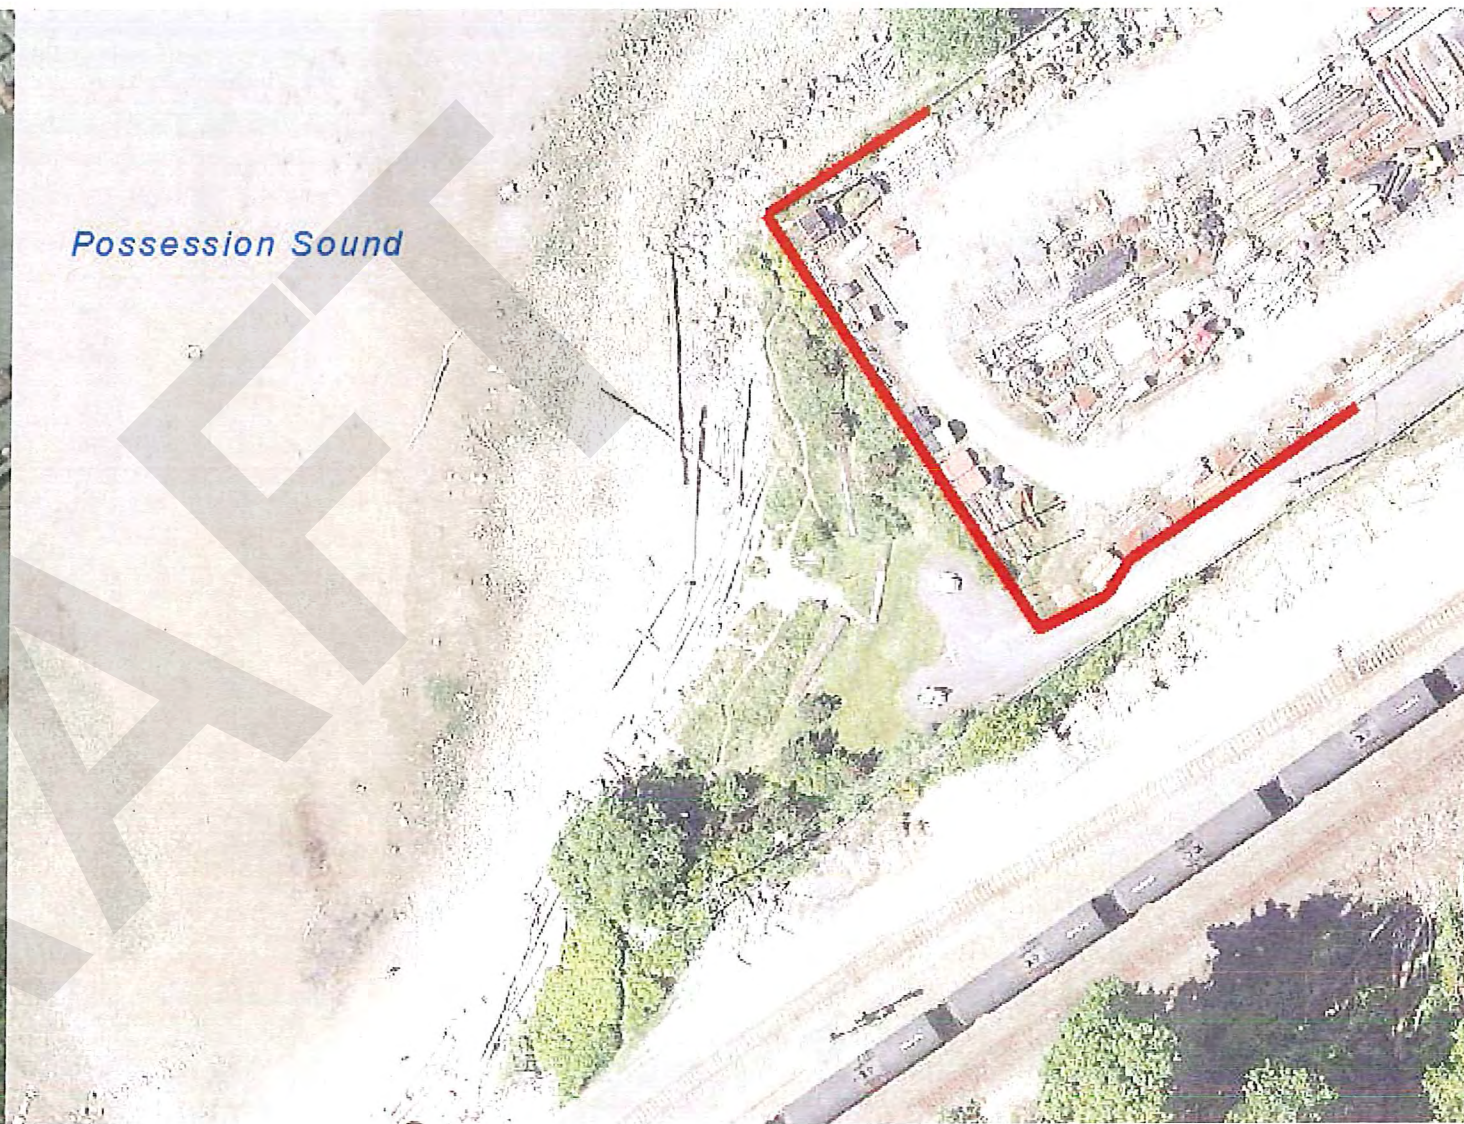
Note: Red line is the fence line digitized in from the 2011 aerial photograph

Figure 1: Pre-Construction (left) 2001 and Post-Construction (right) 2011 Aerial Photography of Project Site
Depp Water Outfall Beach Repair Project

The site was originally uplands and was part of the Port of Everett (Port) as a laydown yard. It extended from the current northwest corner of the Port's laydown area to the southern portion of the project extent (see Figure 1 in Attachment 1).

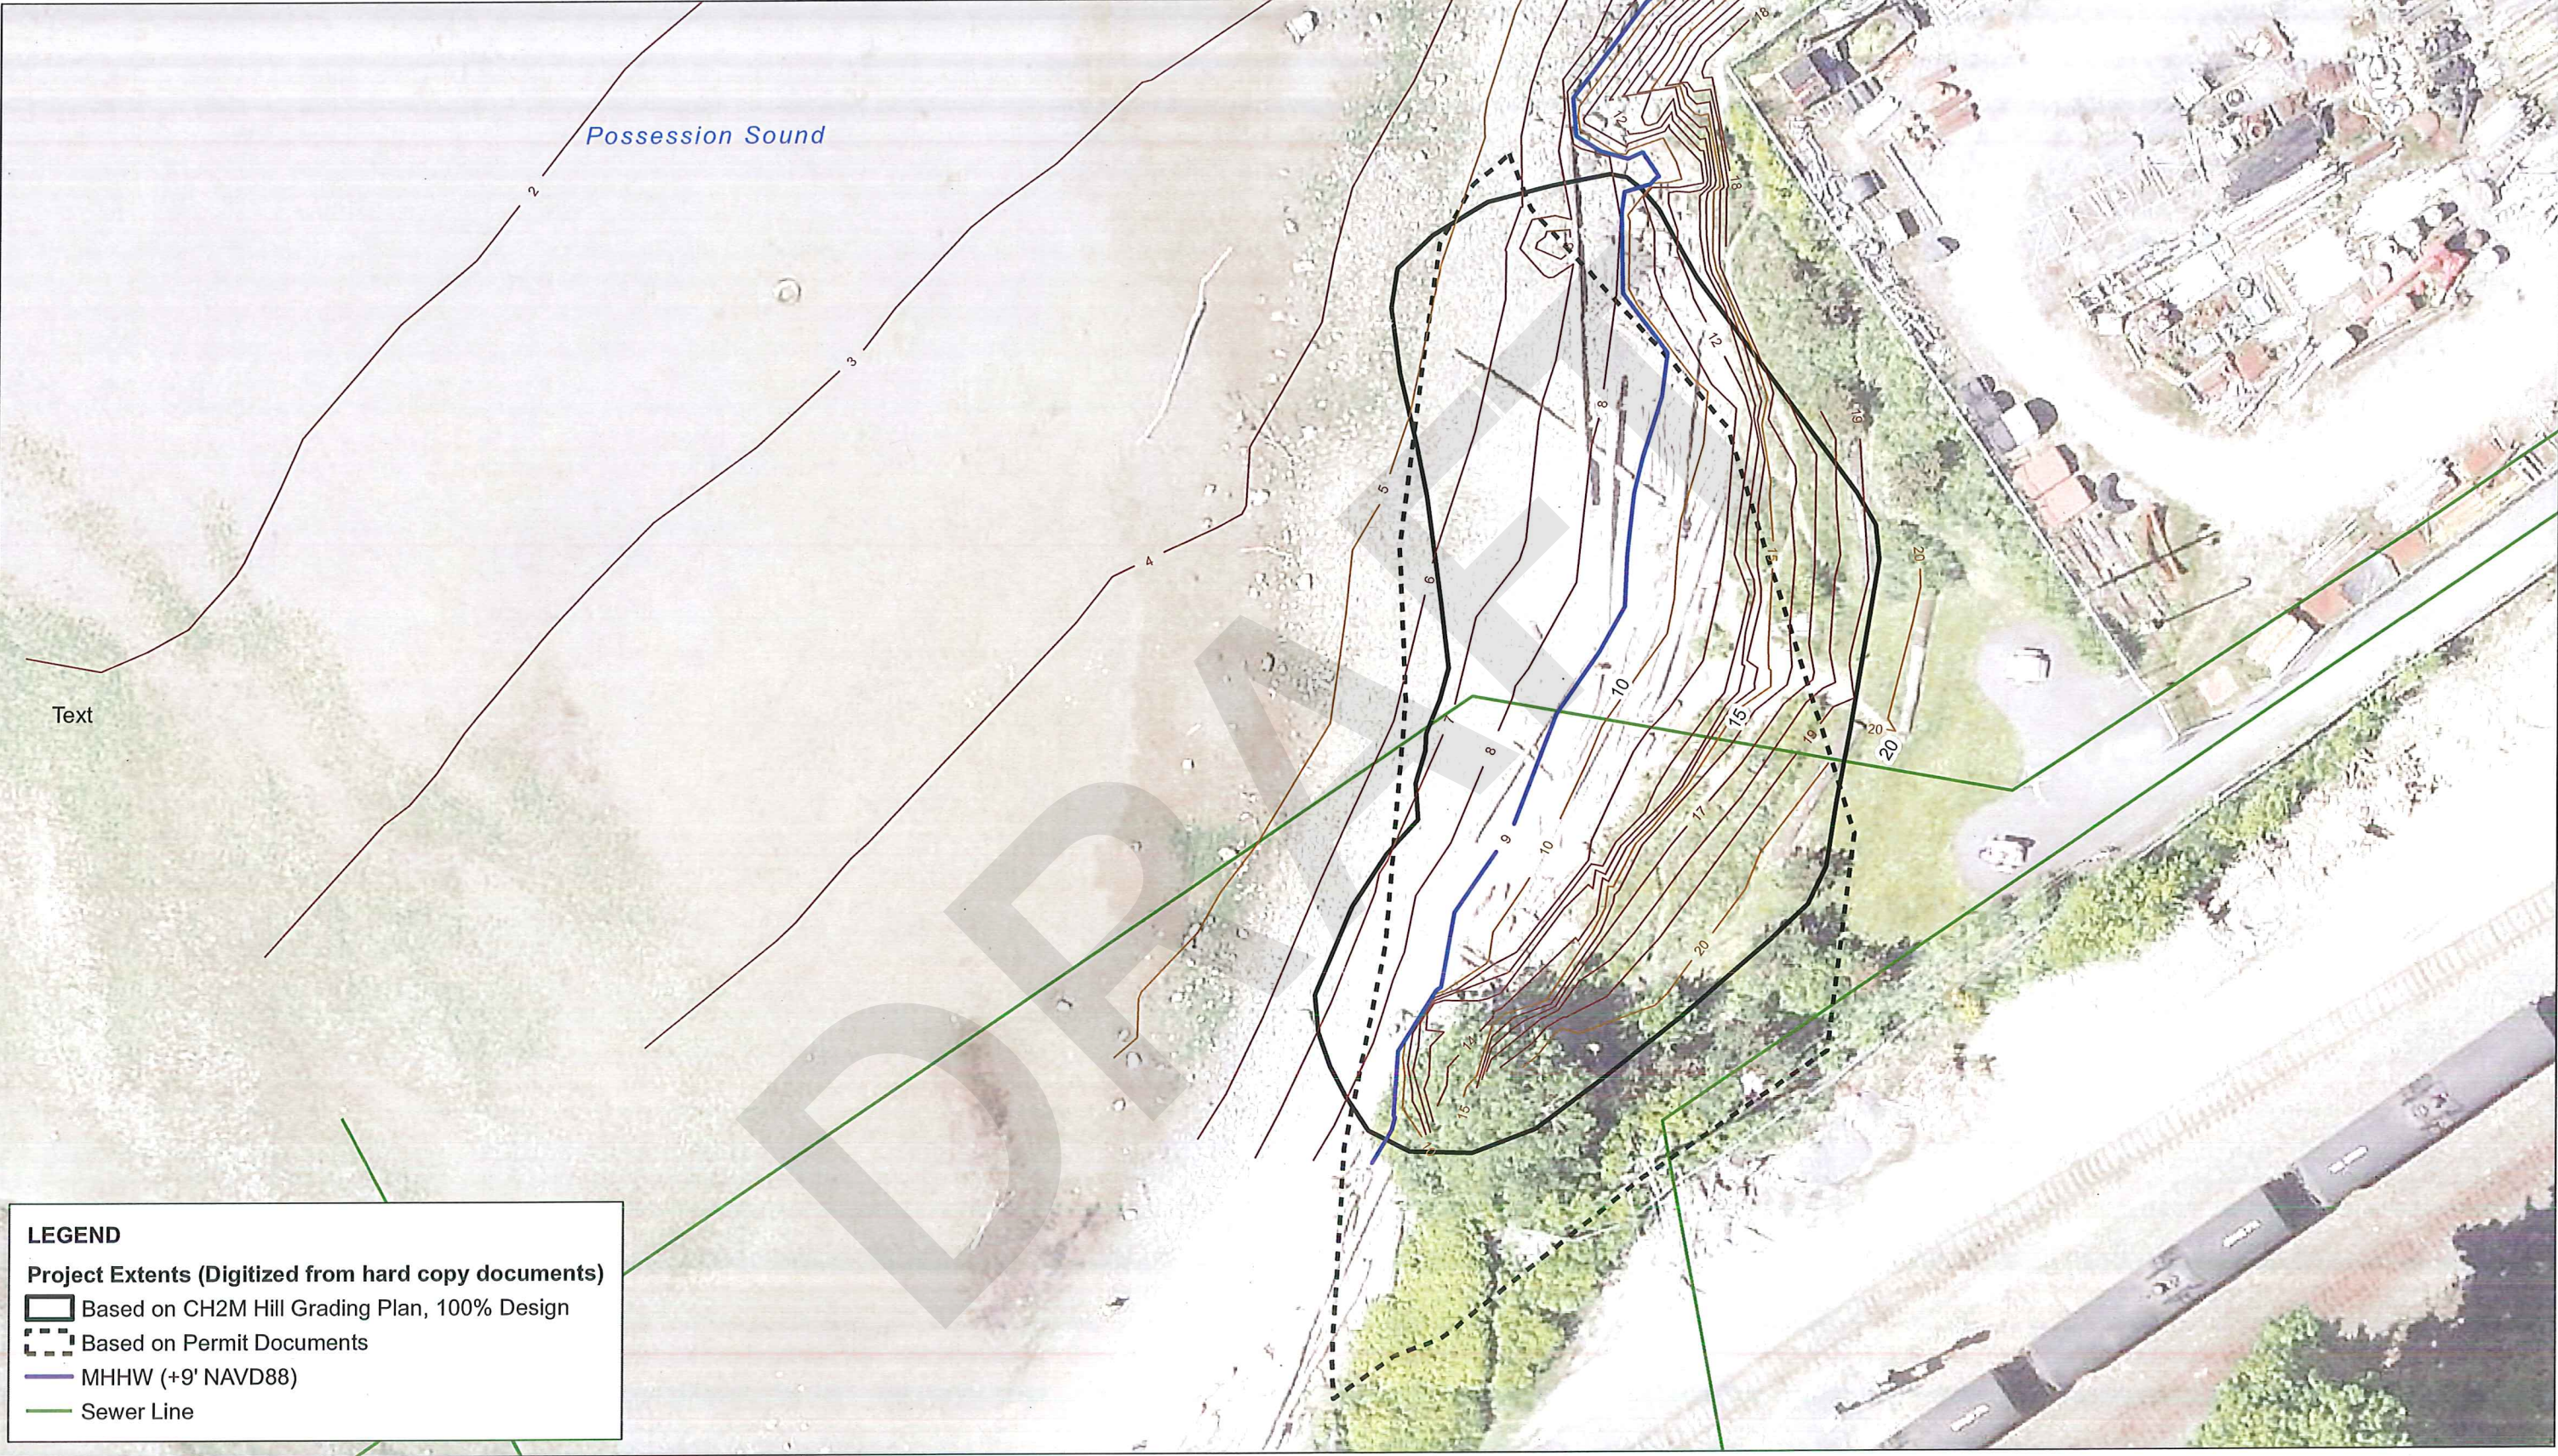
Figure 2: Site Map and Approximate Limits of Grading of Original Beach Enhancement Work
 Deep Water Outfall Beach Repair Project

The project area and vicinity were excavated in late 2003 to place an offshore outfall for Kimberly Clark (KC) and the City. A temporary trestle was built to aid in the placement of the offshore outfall, which extended from its land connection at the project site to the southwest. In February 2004, following construction of the outfall, the site was re-graded and filled to create a pocket beach. The temporary pier was removed and the shoreline was cut back from a straight shoreline to the curved shoreline shown in Figure 2 in Attachment 1. Immediately after construction, the beach sand began eroding due to impacts from wave action (likely between mean high water [MHW] and MHHW), forming a vertical scarp along the shoreline. A month following construction, the beach sand had eroded to the point that the underlying cobble and larger armor rocks became visible (see Figure 3 in Attachment 1). At present, the majority of the placed sand has eroded from the upper intertidal area and the underlying cobble has spread over the area (see Figure 4 in Attachment 1).

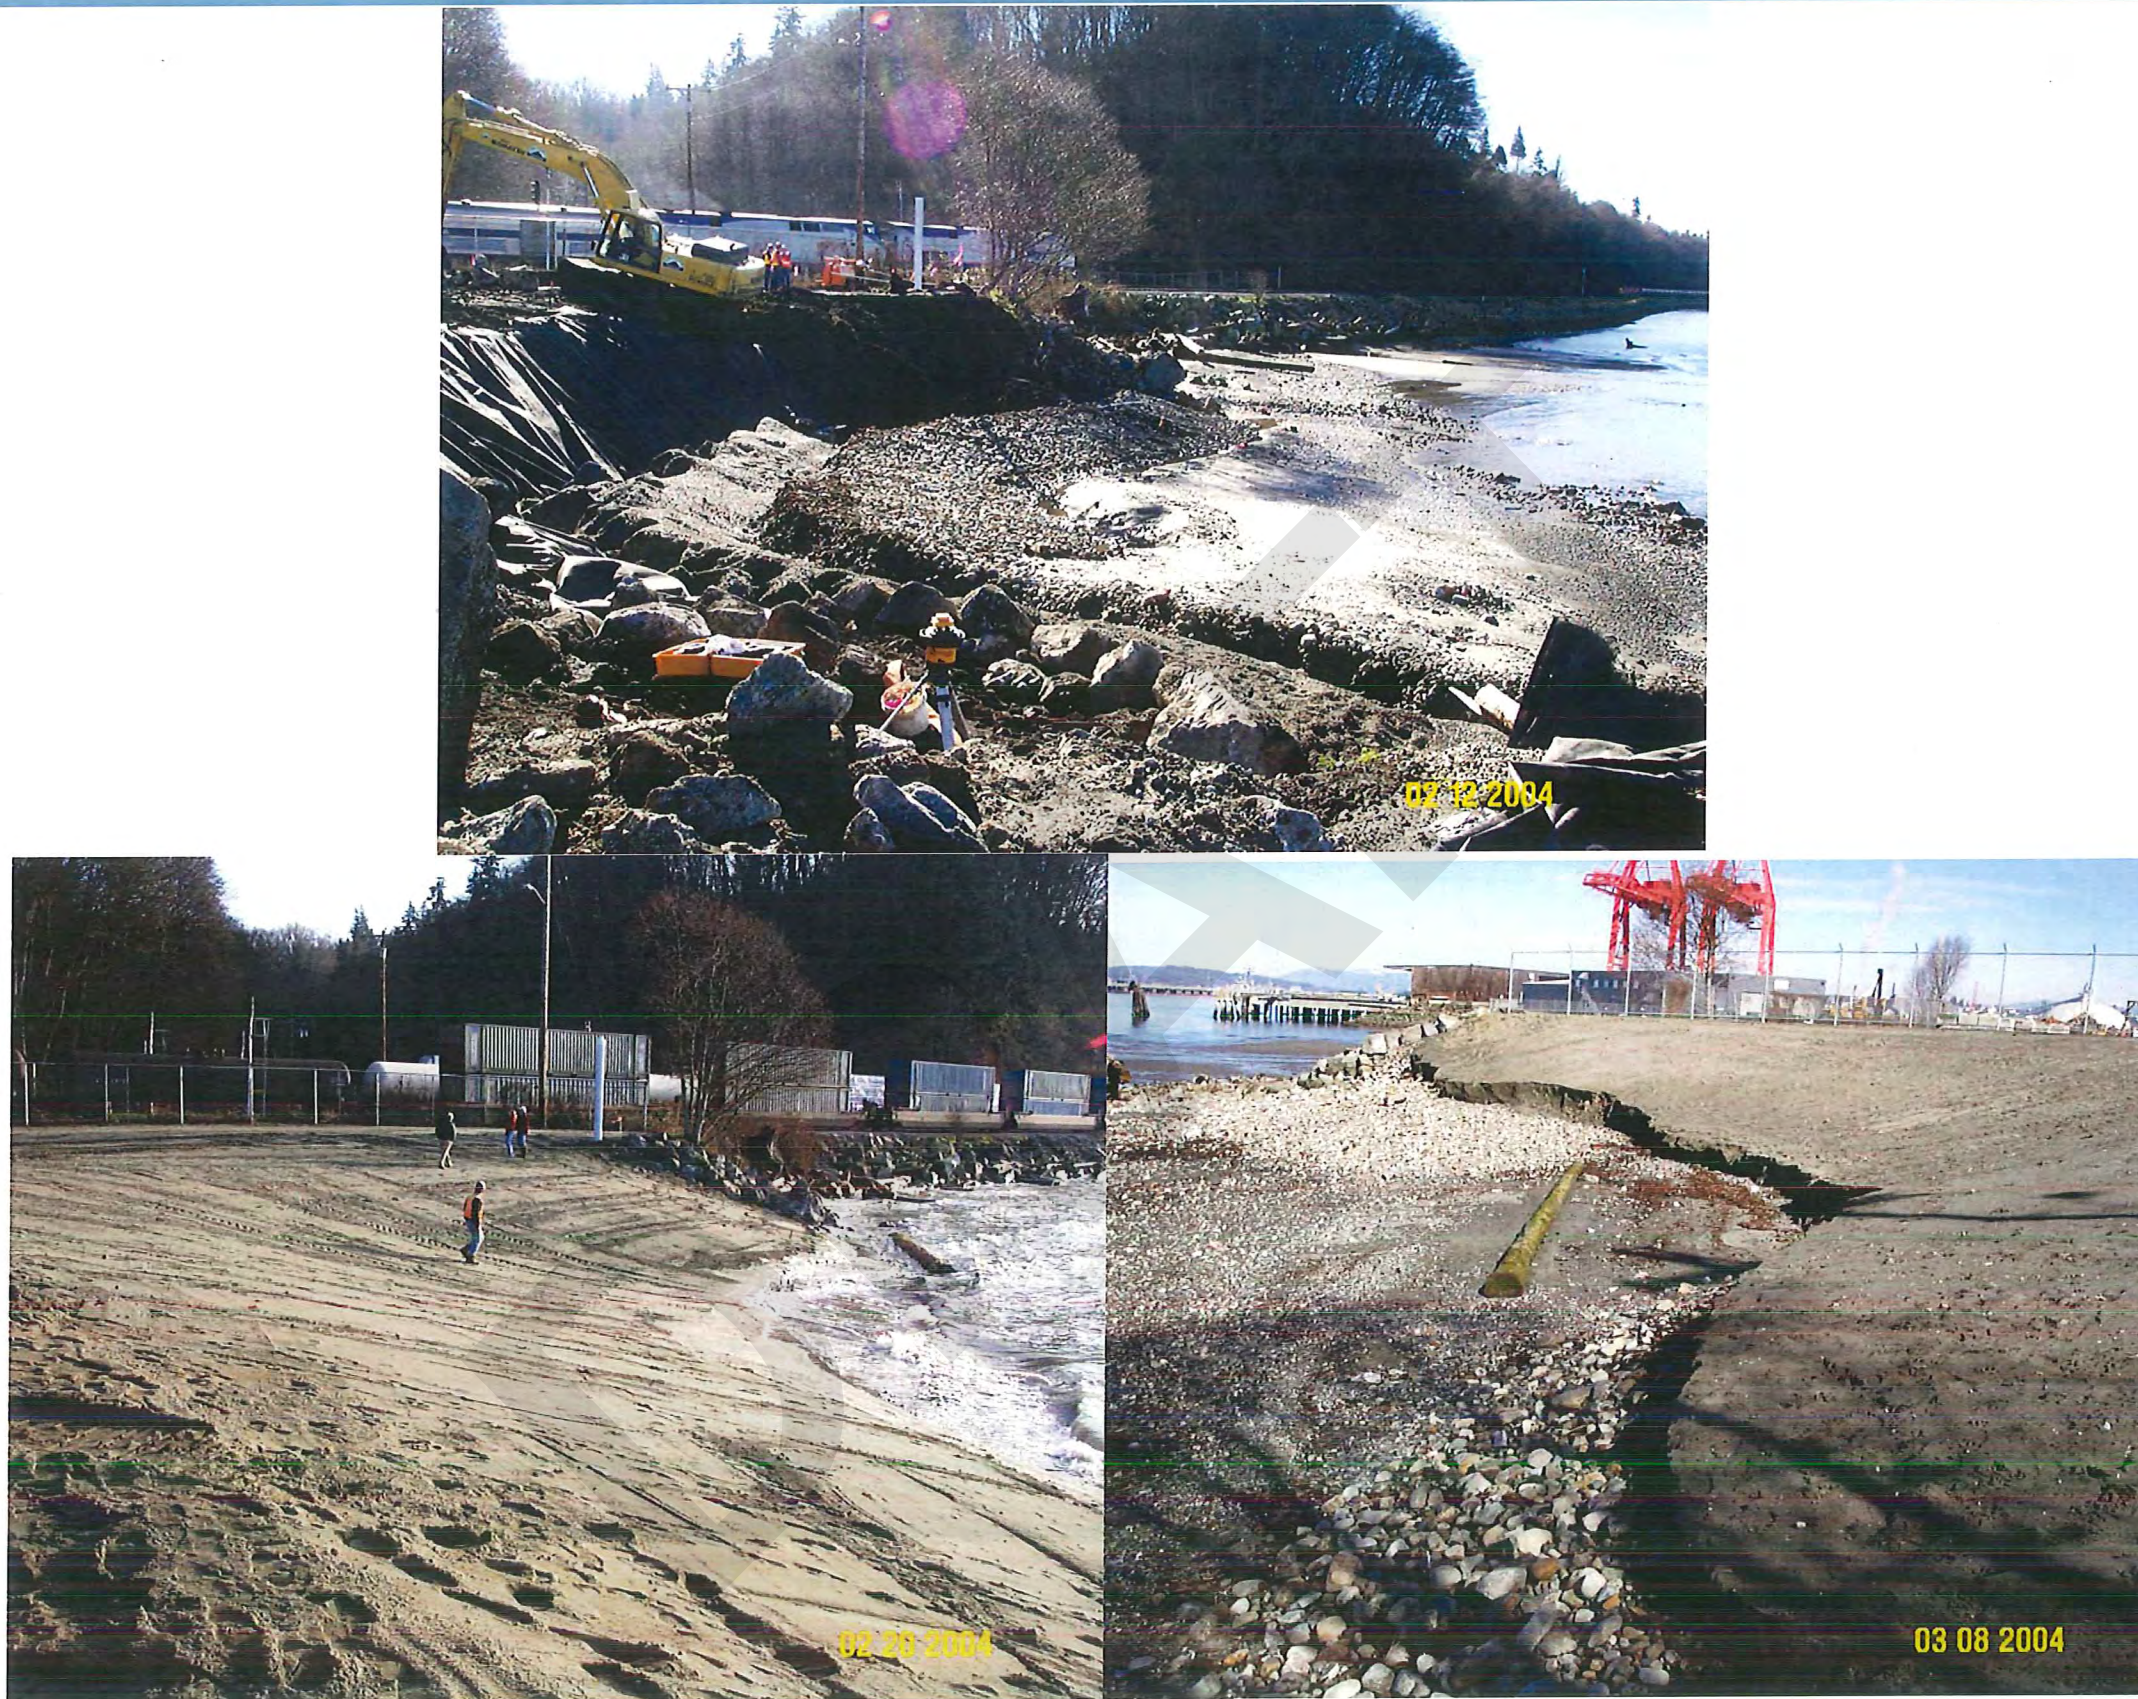
Figure 3: During Construction (top), Post-Construction (bottom left) February 20, 2004 and Beginning of Erosion (bottom right) March 8, 2004
Deep Water Outfall Beach Repair Project

Beach nourishment (placement of beach gravels) is proposed as part of Phase 2 to provide additional shoreline protection to upland areas and provide additional beach area at upper intertidal elevations at the site. The original beach nourishment at the site, constructed in 2004, used sandy sediments as the primary fill material. Due to relatively steep slopes in the fill area (greater than 8H:1V) and high wave energy at the project site, the majority of the sand placed on the site at or below MHHW was significantly eroded within 1 month of placement (see Figure 3 in Attachment 1).

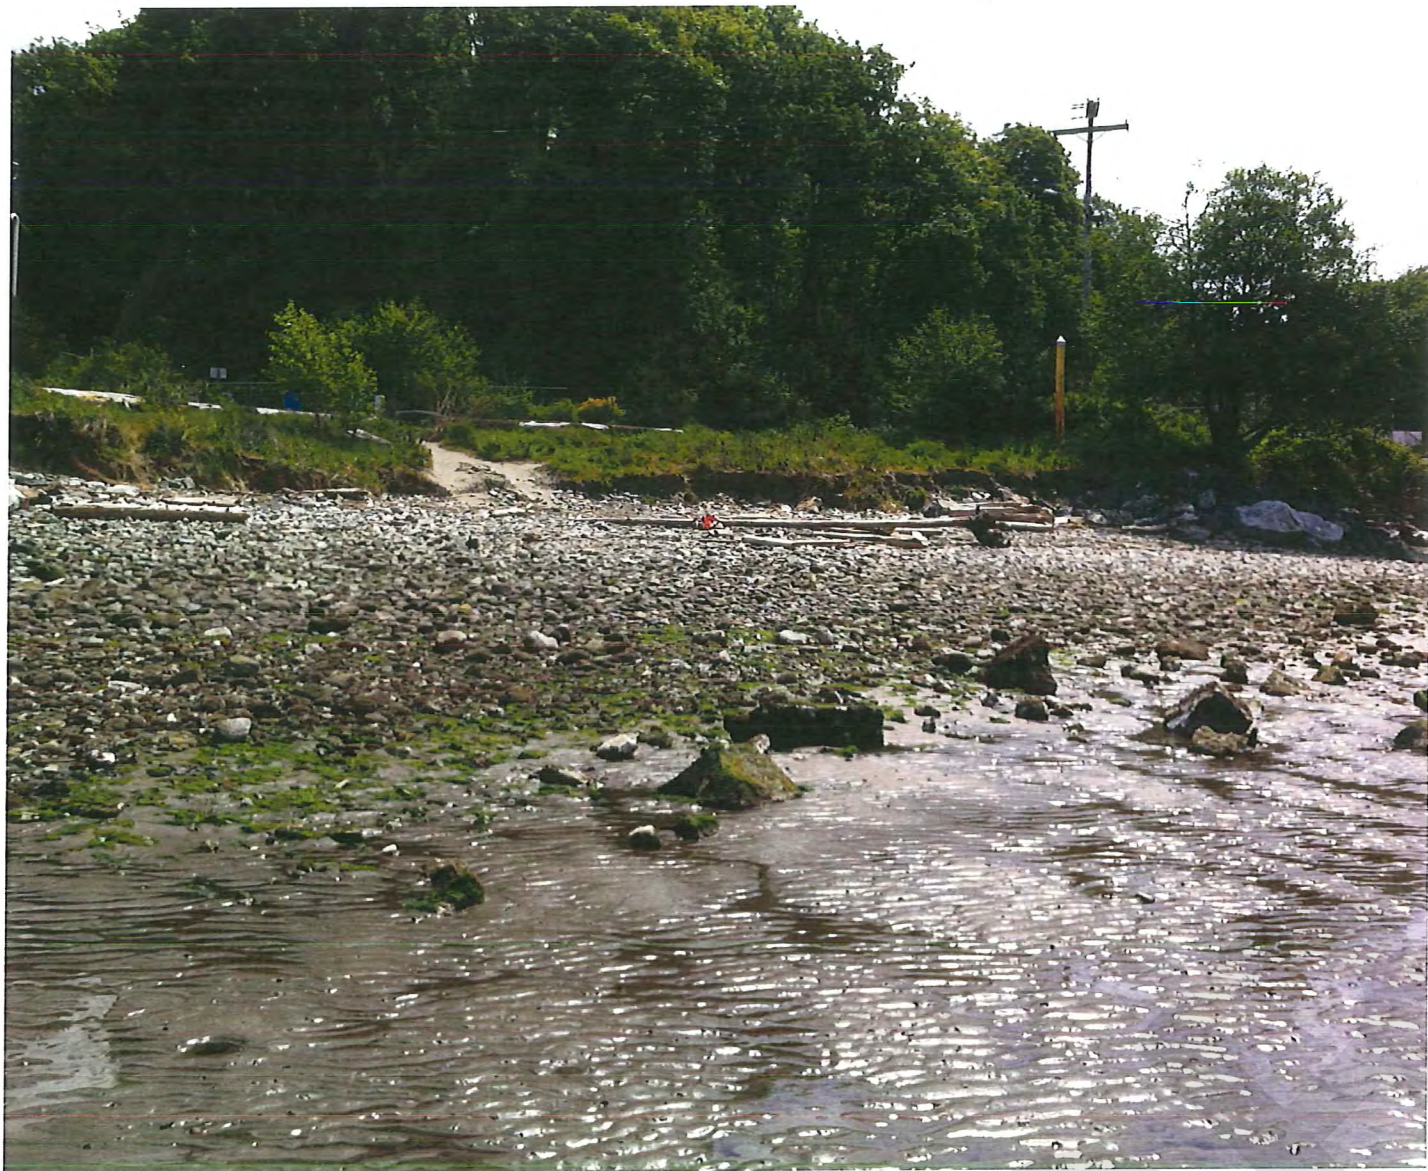
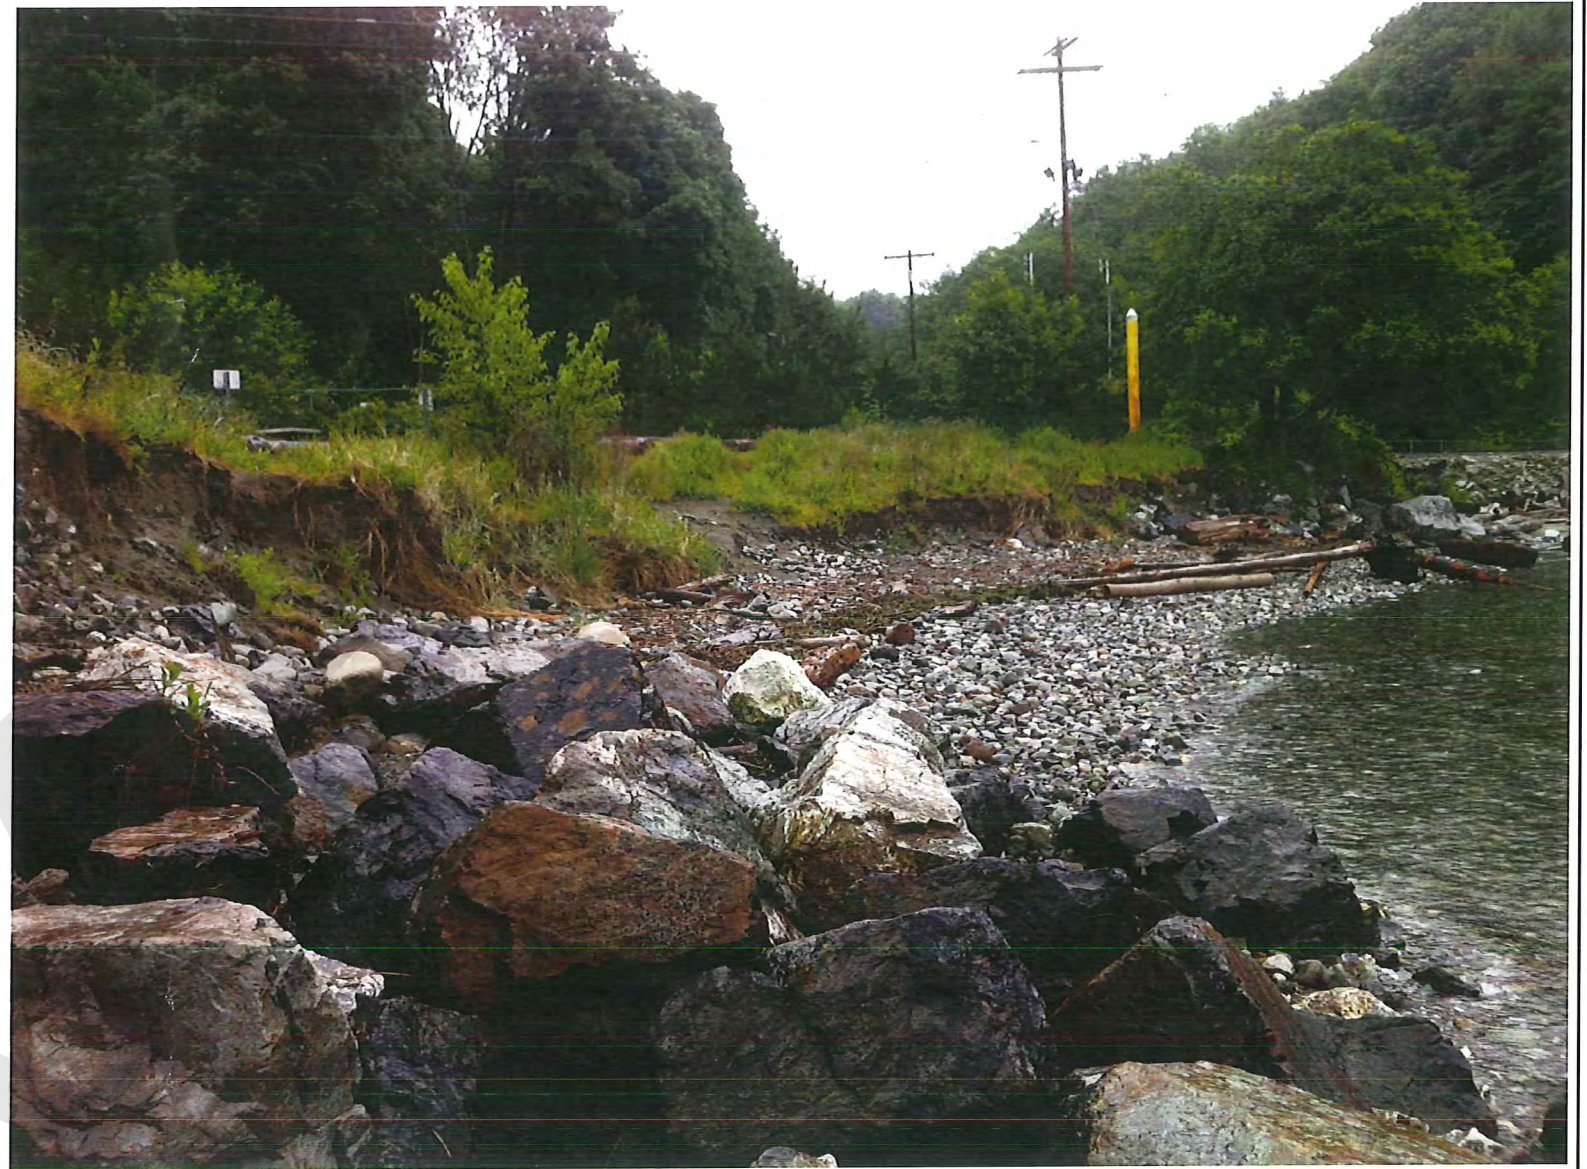
Figure 4: Site Visit May 18, 2012, Low Tide (Left) and Site Visit June 7, 2012, High Tide (Right)
Deep Water Outfall Beach Repair Project

sand had eroded to the point that the underlying cobble and larger armor rocks became visible. At present, the majority of the placed sand has been removed from the upper intertidal area and the underlying cobble has spread over the area. The bank immediately adjacent to the project site is eroding; and portions of the existing (pre-Phase 1 repair work) rock armor slope had failed. In addition to upland Port property, upland portions of the park area are also continuing to erode with potential loss of public park space.

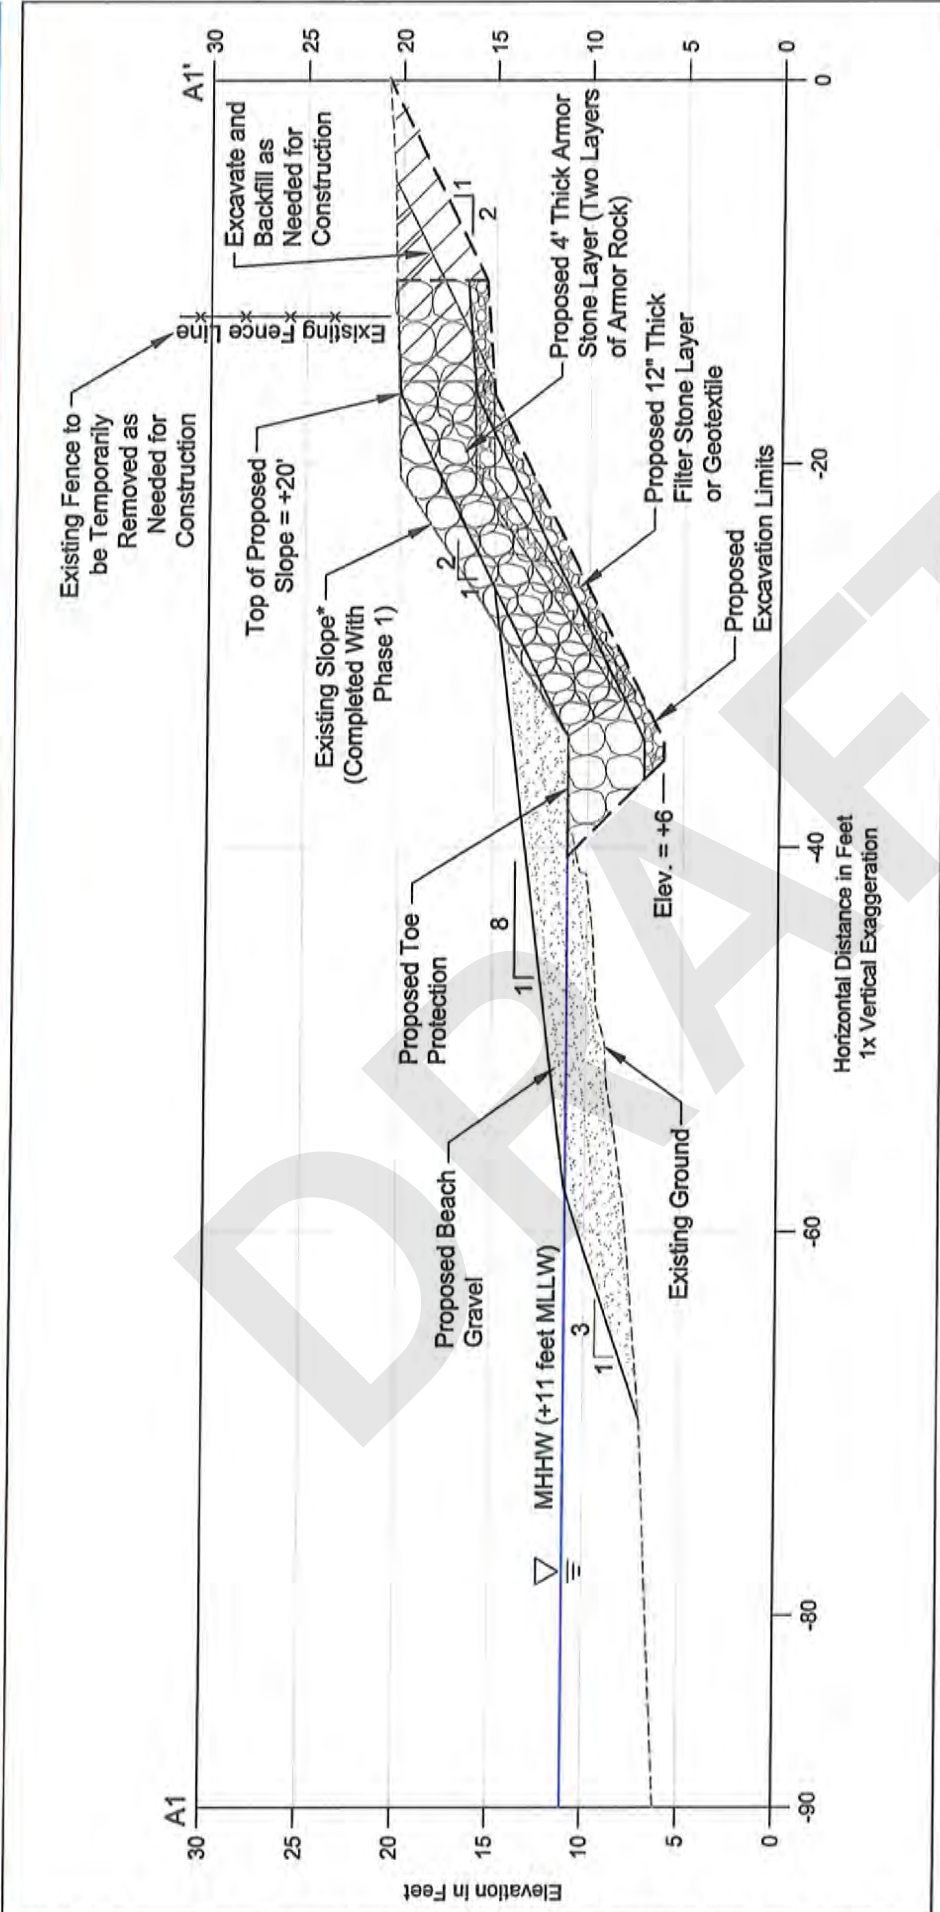
NOTE:
 1. * Deconstruct 1.5H:1V rock armor slope and rebuild as shown. Located above Mean Higher High Water (MHHW).

Figure 6
 Cross Section of Phase 1 / Phase 2 Overlap
 Deep Water Outfall Beach Repair Project

Phase 2 consists of adding additional toe protection to portions of the Phase 1 slope above and below MHHW (see revised Sheet 2 of the Joint Aquatic Resource Permit Application [JARPA] Drawings in Attachment 2). See Figure 6 in Attachment 1 for a cross-section of the overlap between Phase 1 and Phase 2. The toe of the slope from Phase 1 will be extended 50 square feet beyond MHHW to the extent required to build a stable rock revetment to stabilize that area. The revetment would also be modified from the 1.5H:1V slope for the Phase 1 construction, to achieve a 2H:1V slope for the final Phase 2 construction. Please see the JARPA submitted to USACE for a complete description of Phase 2 (City of Everett 2012).

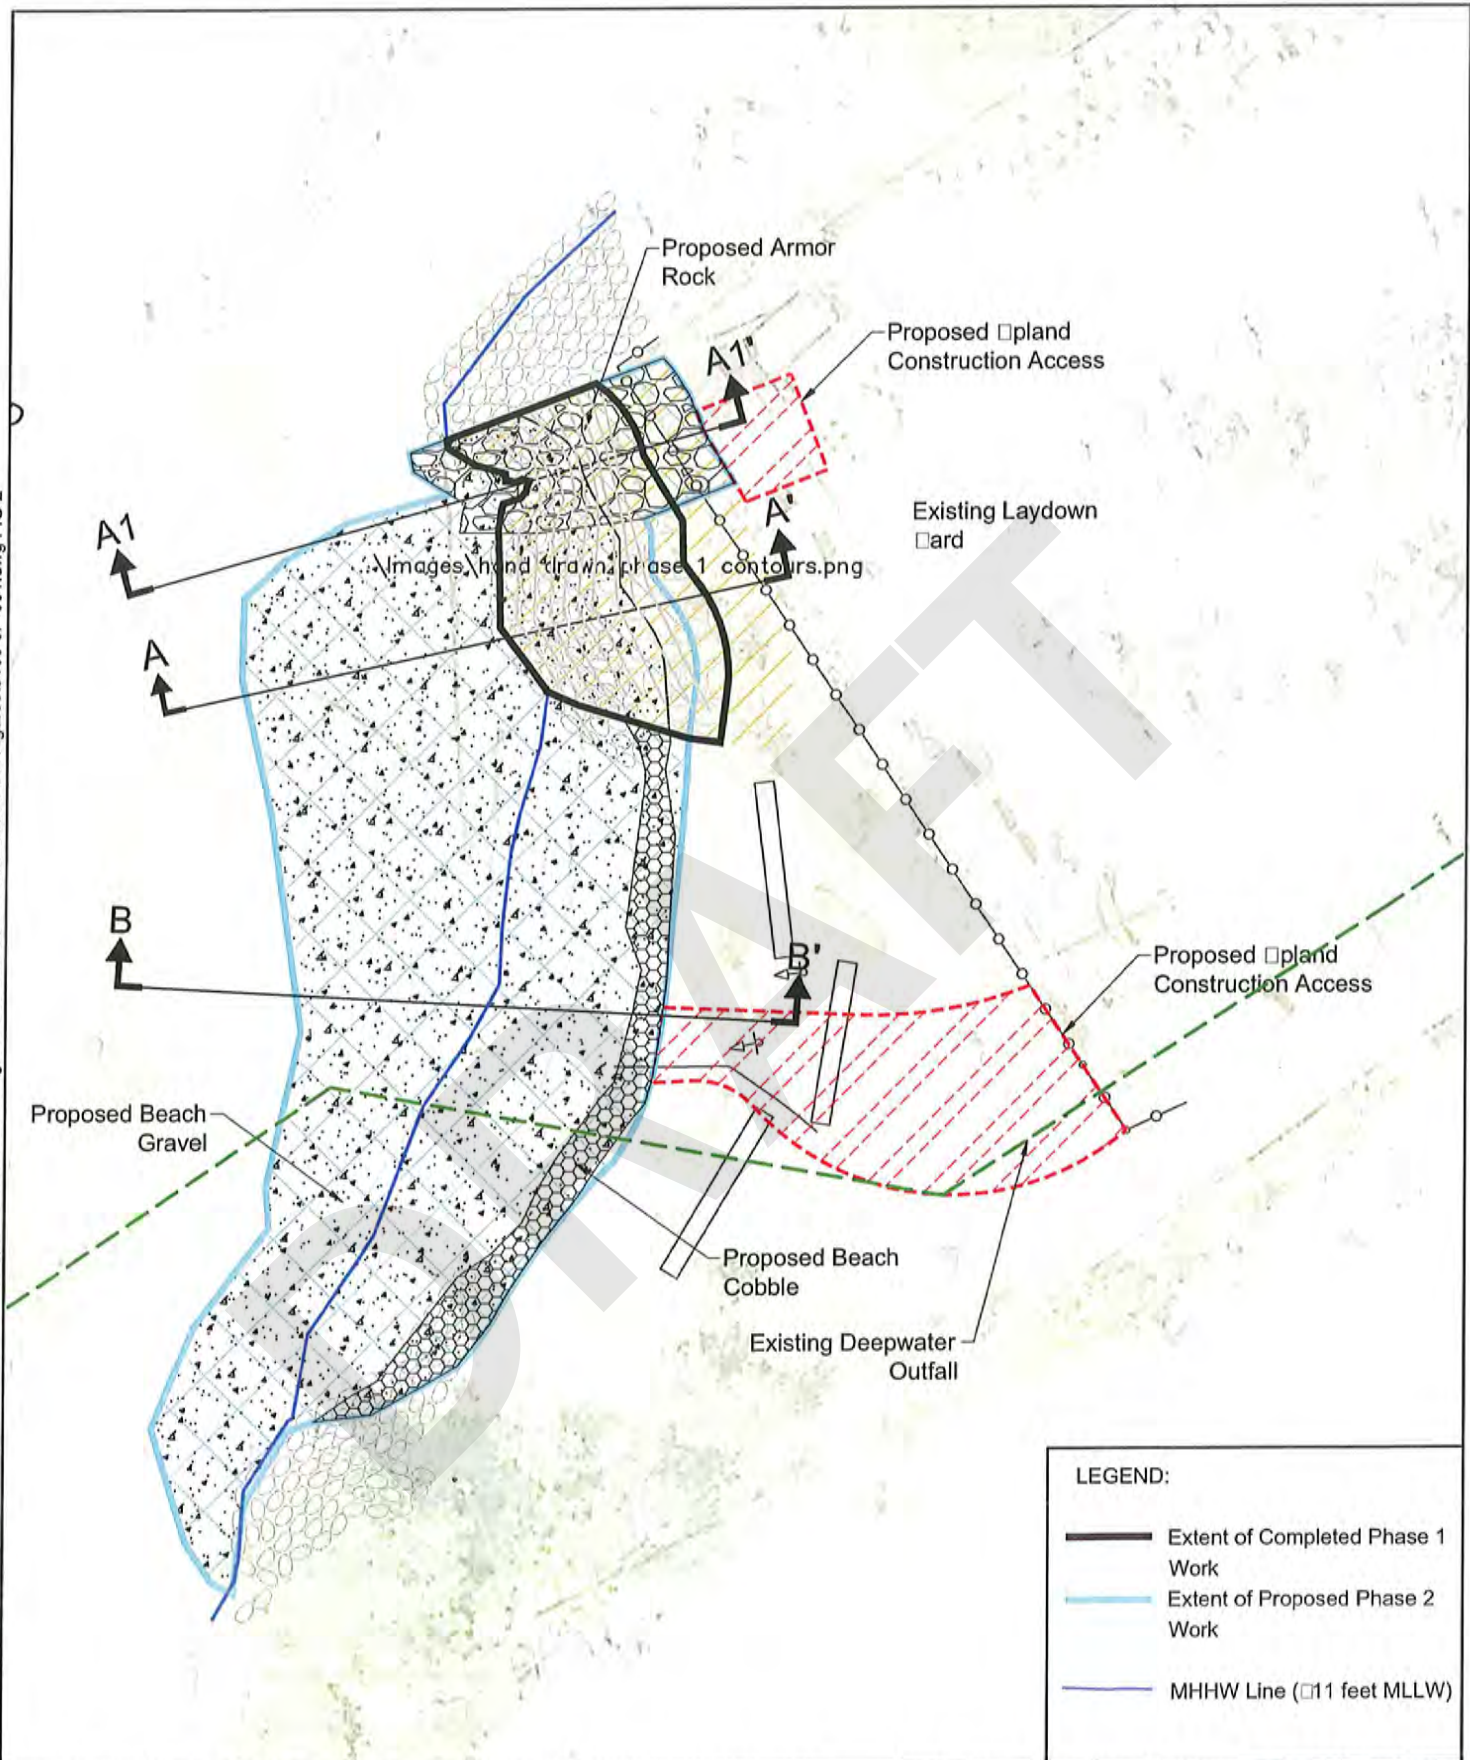
- Extent of Completed Phase 1 Work
- Extent of Proposed Phase 2 Work
- MHHW Line (11 feet MLLW)

PURPOSE: REPAIRING BEACH TO PREVENT EROSION AND SLOPE DESTABILIZATION

PROPOSED: SLOPE STABILIZATION REPAIR AND REHABILITATION

The project area and vicinity were excavated in late 2003 to place an offshore outfall for KC and the City (outfall shown on revised Sheet 2 of the JARPA Drawings in Attachment 2). A temporary trestle was built to aid in the placement of the offshore outfall, which extended from its land connection at the project site to the southwest. In February 2004, following construction of the outfall, the site was re-graded and filled to create a pocket beach. The temporary pier was removed and the shoreline was cut back from a straight shoreline to a curved shoreline. Immediately after construction, the beach sand began eroding due to impacts from storm wave action (as described above in "Original Beach Restoration"), forming a vertical scarp along the shoreline. A month following construction, the beach
