**Anchor QEA Memorandum
“Response to U.S. Army Corp of Engineers’ Request
for Additional Information”**

To: Erin Legge, U.S. Army Corps of Engineers **Date:** March 28, 2013
From: Heather Griffin, City of Everett
Heather Page, Anchor QEA, LLC
Re: Kimberly Clark DWO Project (NWS-2000-34)
Response to U.S. Army Corps of Engineers' Request for Additional Information

FIGURES OF ORIGINAL BEACH RESTORATION, PHASE 1, AND PHASE 2

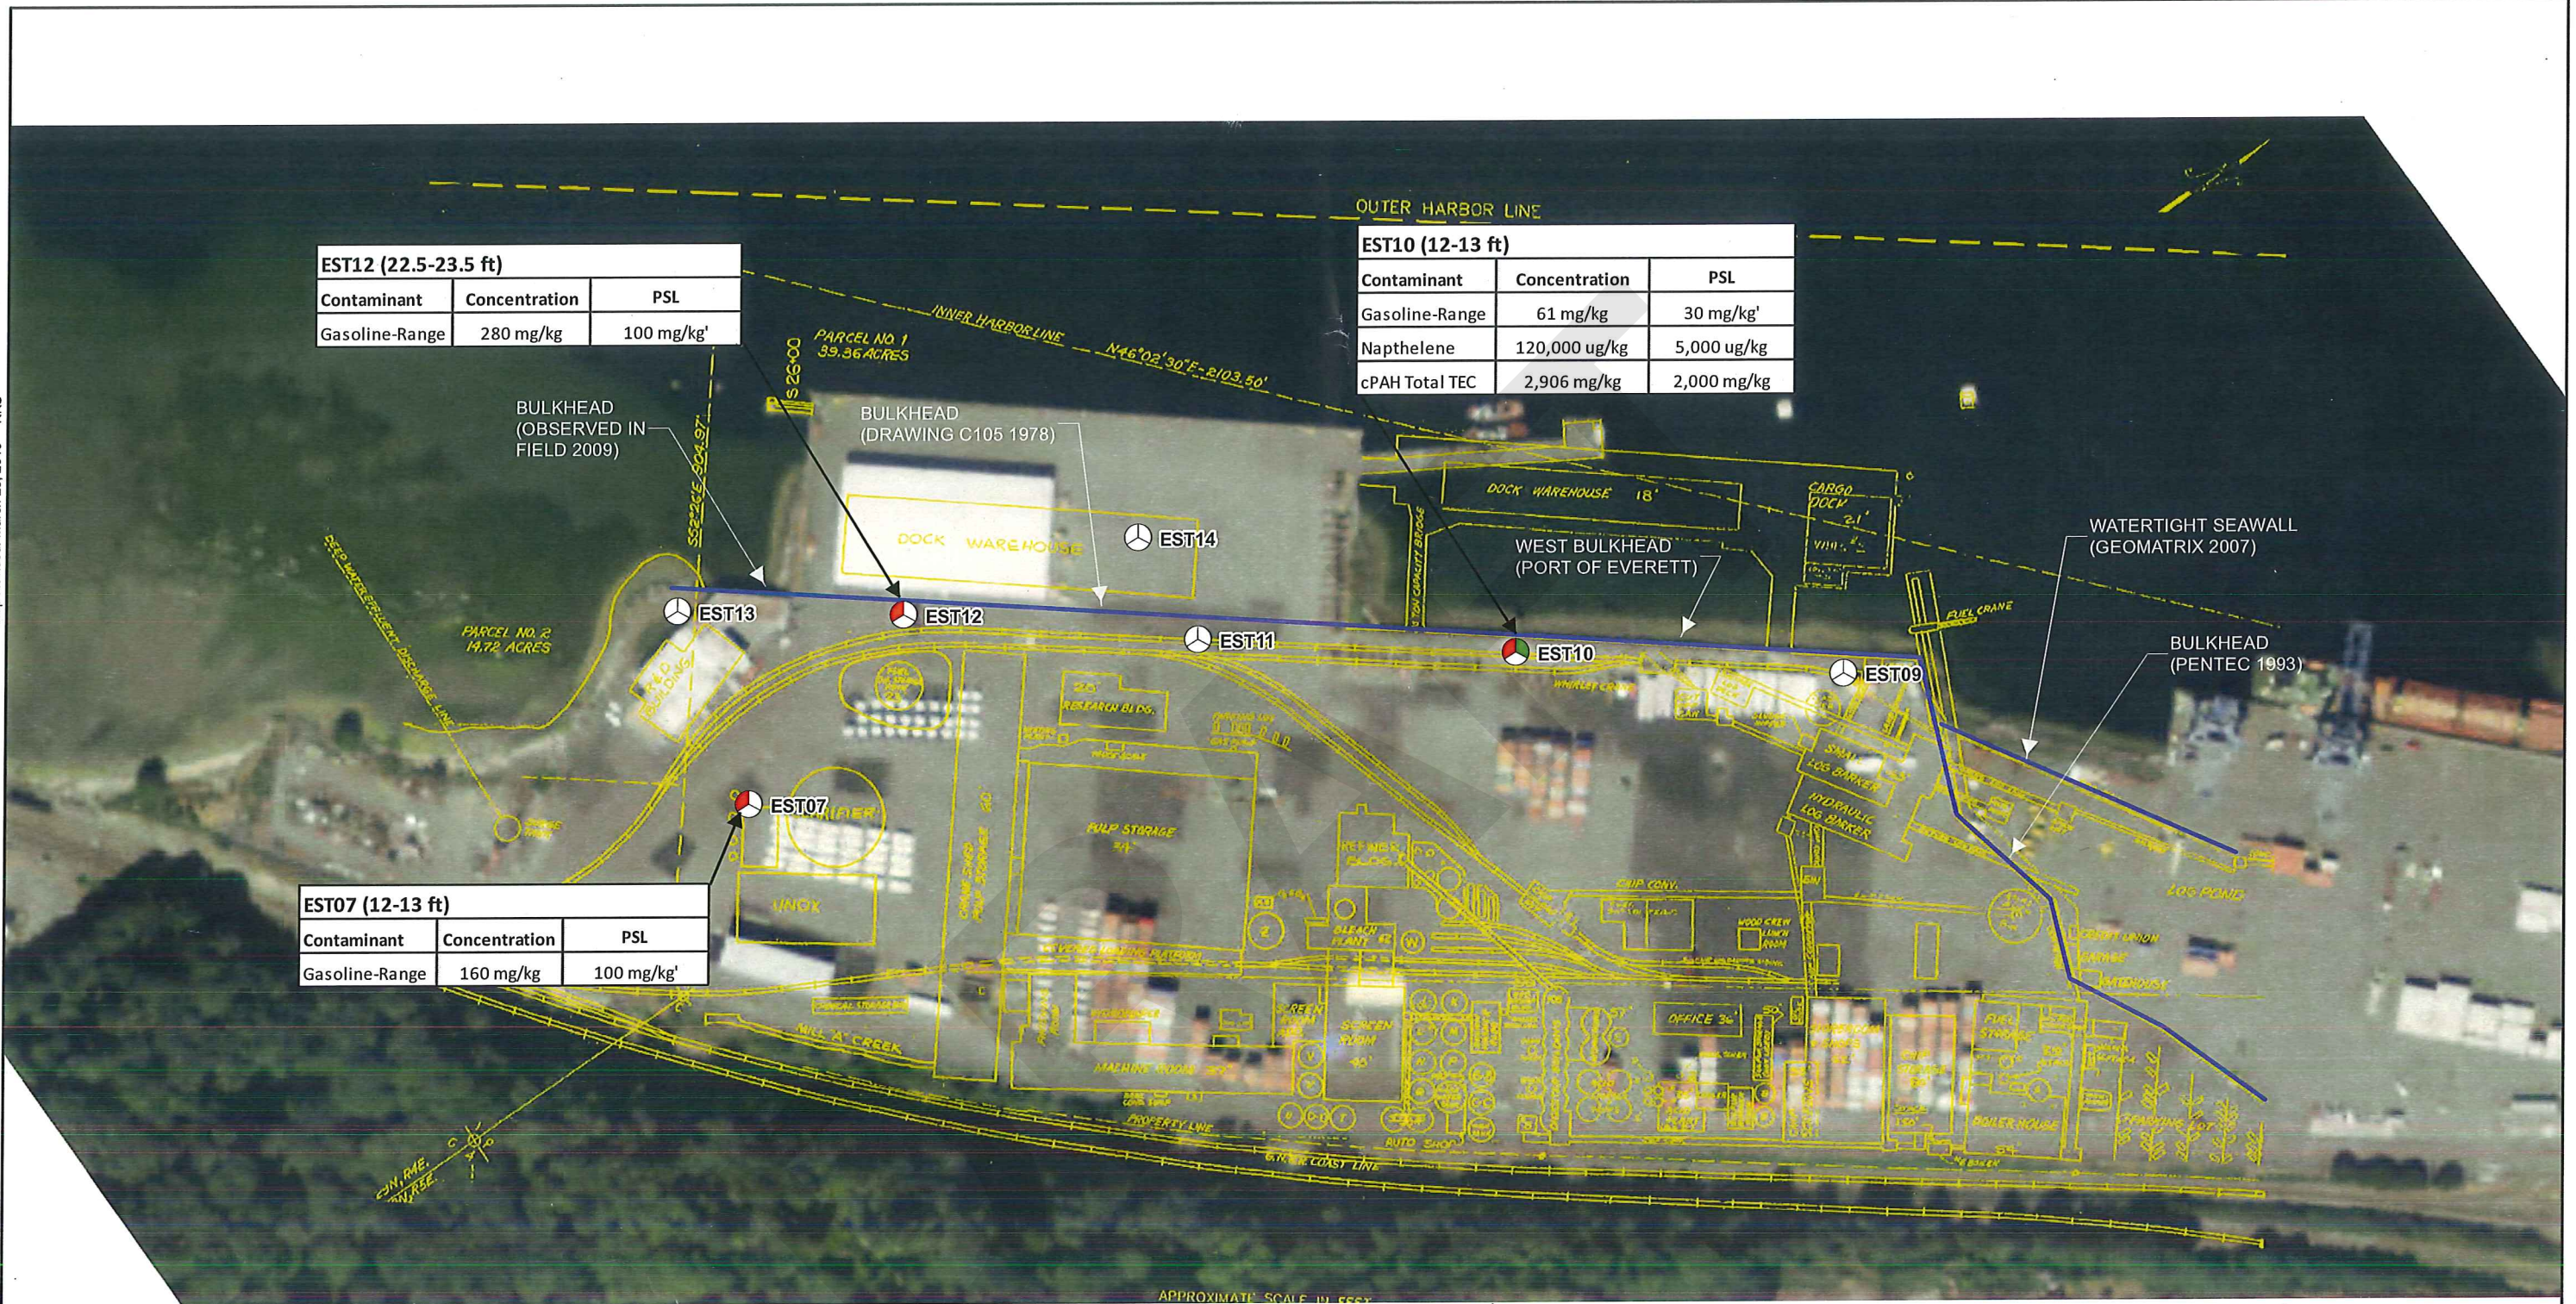
Figure 2

Contaminants of Potential Concern in Soil at Concentrations Exceeding Preliminary Screening Levels	
Port of Everett Everett, Washington

As an update to the City's response in JARPA Question 9.i., the project site has no known contaminated sediment. According to the Washington State Department of Ecology (Ecology)/Port, the project is within the Weyerhaeuser Mill A Former Model Toxics Control Act (MTCA) Site, which has known sediment contamination. The nature and extent of contamination has not been defined for this Site and will be determined as part of the Remedial Investigation/Feasibility Study (RI/FS). Please note that there have been no documented exceedances of the cleanup standards within the KCDWO Project area (see figures in Attachment 3).

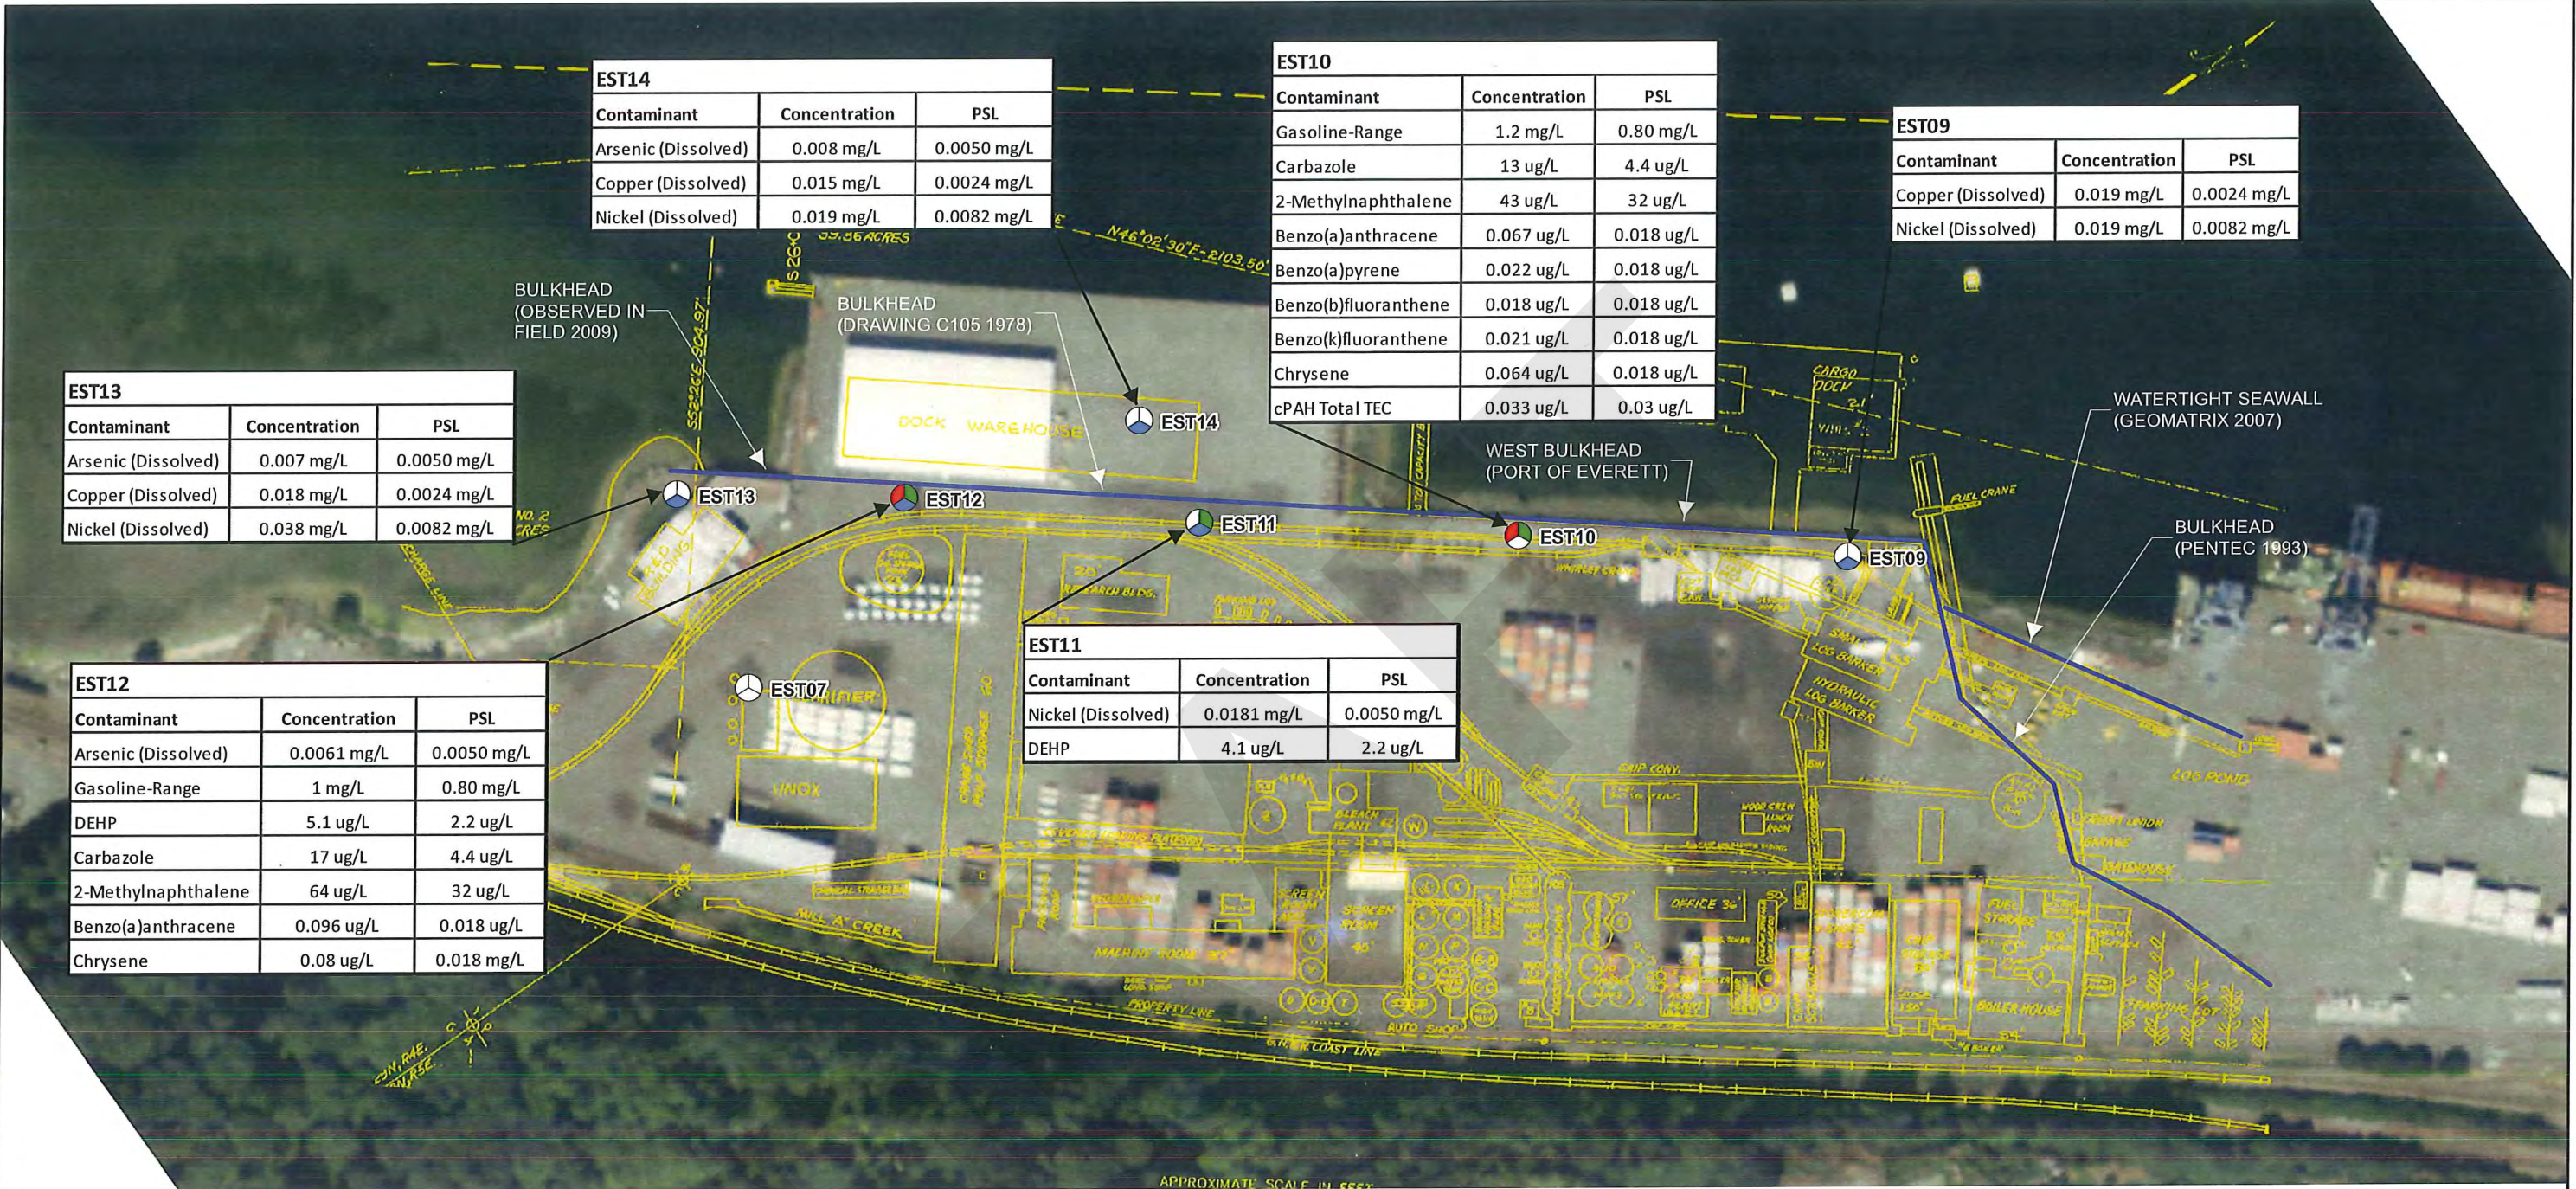
Figure 3

Contaminants of Potential Concern in Groundwater at Concentrations Exceeding Preliminary Screening Levels

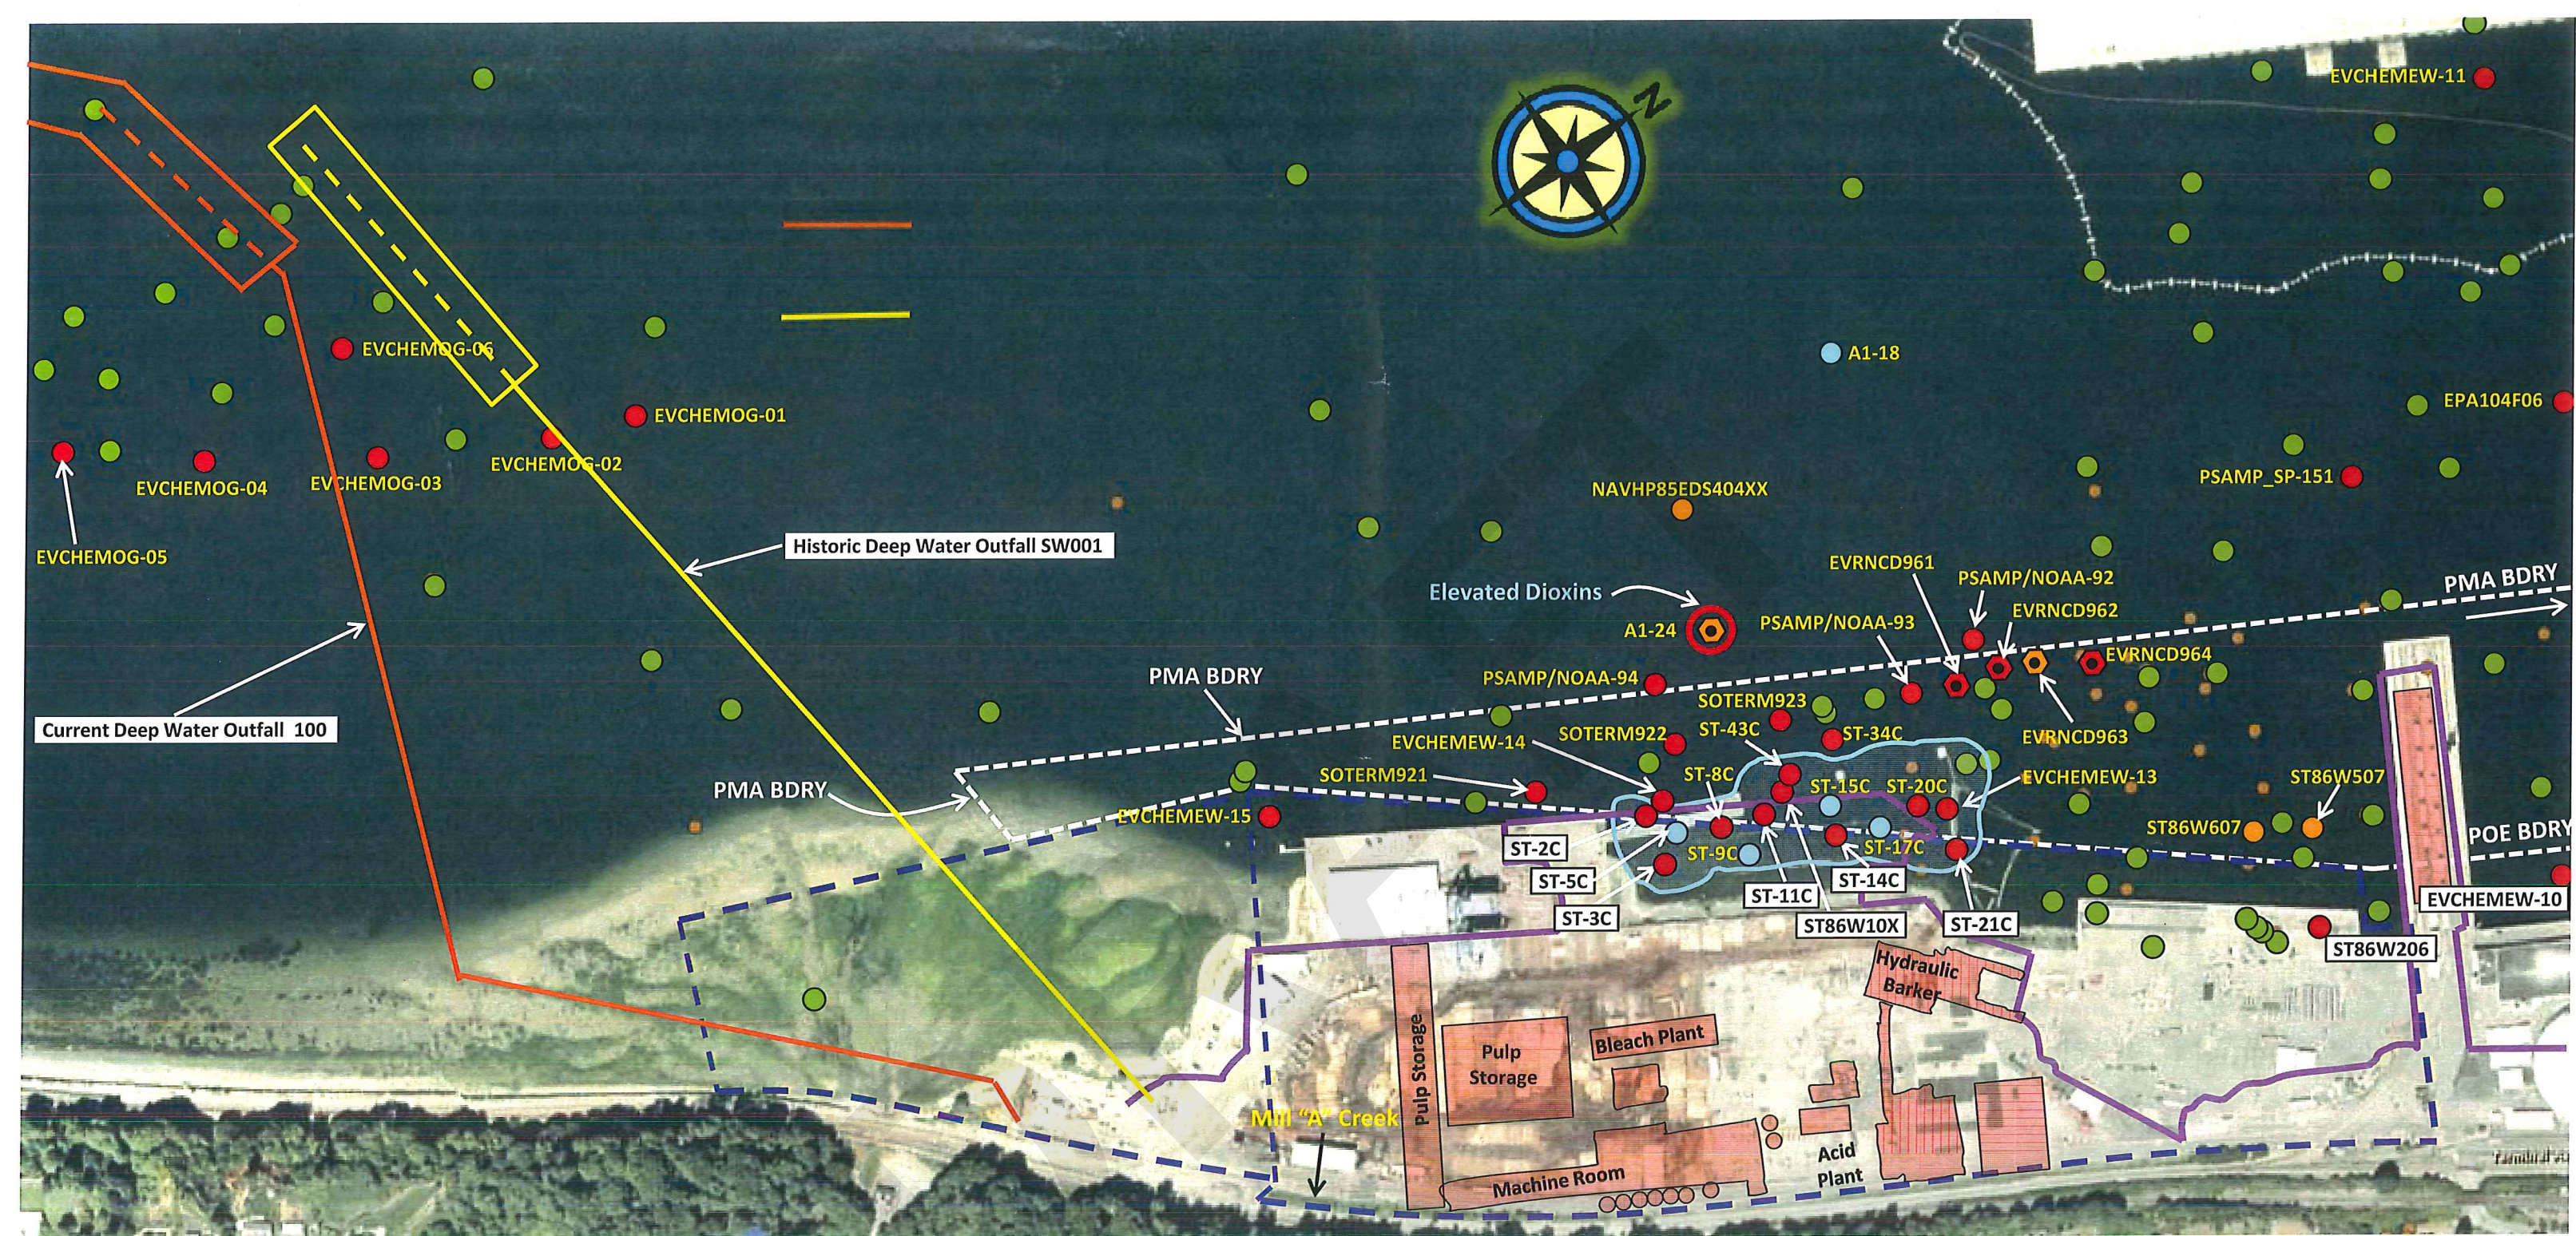
Attachment A – Figure A-6¹ Weyerhaeuser Mill A Former Historical In-Water Sampling Map

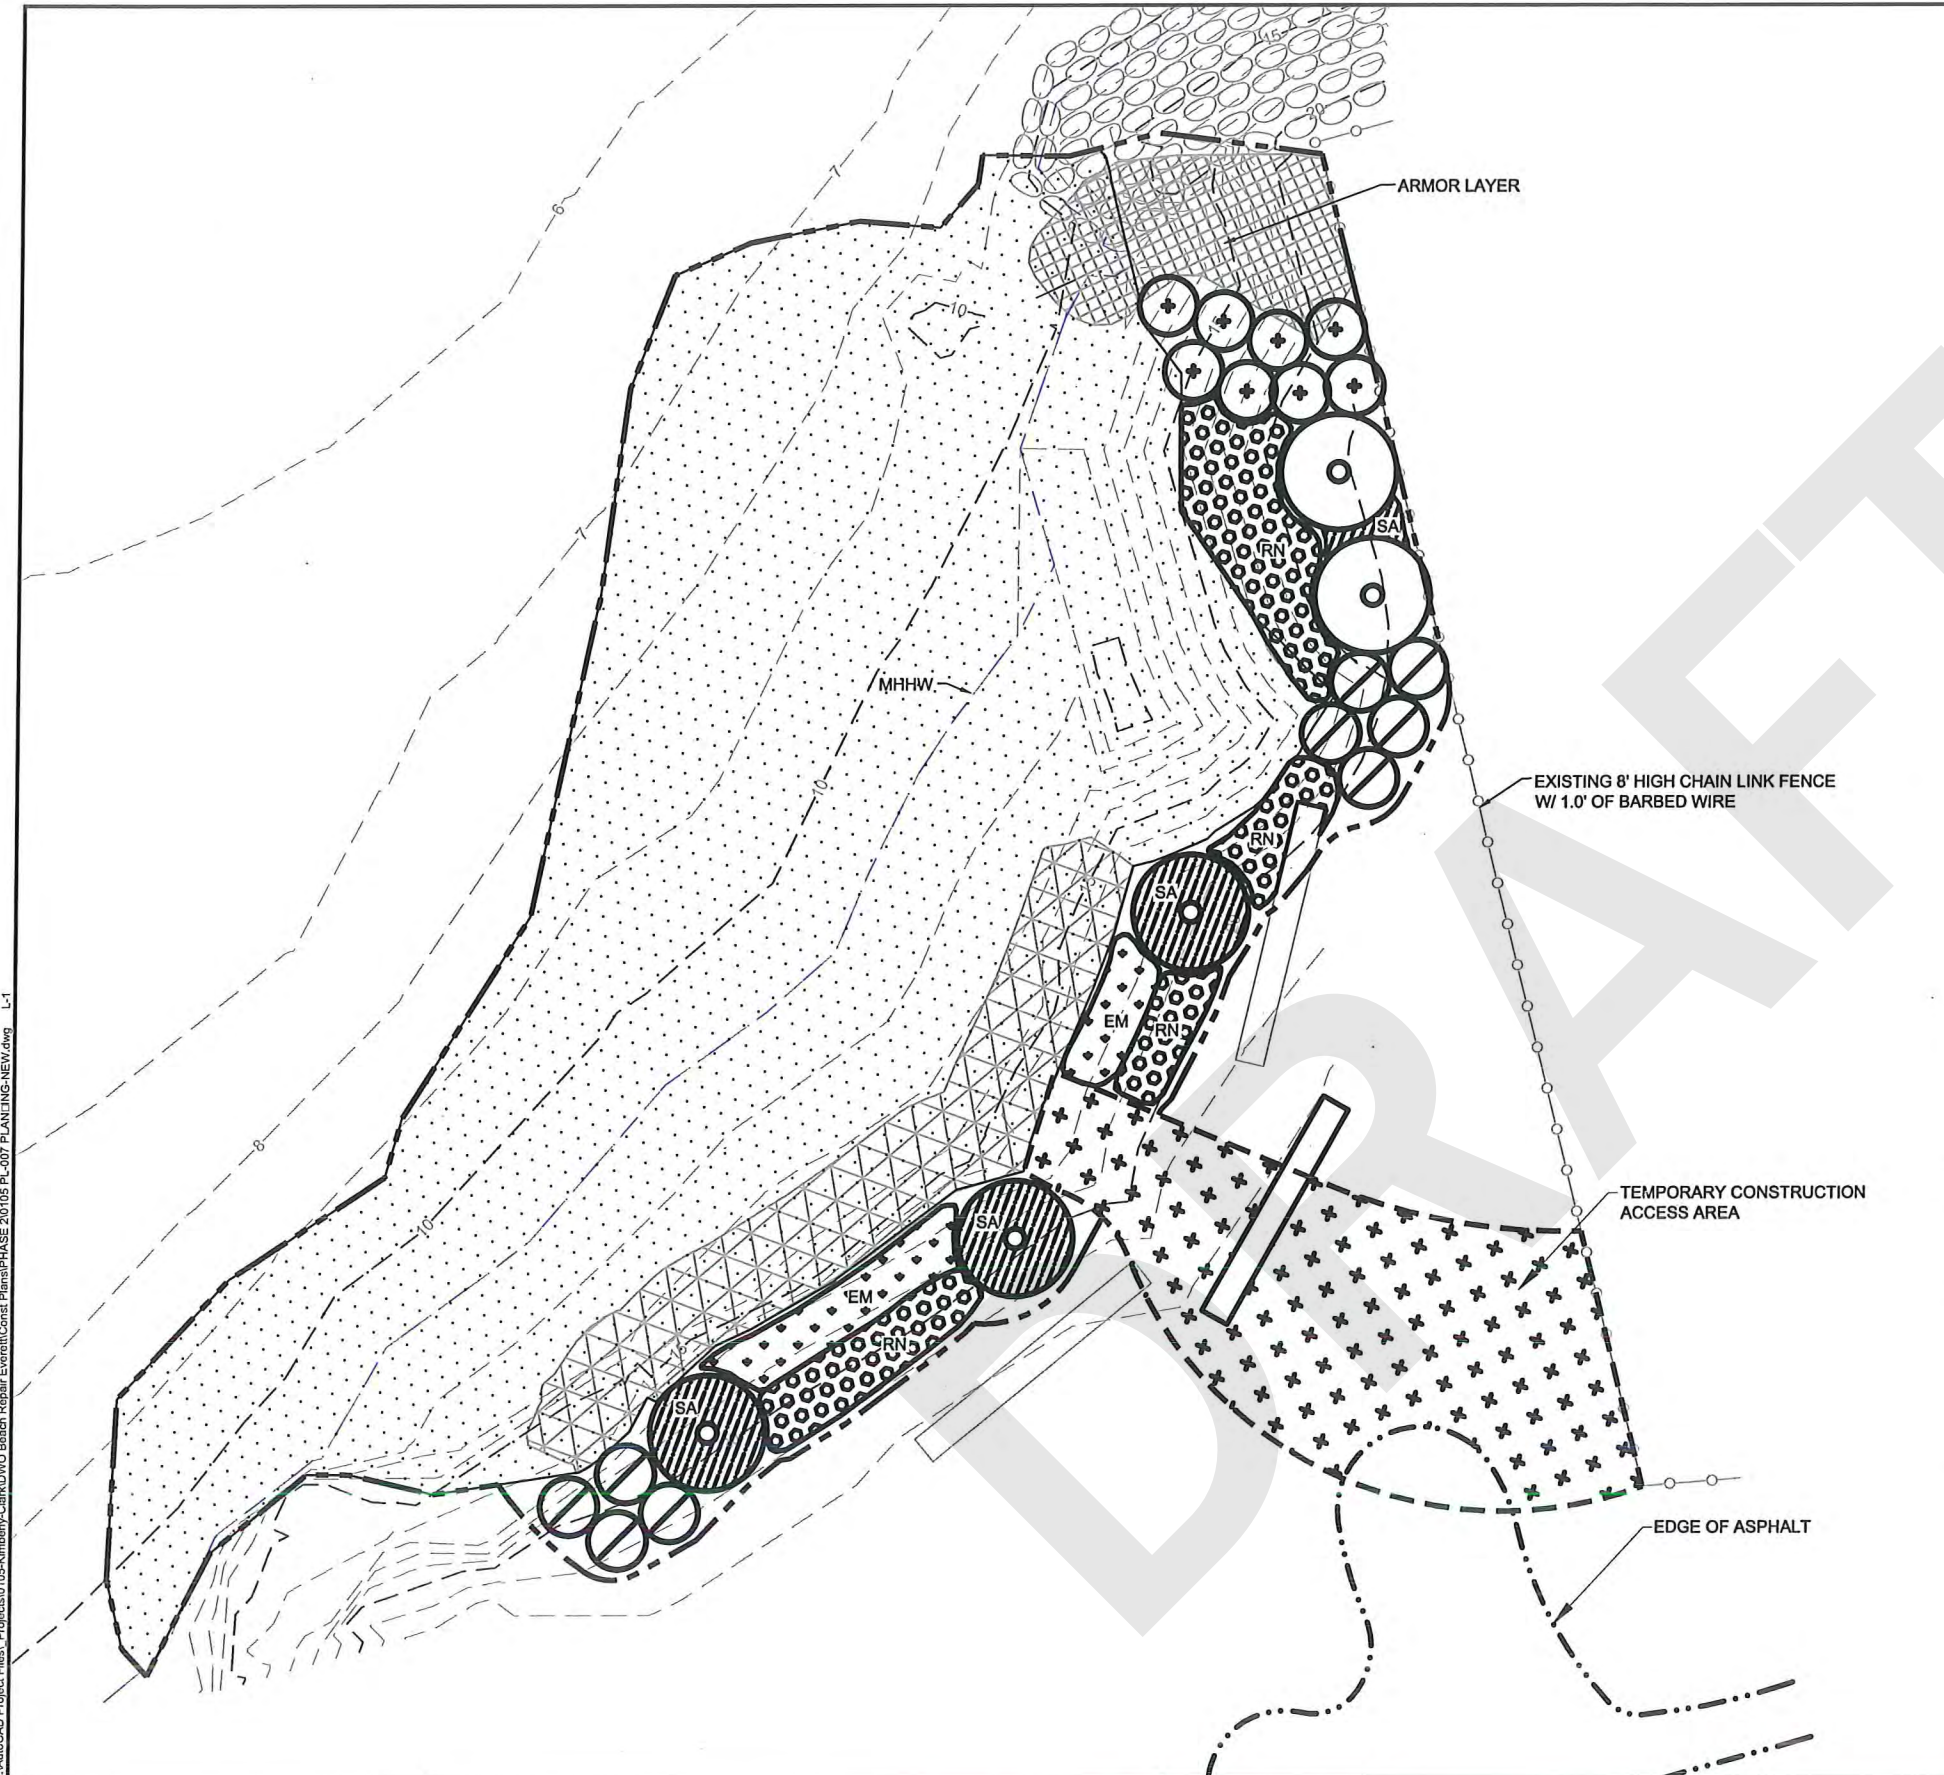
L-1

1. SEE PLAN SCHEDULE SHEET L-2 FOR SPECIES DEFINITION
2. EVENLY SPREAD TOPSOIL (SALVAGED AND IMPORTED) IN ALL PLANTING AREAS; SEE SPECIFICATIONS
3. FOR PLANTING BED PREPARATION AND PLANT INSTALLATION SEE SPECIFICATIONS
4. RESTORE ALL DISURBED LAWN AREAS WITH HYDROSEED, AND FILL AND SMOOTH HOLES AND RIMS CAUSED BY CONSTRUCTION ACTIVITIES

PLANTING PLAN

Please see Attachment 3 the planting plan proposed for the project.

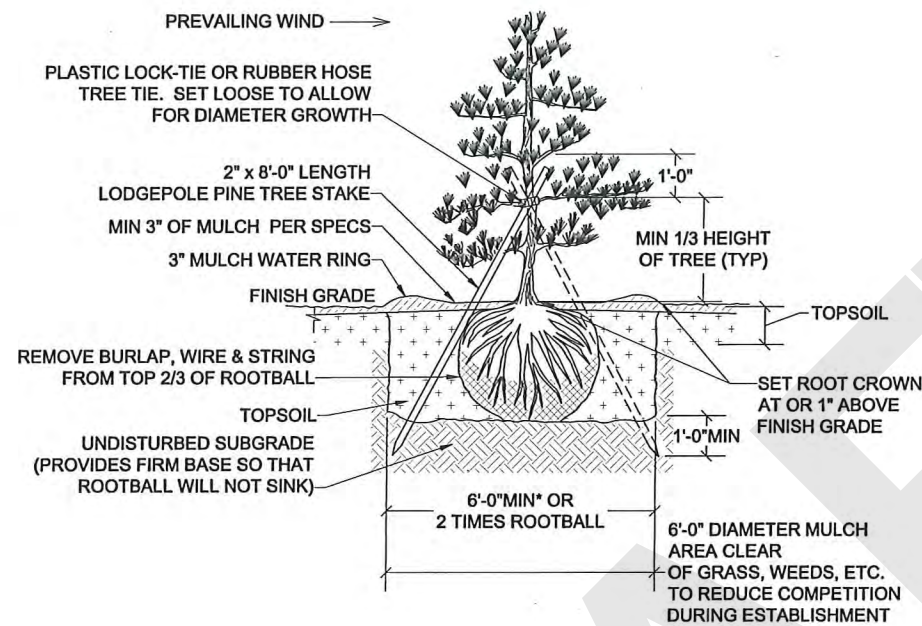
2 CONIFEROUS TREE PLANTING & STAKING
SCALE: NTS

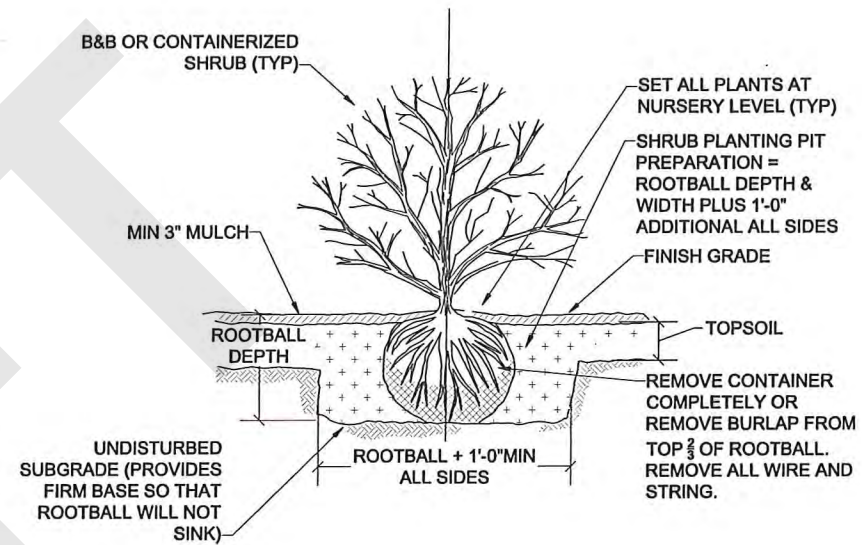
3 SMALL TREE AND SHRUB PLANTING
SCALE: NTS

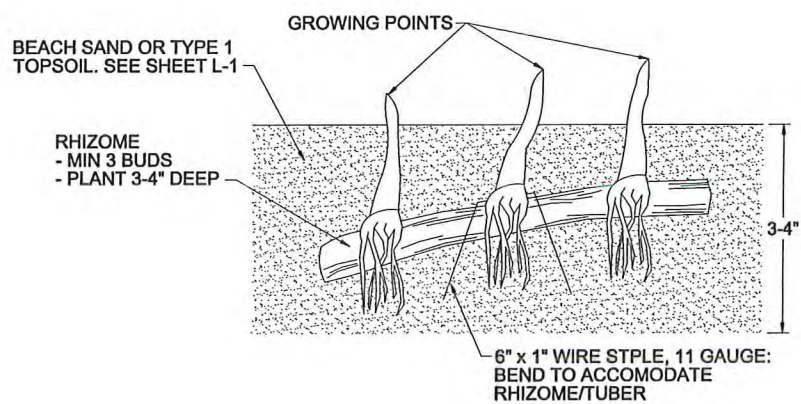
4 BEACHGRASS PLANTING DETAIL
SCALE: NTS
